## **Introduction**

We are confident that data presented herein demonstrates that depth to ground water beneath the release footprint exceeds 50-feet. However, the recent sampling event shows that the volume potentially subject to remediation is small and a dig-haul-dispose remedy to the most stringent standards (depth of 50-feet) provides better protection of groundwater and is financially more responsible than drilling a boring to generate high-quality data that provides the level of certainty preferred in OCD Guidance.

### Nature of Release and Specific Justification for Volume Estimate

McElvain Energy - Fed #2 Release

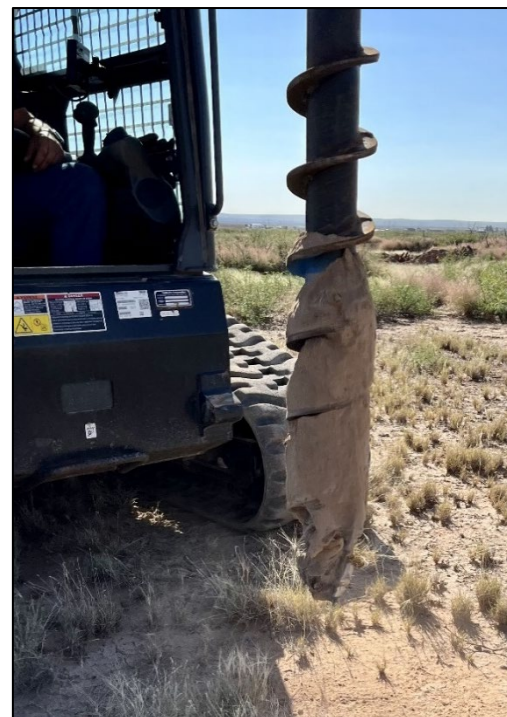
Advancing the auger and bit at a rate such that the auger is essentially “screwed into the ground” can yield the best samples from soft earth material (soil or sand). The adjacent image illustrates this slow rotation method, collected from 0-2 feet. This method maximizes the amount of cuttings on the auger and minimizes slough on the surface around the borehole. This slow rotation method does not generate excessive heat nor mix the sample intervals.

*Slow rotation method, 0-2 ft sample*

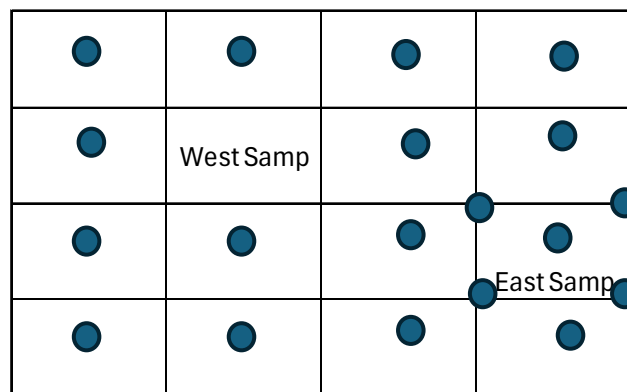
Figure 3 Proposed sampling grid of remediation cell

We request that OCD consider any sample from this task that are below Table 1 criteria as final sampling for the areas represented by said sample. The sample density for the proposed final sampling is 19 samples/4356 square feet (1 samples/217 square feet as displayed in Figure 3).

Upon receipt of analytical results, identify all samples that exceed Table I closure criteria. Repeat the protocol B and C for the excavation cell that includes these samples.

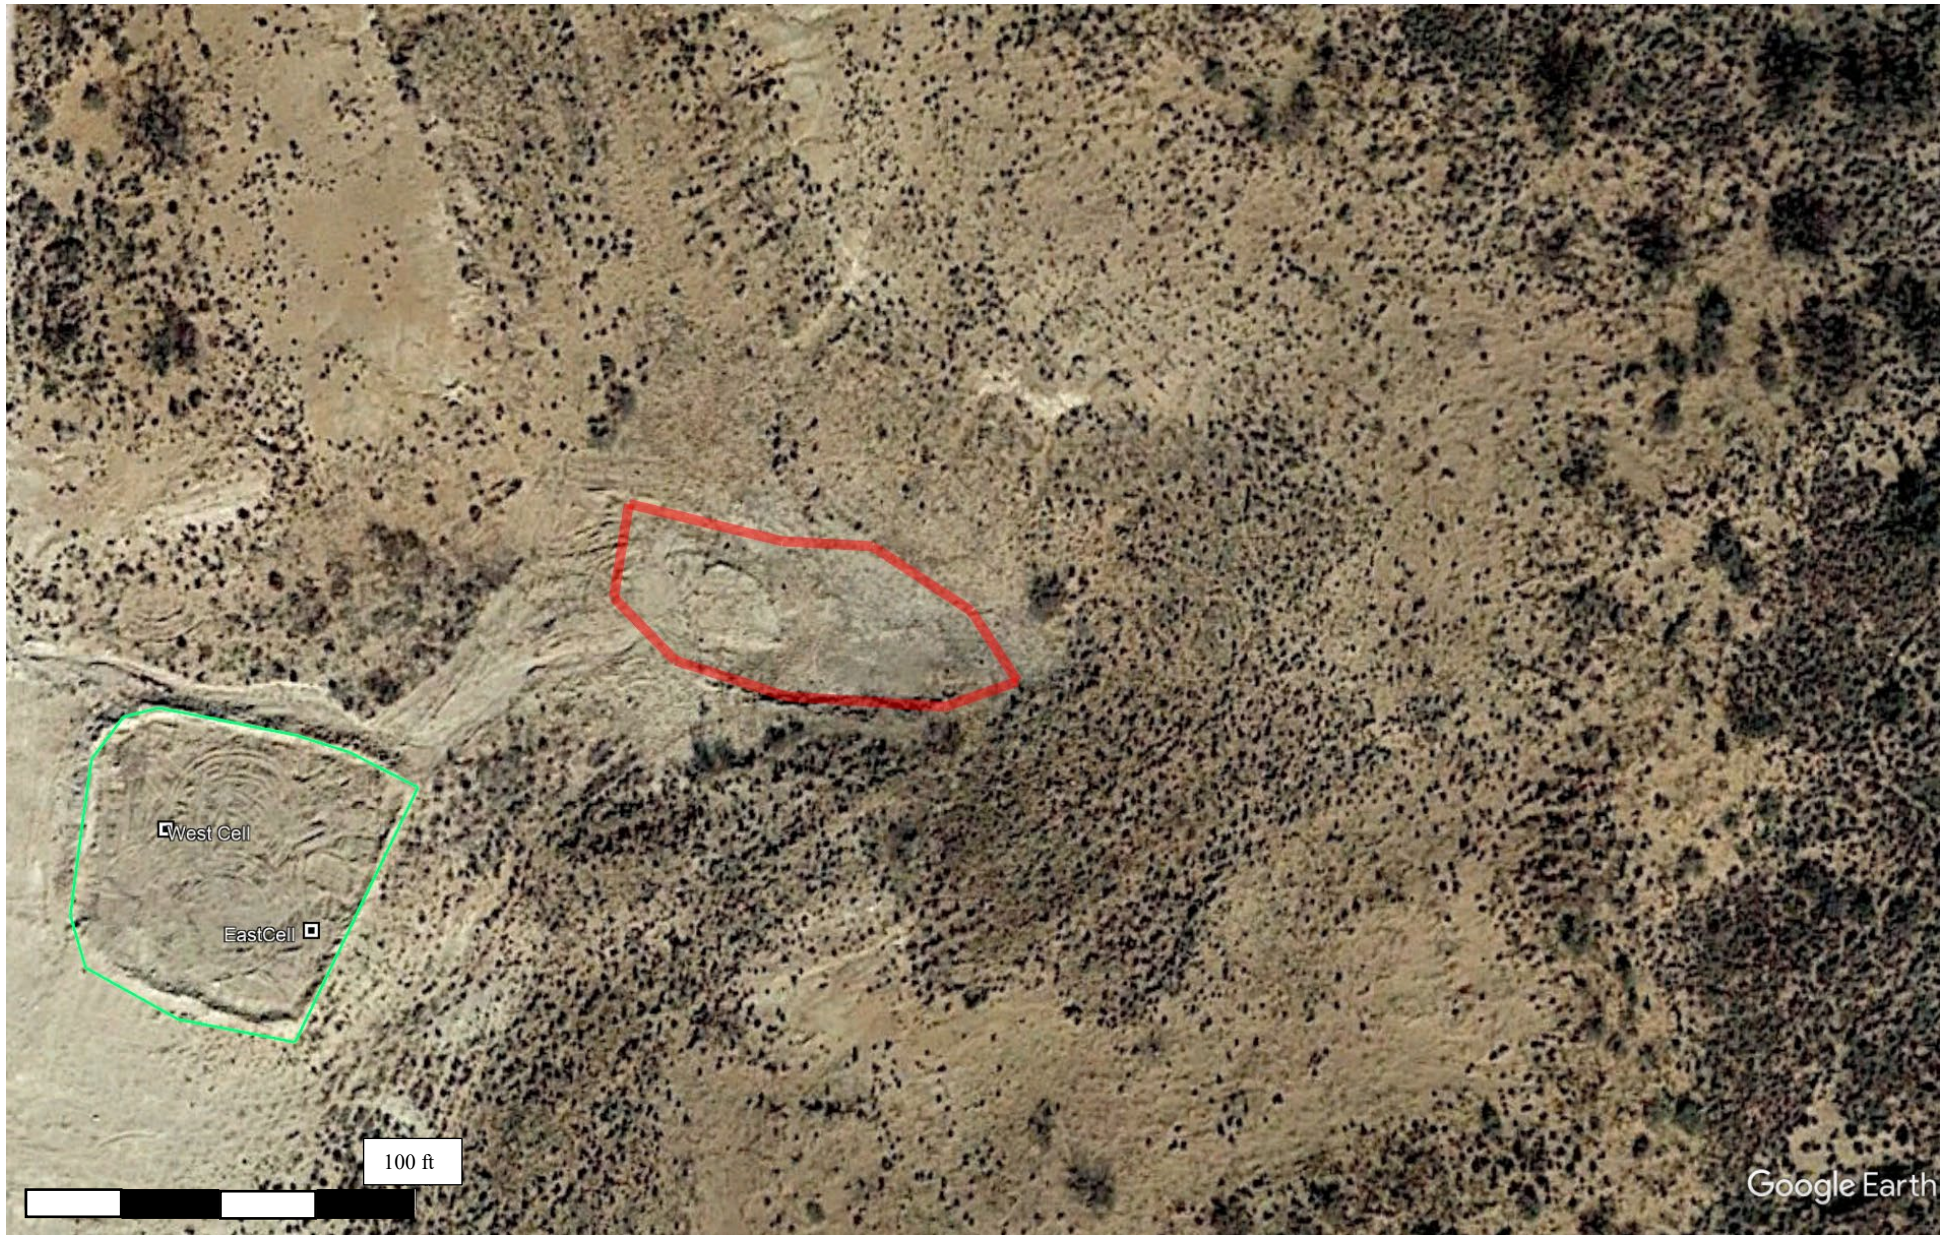
Figure 2  
Google Earth image from 2/1/2017, four months after the release. McElvain removed crude oil pooling in the caliche pit (red polygon) to the square phyto-remediation cell shown in green. The approximate location of the two sampling points within the cell are displayed.
