Remediation Summary and Closure Request

JR HOLT A #001
API # 30-025-05559
Historical Produced Water and
Crude Oil Release
Incident Nos.: nPRS0522047385 and
nSAD0521635557

Morgan Operating, Inc.
OGRID #224367
Hobbs, New Mexico 88241

Crain Environmental
2925 East 17th Street
Odessa, Texas 79761

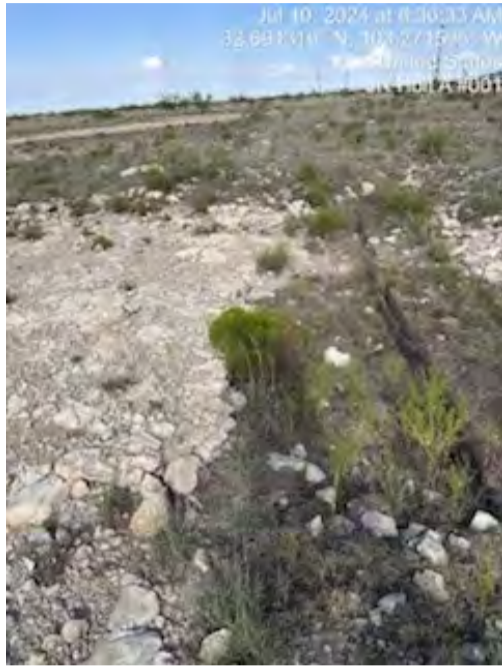
View to E of Sample 1 location (7/10/24).

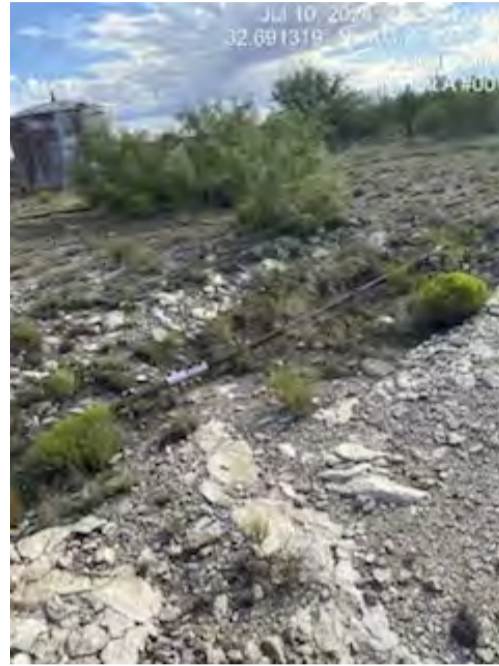
View to NE of Sample 1 Location (7/10/24).

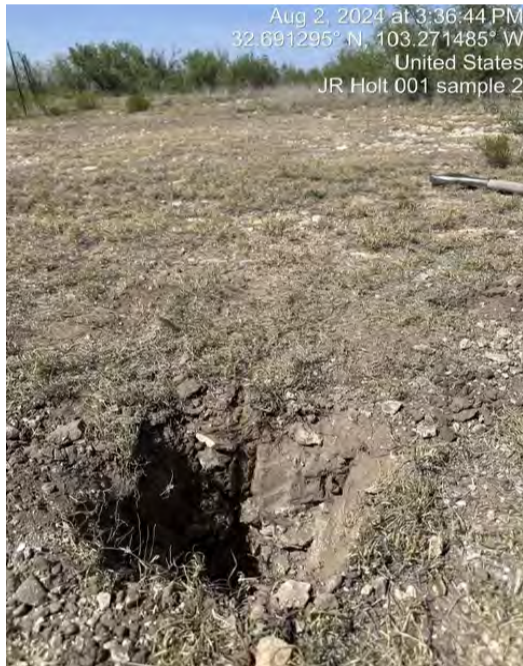
View of Sample 2 location (8/2/24).

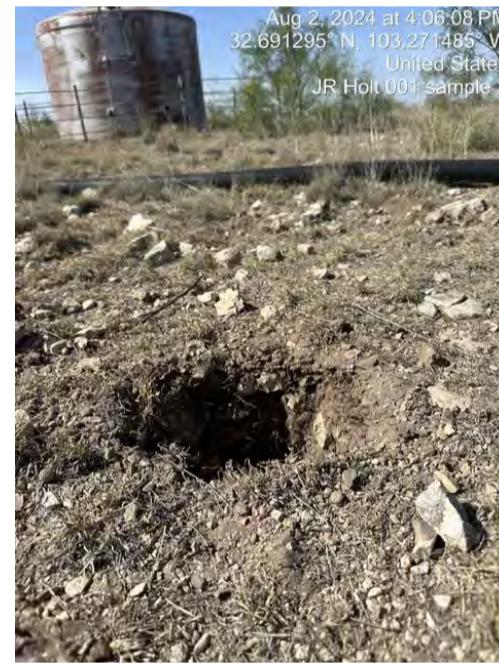
View of sample 3 location (8/2/24).

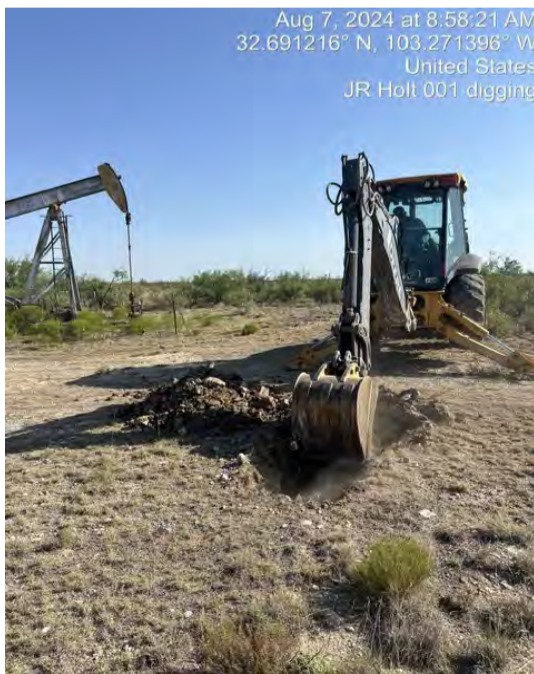
View to E of Sample 1 location (8/7/24).

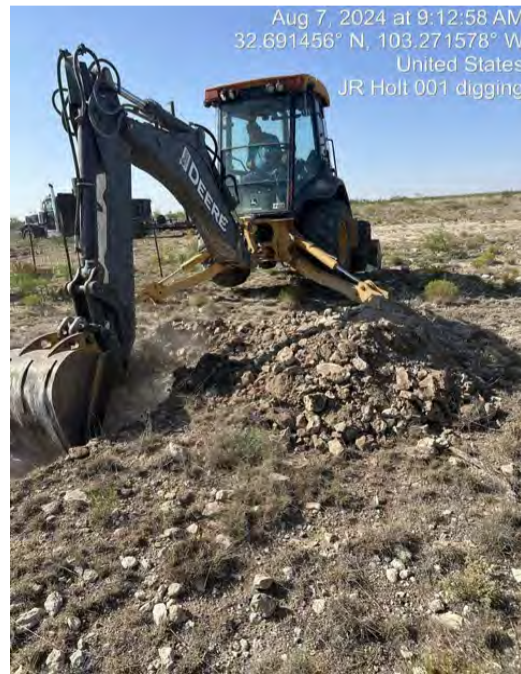
View of test hole sampling (8/7/24).

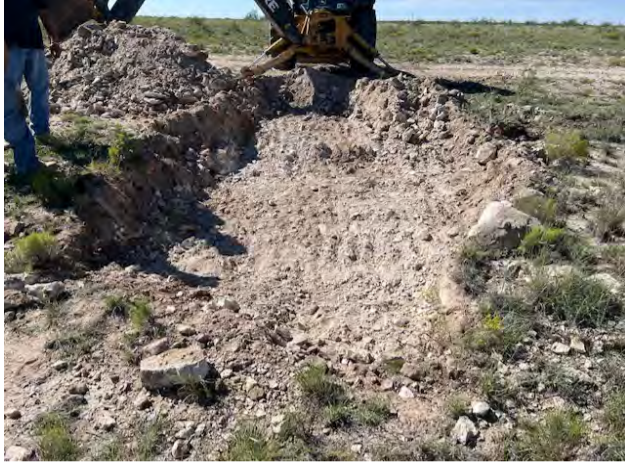
View to S of excavation (9/25/24).

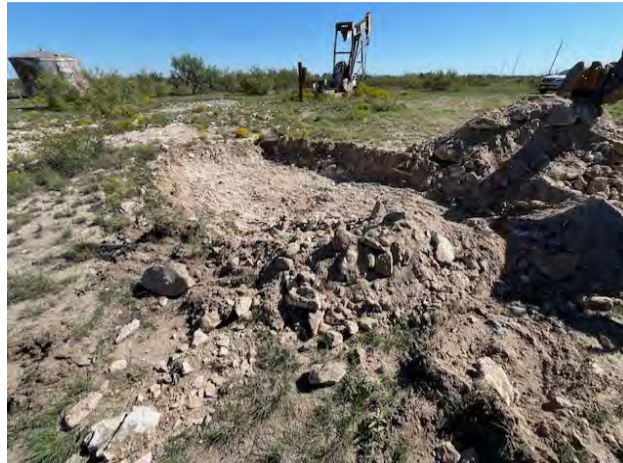
View to NE of excavation (9/25/24).

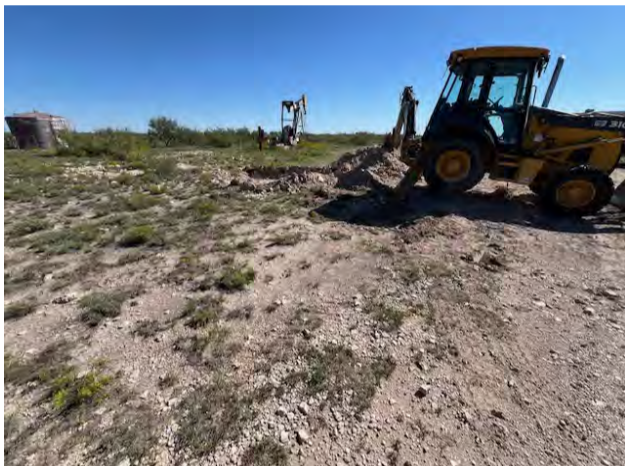
View to E of excavating (9/25/24).

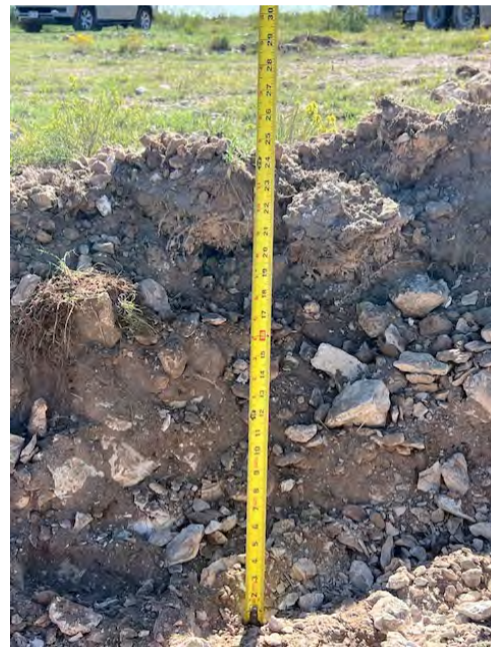
View of tape measure at E sidewall (9/25/24).

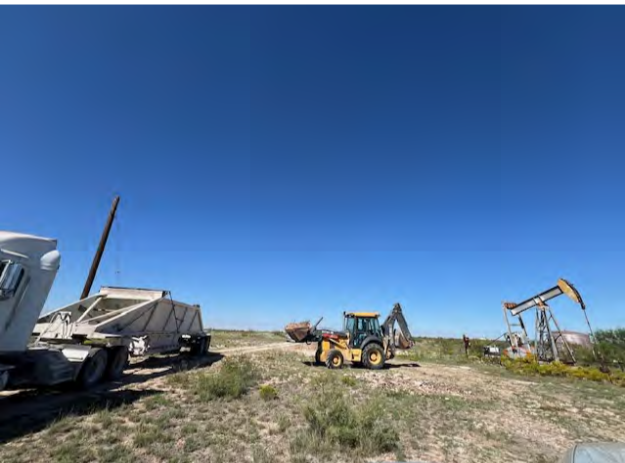
View to W of loading dump truck with excavated soil (9/25/24).
