# Remediation Summary & Variance Request

## Mewbourne Oil Company Dagger Draw Trunk Line

Eddy County, New Mexico  
Unit Letter "O", Section 10, Township 20 South, Range 25 East  
Latitude 32.580784 North, Longitude 104.470355 West  
**NMOCD Reference No. nAPP2409454303**

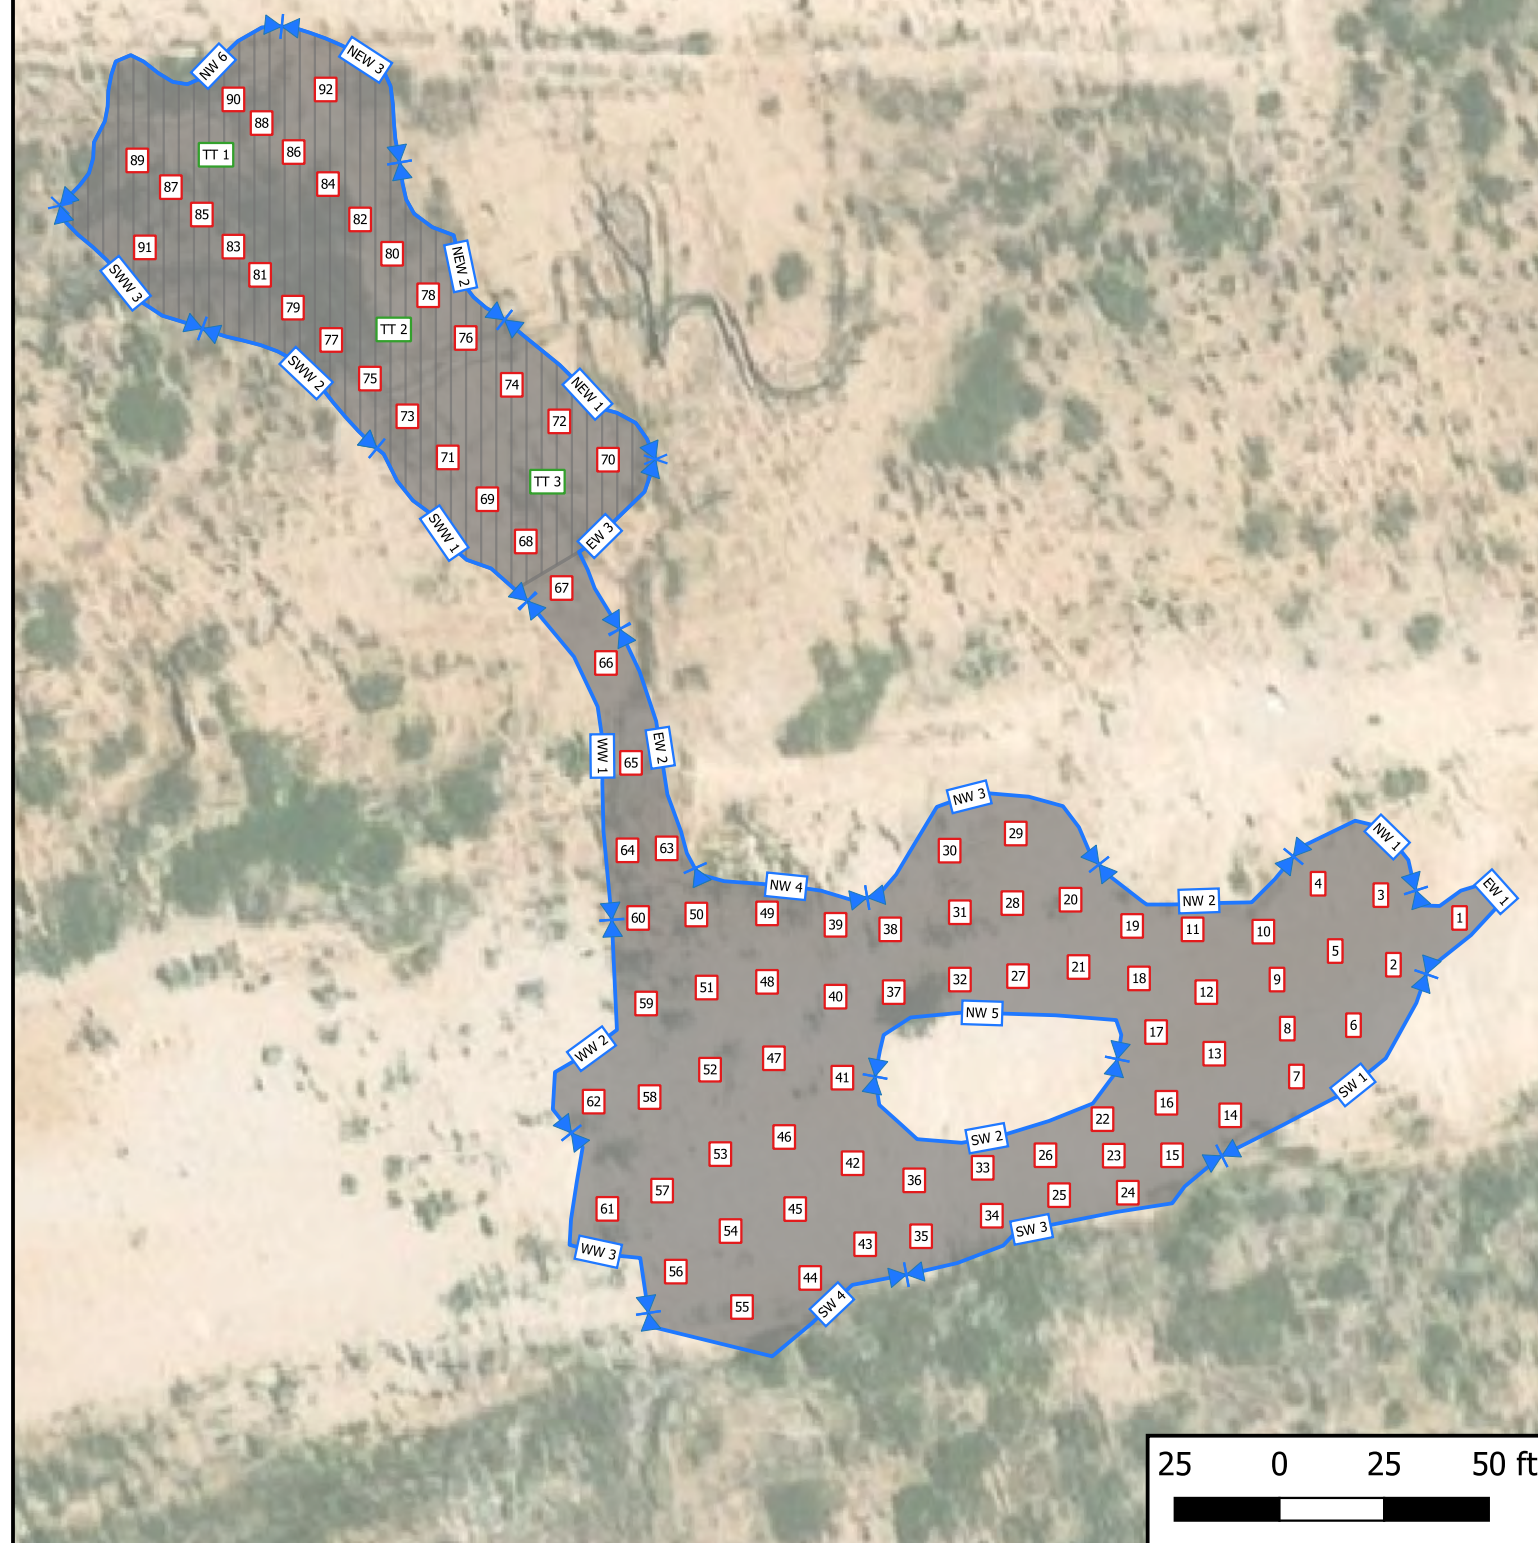
## **Figure 3**

### **Sample Location Map**

- Excavation Extent (25,501 ft<sup>2</sup>)
- Proposed Clay Liner (8,273 ft<sup>2</sup>)
- Composite Floor Sample
- Composite Wall Sample
- Test Trench

The affected area characterized by soil samples FL 68 @ 8' through FL 92 @ 8' and test trenches TT 1, TT 2, and TT 3 (henceforth, "Upper Excavation") is located within the bluff of an arroyo, which is inherently higher in elevation, of steeper grade, and more unstable than the surrounding topography. According to the aforementioned *Karst Survey*, "pseudokarst (soil piping) was identified within the aerial survey area, which may pose a hazard to equipment and personnel. Even though no surface karst features were found within the aerial karst survey boundary, this area has karst features nearby and may contain buried karst features....This area may be prone to rapid karst formation in the underlying stratigraphy and warrants careful planning and engineering to mitigate karst-forming processes that could be accelerated by poor planning and considerations." Excavation activities conducted to date have potentially further destabilized this inherently unstable area. In consideration of this information, Mewbourne Oil Company affirms that the Upper Excavation has been advanced to the extent practicable, and any excavation beyond eight (8) feet bgs poses a risk to human health and safety that exceeds the benefits of the removal of additional soil affected above the NMOCD Closure Criteria.

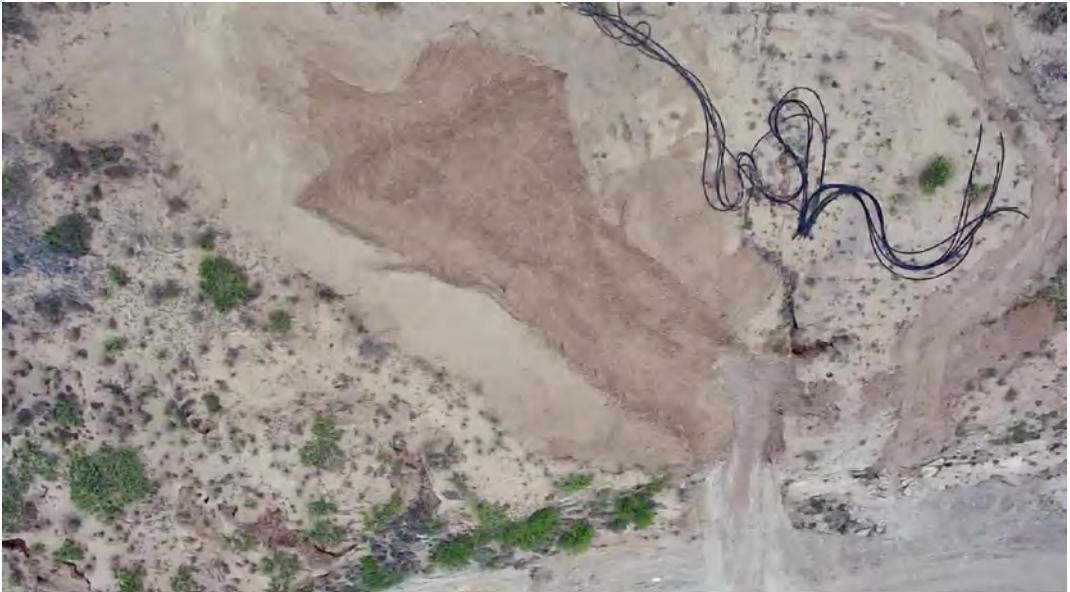
<b>Photo Number:</b> 1

<b>Photo Direction:</b> Overhead/Bird's Eye	
<b>Coordinates:</b> 32.580980,-104.470294	
<b>Date Taken:</b> 4/24/2024	
<b>Photo Description:</b>  Aerial view of a portion of the excavated area.

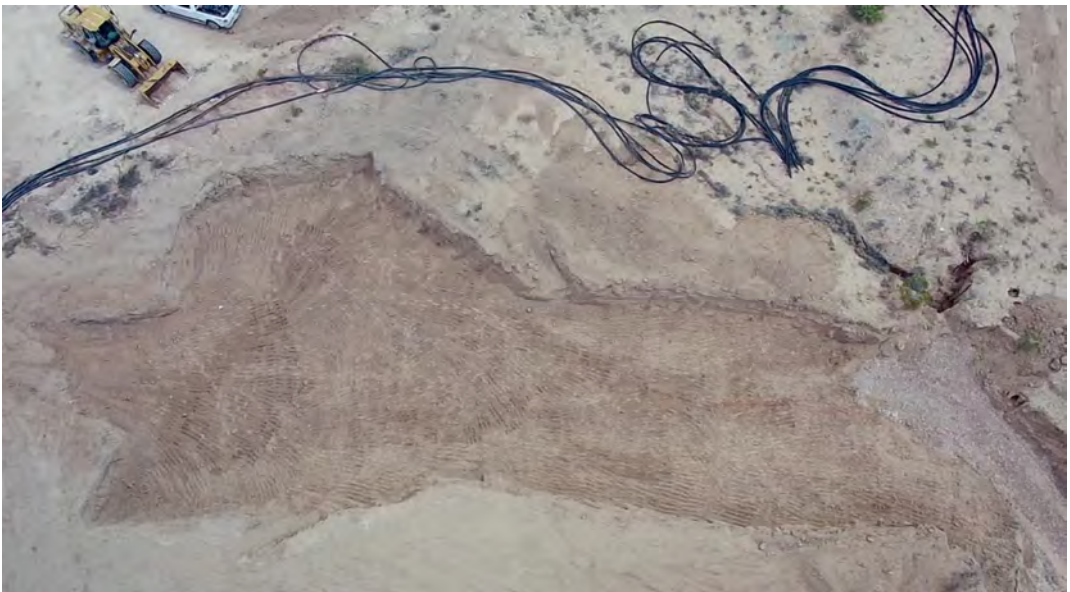
<b>Photo Number:</b> 2

<b>Photo Direction:</b> Overhead/Bird's Eye	
<b>Coordinates:</b> 32.580793,-104.470289	
<b>Date Taken:</b> 4/24/2024	
<b>Photo Description:</b>  Aerial view of a portion of the excavated area.

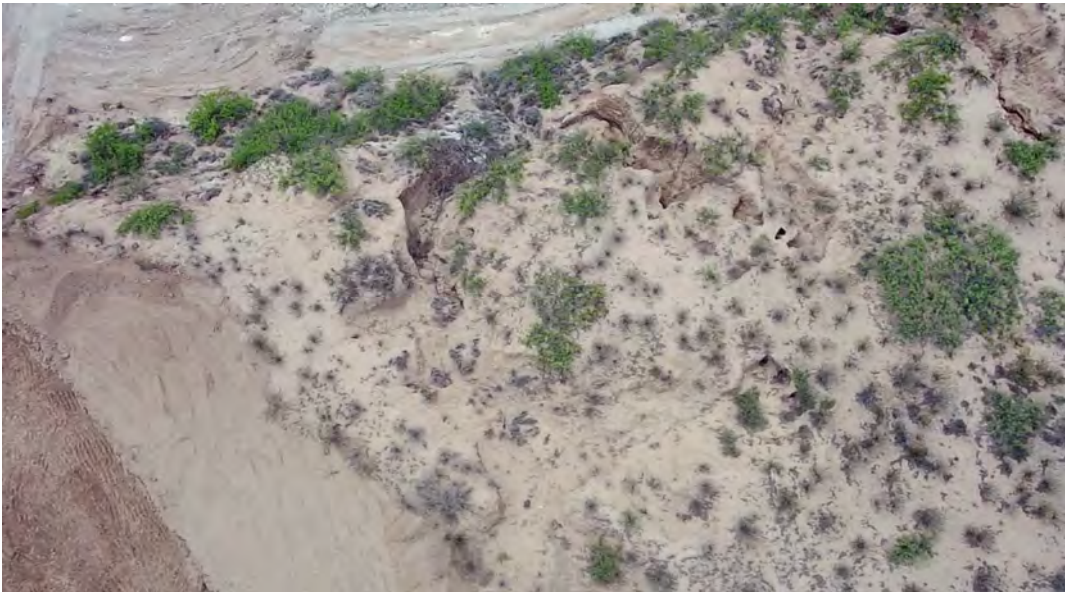
<b>Photo Number:</b> 3

<b>Photo Direction:</b> Southwest	
<b>Coordinates:</b> 32.580558,-104.470429	
<b>Date Taken:</b> 4/24/2024	
<b>Photo Description:</b>  Aerial view of karst features near the excavated area.

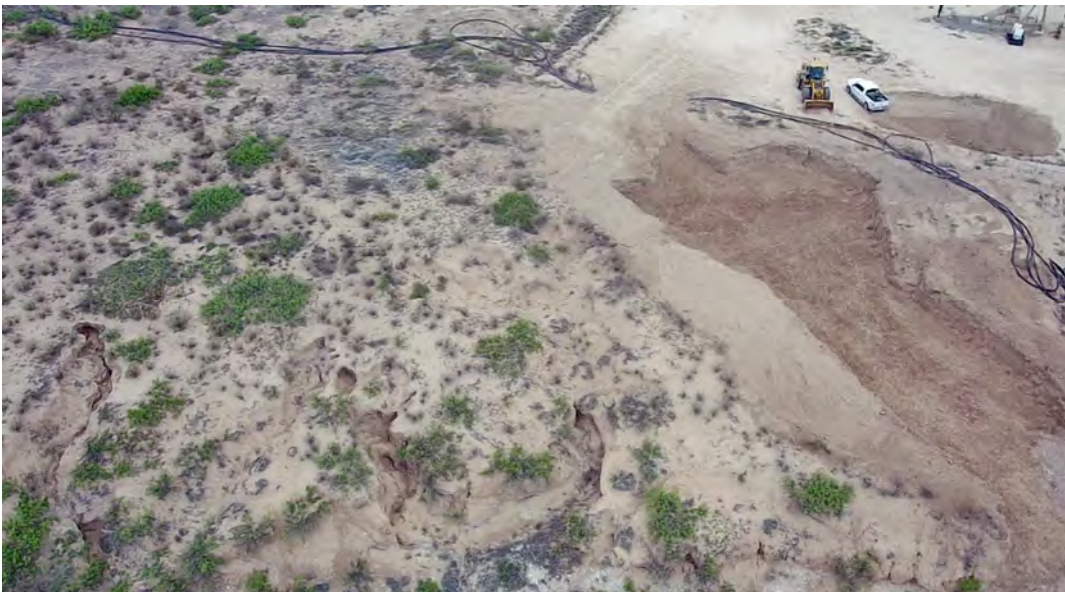
<b>Photo Number:</b> 4

<b>Photo Direction:</b> North-Northeast	
<b>Coordinates:</b> 32.580366,-104.470387	
<b>Date Taken:</b> 4/24/2024	
<b>Photo Description:</b>  Aerial view of karst features near the excavated area.

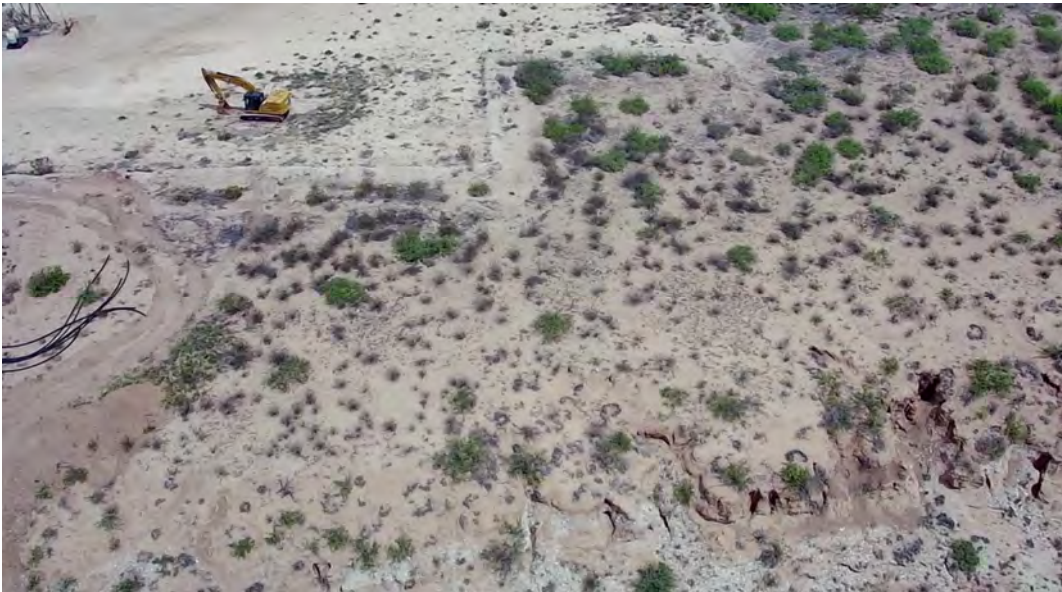
<b>Photo Number:</b> 5

<b>Photo Direction:</b> North	
<b>Coordinates:</b> 32.580547,-104.469387	
<b>Date Taken:</b> 4/24/2024	
<b>Photo Description:</b>  Aerial view of karst features near the excavated area.

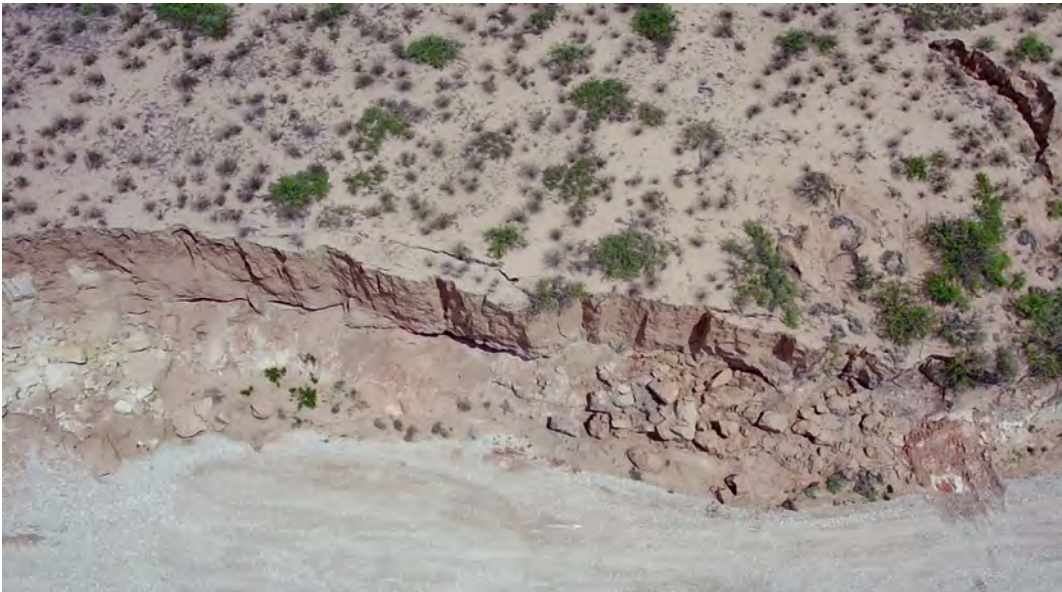
<b>Photo Number:</b> 6

<b>Photo Direction:</b> Overhead/Bird's Eye	
<b>Coordinates:</b> 32.580331,-104.470666	
<b>Date Taken:</b> 4/24/2024	
<b>Photo Description:</b>  Aerial view of karst features near the excavated area.

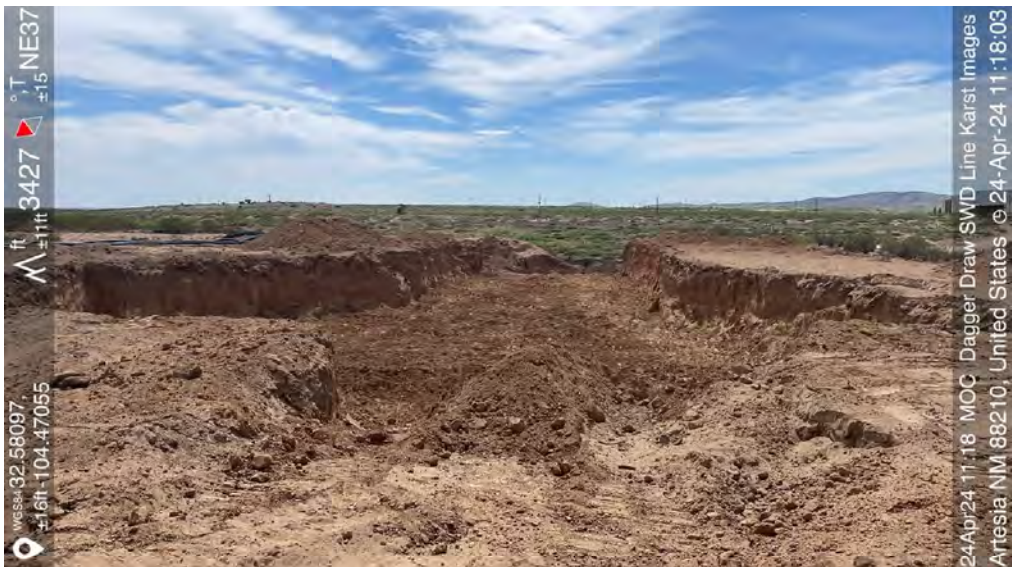
<b>Photo Number:</b> 7

<b>Photo Direction:</b> Northeast	
<b>Photo Description:</b>  View of the excavated area.

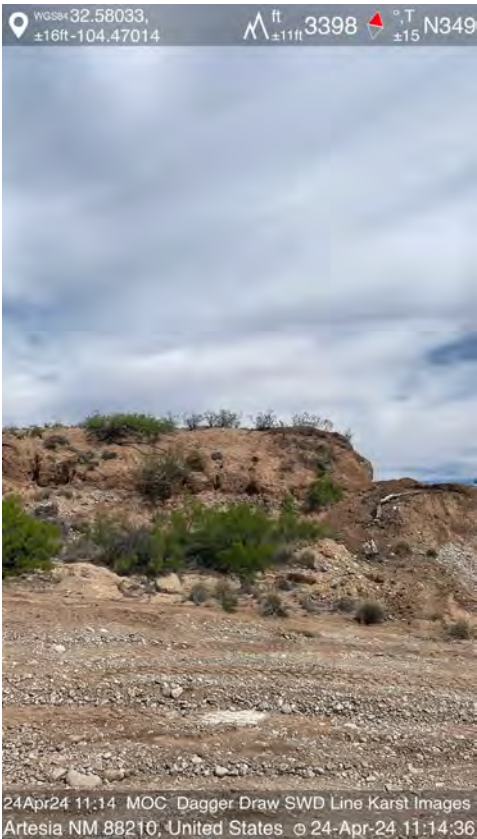
<b>Photo Number:</b> 13

<b>Photo Direction:</b> North	
<b>Photo Description:</b>  View of karst features near the excavated area.

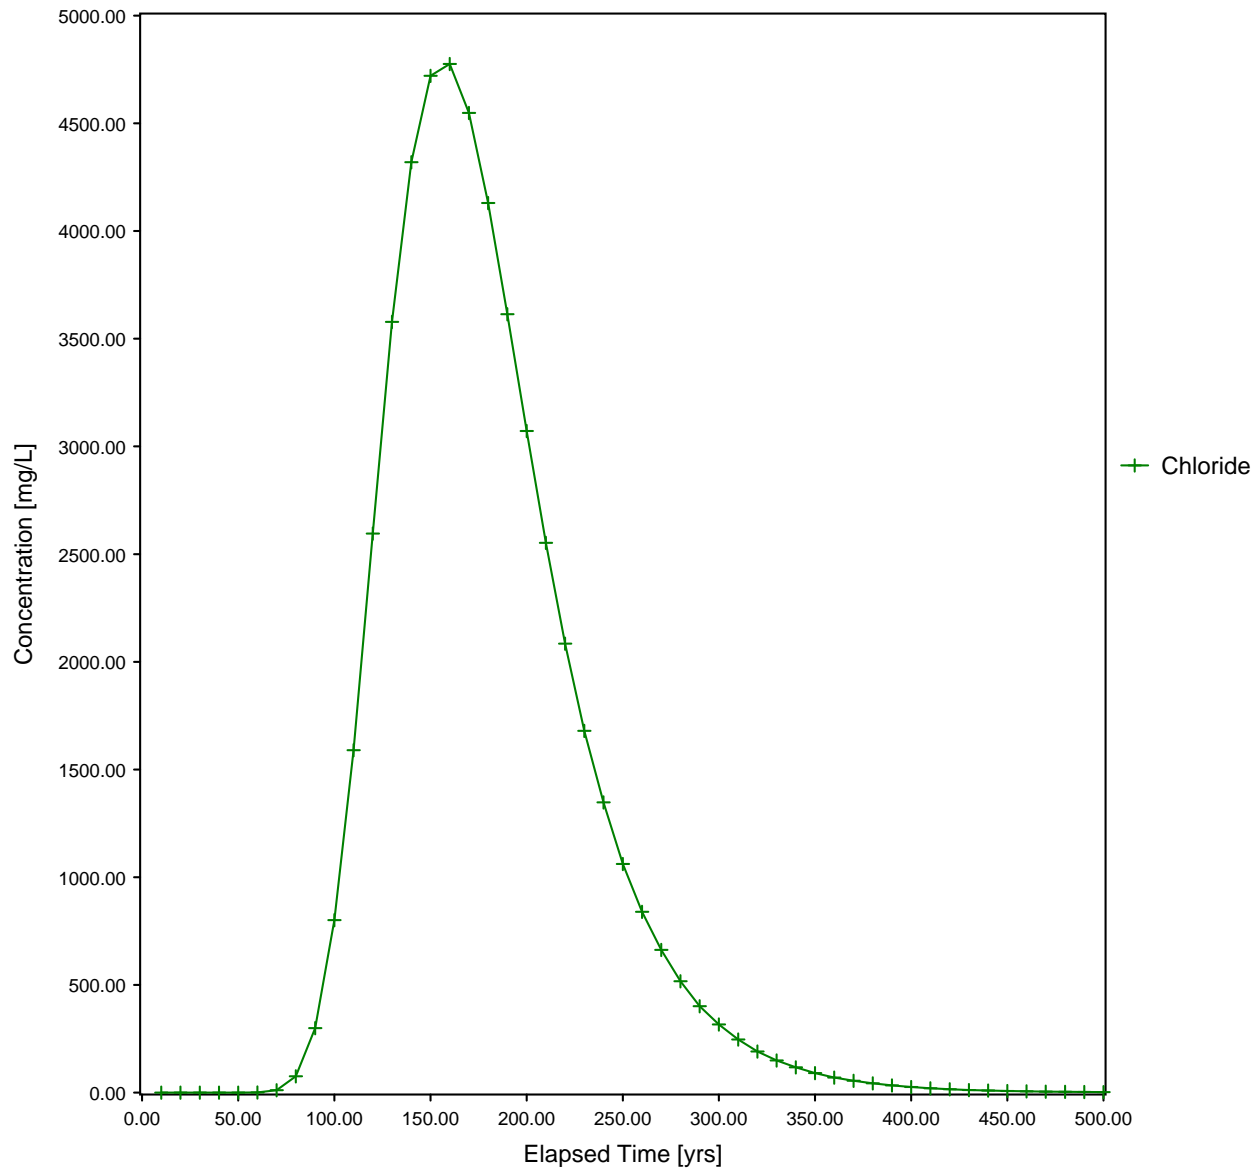
# Chloride Concentration at the Receptor Well (No Liner)

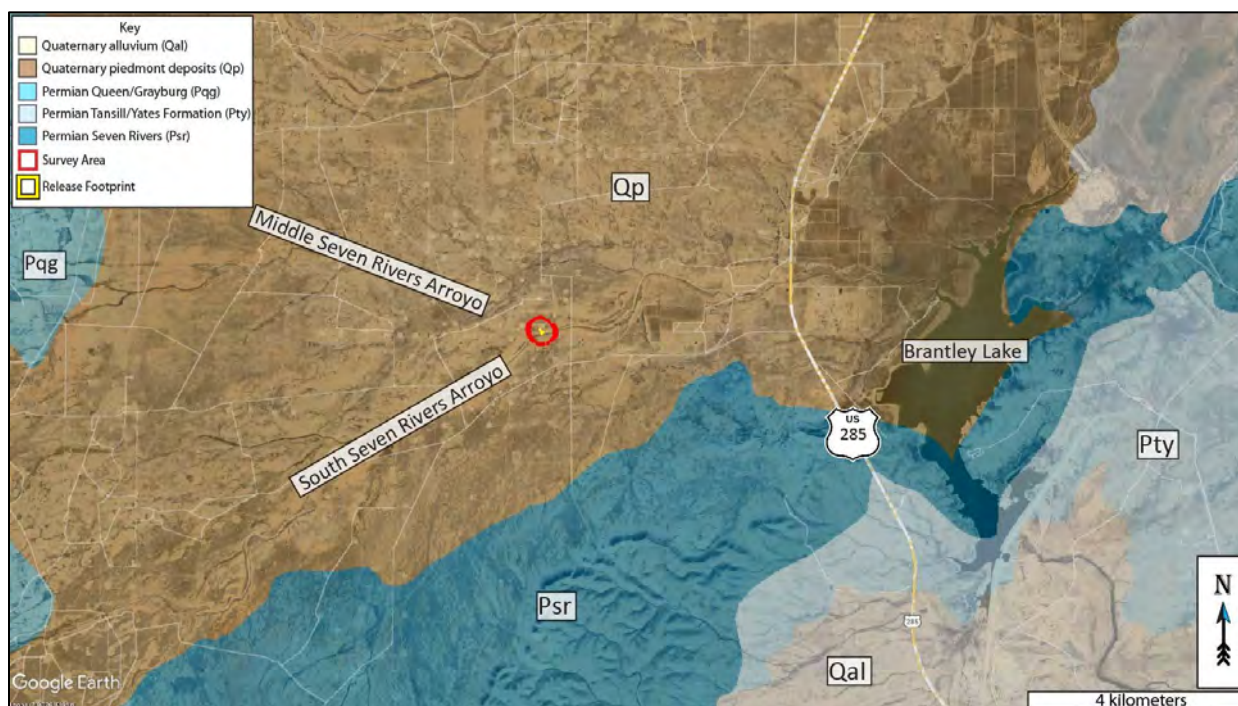
The Seven Rivers is a back-reef facies containing interbeds of dolomite and gypsum with occasional sandstone lenses and thickly bedded anhydrite. Both the dolomite and gypsum/anhydrite are subject to karst formation. From north to south, the Seven Rivers transitions from an evaporite facies to a basin facies near the reef escarpment. This facies is prone to karst formation, especially along the contact with the Capitan Reef Front further to the south<sup>[8]</sup>.

The Seven Rivers overlies the Permian Queen Formation, a calcite rich siliciclastic unit<sup>[8]</sup>. Beneath the Queen lies the Greyburg, a dolomitic limestone.

**Figure 3: Geology overview.** Map credit: The Digital Geologic Map of New Mexico in ARC/INFO Format<sup>[9]</sup>, and Google Earth. Image date: January 8, 2024. Datum: WGS-84.

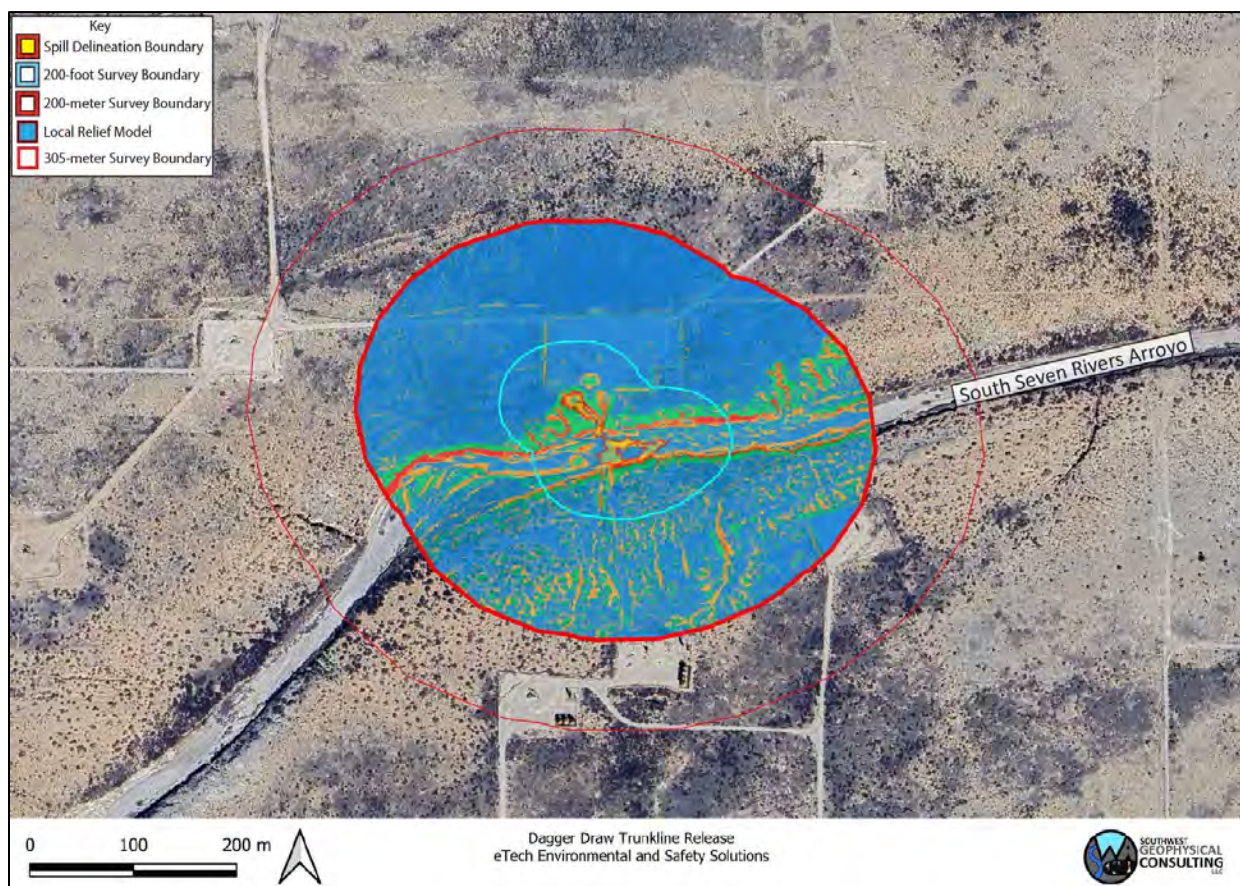
Aerial karst surveys are conducted at low elevation following a preplanned raster pattern flightpath designed for the purpose of generating at least 75% imagery overlap. The collected high-resolution, georeferenced imagery is stitched together to develop orthomosaic imagery which is further developed into a digital elevation model (DEM); the DEM is then processed into a local relief model (LRM) (**Figure 4**). This LRM is color coded to enhance differences in elevation of as little as five centimeters. The orthoimagery, DEM, and LRM are uploaded to a server where they are analyzed by a highly qualified karst geologist. Finally, the data is reviewed by a senior karst geologist for quality assurance and downloaded into a table for inclusion in a written report<sup>[10]</sup>.

Figure 4: Survey overview. Background image credit: Google Earth. Image date: December 21, 2019. Datum: WGS-84.

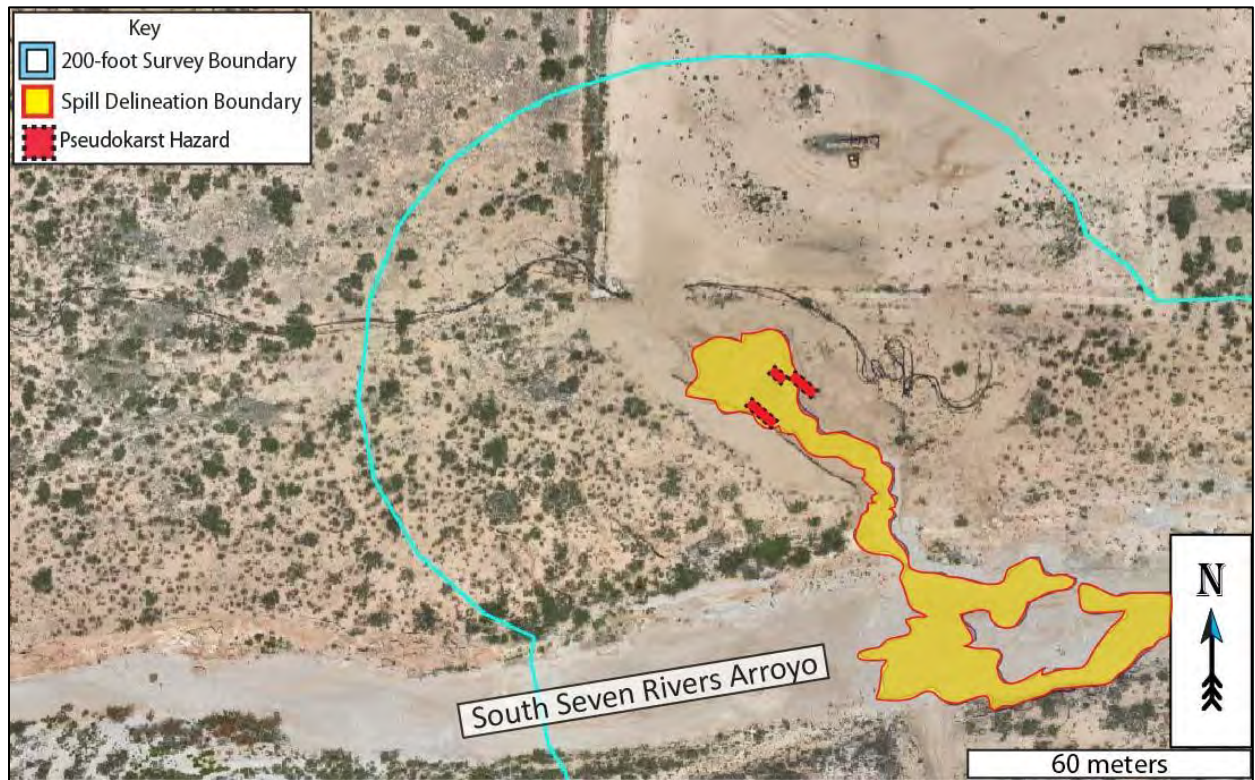
Three small subsidence zones were found within the excavation (**Figure 5**). The subsidence is related to soil piping along trenches and previously established surface flow paths that were buried at some point. It was also noted that soil piping occurs near the northern edge of the South Seven Rivers arroyo, within the survey boundary.

Figure 5: Survey closeup. Background image credit: Google Earth. Image date: December 21, 2019. Datum: WGS-84.

The lack of surface karst features does not mean the area is not karstified. Please be aware that the area may contain buried karst features. Caution is advised while clearing brush and during trenching and excavation activities. Employing a BLM-CFO approved karst monitor on site during these activities should be considered.
