Remediation Summary & Variance Request

Mewbourne Oil Company CWMS Whitesnake Riser

Eddy County, New Mexico
Unit Letter "C", Section 20, Township 23 South, Range 28 East
Latitude 32.29585 North, Longitude 104.11035 West
NMOCD Reference No. nAPP2422659329

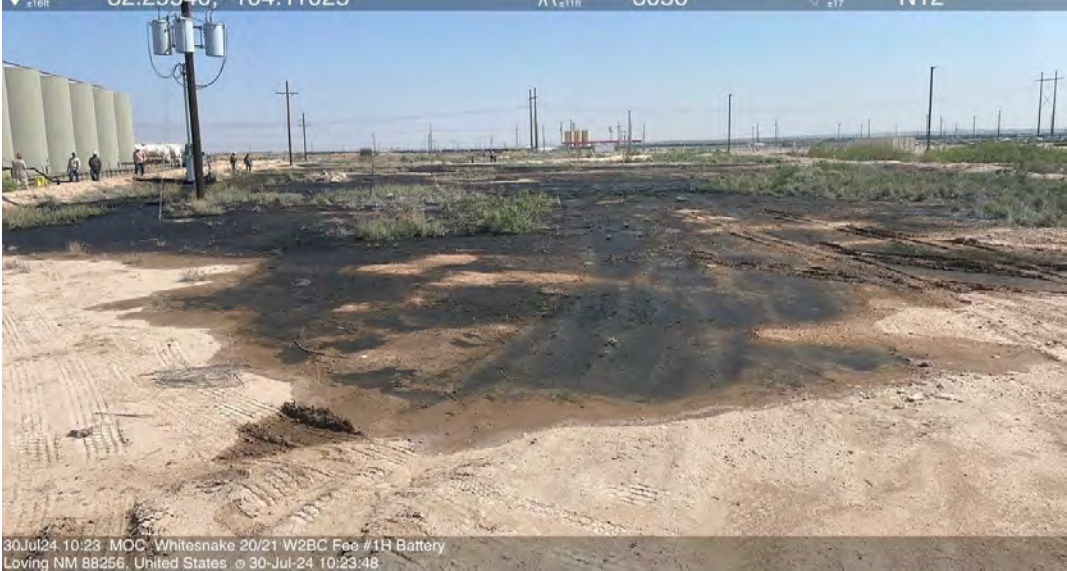
Photo Number: 5	<div><div><div>WGS84 ±16ft</div><div>32.29540, -104.11025</div><div><div><div><div></div><div>3056</div><div></div></div><div><div><div></div><div>±17</div><div></div></div><div>N12</div></div></div></div>

<div>30Jul24 10:23 MOC Whitesnake 20/21 W2BC Fee #1H Battery Loving NM 88256, United States © 30-Jul-24 10:23:48</div></div></div>
Photo Direction: North	
Photo Description: View of the affected area

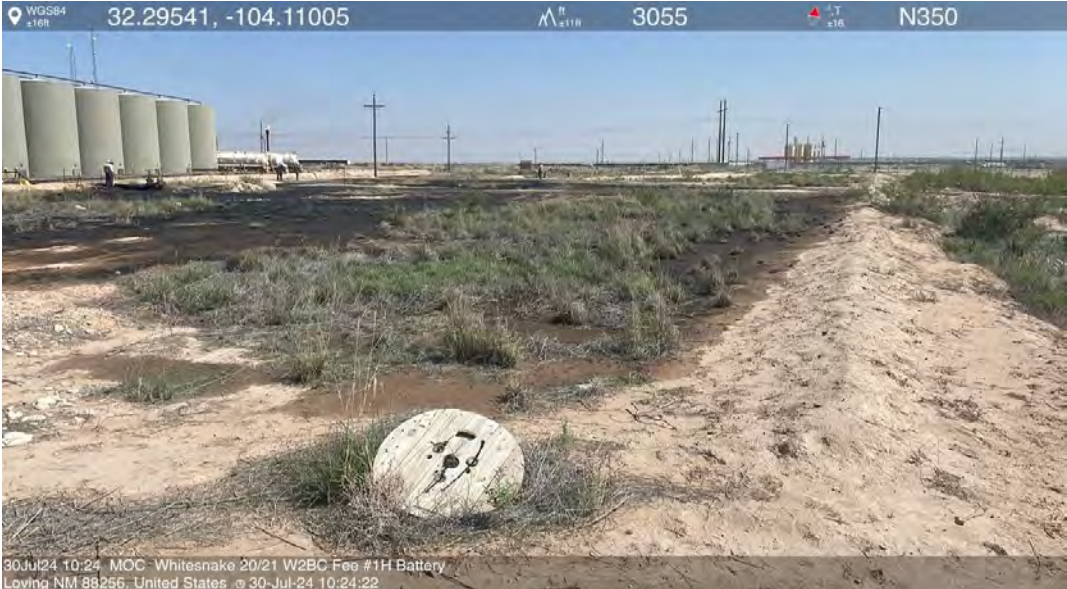
Photo Number: 6	<div><div><div>WGS84 ±16ft</div><div>32.29541, -104.11005</div><div><div><div><div></div><div>3055</div><div></div></div><div><div><div></div><div>±16</div><div></div></div><div>N350</div></div></div></div>

<div>30Jul24 10:24 MOC Whitesnake 20/21 W2BC Fee #1H Battery Loving NM 88256, United States © 30-Jul-24 10:24:22</div></div></div>
Photo Direction: North	
Photo Description: View of the affected area

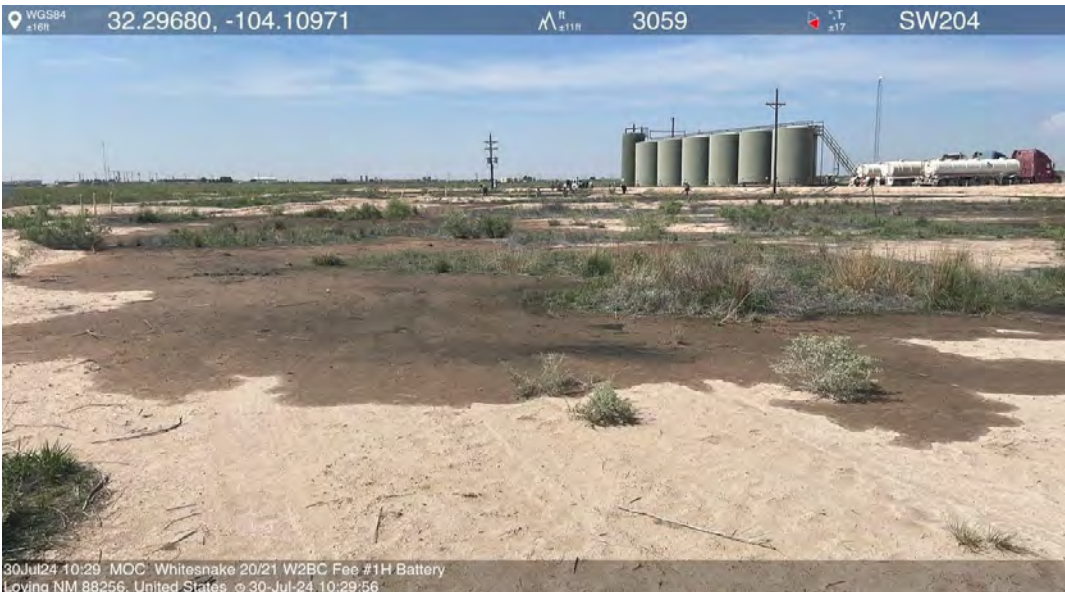
Photo Number: 8

<p>30Jul24 10:29 MOC Whitesnake 20/21 W2BC Fee #1H Battery Loving NM 88256, United States © 30-Jul-24 10:29:56</p>
Photo Direction: South-Southwest	
Photo Description: View of the affected area

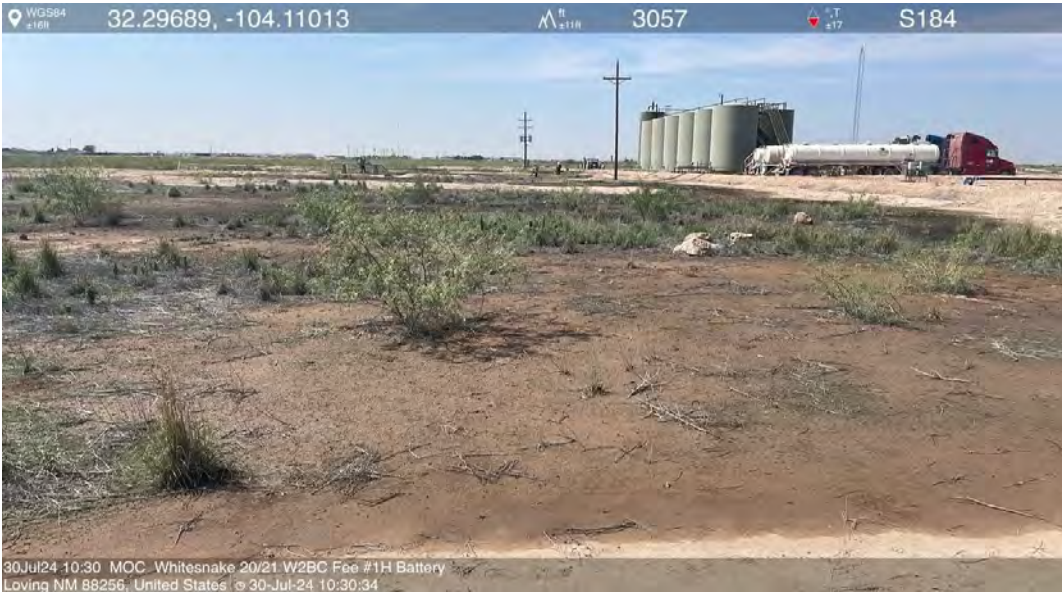
Photo Number: 9

<p>30Jul24 10:30 MOC Whitesnake 20/21 W2BC Fee #1H Battery Loving NM 88256, United States © 30-Jul-24 10:30:34</p>
Photo Direction: South	
Photo Description: View of the affected area

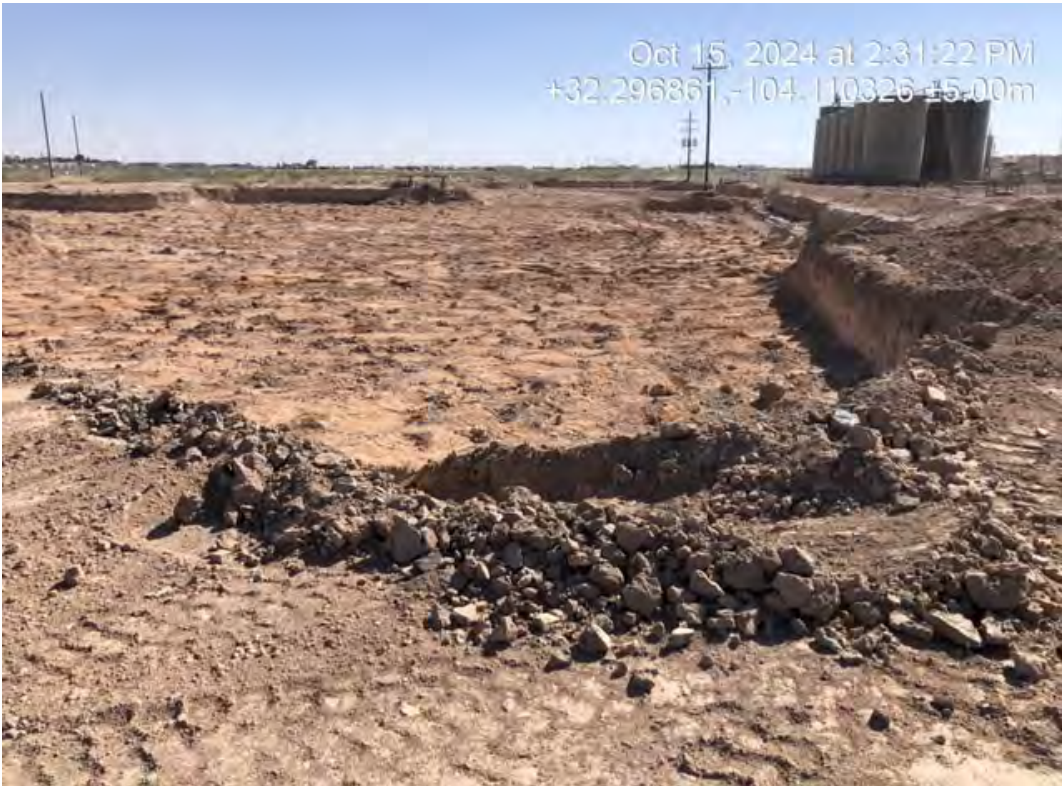
Photo Number: 13

Photo Direction: South	
Photo Description: View of the excavated area.
