RED HILLS 5 AMINE SPILL

Remediation Summary & Closure Report

NMOCD Incident No. nAPP2404624980
UL "F", Sec. 13, T24S, R33E
32.219788°, -103.527938°
Lea County, New Mexico

August 23, 2024

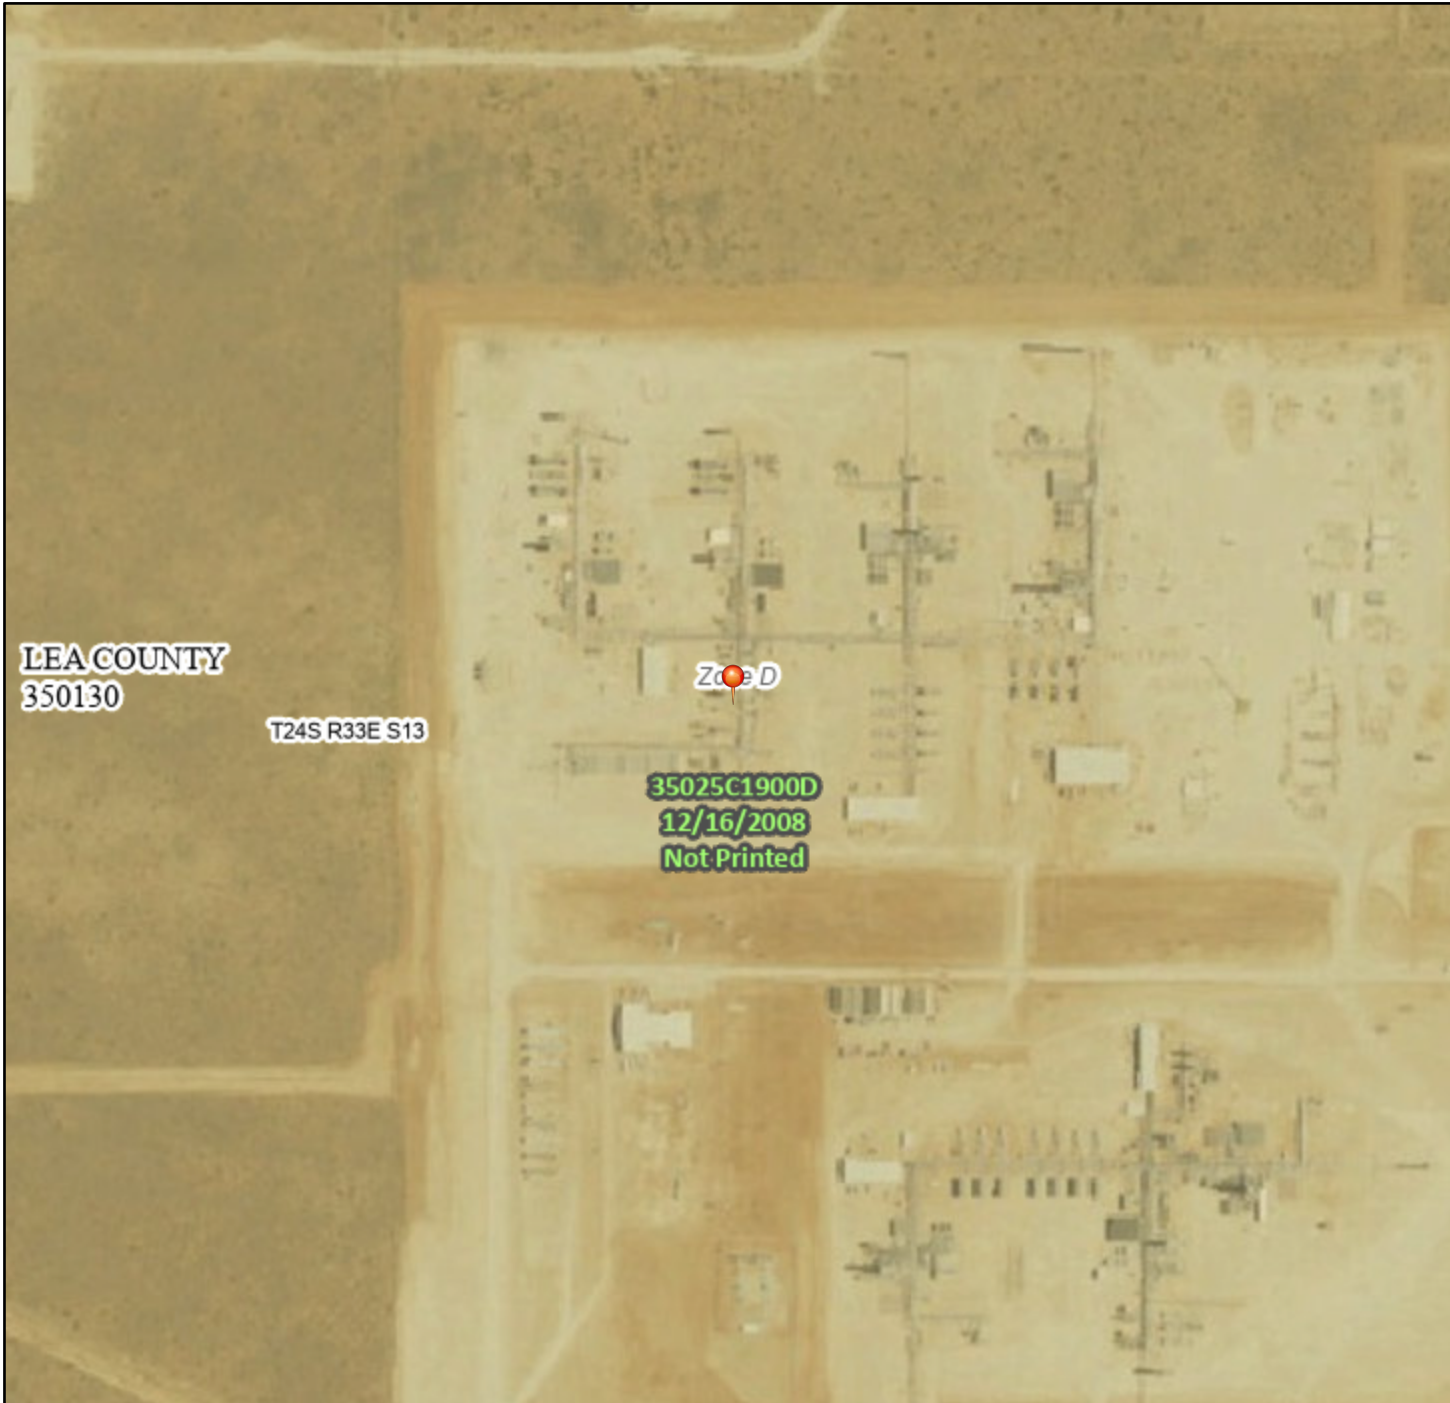
Review of flood map data published by the Federal Emergency Management Agency (FEMA) indicates the site is not within a 100-year floodplain. A copy of the FEMA FIRMe Map can be found attached as Figure 4.

National Flood Hazard Layer FIRMMette

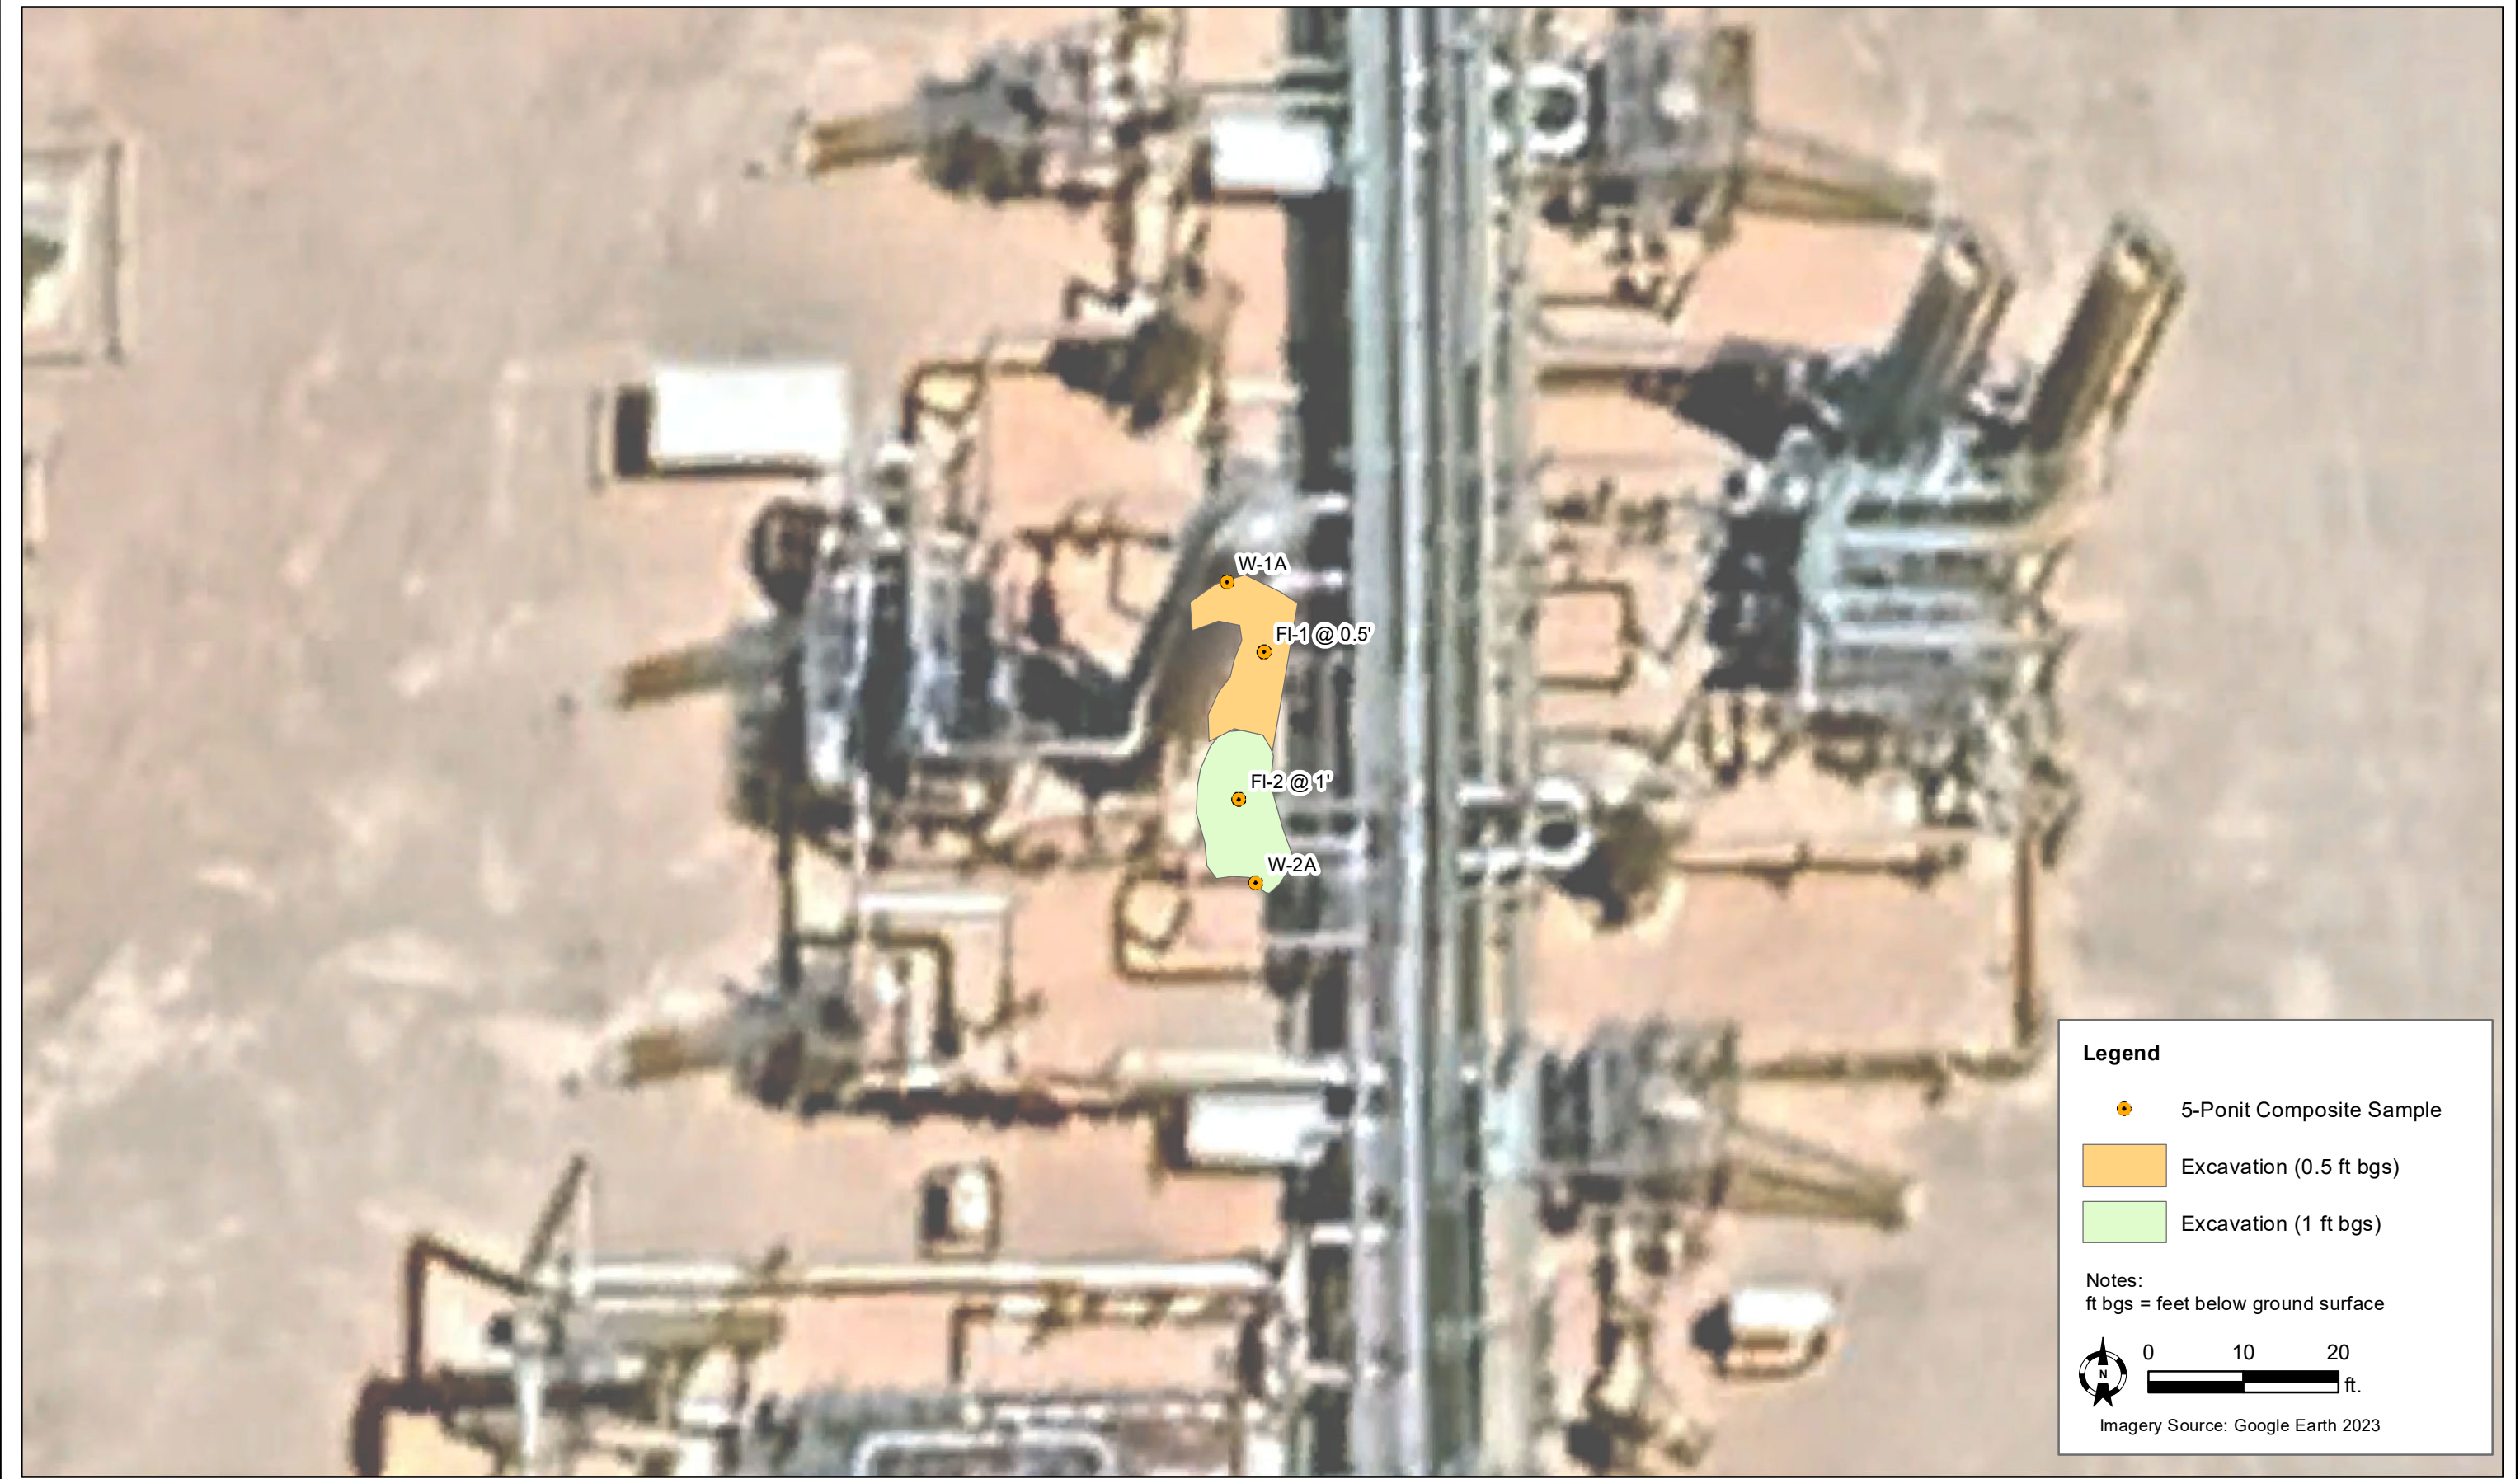
A summary of soil analytical results are provided as Table 1 and certified laboratory analytical reports are provided in Appendix D. The attached Figure 5 illustrates excavation extents and confirmation sample locations.

From April 4 to May 31, 2024, Tasman manually excavated impacted soil from within the release area. Excavated material was stockpiled on-site atop a polyethylene liner pending transportation to an NMOCD approved disposal facility. The remedial final excavations measured approximately 7-ft long by 7-ft wide at 0.5-ft deep and 17-ft long by 8-ft wide at 1-ft deep. Approximately 12 cubic yards of excavated material was exported to Northern Delaware Basin Landfill.
