Remediation Summary & Soil Closure Request

XTO Energy, Inc.

Nash Riser 11

NMOCD Reference No. nAPP2415234797

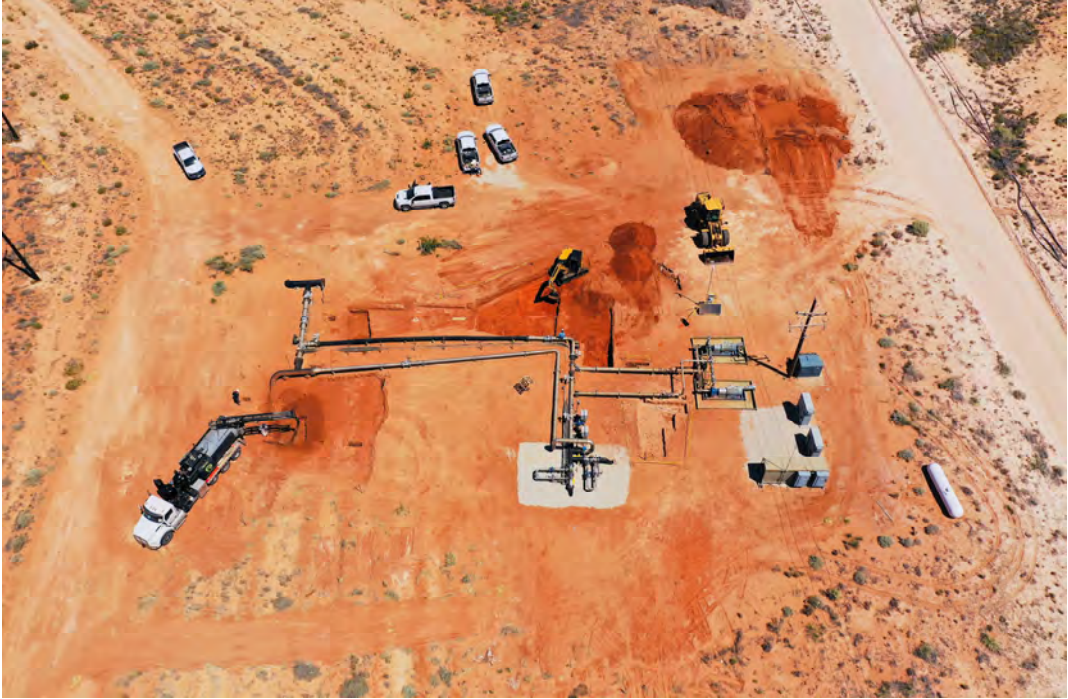
Photo Number: 5

Photo Direction: North-Northwest	
Coordinates: 32.246486,-103.922238	
Photo Description: Aerial view of the excavated area.

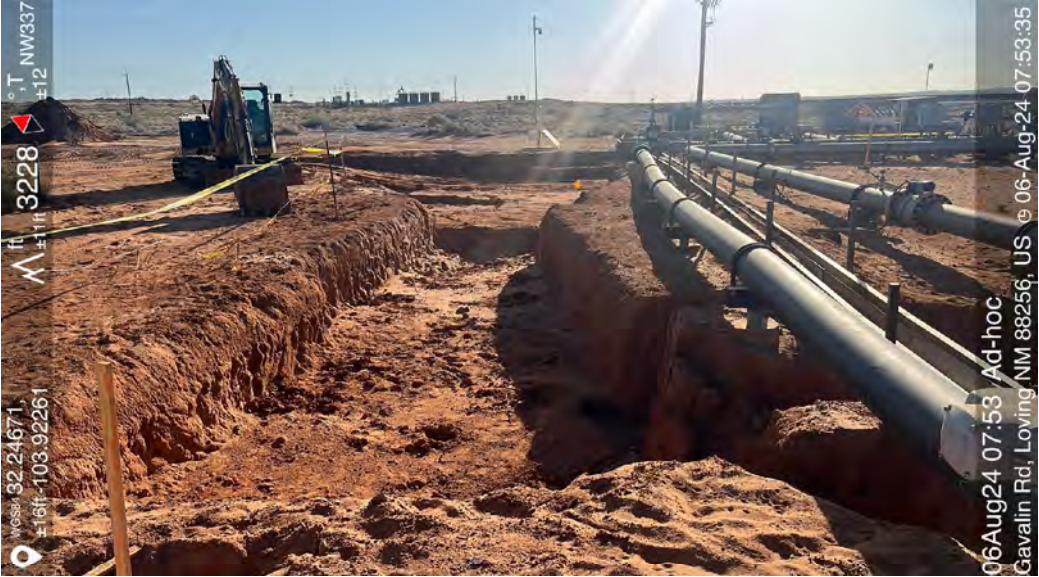
<div>Photo Number: 7</div>

<p>06Aug24 07:53 Ad-hoc Gavalin Rd, Loving NM 88256, US © 06-Aug-24 07:53:35</p>
<div>Photo Direction: North-Northwest</div>	
<div>Photo Description: View of the excavated area.</div>

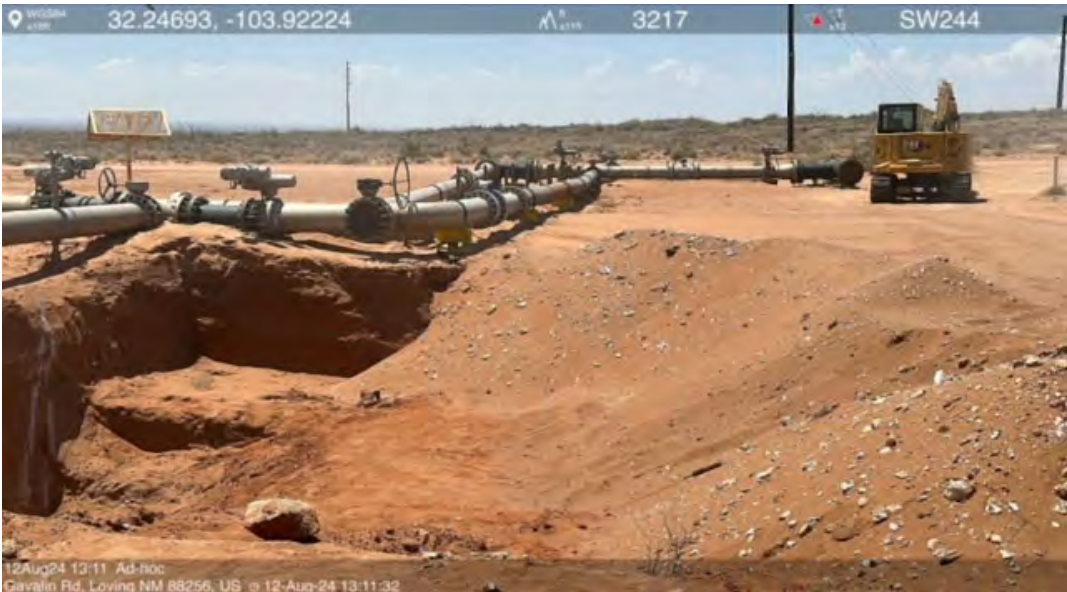
Photo Number: 10

<p>12Aug24 13:11 Ad-hoc Gavalin Rd, Loving NM 88256, US © 12-Aug-24 13:11:32</p>
Photo Direction: West-Southwest	
Photo Description: View of the excavated area during backfilling.

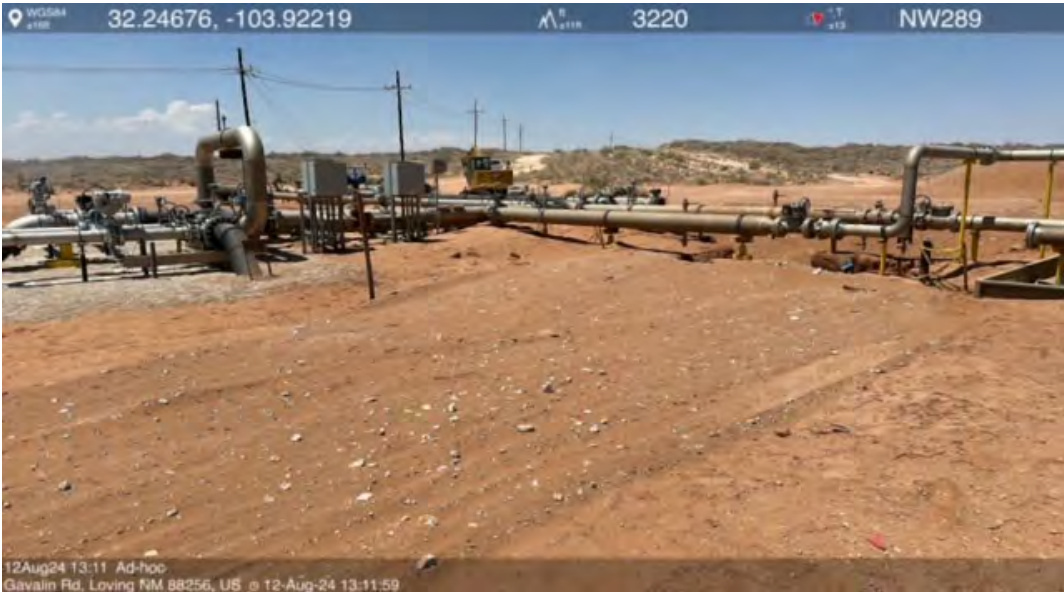
Photo Number: 11

<p>12Aug24 13:11 Ad-hoc Gavali Rd, Loving NM 88256, US @ 12-Aug-24 13:11:59</p>
Photo Direction: West-Northwest	
Photo Description: View of the remediated area during backfilling.

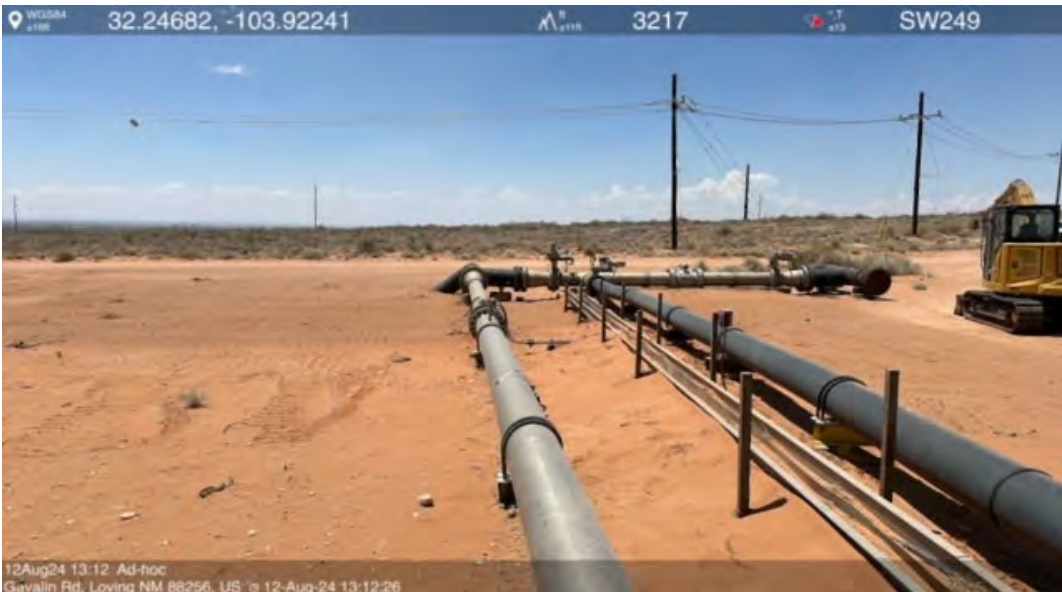
Photo Number: 13

<p>12Aug24 13:12 Ad-hoc Gavalin Rd, Loving NM 88256, US @ 12-Aug-24 13:12:26</p>
Photo Direction: West-Southwest	
Photo Description: View of the remediated area following backfilling and regrading.

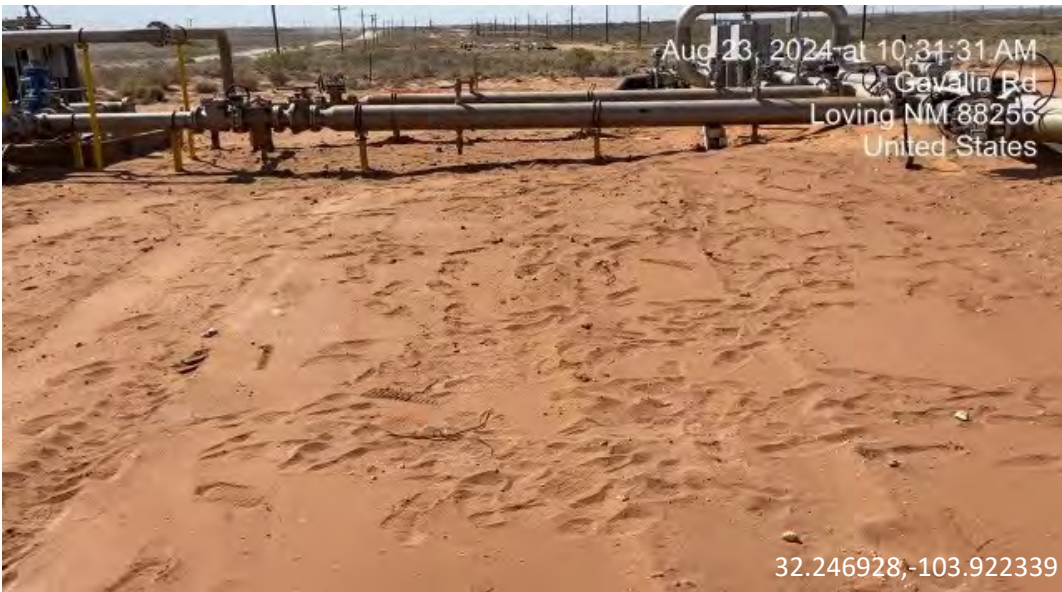
Photo Number: 14

<p>Aug 23, 2024 at 10:31:31 AM Gavalin Rd Loving NM 88256 United States</p> <p>32.246928, -103.922339</p>
Photo Direction: South-Southeast	
Photo Description: View of the remediated area following backfilling and regrading.
