Re: Closure Request Report Addendum

**Boundary Raider 7 CTB 2**

Incident Number nAPP2415972085

Lea County, New Mexico

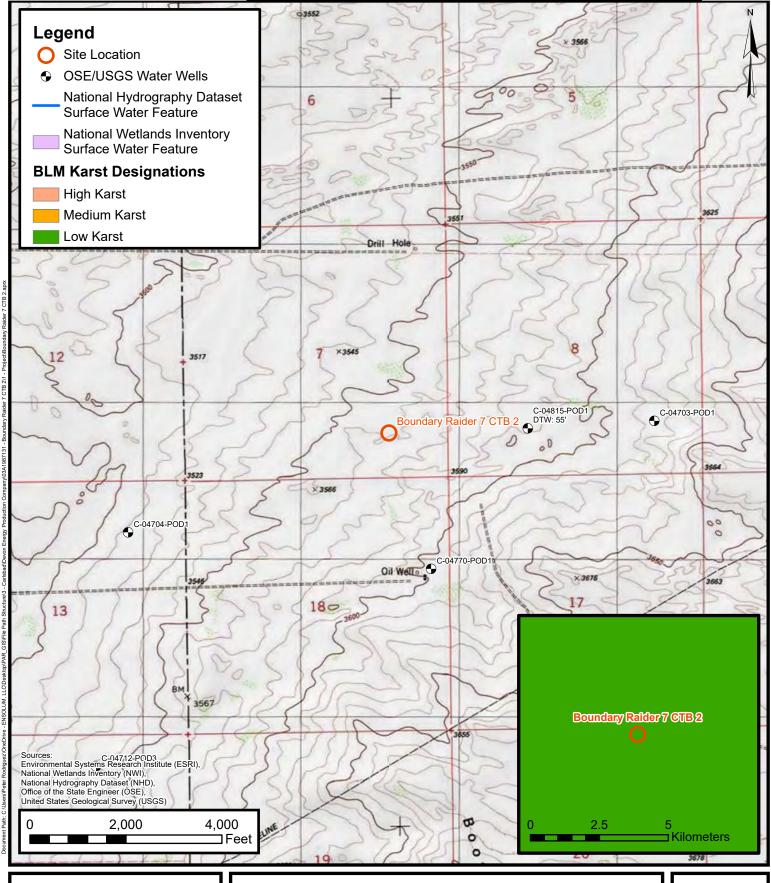
1

The closest continuously flowing or significant watercourse to the Site is an intermittent dry wash, located approximately 3.04 miles northwest of the Site. The Site is greater than 200 feet from a lakebed, sinkhole, or playa lake and greater than 300 feet from an occupied residence, school, hospital, institution, church, or wetland. The Site is greater than 1,000 feet to a freshwater well or spring and is not within a 100-year floodplain or overlying a subsurface mine. The Site is not underlain by unstable geology (low potential karst designation area). Site receptors are identified on Figure 1.

## **Site Receptor Map**

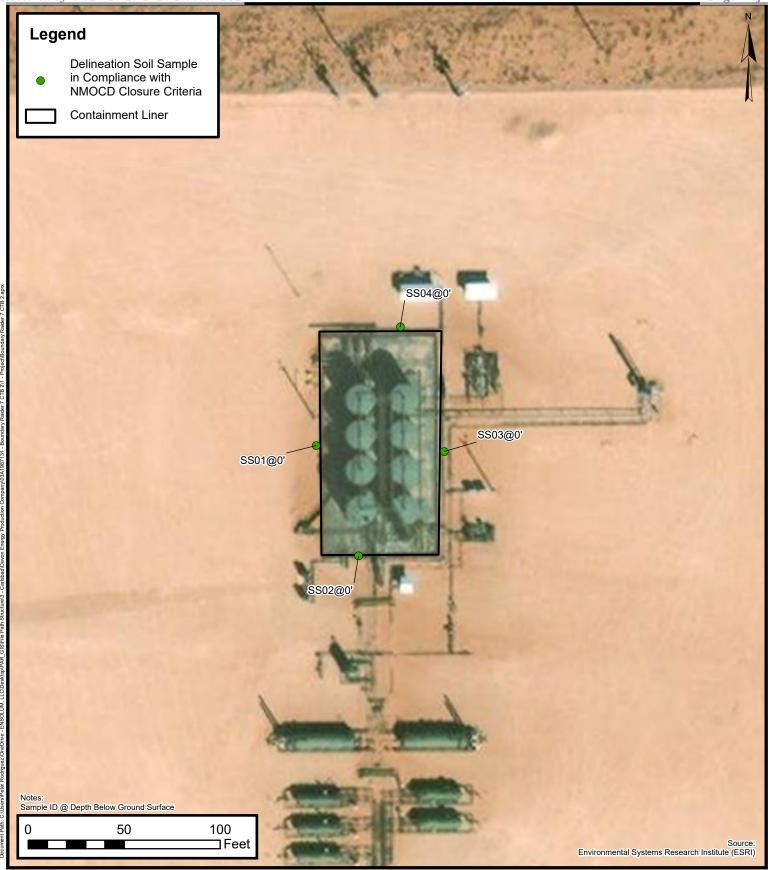
Unit P, Section 07, T 23S, R 32E Lea County, New Mexico FIGURE 2

On June 3, 2024, Ensolum personnel arrived onsite to collect lateral surface samples associated with incident number nAPP2414543825. Four lateral delineation sample points (SS01 through SS04) were collected on all sides of the lined containment at ground surface to verify the release remained inside the lined containment. Delineation soil samples were field screened for chloride and TPH utilizing Mohr's titration method and a PetroFLAG® Soil Analyzer System, respectively. The delineation sample locations were mapped utilizing a handheld Global Positioning System (GPS) unit and are depicted on Figure 2.

On July 1, 2024, Ensolum personnel returned to the Site to collect lateral surface samples associated with incident number nAPP2415972085. Four lateral delineation sample points (SS01 through SS04) were recollected in the same locations as incident number nAPP2414543825 on all sides of the lined containment at ground surface to verify the release remained inside the lined containment. Delineation soil samples were analyzed and handled in the same manner previously described and the sample locations are depicted on Figure 2.

## **Delineation Soil Sample Locations**

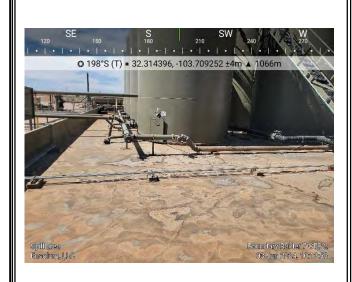
Photograph 3 Date: 6/3/2024 Description: Spill area - nAPP2414543825

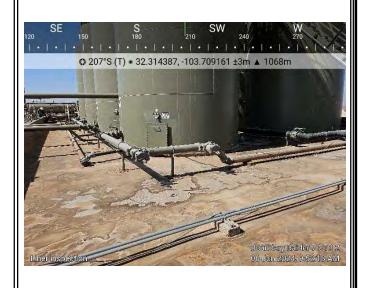
On June 6, 2024, Ensolum personnel competent in conducting liner inspections, returned to the Site to visually inspect the integrity of the containment liner associated with incident number nAPP2414543825. Prior to conducting the inspection, NMOCD was provided with a 48-hour liner inspection notification via email on June 3, 2024 (Appendix B). Ensolum personnel verified there was no visual evidence of a breach in the lined containment or any visible staining in the areas immediately surrounding the containment walls. It was determined the liner remained intact and had to the ability to contain the release in question. Photographs taken during the liner inspection are included in Appendix C.

Photograph 5 Date: 6/6/2024 Description: Liner Inspection - nAPP2414543825

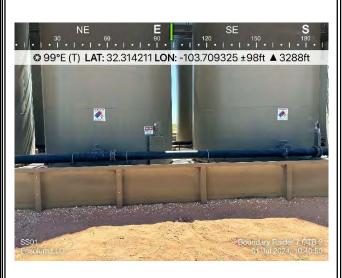
Photograph 9 Date: 7/1/2024 Description: Delineation - nAPP2415972085

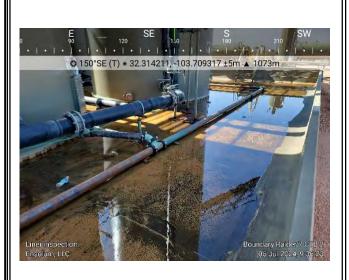
On July 7, 2024, Ensolum personnel competent in conducting liner inspections, returned to the Site to visually inspect the integrity of the containment liner associated with incident number nAPP2415972085. Prior to conducting the inspection, NMOCD was provided with a 48-hour liner inspection notification via email on July 2, 2024 (Appendix B). Due to heavy rains on July 4, 2024, an inch of water was present in the containment during the inspection on July 5, 2024, however the water was clear, and the liner inspection was still possible. Ensolum personnel verified there was no visual evidence of a breach in the lined containment or any visible staining in the areas immediately surrounding the containment walls. It was determined the liner remained intact and had to the ability to contain the release in question.

Photograph 11 Date: 7/5/2024 Description: Liner Inspection - nAPP2415972085

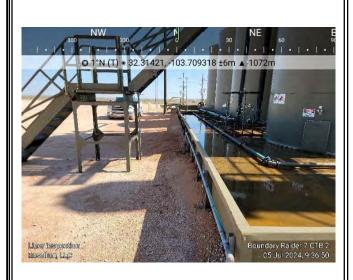
Photograph 13 Date: 7/1/2024 Description: Liner Inspection - nAPP2415972085

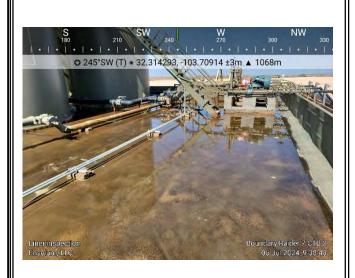
Photograph 15 Date: 7/5/2024 Description: Liner Inspection - nAPP2415972085

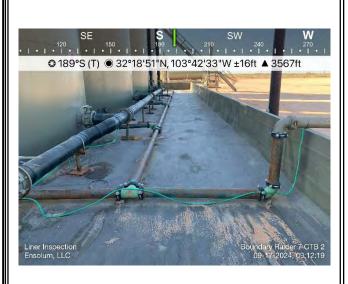
Following the CR denial by NMOCD, Devon pressure washed the liner and collected all fluids and debris prior to inspection for the liner's integrity. Ensolum personnel returned to the Site on September 17, 2024, to conduct a second liner integrity inspection for the two incident numbers. Prior to conducting the inspection, NMOCD was provided with a 48-hour liner inspection notification and the liner was found to be intact and had the ability to contain the releases in question. Photographic documentation is included in Appendix C.

Photograph 17 Date: 9/17/2024 Description: Liner Inspection - nAPP2415972085

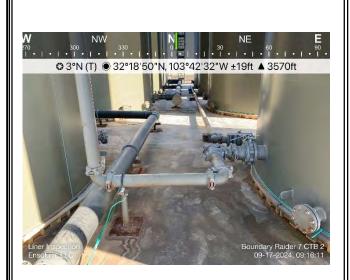
Photograph 19 Date: 9/17/2024 Description: Liner Inspection - nAPP2415972085
