Remediation Summary & Soil Closure Request

Permian Resources

Woody CTB 1

NMOCD Reference No. nAPP2411548875

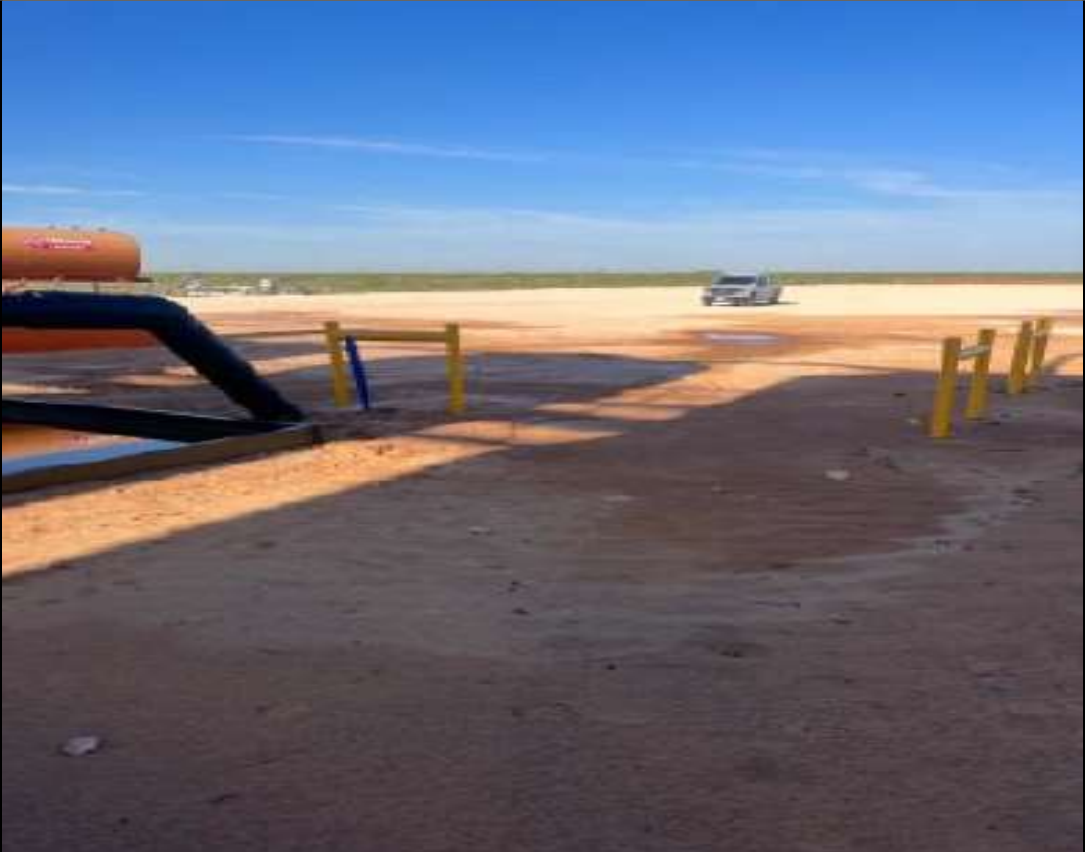
Photo Number: 1

A photograph showing a wide, flat, sandy area under a clear blue sky. In the foreground, there are yellow metal barriers and a large black pipe. In the distance, a white vehicle is visible on the horizon.
Photo Direction: Southwest	
Photo Description: Initial view of the affected area.
