SITE ASSESSMENT, REMEDIATION AND CLOSURE REPORT

Jones Federal B #3

Incident ID: NMLB1129240104

API: 30-015-10394

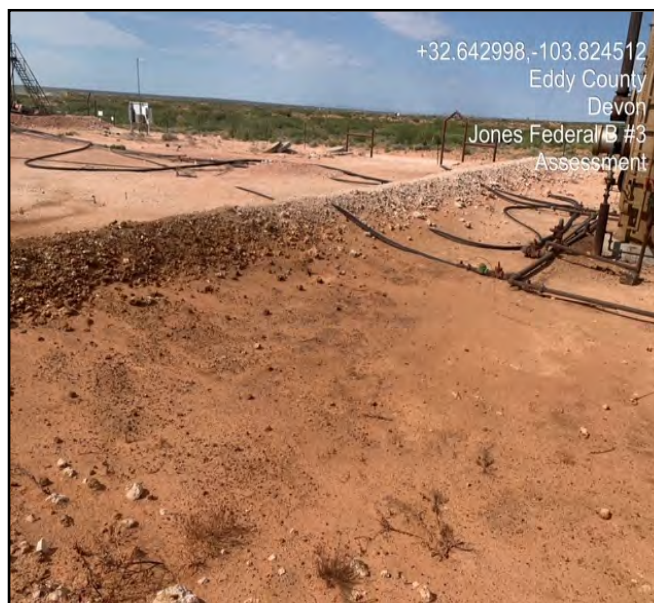
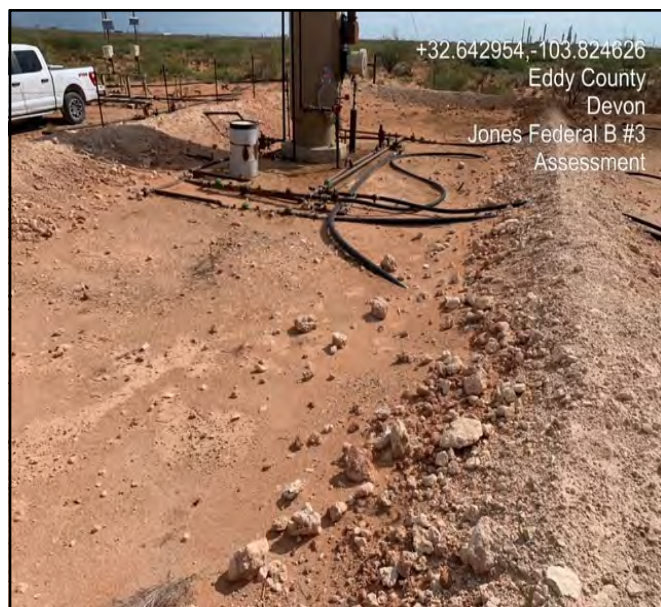
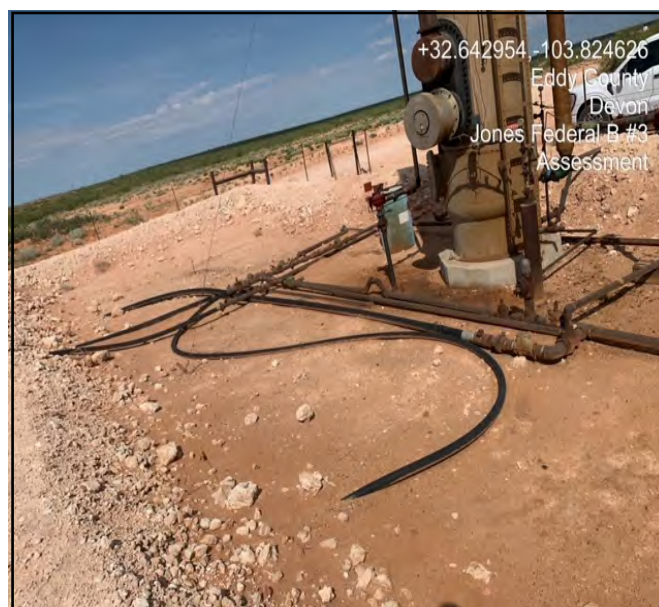
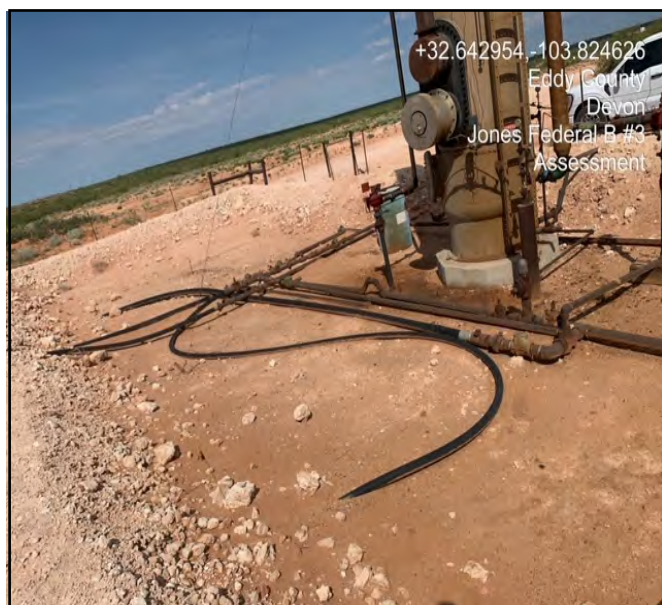
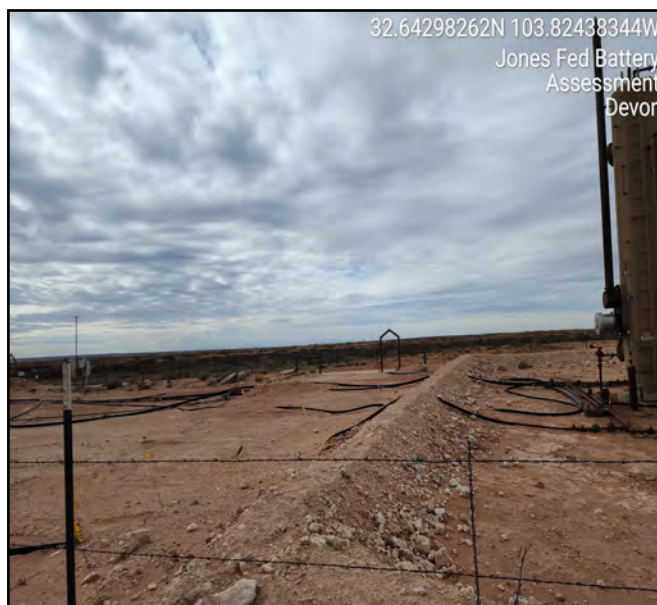
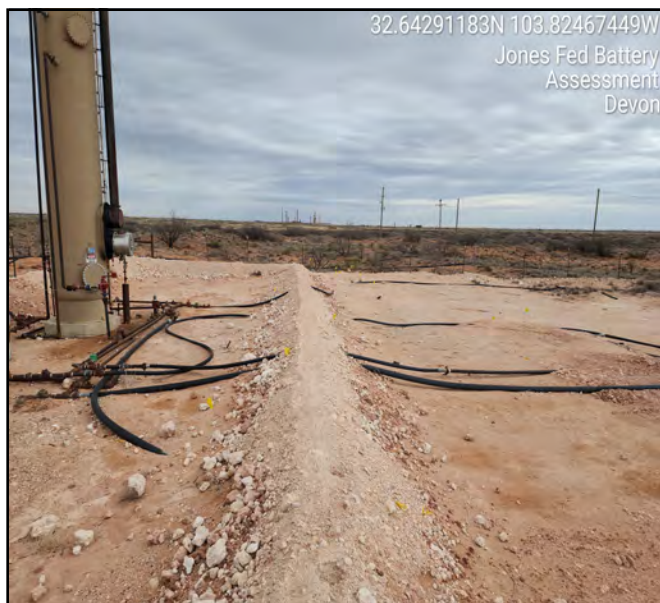
Photo showing the area of the release.

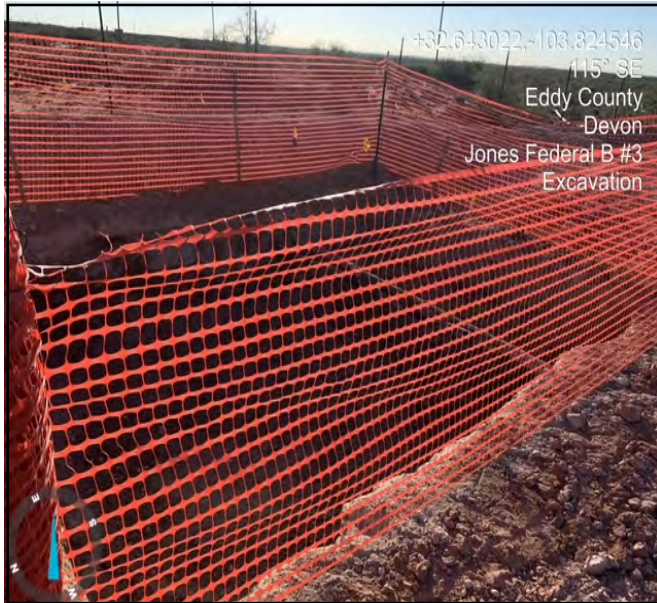
Photograph illustrating the depth of the excavation site, facing southeast.

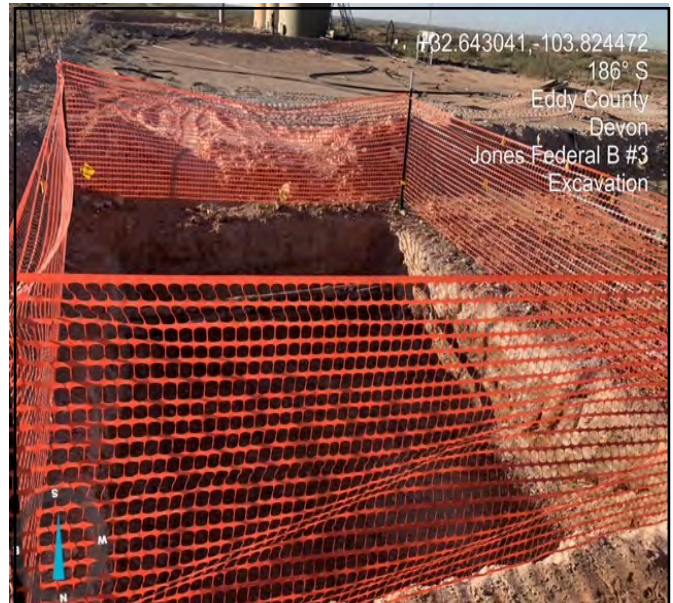
Photograph illustrating the depth of the excavation site, facing south.

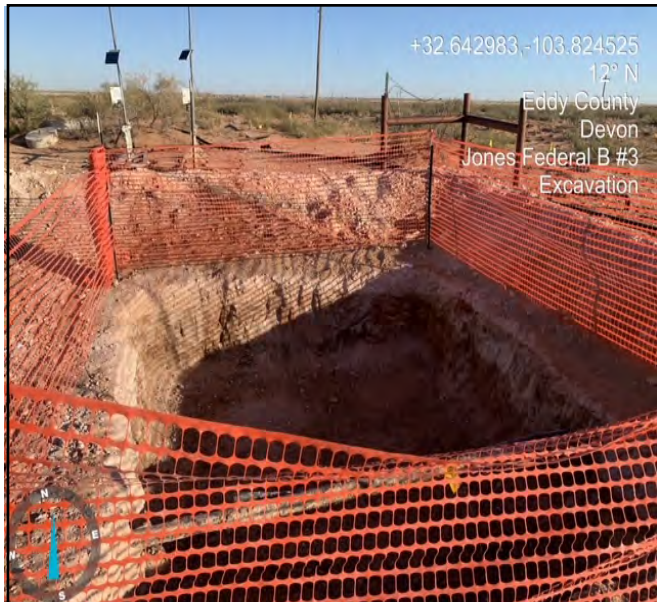
Photograph illustrating the depth of the excavation site, facing north.

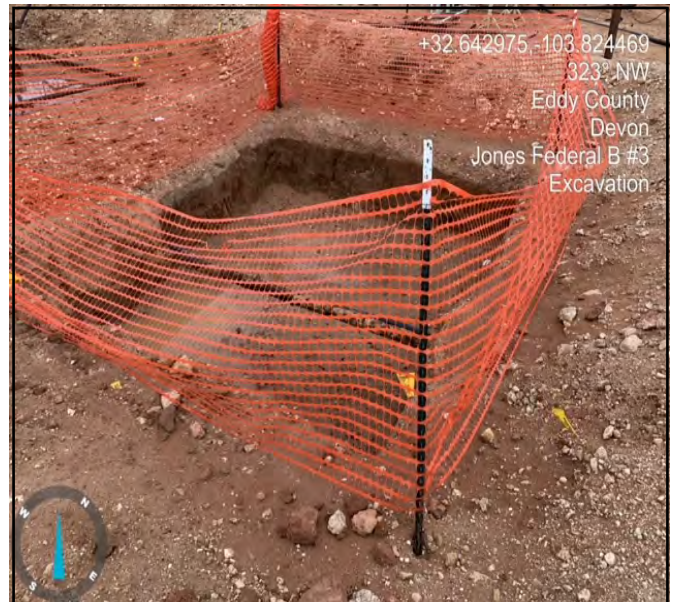
Photograph illustrating the depth of the excavation site, facing northwest.

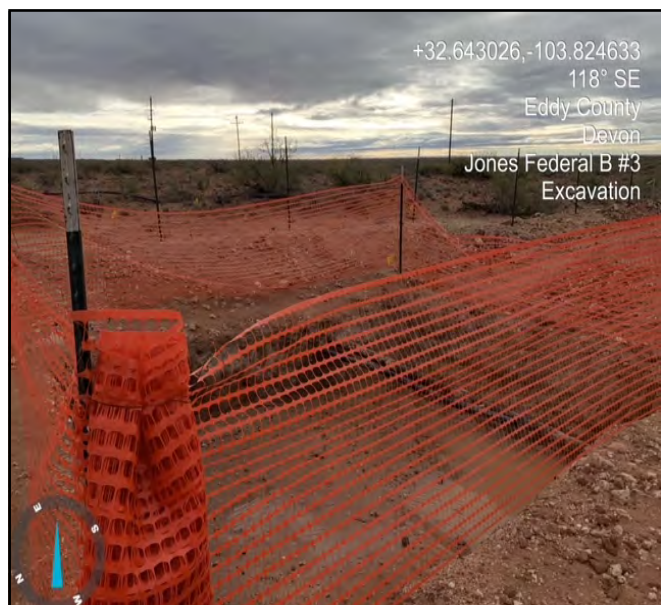
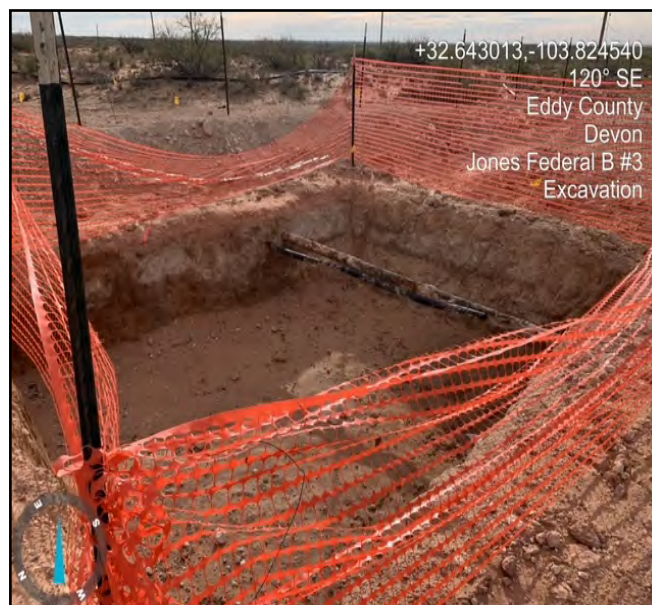
Photo showing the depth of the excavation site.

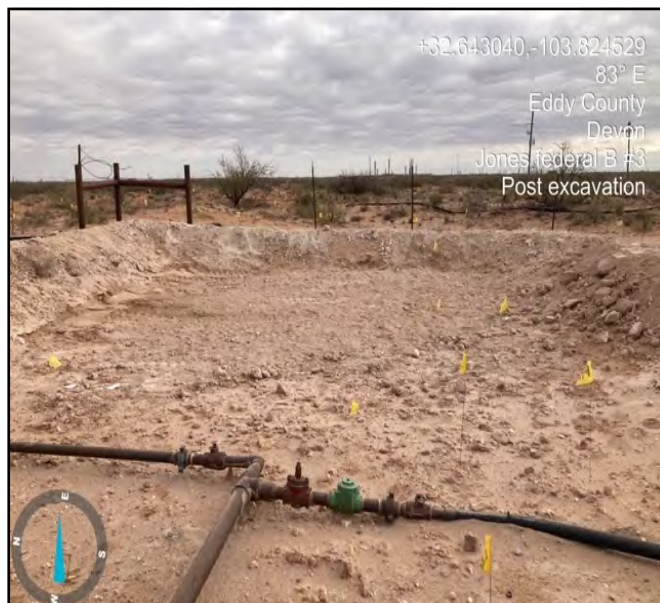
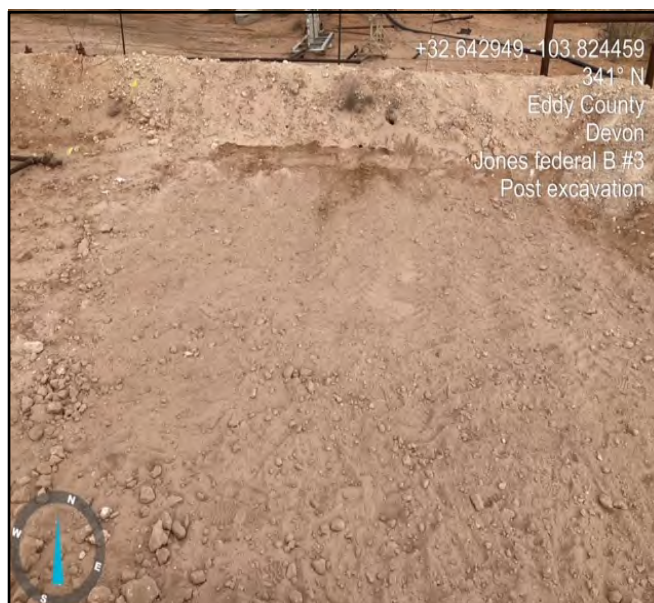
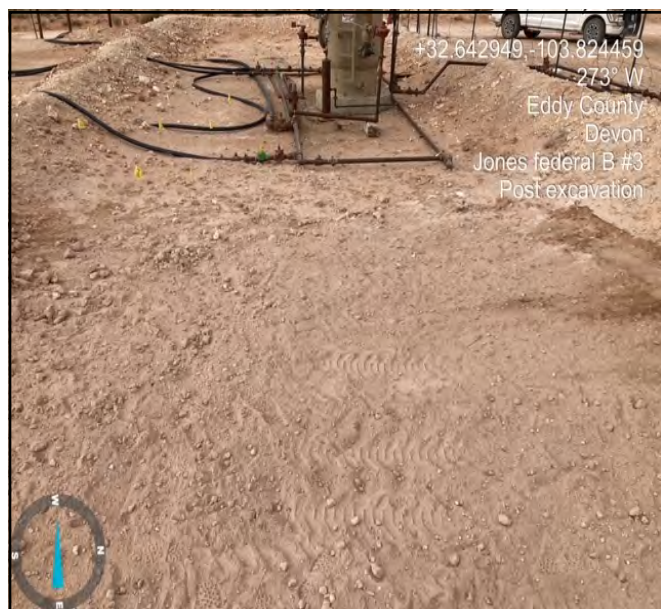
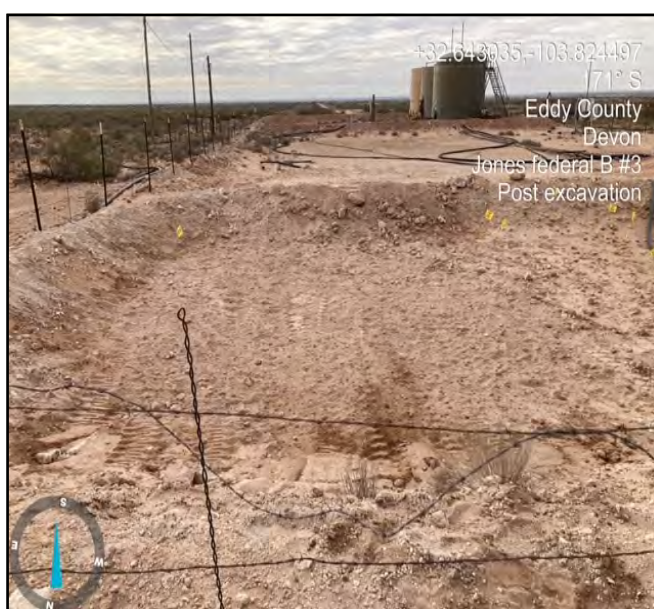
Photo showing the area being completed and backfilled.
