**Re: Release Characterization and Remediation Work Plan
ConocoPhillips
Deckard Federal Com #002H Flowline Release
Unit Letter C, Section 13, Township 24 South, and Range 33 East
Lea County, New Mexico
Incident ID NAPP2418342470
Landowner: Private**

Release Characterization and Remediation Work Plan
December 18, 2024

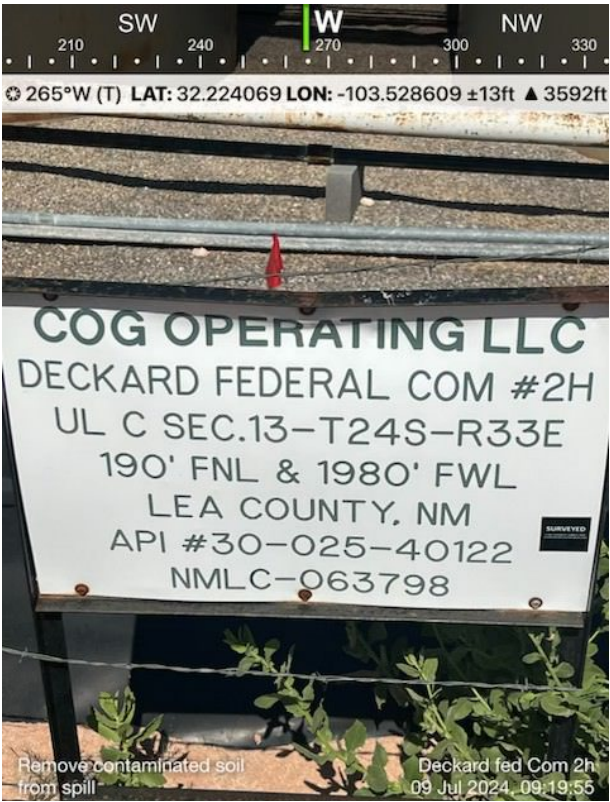
TETRA TECH, INC. PROJECT NO. 212C-MD-03575	DESCRIPTION	View south-southeast of site signage. Deckard Federal Come #2H.	1
	SITE NAME	Deckard Federal Com #003H Flowline Release	7/9/2024

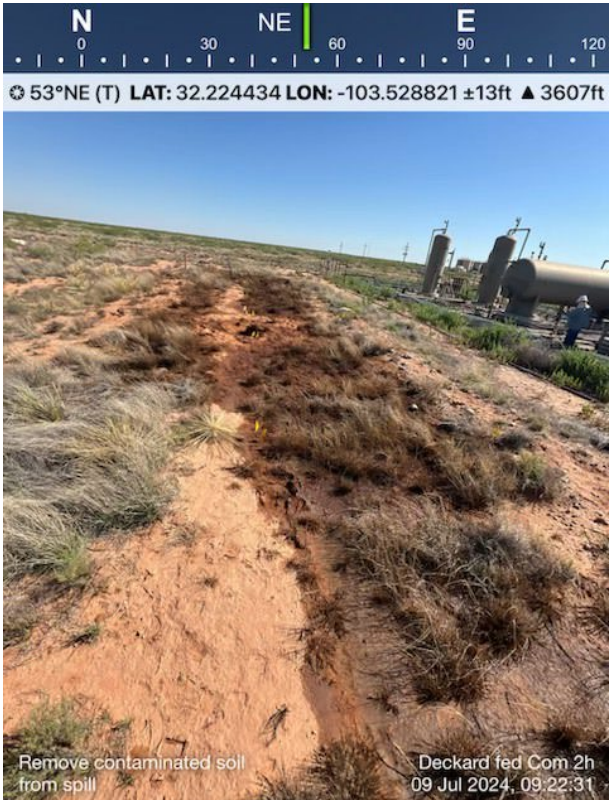
TETRA TECH, INC. PROJECT NO. 212C-MD-03575	DESCRIPTION	View northeast of approximate release extent.	2
	SITE NAME	Deckard Federal Com #003H Flowline Release	7/9/2024

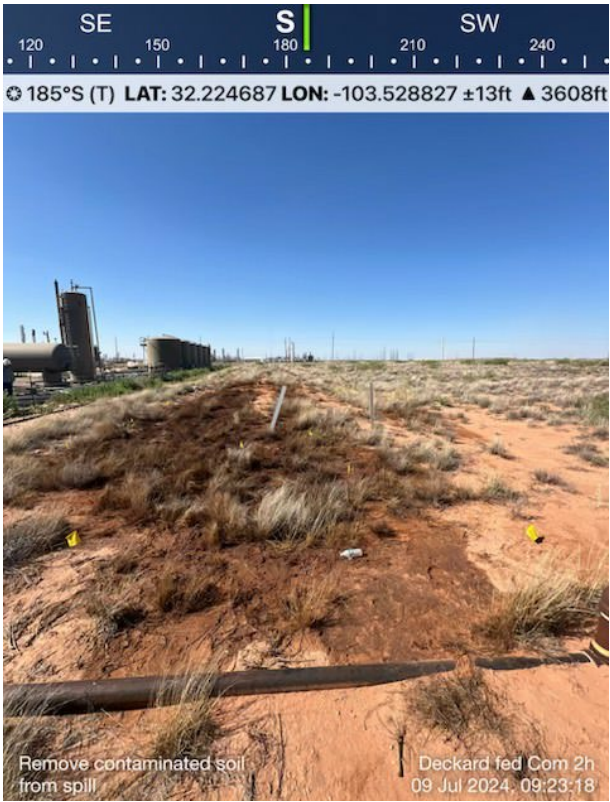
TETRA TECH, INC. PROJECT NO. 212C-MD-03575	DESCRIPTION	View south of approximate release extent.	3
	SITE NAME	Deckard Federal Com #003H Flowline Release	7/9/2024

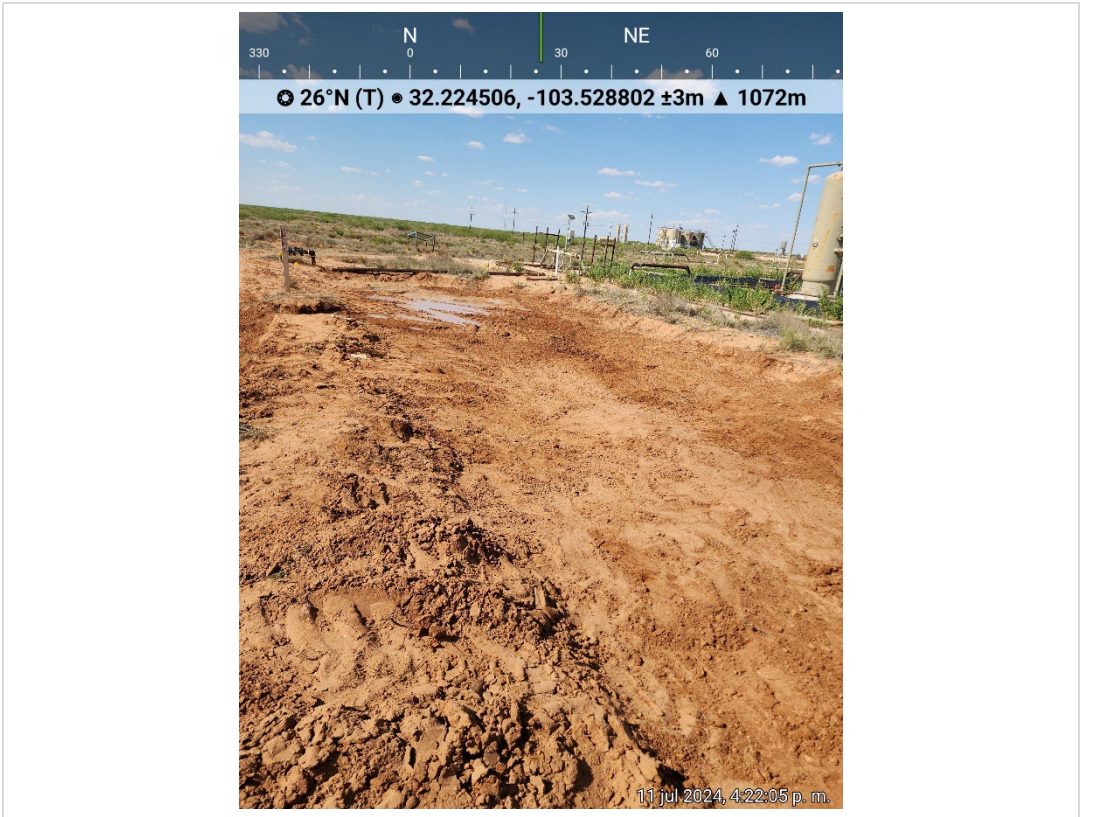
TETRA TECH, INC. PROJECT NO. 212C-MD-03575	DESCRIPTION	View north-northeast of initial response activities. View of approximate scrape area.	5
	SITE NAME	Deckard Federal Com #003H Flowline Release	7/11/2024

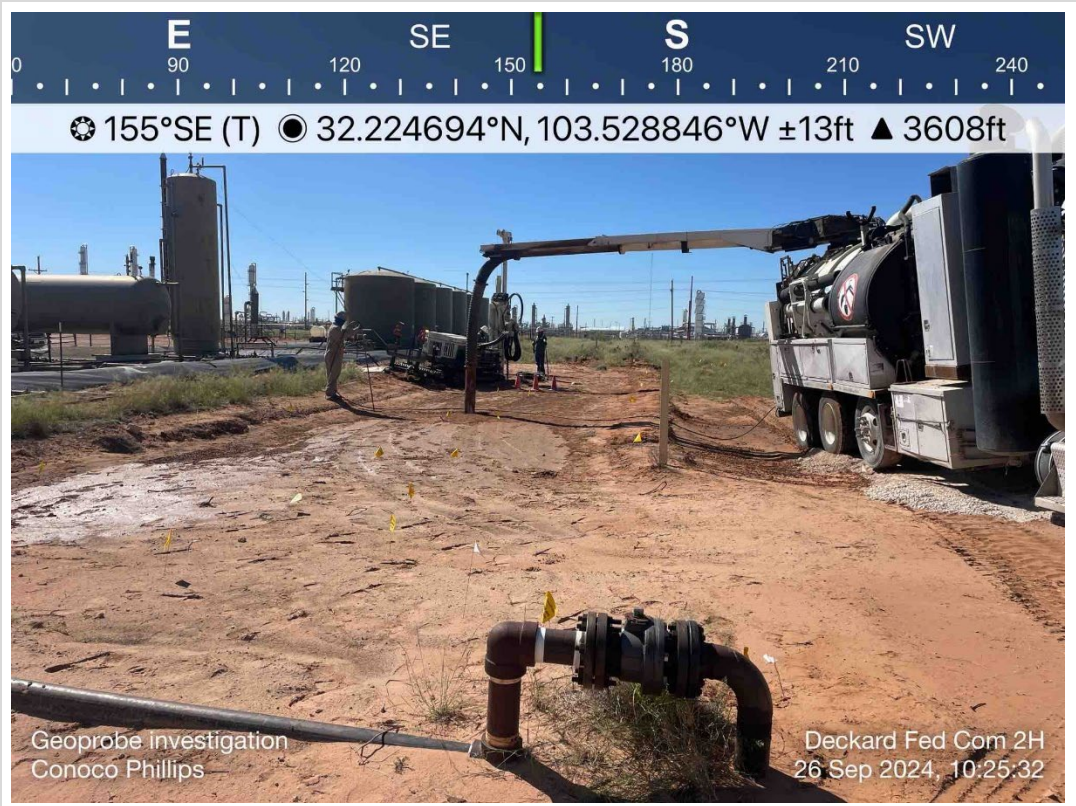
TETRA TECH, INC. PROJECT NO. 212C-MD-03575	DESCRIPTION	View south-southeast of Geoprobe assessment activities inside approximate release extent.	11
	SITE NAME	Deckard Federal Com #003H Flowline Release	9/26/2024
