COTTON DRAW UNIT #605H

Incident ID nAPP2311446508

Remediation Work Plan

Re: Site Characteristic and Remediation Plan Report
Cotton Draw Unit #605H
API # 30-015-47297
NMOCD Incident ID nAPP2311446508
ULSTR - C - 26 - 24S - 31E 385 FNL 2530 FWL Eddy County, NM
GPS Coordinates: Latitude 32.1953226 Longitude -103.751473

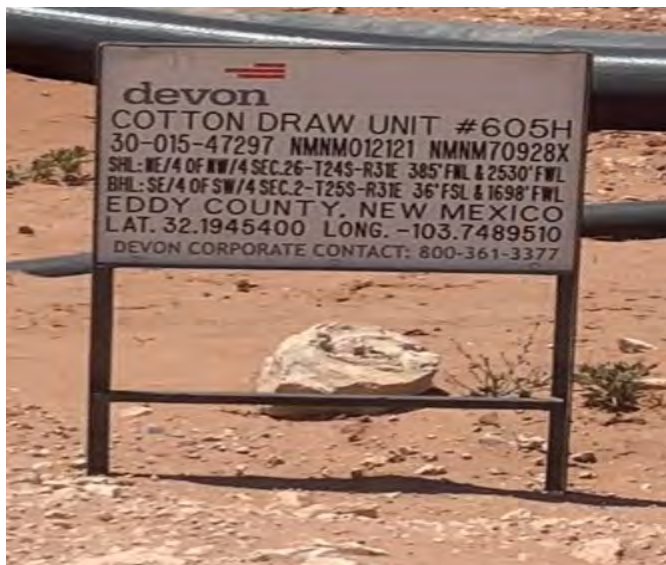
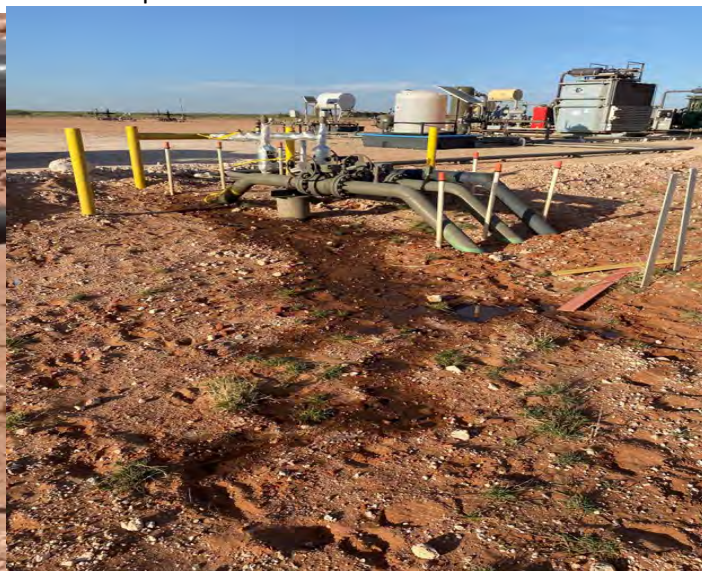
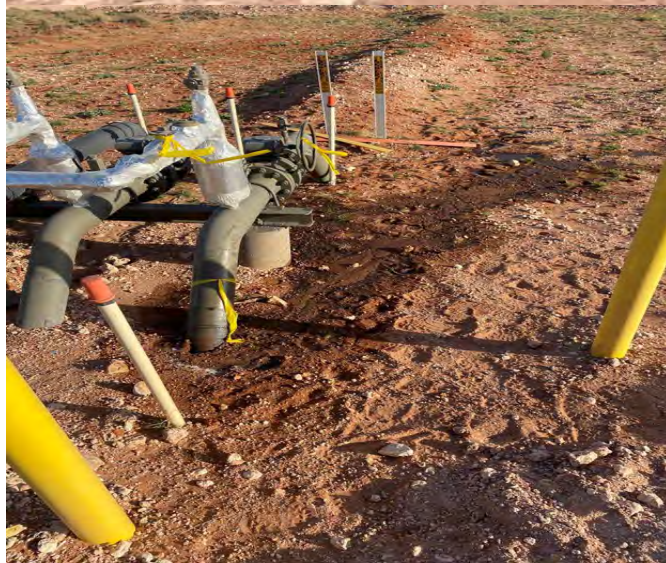
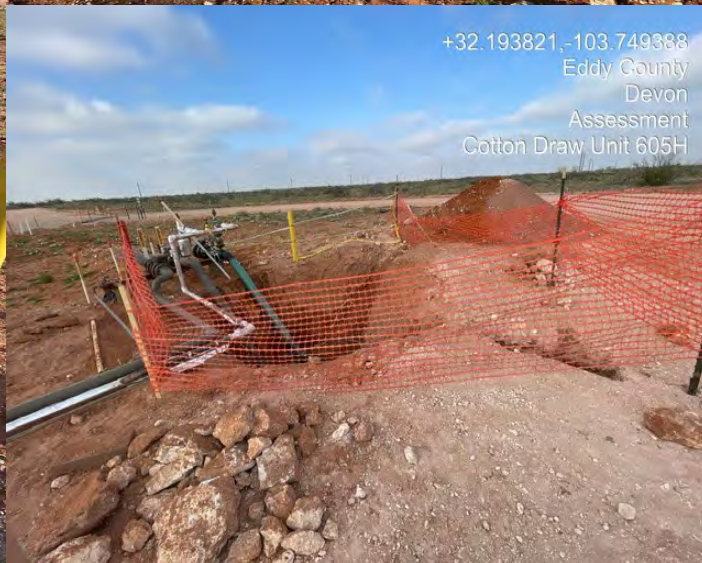
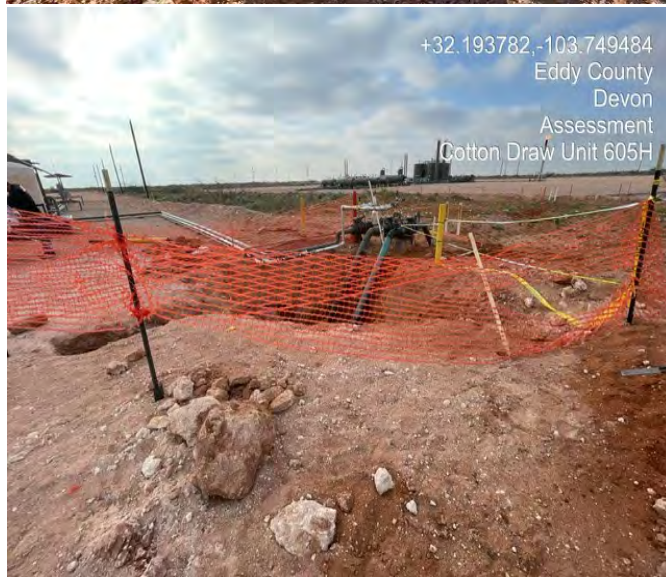
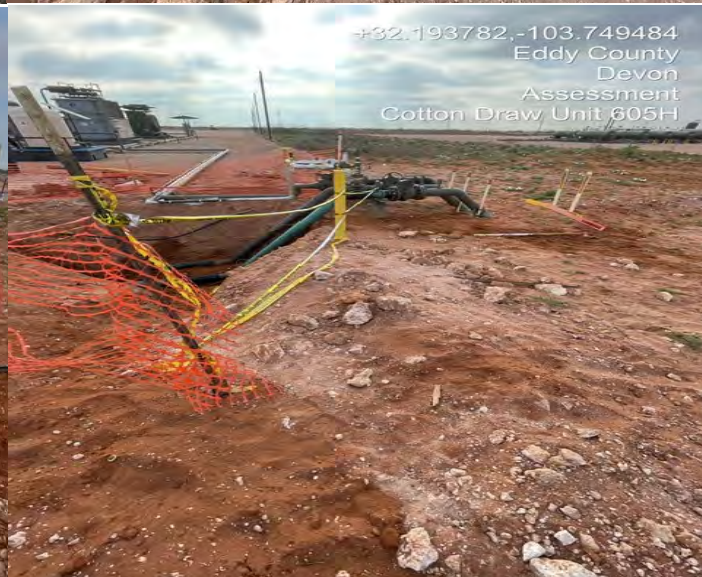
Initial Release and Flowline Repair - 2023

nAPP2311446508: On April 17, 2023, Operator found fluid coming up from the flow line for the CDU 605 at the edge of the well pad. The well was shut in to stop the leak. Fluid from spill soaked into the ground approximately 20 feet of the south side of the well pad. No fluids were recovered.

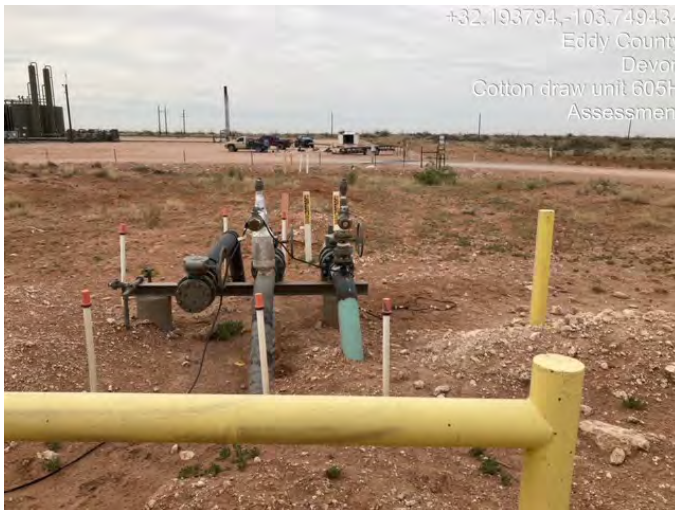
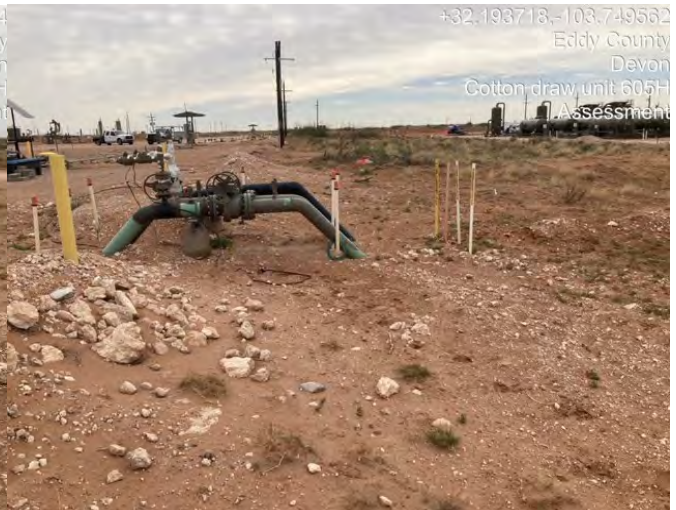
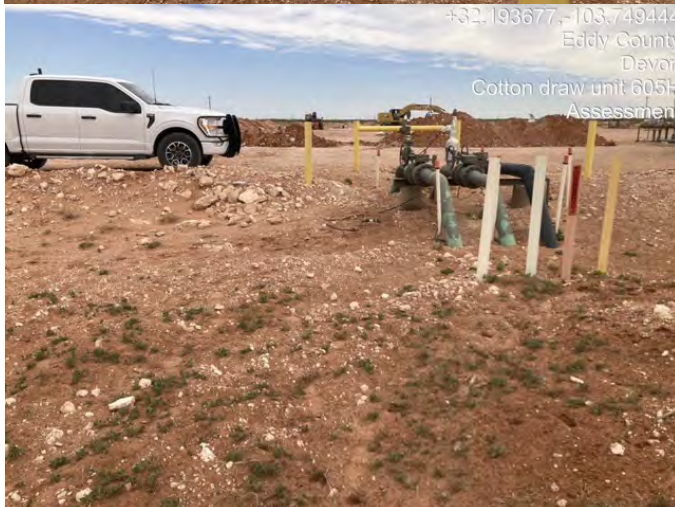
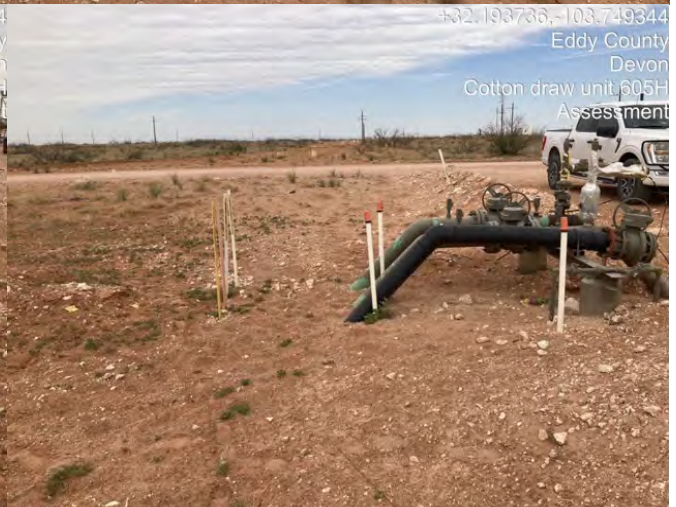
Reassessment 2024

On May 15, 2024, Pima personnel returned to the site to reassess the release area. Soil had been removed from this area and replaced during the previous pipeline/flowline work activities. Samples needed to be collected and analyzed to find out if contamination had been removed as well. Four (4) discrete samples were collected from the S1 sample point from depths of 1', 2', 3', and 4' bgs. Four (4) discrete samples were collected from SW1 through SW4 sample points from a depth of 1' bgs. One (1) sample was collected from the previous BG1 sample point at a depth of 1' bgs. These samples were put on ice, prepared for delivery, and delivered to Envirotech Analytical Laboratories for official analysis of all constituents listed in Table 1 19.15.29.12 NMAC.
