## Shugart 23 Federal Com #001 – Raybaw Operating, LLC

Proposed Sampling Plan Report  
Written by Sapec-Eco, LLC for Raybaw  
Operating, LLC

**RE:** Proposed Sampling Plan Report  
Shugart 23 Federal Com #001  
API No. 30-015-30448 Raybaw Operating, LLC [330220]  
Surface Location: J - 23 - 18S - 31E 1650 FSL 1980 FEL  
Lat/Long: 32.7303581, -103.838028 NAD83  
NMOCD Incident IDs - nMLB0912449922 & nMLB1125557019

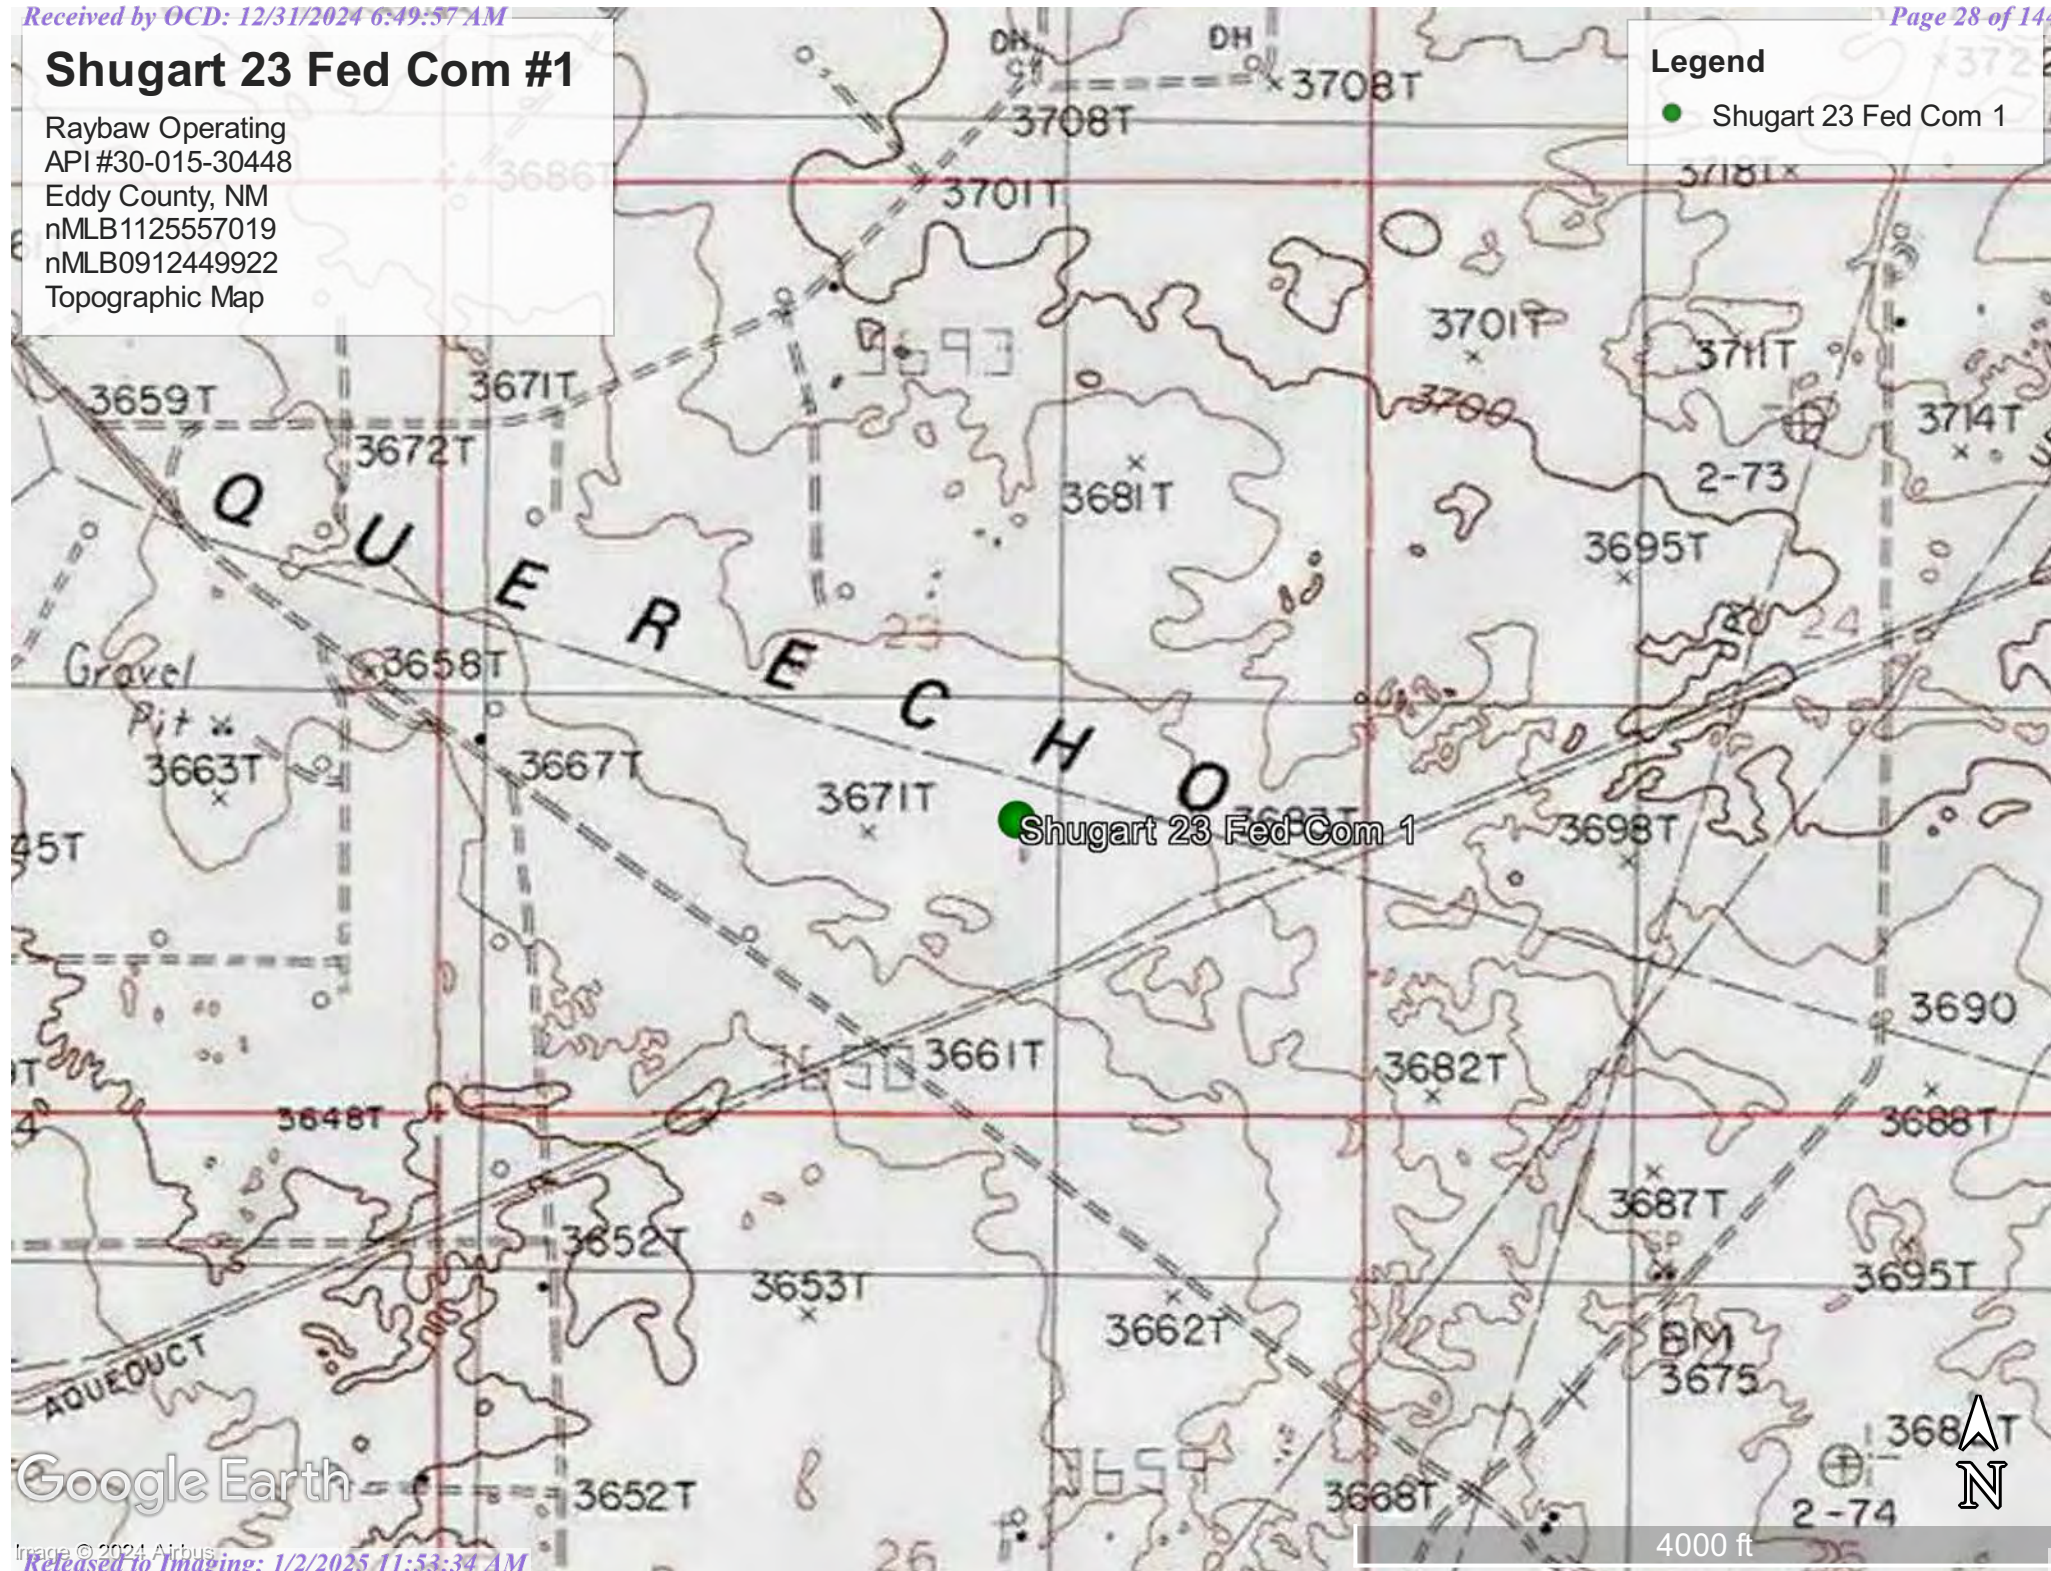
Raybaw Operating  
API #30-015-30448  
Eddy County, NM  
nMLB1125557019  
nMLB0912449922  
Proposed Sampling Map

1. Submit a 48-Hour Notification of Sampling event to the NMOCD. Also, please see the variance requests below.
2. Collect discrete samples from eleven (24) sample points within the previously treated areas and the ex-situ treatment cell area. These samples will be collected from each sample point at depth intervals of surface, 1', 2', 3', and 4' bgs. The samples that will be collected from around the secondary tank containment should be angled underneath the containment as much as safely possible to represent the previously treated soil.

3. Collect discrete samples from eight (16) sample points from around the edges of the previously treated areas and the ex-situ treatment cell area. These samples will also be collected from each sample point at depth intervals of surface, 1', 2', 3', and 4' bgs. A Proposed Sampling Map can be referenced in Figure 3.

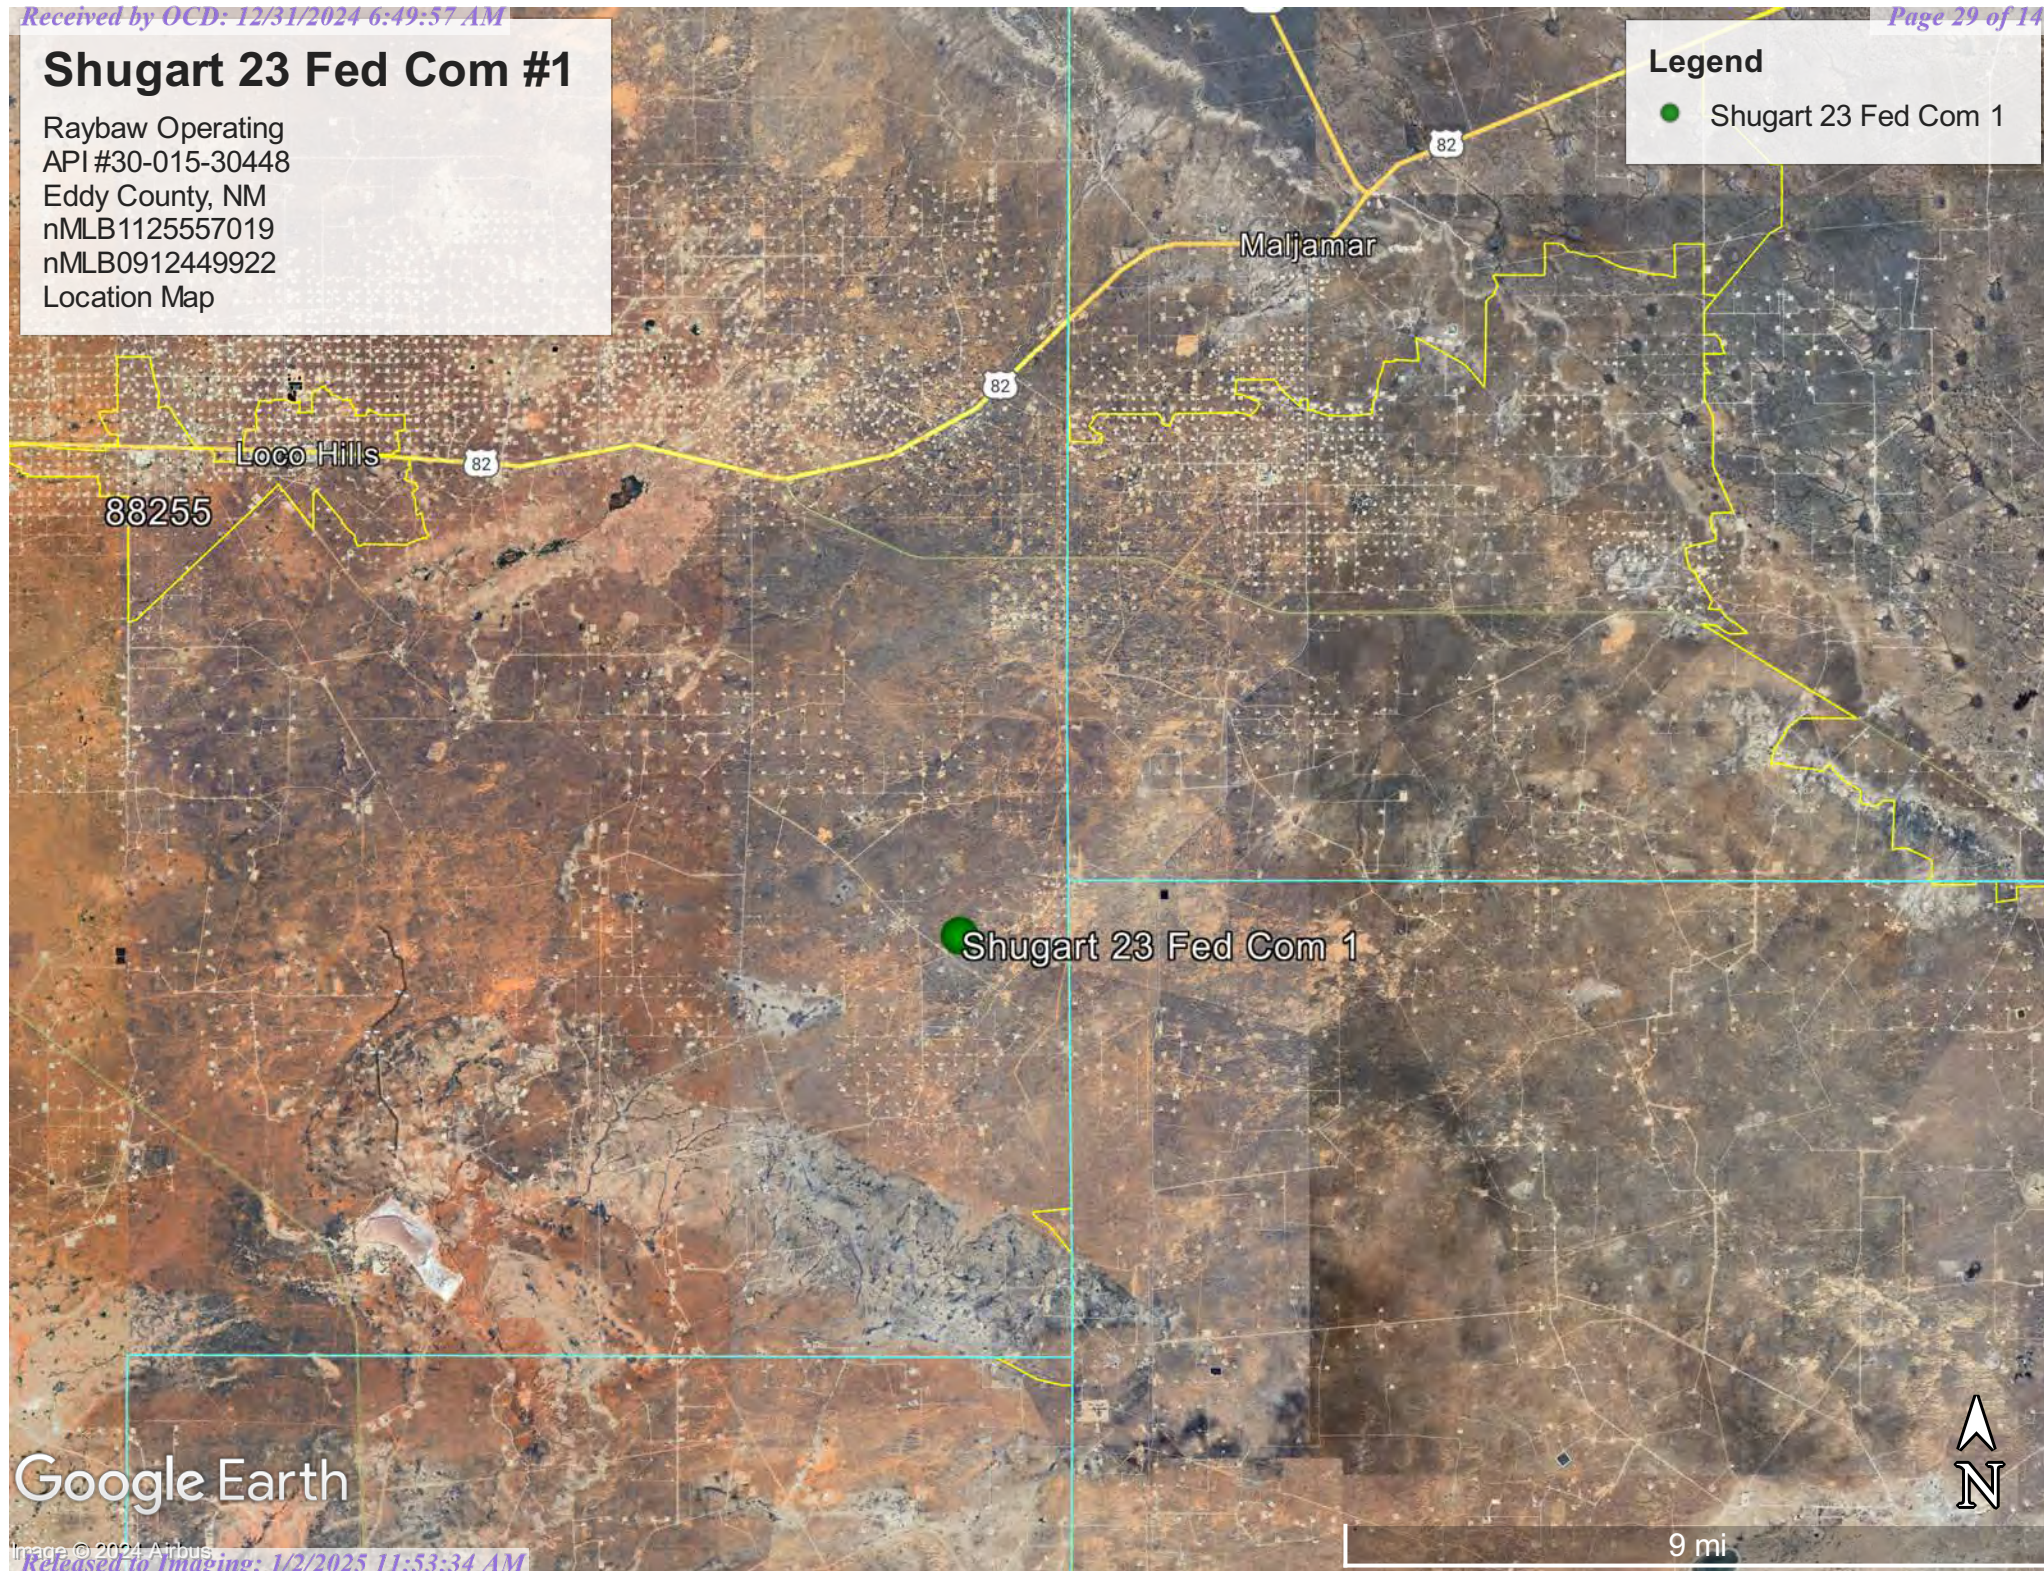
Raybaw Operating  
API #30-015-30448  
Eddy County, NM  
nMLB1125557019  
nMLB0912449922  
Location Map

The Shugart is in Eddy County, NM approximately ten (10) miles southeast of Loco Hills, NM. This release site is in Unit J, Section 23, Township 18S, Range 31E, at GPS coordinates 32.7303581 latitude and -103.838028 longitude. It can be accessed by a lease road that bears entry from the southwest. A Location Map can be referenced in Figure 6.

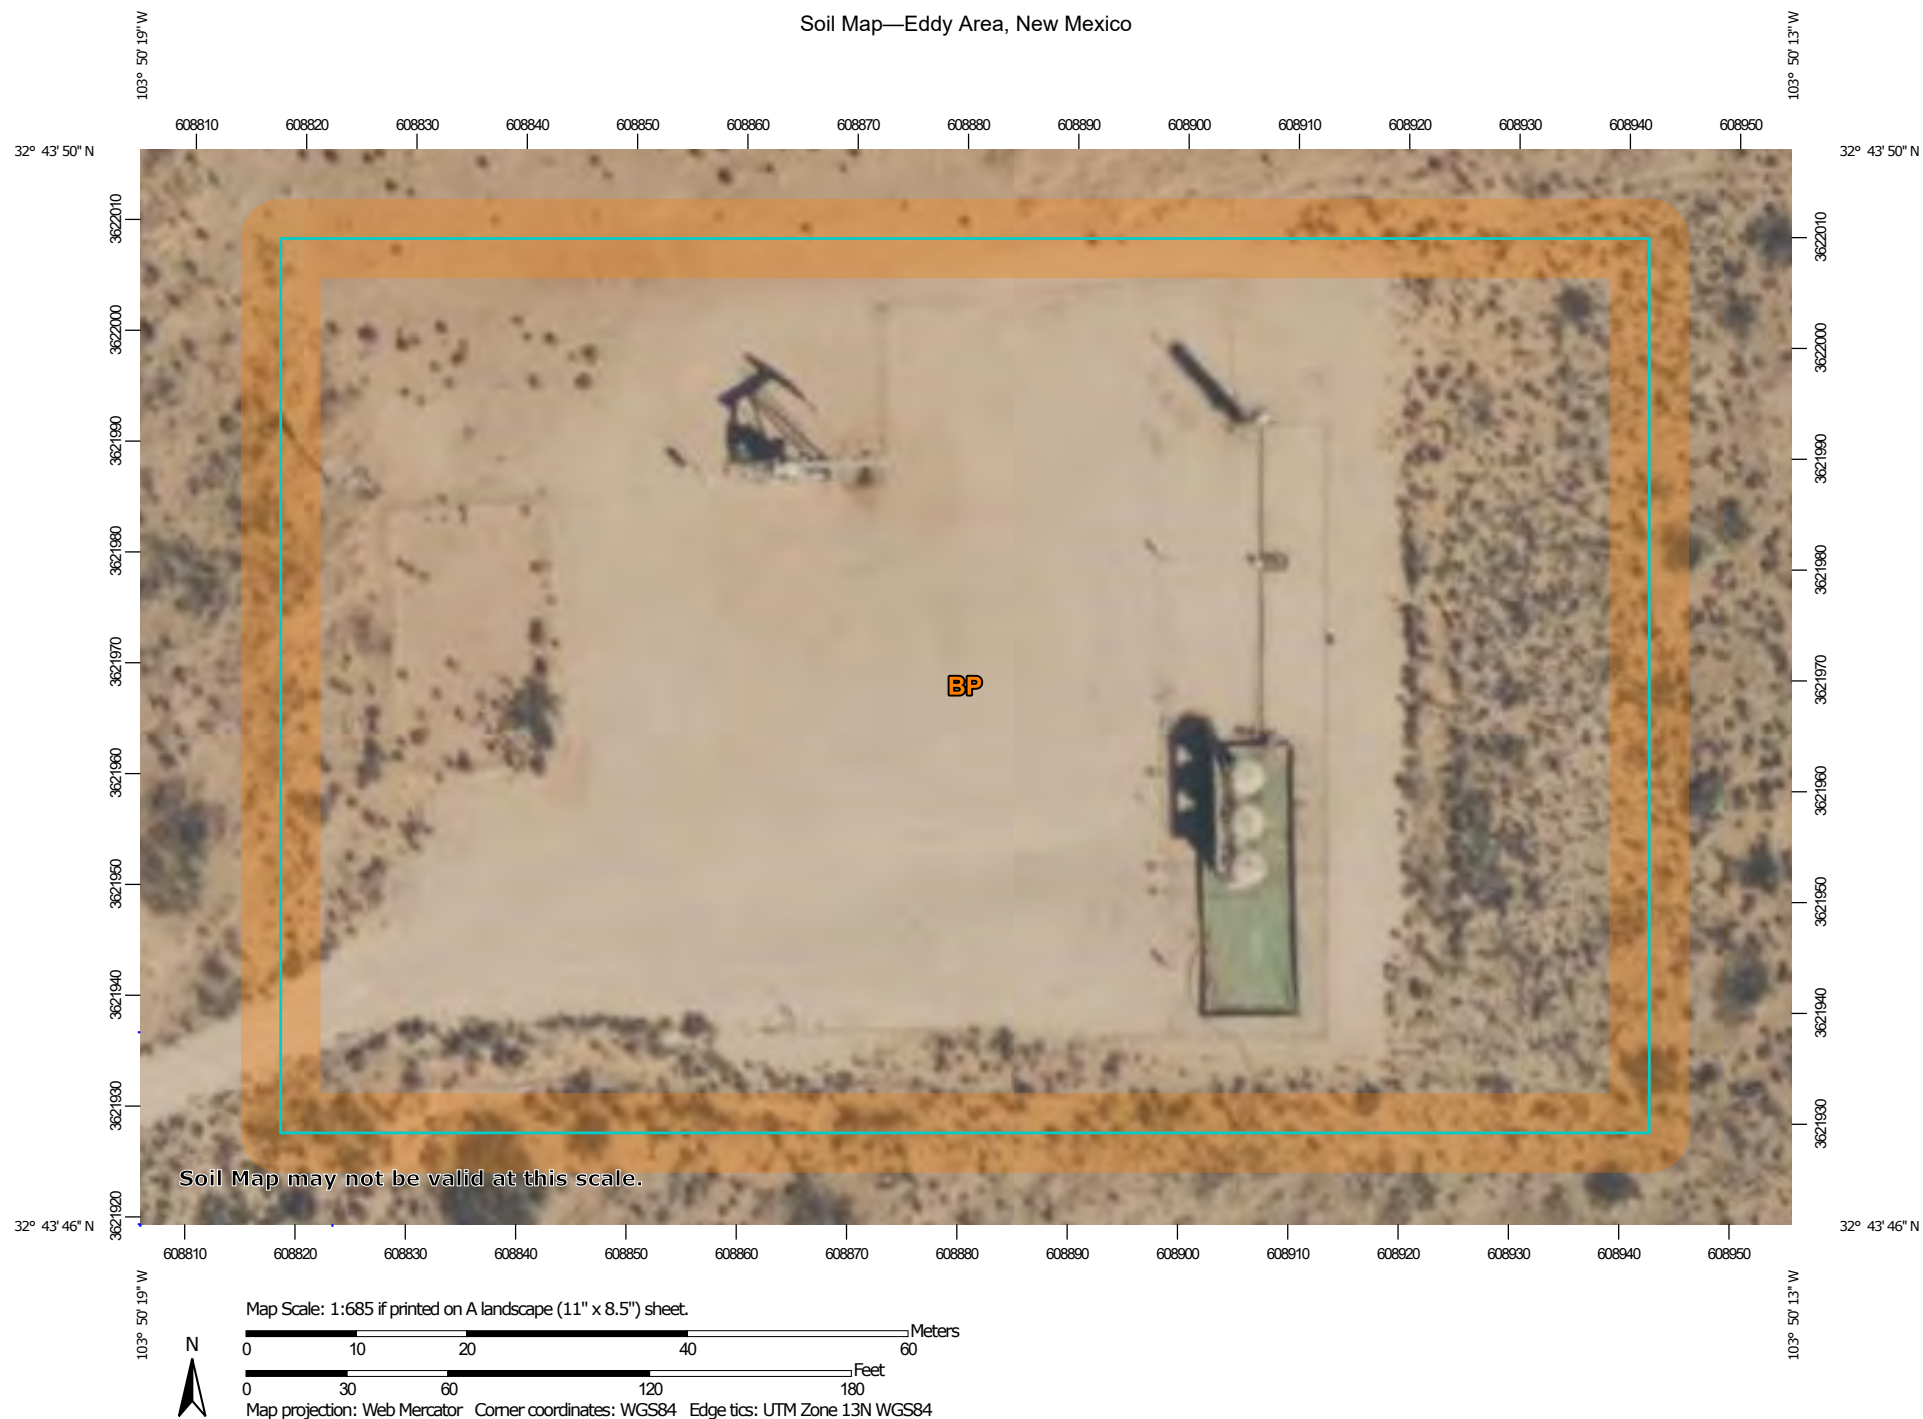
# Soil Map—Eddy Area, New Mexico

The soil in this area, according to the United States Department of Agriculture Natural Resources Conservation Service soil survey, is made up of Berino-Parajito complex, having 0 to 3 percent slopes, eroded. The drainage class in this area is well drained. There is a low potential for karst geology to be present around the Shugart (Figure 4) with the nearest medium karst zone being 4 miles away. Soil Survey and Geological Data can be found in Appendix B. A Topographic Map can be referenced in Figure 5.
