**Re: Interim Remediation Report and Deferral Request  
ConocoPhillips  
Wilder CTB Vessel Release  
Unit Letter A, Section 29, Township 26 South, and Range 32 East  
Lea County, New Mexico  
Incident ID NAPP2317132356**

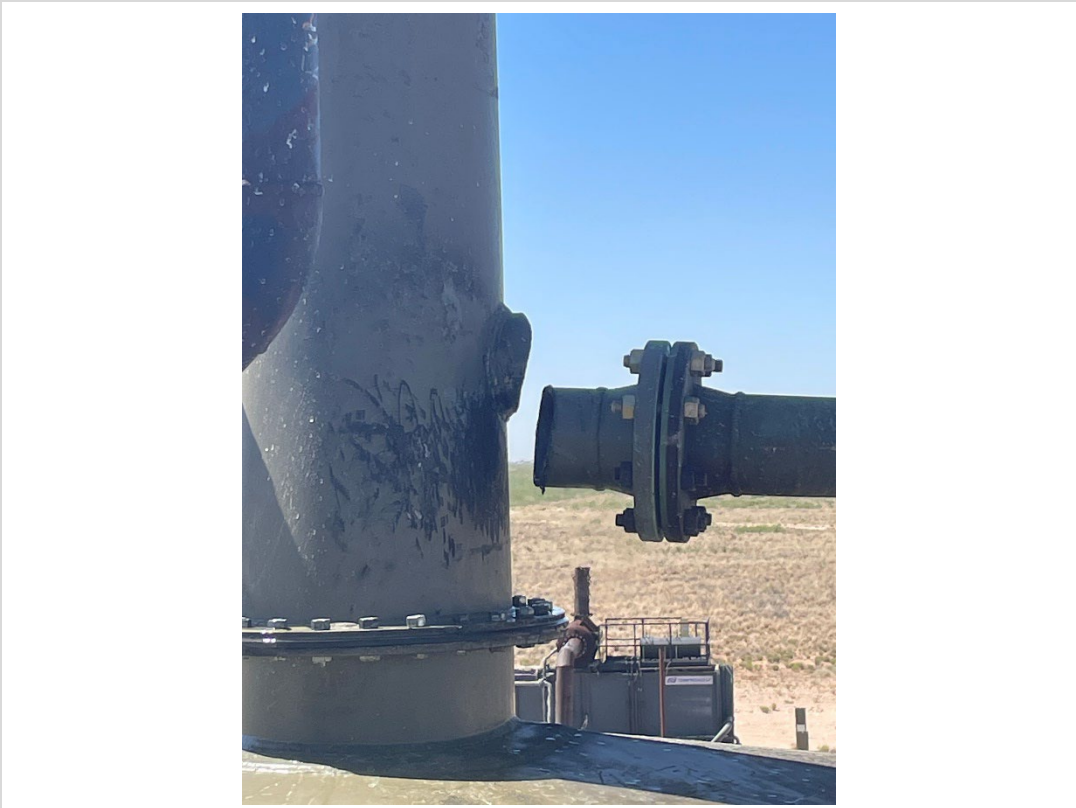
TETRA TECH, INC. PROJECT NO. 212C-MD-03183	DESCRIPTION	View unknown. Failed weld at release location.	1
	SITE NAME	WILDER CTB Vessel Release	6/2023

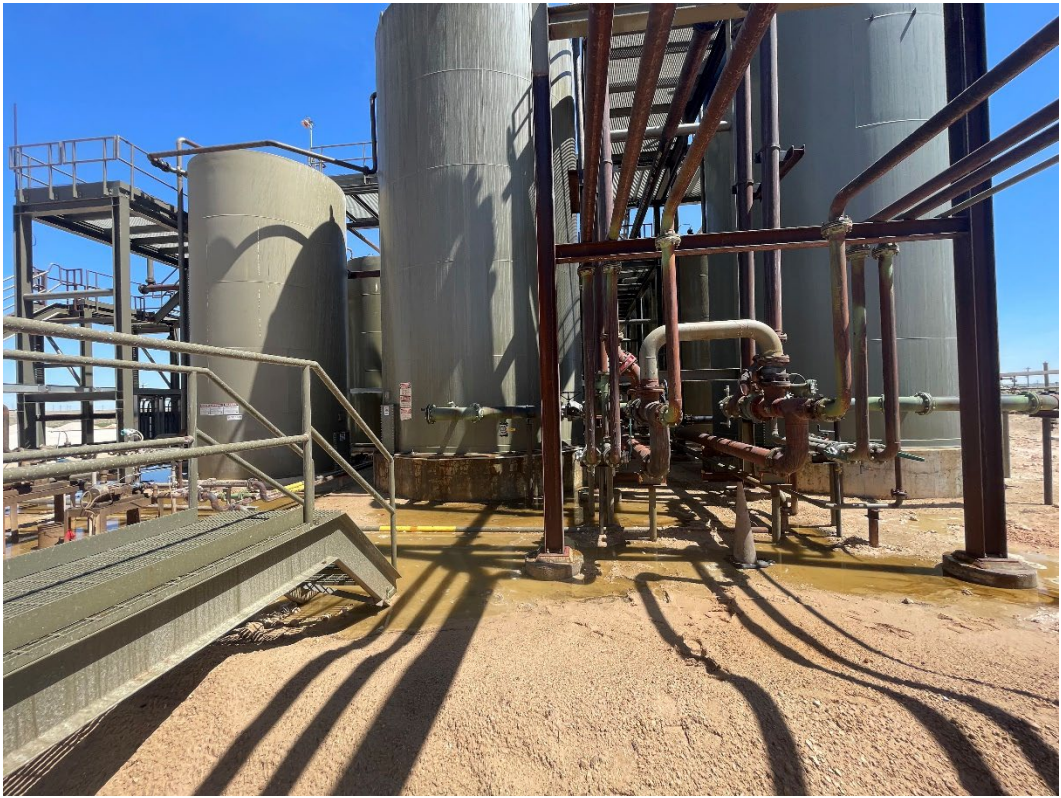
TETRA TECH, INC. PROJECT NO. 212C-MD-03183	DESCRIPTION	View north. Southeastern portion of release footprint.	2
	SITE NAME	WILDER CTB Vessel Release	6/2023

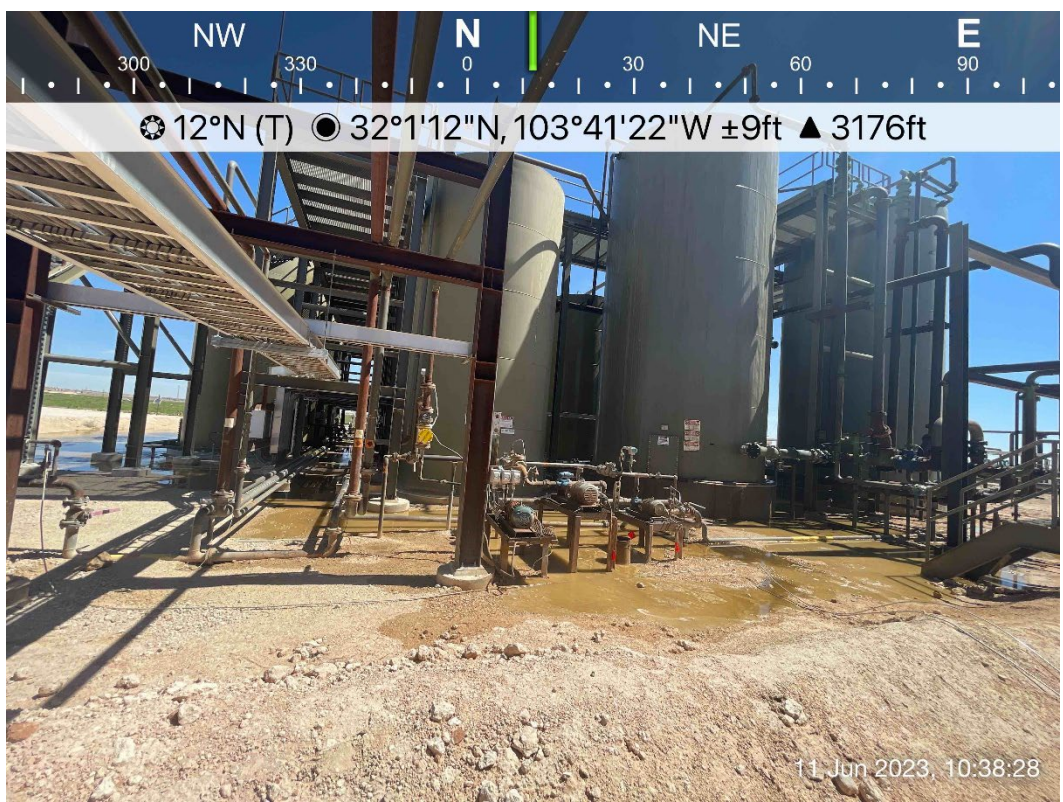
TETRA TECH, INC. PROJECT NO. 212C-MD-03183	DESCRIPTION	View north. Southern portion of release footprint.	3
	SITE NAME	WILDER CTB Vessel Release	6/2023

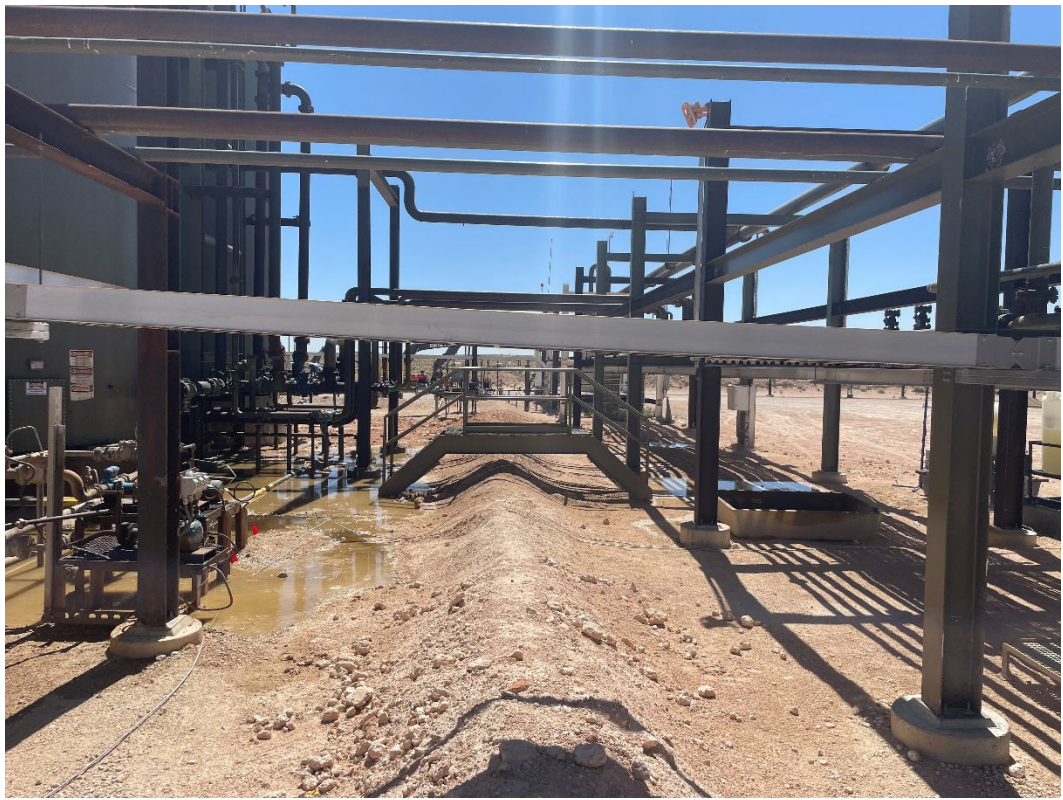
TETRA TECH, INC. PROJECT NO. 212C-MD-03183	DESCRIPTION	View east. Southern portion of release footprint. Fluid visible south of berm.	4
	SITE NAME	WILDER CTB Vessel Release	6/2023

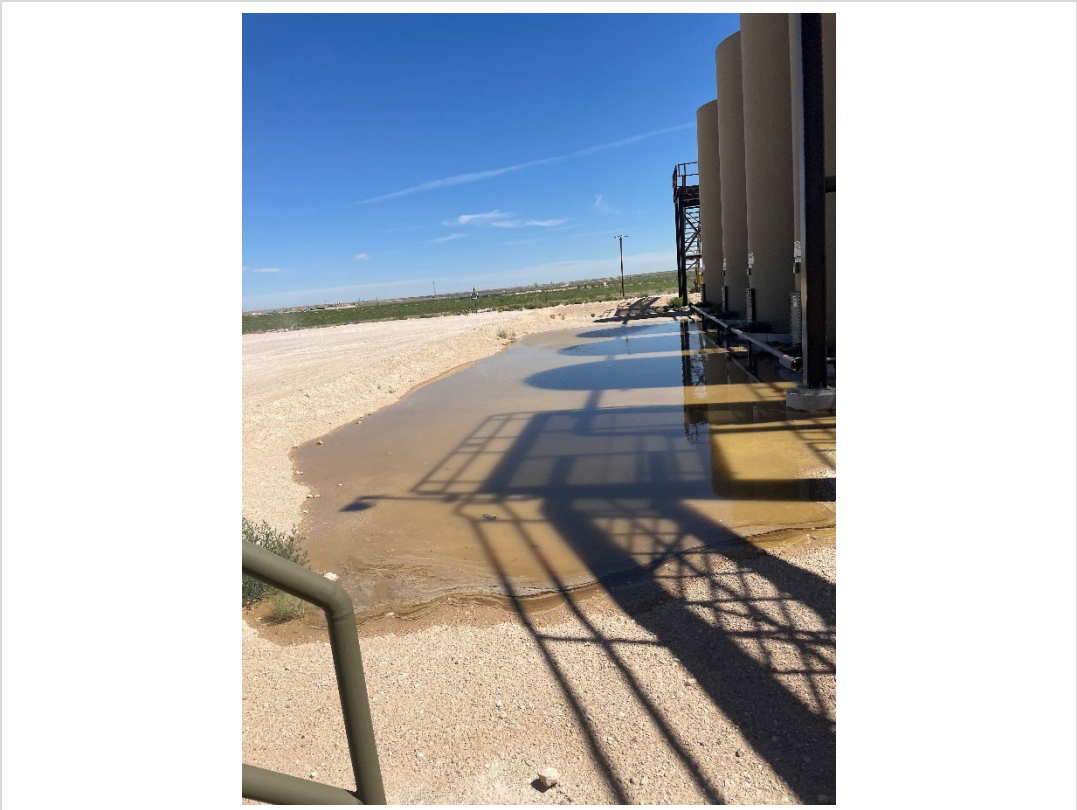
TETRA TECH, INC. PROJECT NO. 212C-MD-03183	DESCRIPTION	View north. Western portion of release footprint.	5
	SITE NAME	WILDER CTB Vessel Release	6/2023

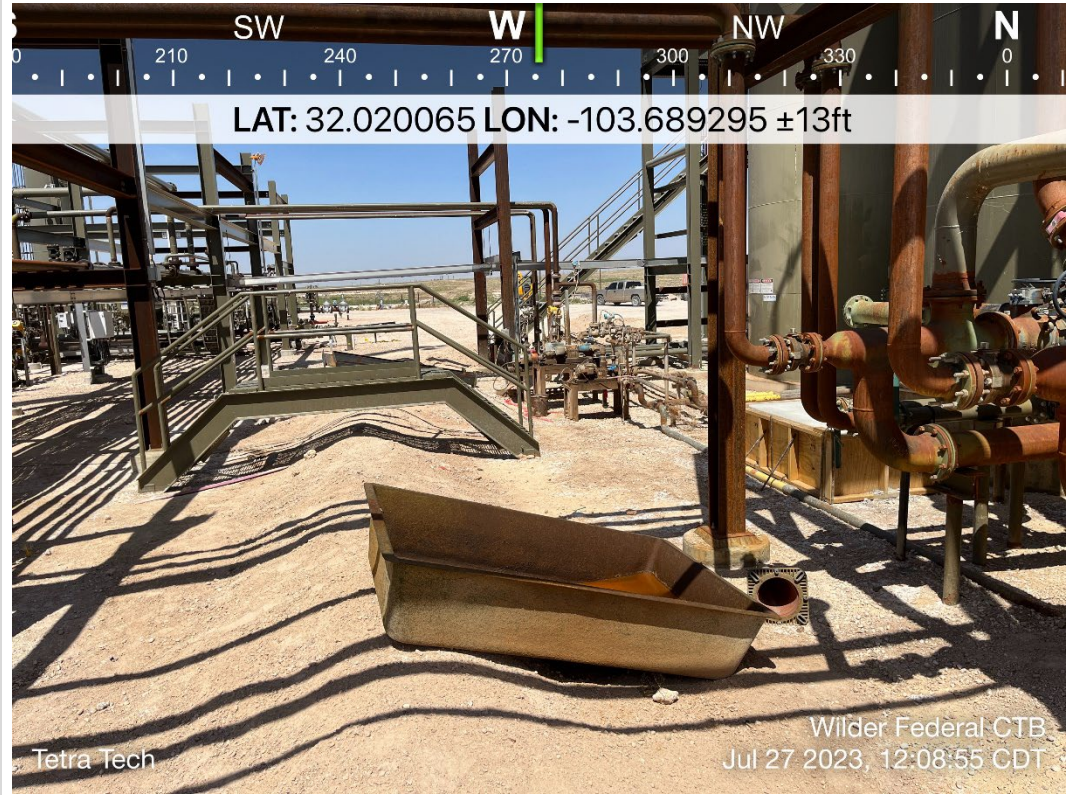
TETRA TECH, INC. PROJECT NO. 212C-MD-03183	DESCRIPTION	View west. Southern portion of release footprint.	6
	SITE NAME	WILDER CTB Vessel Release	7/27/2023

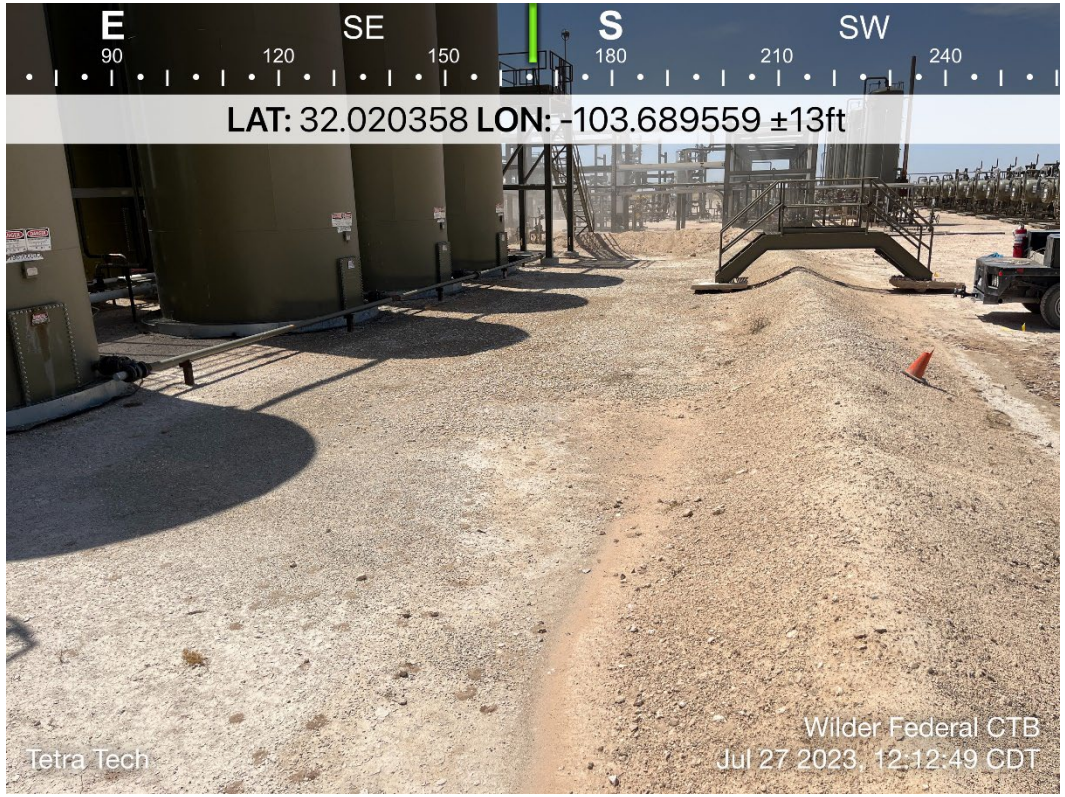
TETRA TECH, INC. PROJECT NO. 212C-MD-03183	DESCRIPTION	View south, berm along right side of photo, visible discoloration on pad surface inside berm.	8
	SITE NAME	WILDER CTB Vessel Release	7/27/2023

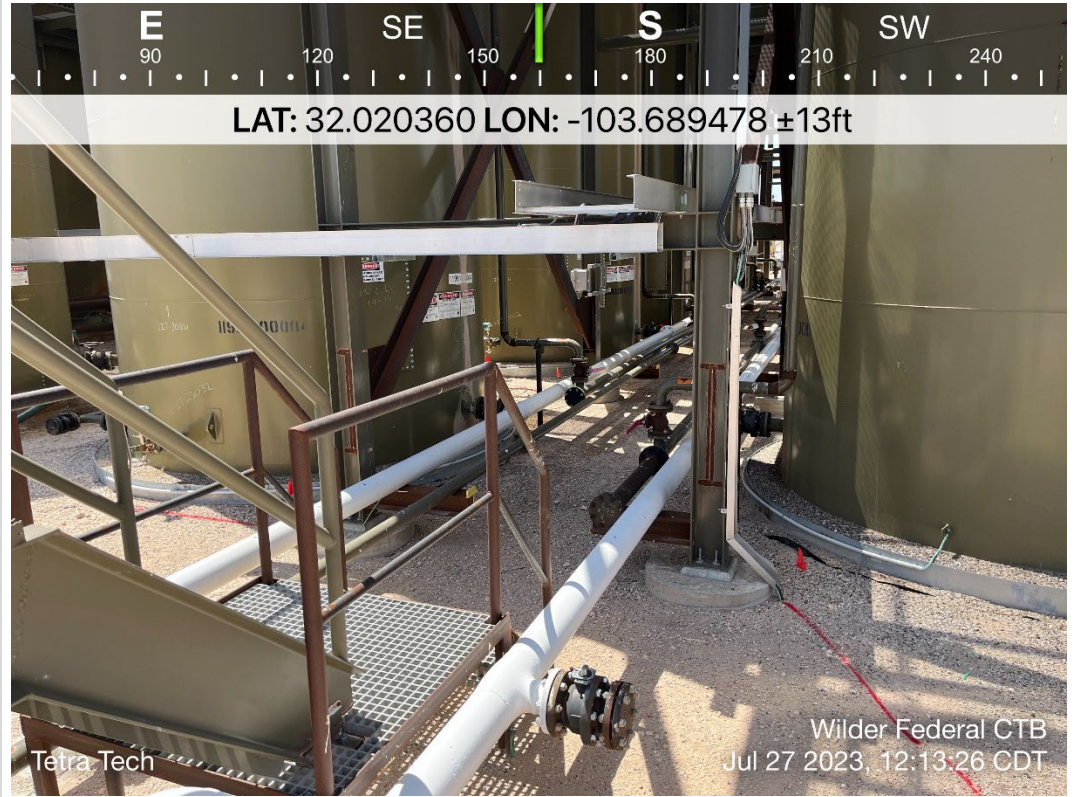
TETRA TECH, INC. PROJECT NO. 212C-MD-03183	DESCRIPTION	View south-southeast. Facility lines and subsurface electrical line markings in northwestern portion of the tank battery.	10
	SITE NAME	WILDER CTB Vessel Release	7/27/2023

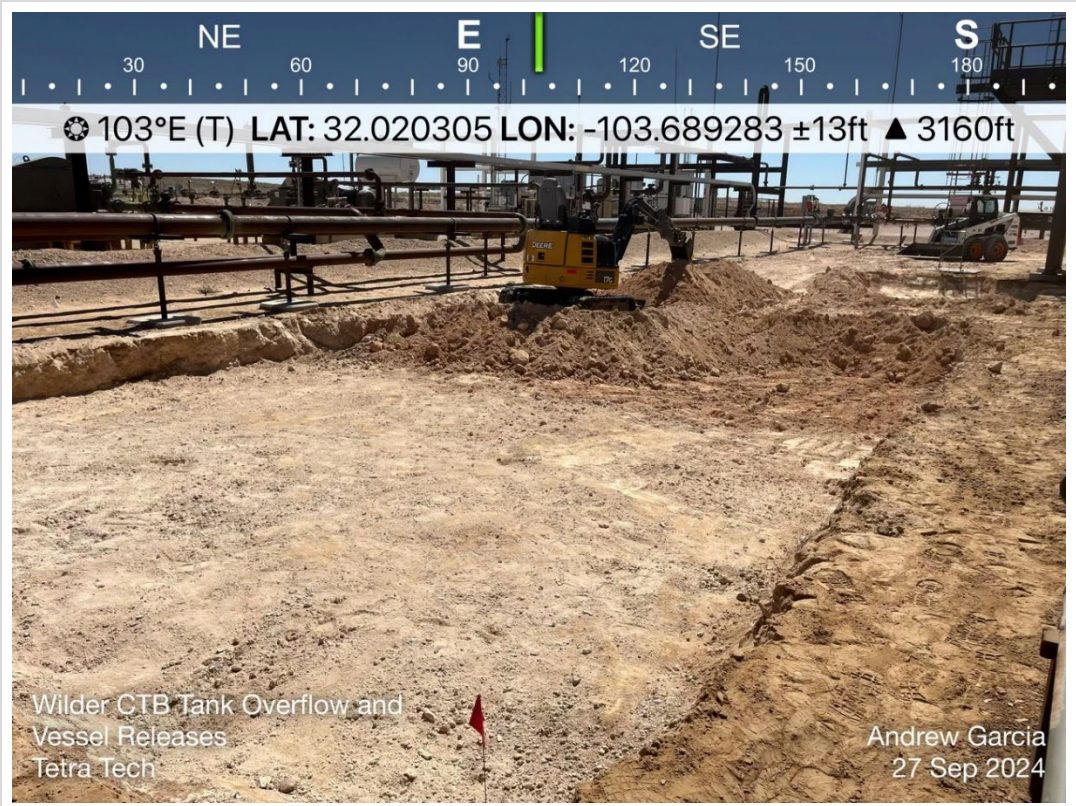
TETRA TECH, INC. PROJECT NO. 212C-MD-03442	DESCRIPTION	View East. East side of battery, interim remedial activities.	11
	SITE NAME	Wilder CTB Tank Overflow and Vessel Releases	9/27/2024

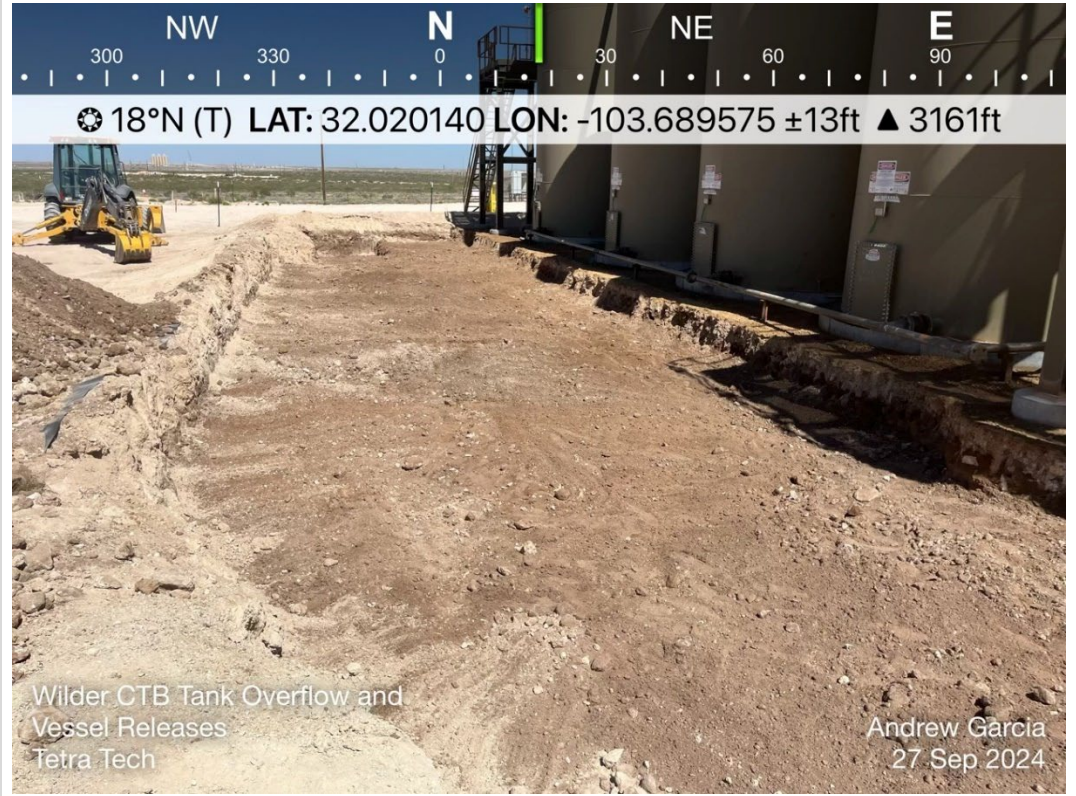
TETRA TECH, INC. PROJECT NO. 212C-MD-03442	DESCRIPTION	View North. West side of battery, interim remedial activities.	12
	SITE NAME	Wilder CTB Tank Overflow and Vessel Releases	9/27/2024

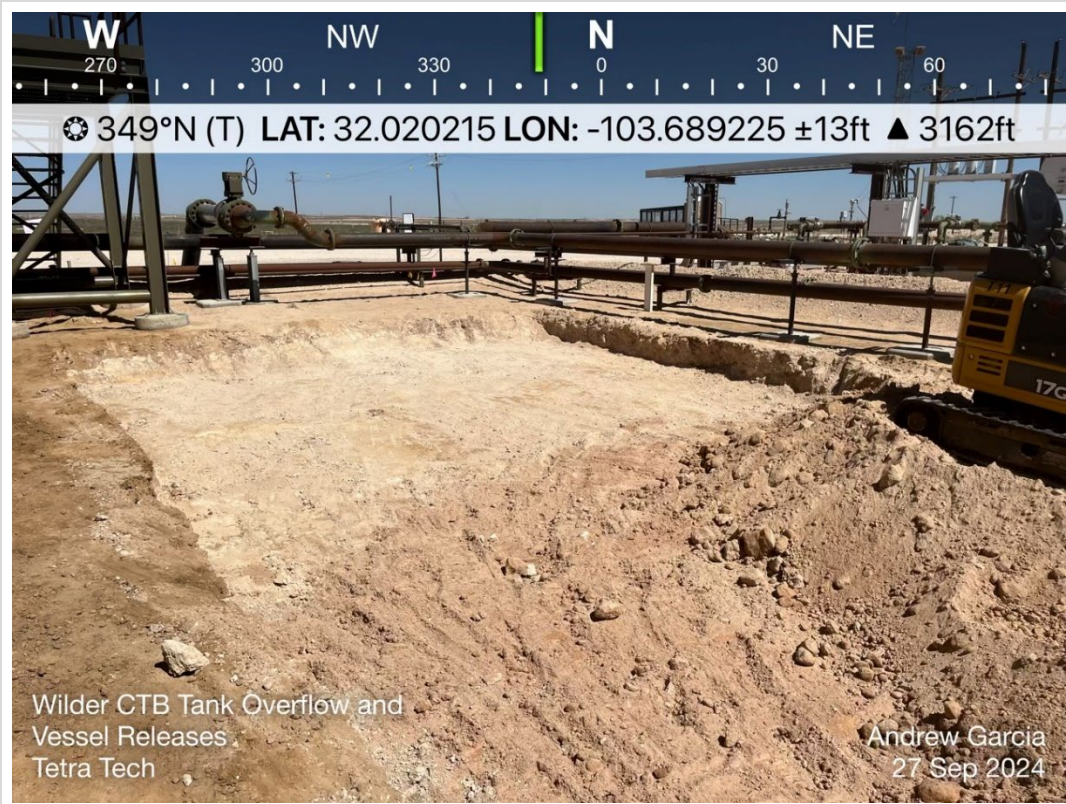
TETRA TECH, INC. PROJECT NO. 212C-MD-03442	DESCRIPTION	View north. East side of battery, interim remedial activities.	13
	SITE NAME	Wilder CTB Tank Overflow and Vessel Releases	9/27/2024

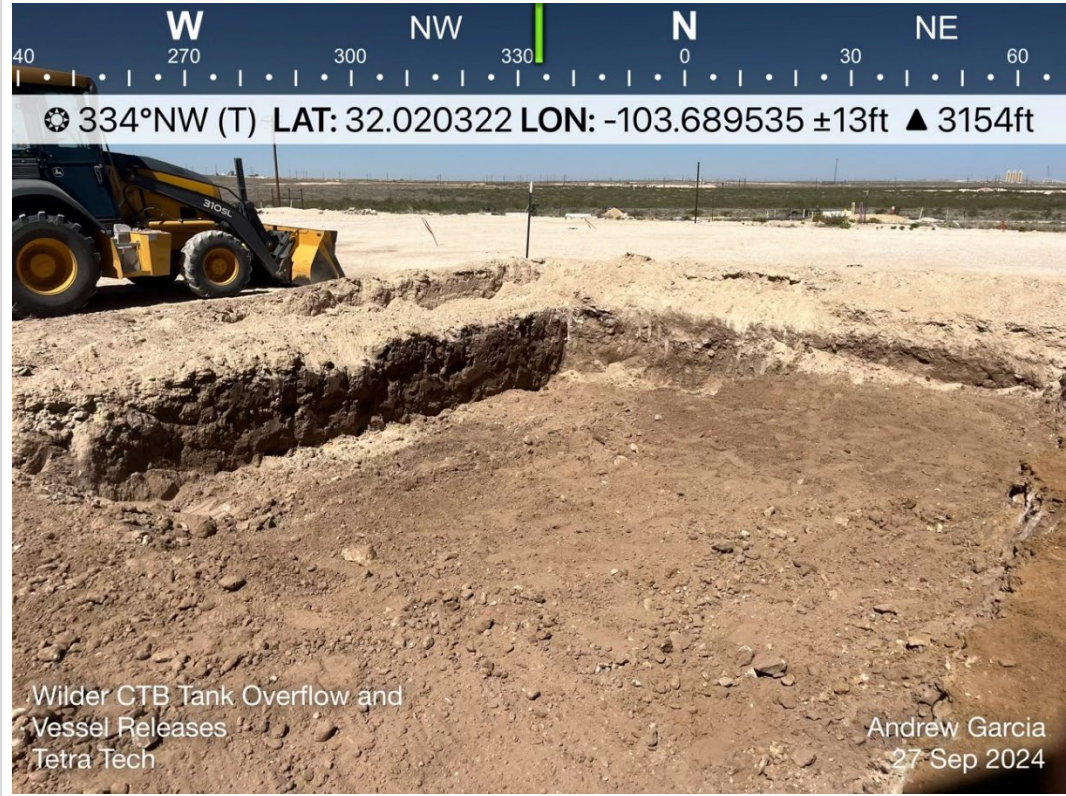
TETRA TECH, INC. PROJECT NO. 212C-MD-03442	DESCRIPTION	View north northwest. West side of battery, interim remedial activities.	14
	SITE NAME	Wilder CTB Tank Overflow and Vessel Releases	9/27/2024

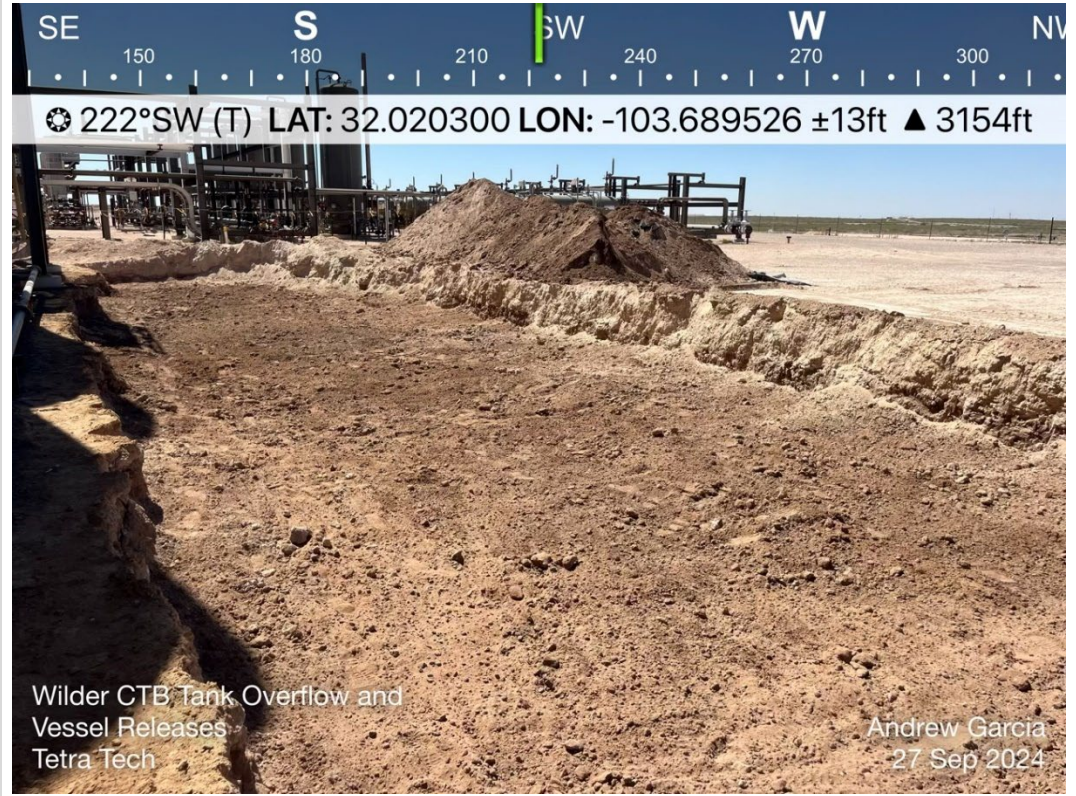
TETRA TECH, INC. PROJECT NO. 212C-MD-03442	DESCRIPTION	View south. West side of battery, interim remedial activities.	16
	SITE NAME	Wilder CTB Tank Overflow and Vessel Releases	9/27/2024

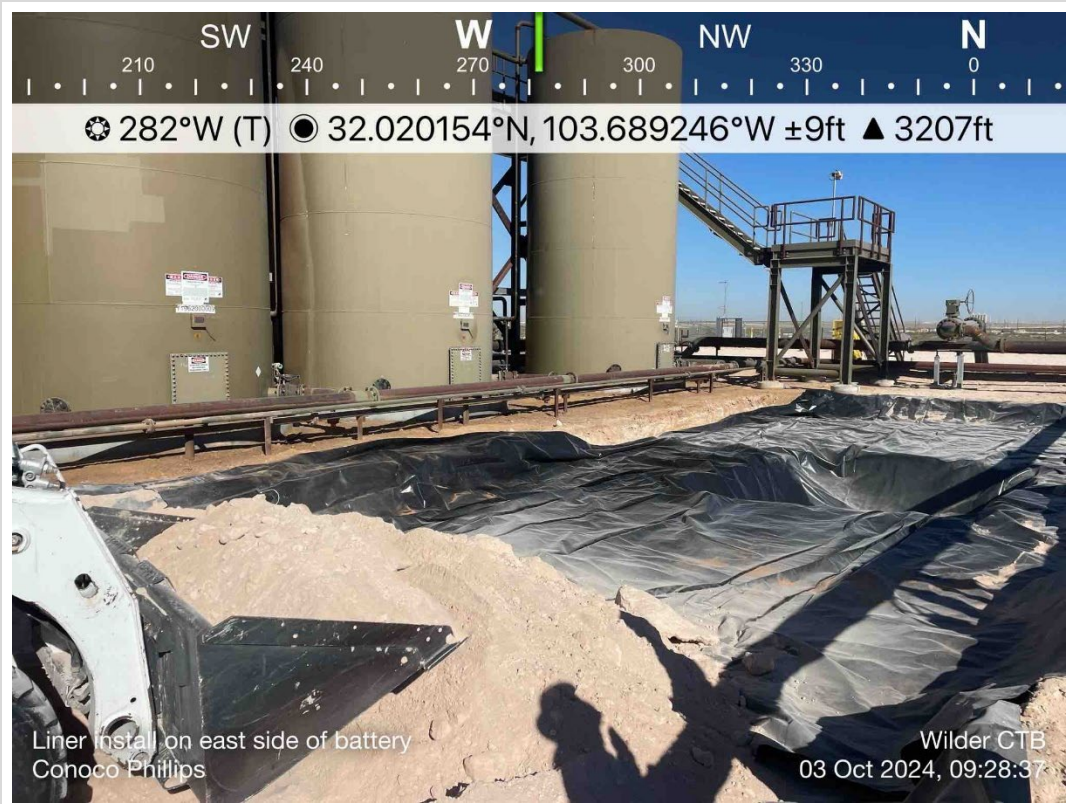
TETRA TECH, INC. PROJECT NO. 212C-MD-03442	DESCRIPTION	View west. East side of battery, interim remedial activities, liner installation.	17
	SITE NAME	Wilder CTB Tank Overflow and Vessel Releases	10/3/2024

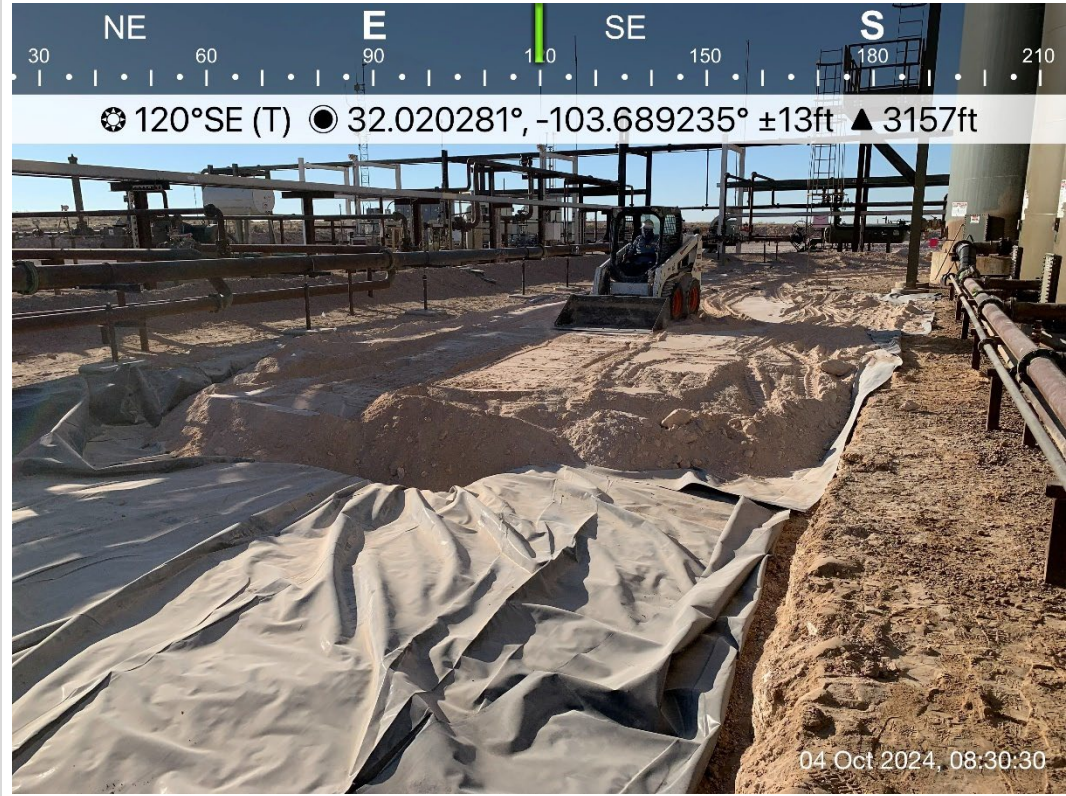
TETRA TECH, INC. PROJECT NO. 212C-MD-03442	DESCRIPTION	View southeast. East side of battery, interim remedial activities, liner installation.	18
	SITE NAME	Wilder CTB Tank Overflow and Vessel Releases	10/4/2024

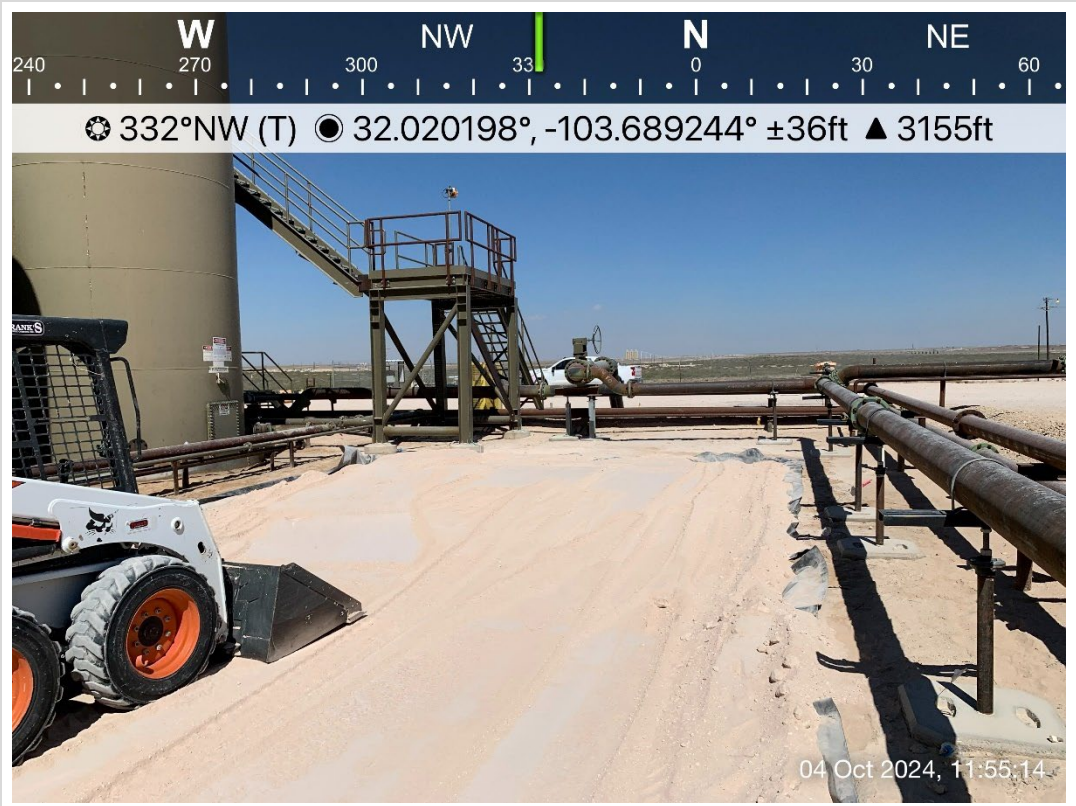
TETRA TECH, INC. PROJECT NO. 212C-MD-03442	DESCRIPTION	View northwest. East side of battery, interim remedial activities, backfill.	19
	SITE NAME	Wilder CTB Tank Overflow and Vessel Releases	10/4/2024

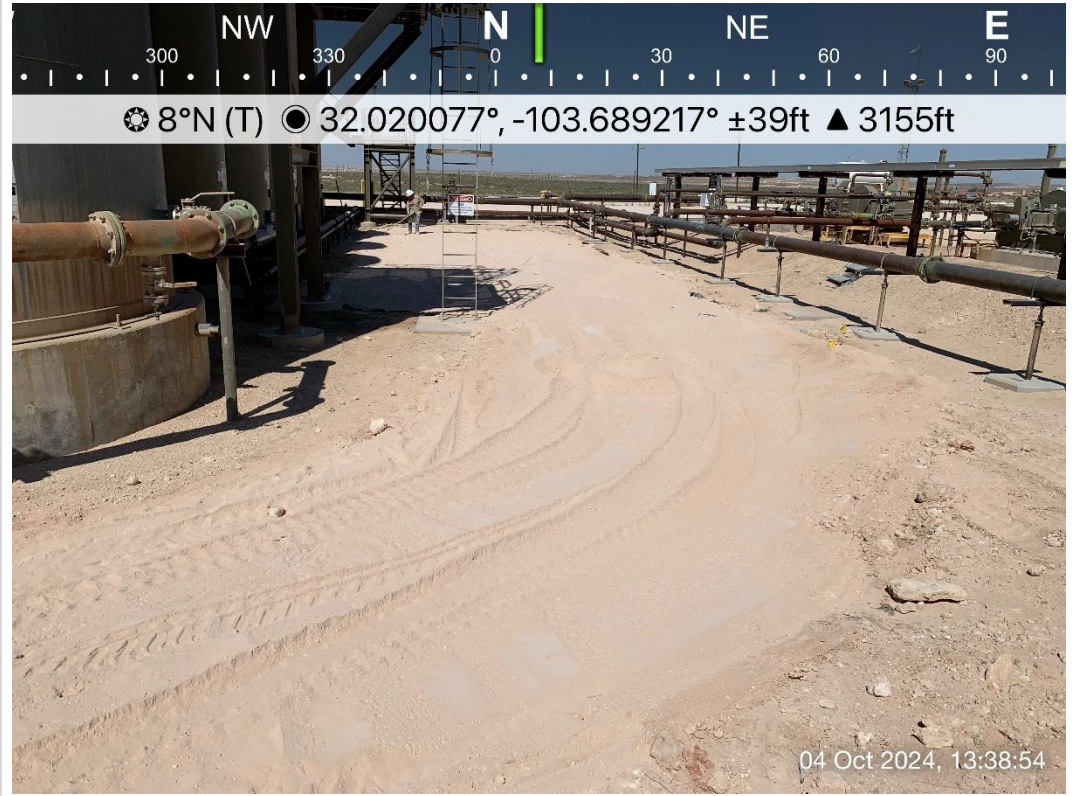
TETRA TECH, INC. PROJECT NO. 212C-MD-03442	DESCRIPTION	View north. East side of battery, interim remedial activities, backfill.	20
	SITE NAME	Wilder CTB Tank Overflow and Vessel Releases	10/4/2024

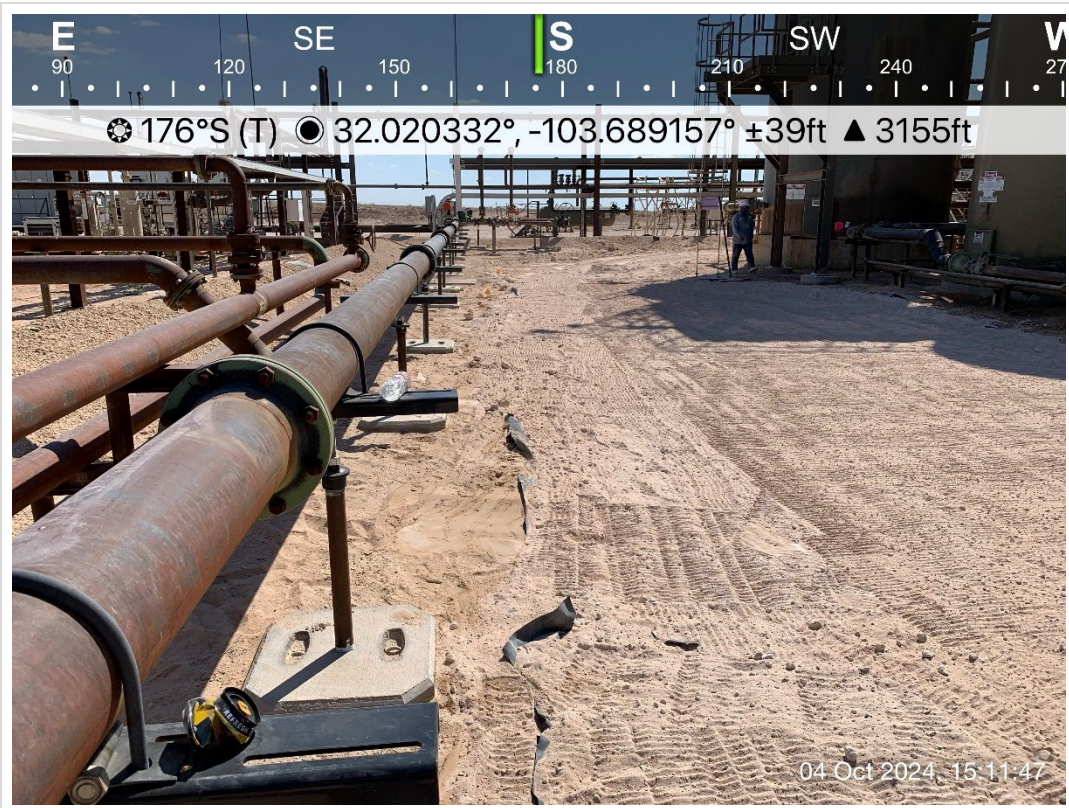
TETRA TECH, INC. PROJECT NO. 212C-MD-03442	DESCRIPTION	View south. East side of battery, interim remedial activities, backfill.	21
	SITE NAME	Wilder CTB Tank Overflow and Vessel Releases	10/4/2024

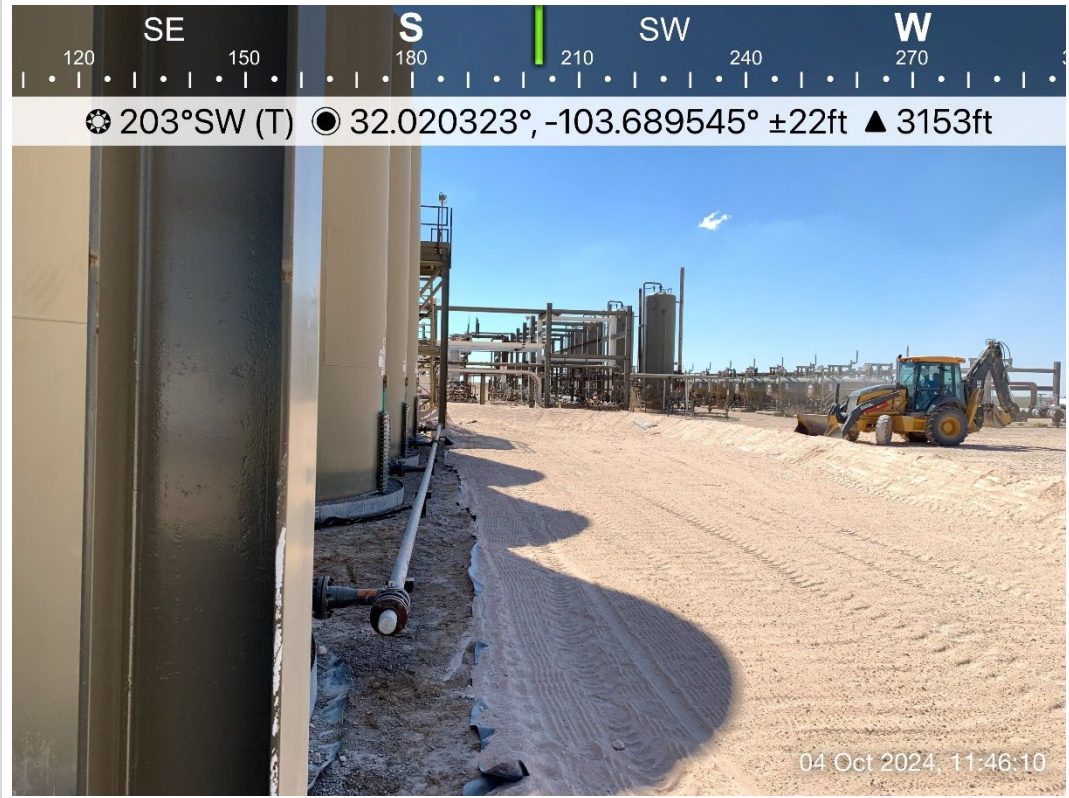
TETRA TECH, INC. PROJECT NO. 212C-MD-03442	DESCRIPTION	View south southwest. West side of battery, interim remedial activities, backfill.	22
	SITE NAME	Wilder CTB Tank Overflow and Vessel Releases	10/4/2024
