**Re: Deferral Request
Poker Lake Unit 28 BS 167H
Incident Number nAPP2421842514
Eddy County, New Mexico**

Ensolum, LLC (Ensolum), on behalf of XTO Energy, Inc. (XTO), has prepared this *Deferral Request* to document assessment, delineation, excavation, and soil sampling activities at the Poker Lake Unit 28 BS 167H (Site). The purpose of the Site assessment and soil sampling activities was to assess for the presence or absence of impacts to soil following a crude oil, produced water, and vented natural gas release due to corrosion on a flow line. Based on field observations, field screening activities, and soil sample laboratory analytical results, XTO is submitting this *Deferral Request*, describing Site assessment, delineation, and excavation activities that have occurred and requesting deferral of final remediation for Incident Number nAPP2421842514 until the Site is reconstructed, and/or the well pad is abandoned.

XTO Energy, Inc
Poker Lake Unit 28 BS 167H
Incident Number: nAPP2421842514
Unit H, Section 28, T 25S, R 31E
Eddy County, New Mexico

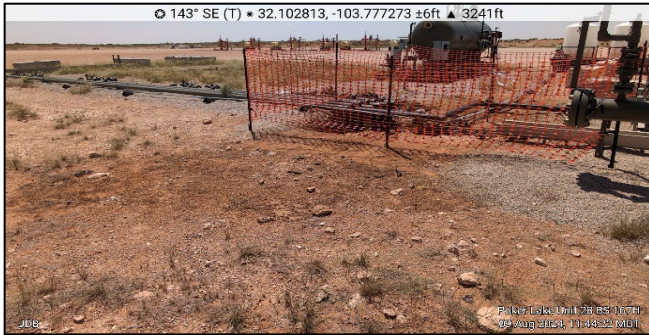
Photograph: 1 Date: 8/9/2024
Description: Soil staining in release footprint
View: Southeast

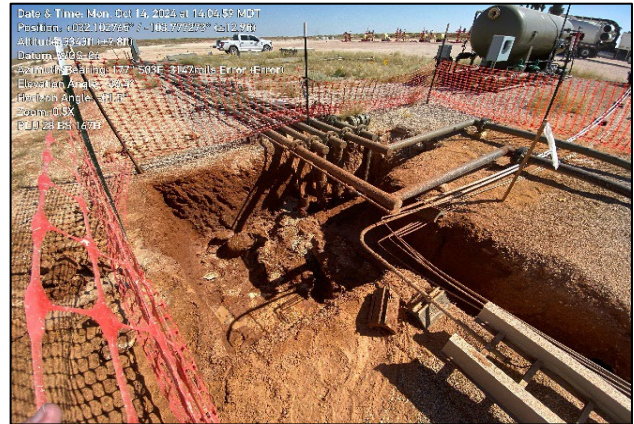
Photograph: 2 Date: 10/14/2024
Description: Excavation activities
View: Southeast

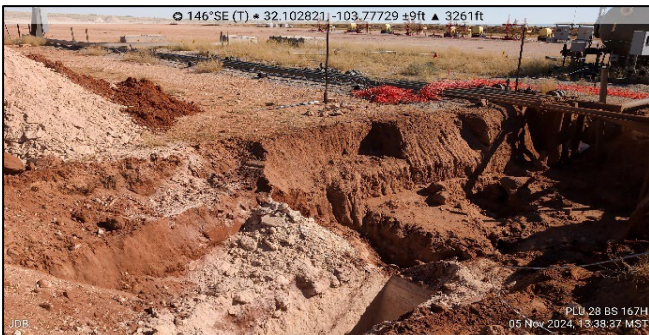
Photograph: 3 Date: 11/5/2024
Description: Final excavation extent
View: Southeast

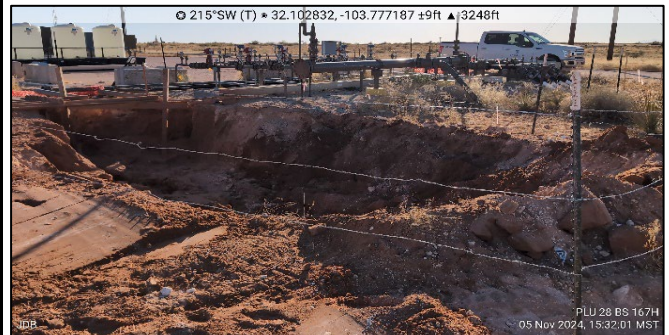
Photograph: 4 Date: 11/5/2024
Description: Final excavation extent
View: Southwest
