C-24-1 LINE LEAK

Remediation Action Plan

NMOCD Incident No. nAPP2417743733
UL "N", Sec. 8, T18S, R33E
32.754798°, -103.689114°
Lea County, New Mexico

February 3, 2025

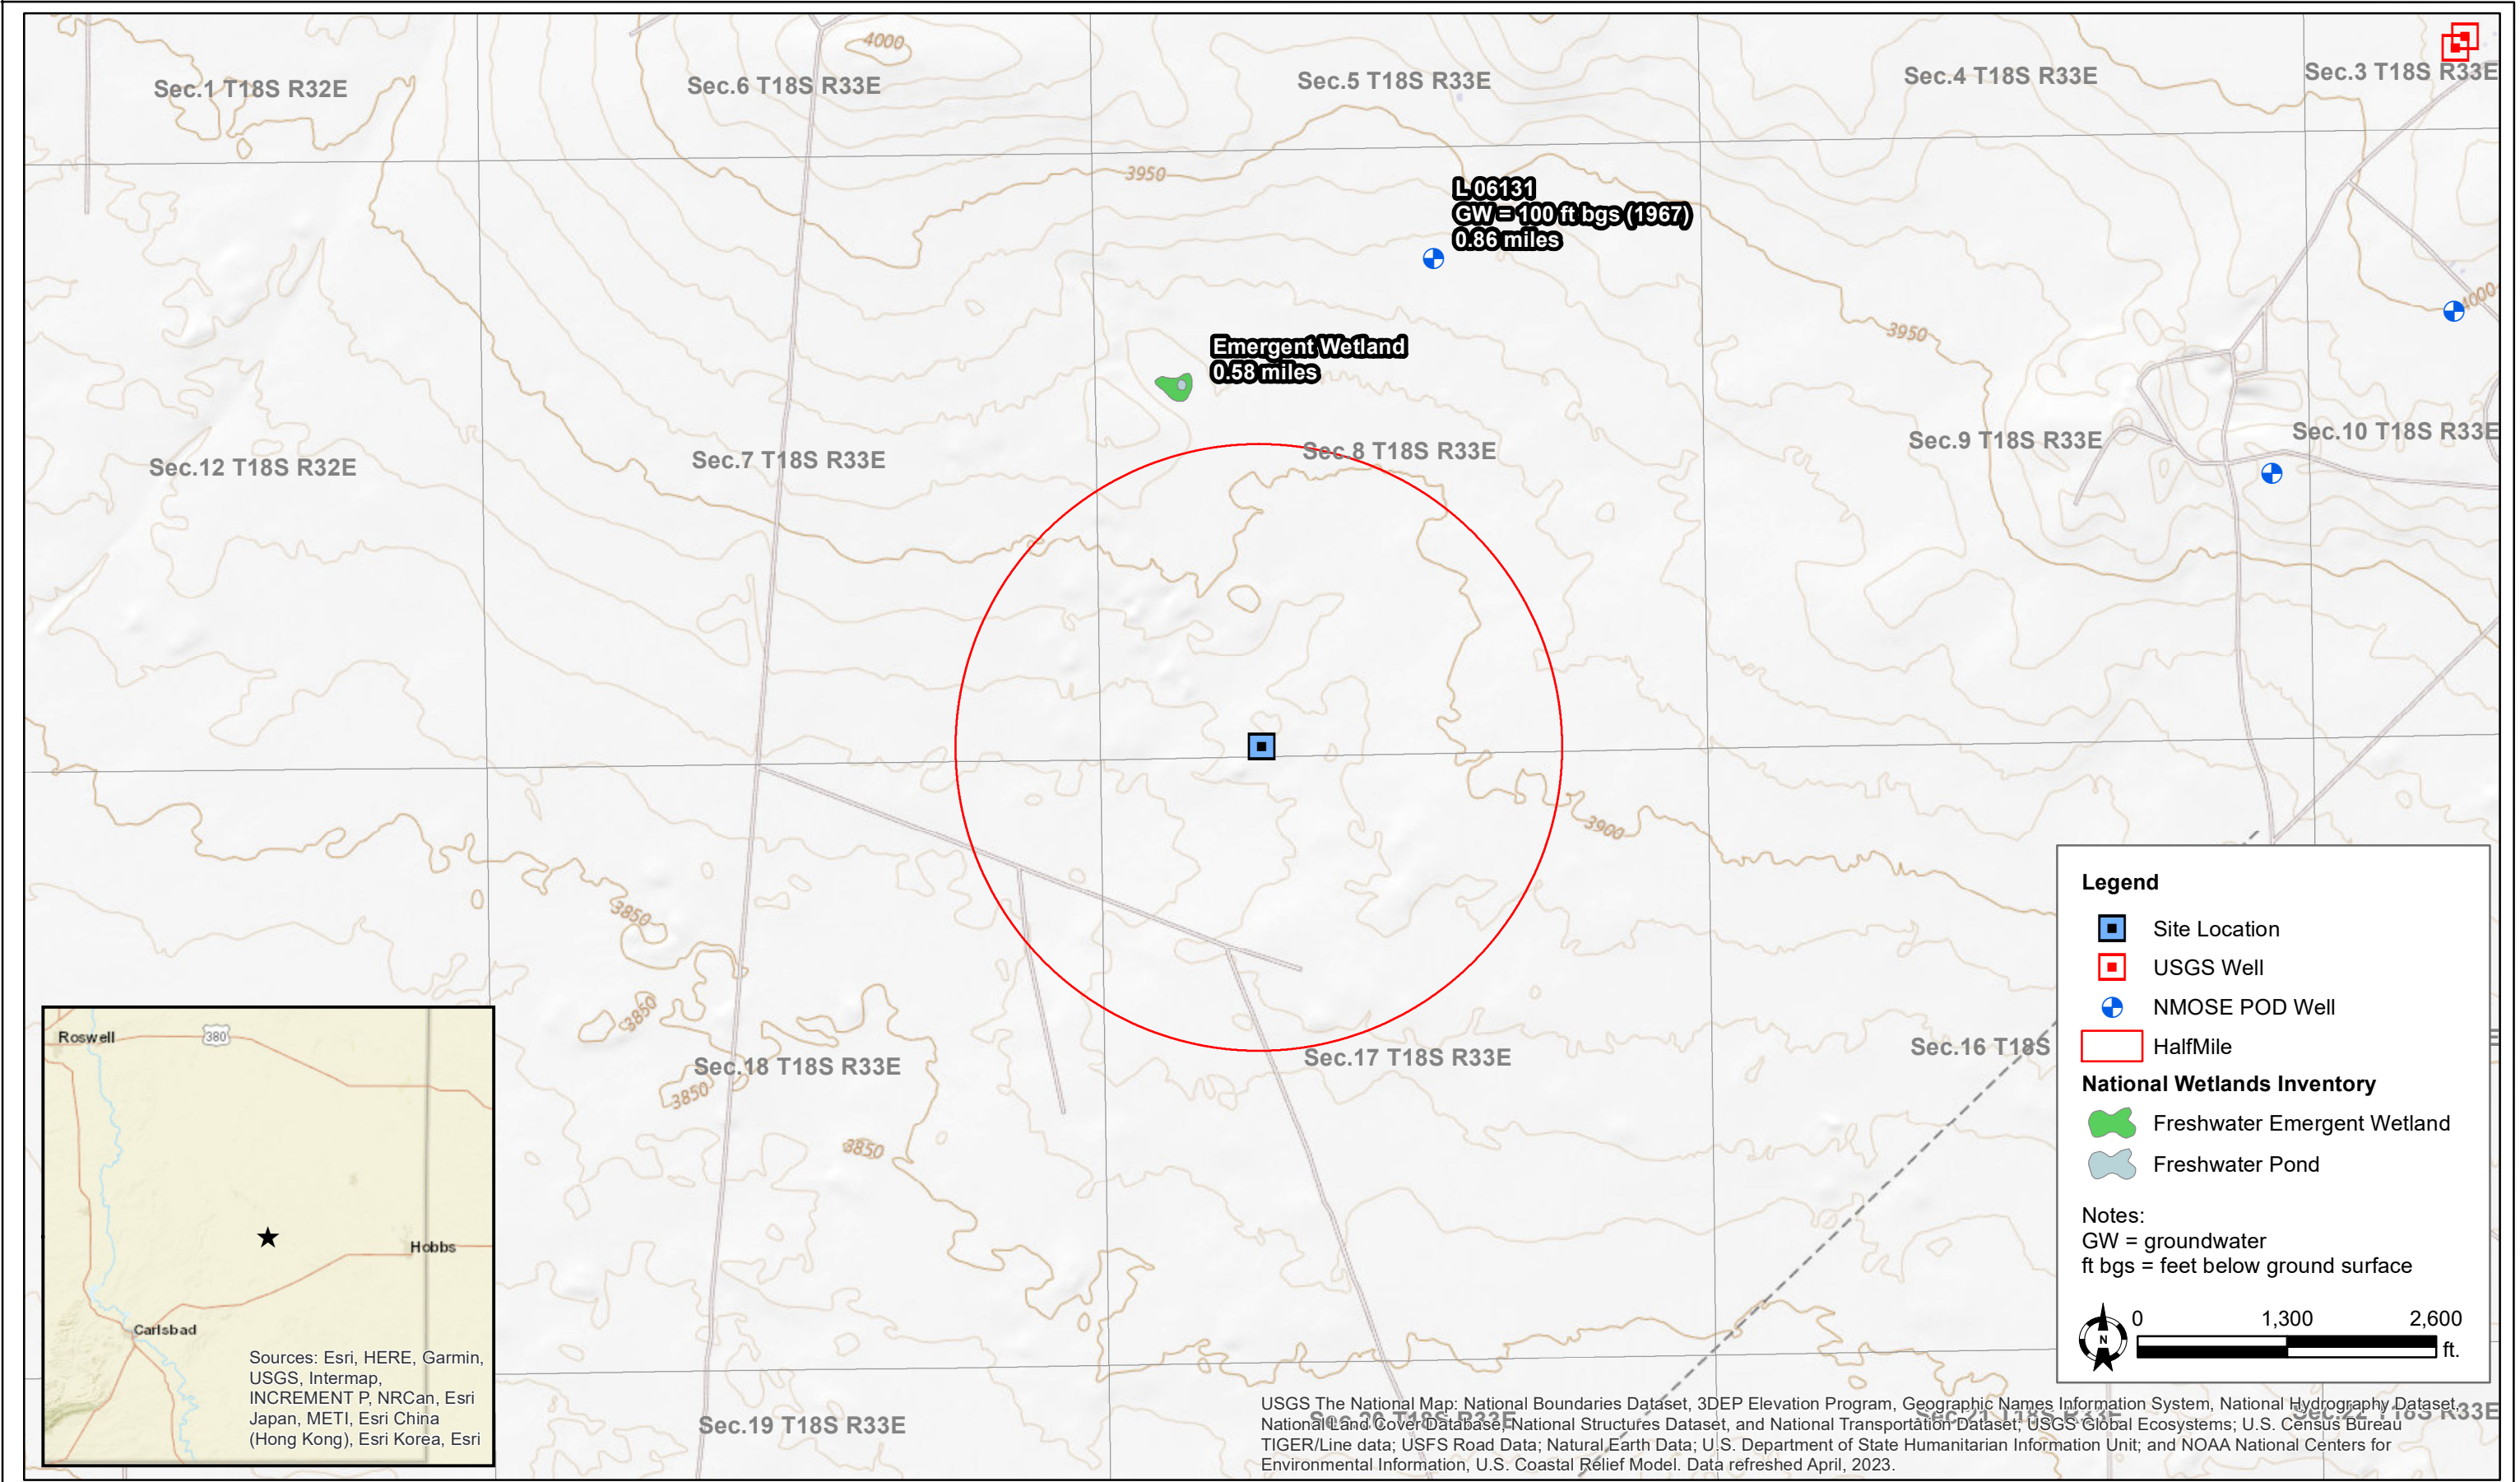
Tasman, Inc. 6855 W. 119th Ave Broomfield, CO 80020	DCP Operating Company, LP C-24-1 Line Leak - nAPP2417743733 UL "N", Sec. 8, T18S, R33E Lea County, New Mexico	Site Location & Groundwater Map	Figure 1
DESIGNED BY: B. Dennis				
DRAWN BY: B. Dennis

The site is located in Unit Letter “N” of Section 8, Township 18 South, Range 33 East in Lea County, New Mexico. The release occurred at the C-24-1 pipeline. The release ensued on property held by the Bureau of Land Management (BLM). A site location map can be found attached as Figure 1.

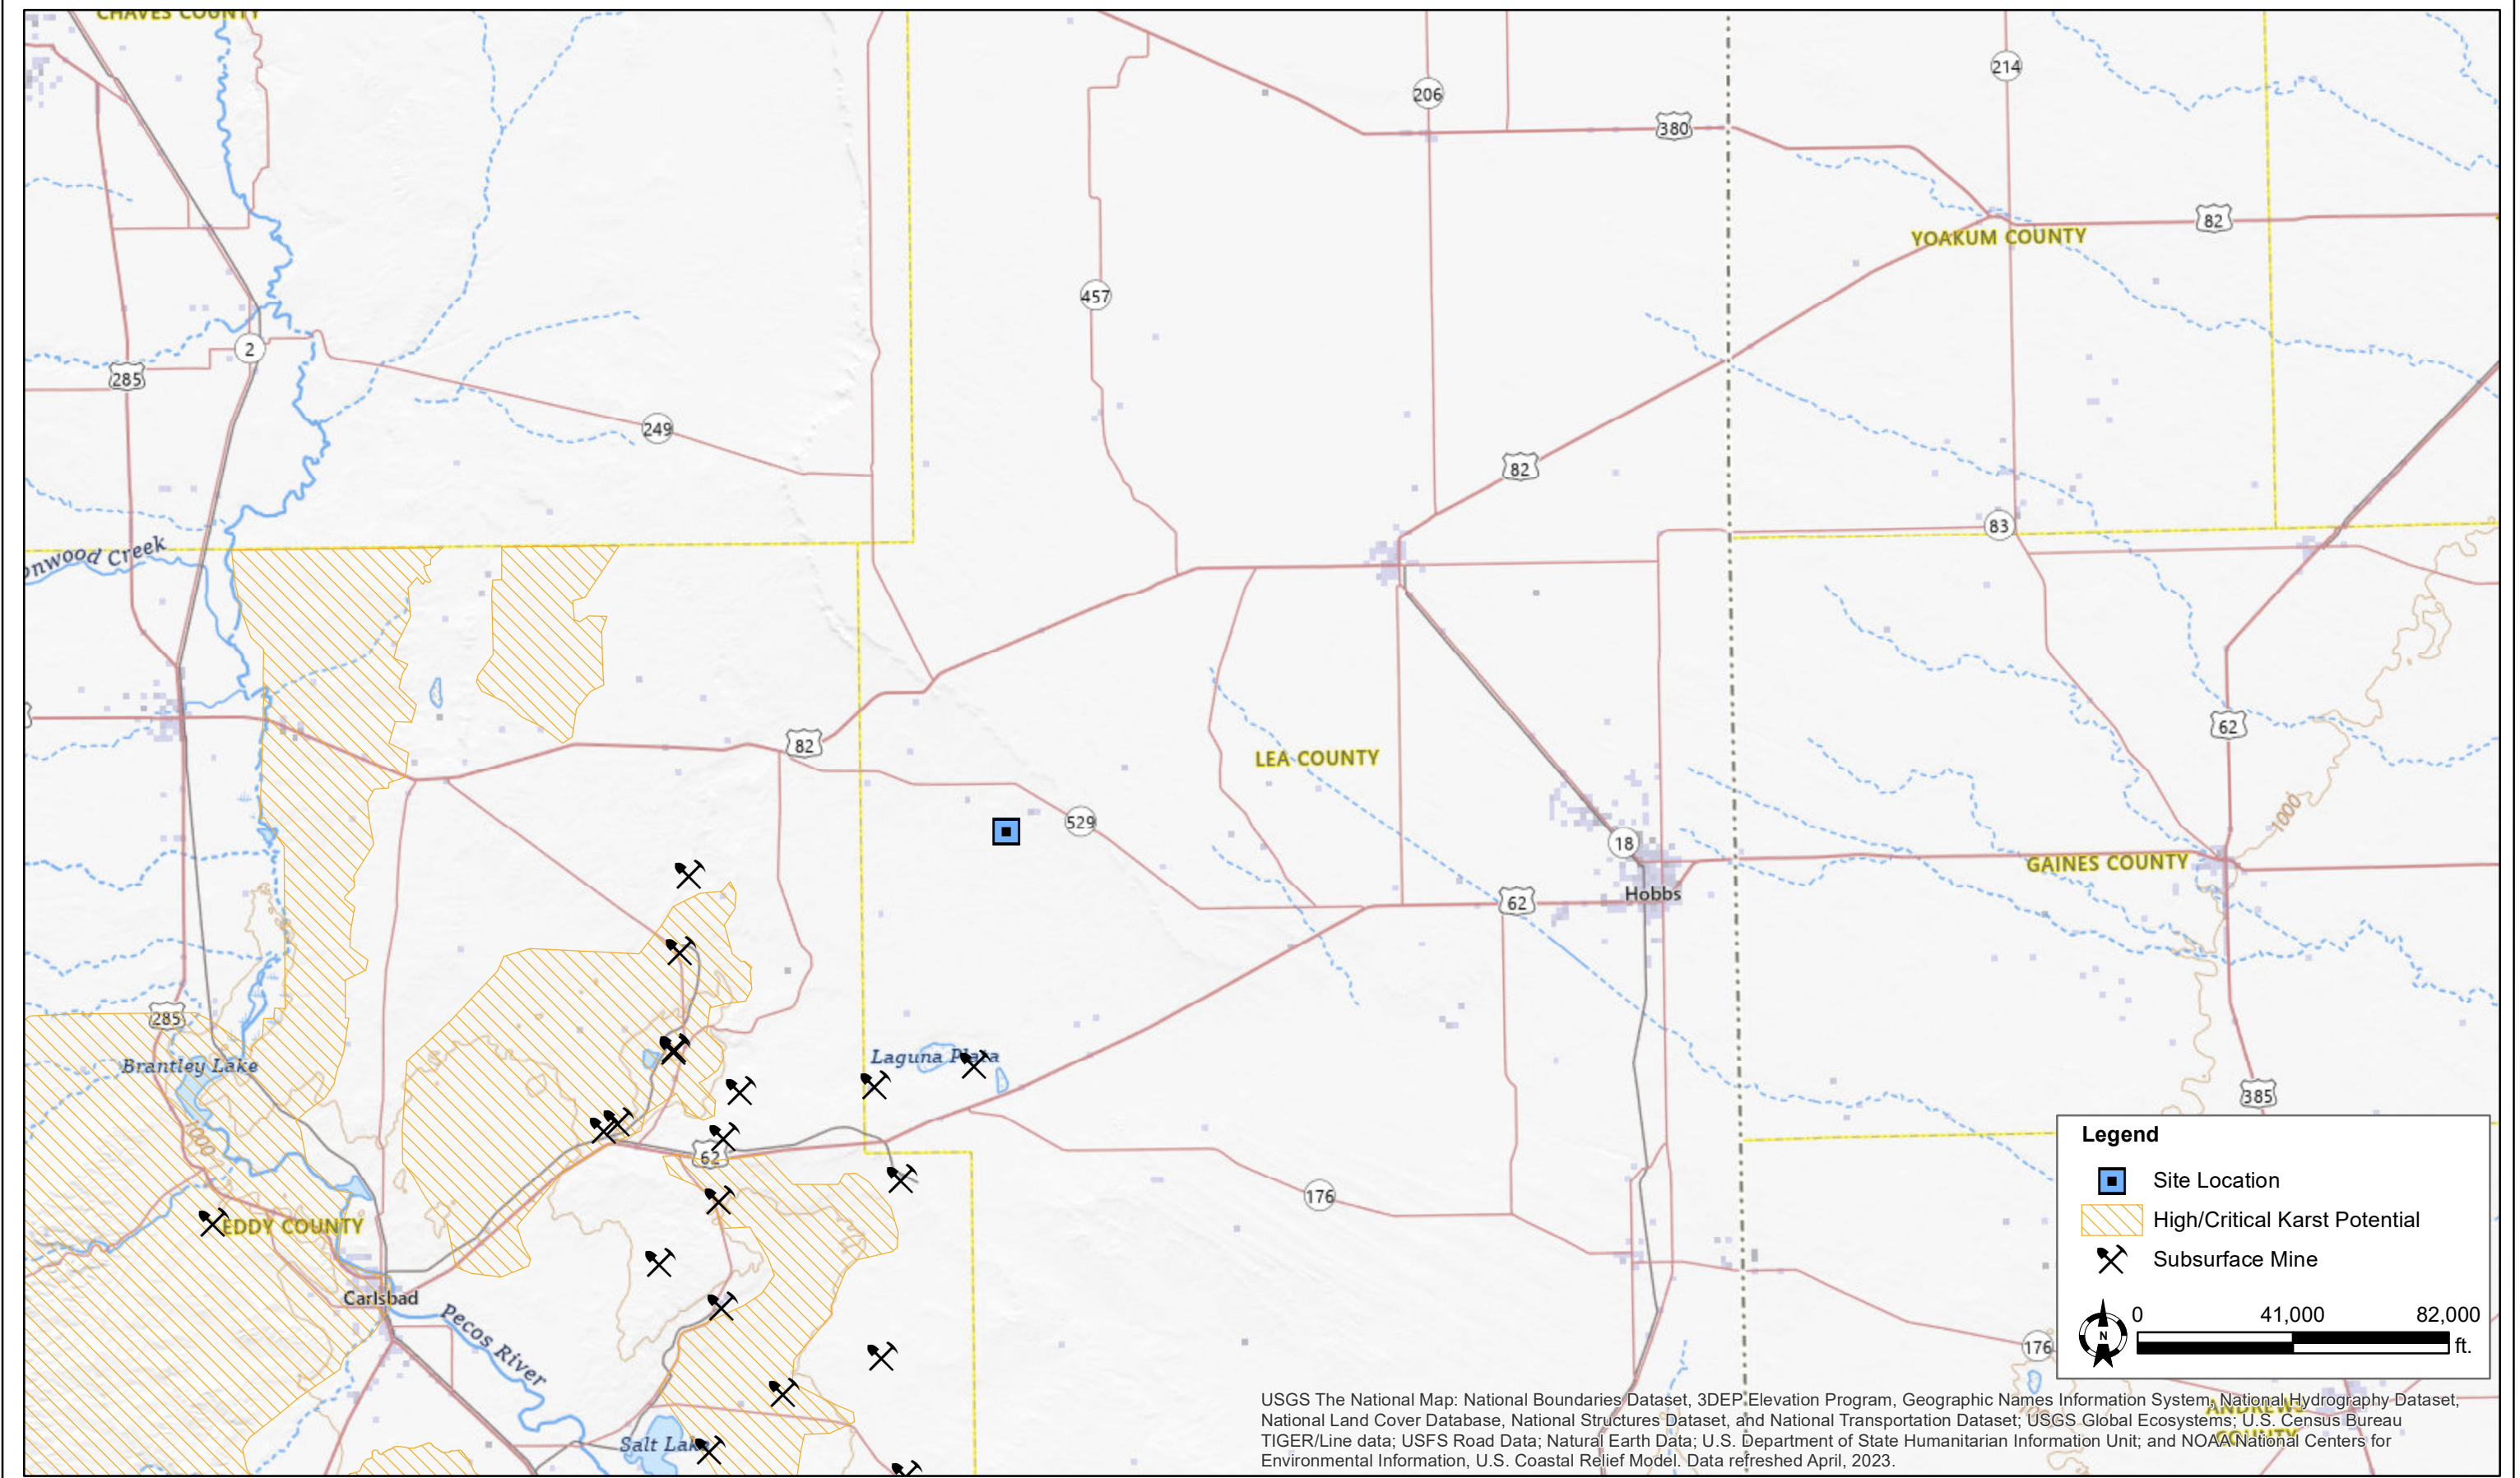
Figure
2

Karst Potential & Subsurface
Mine Map

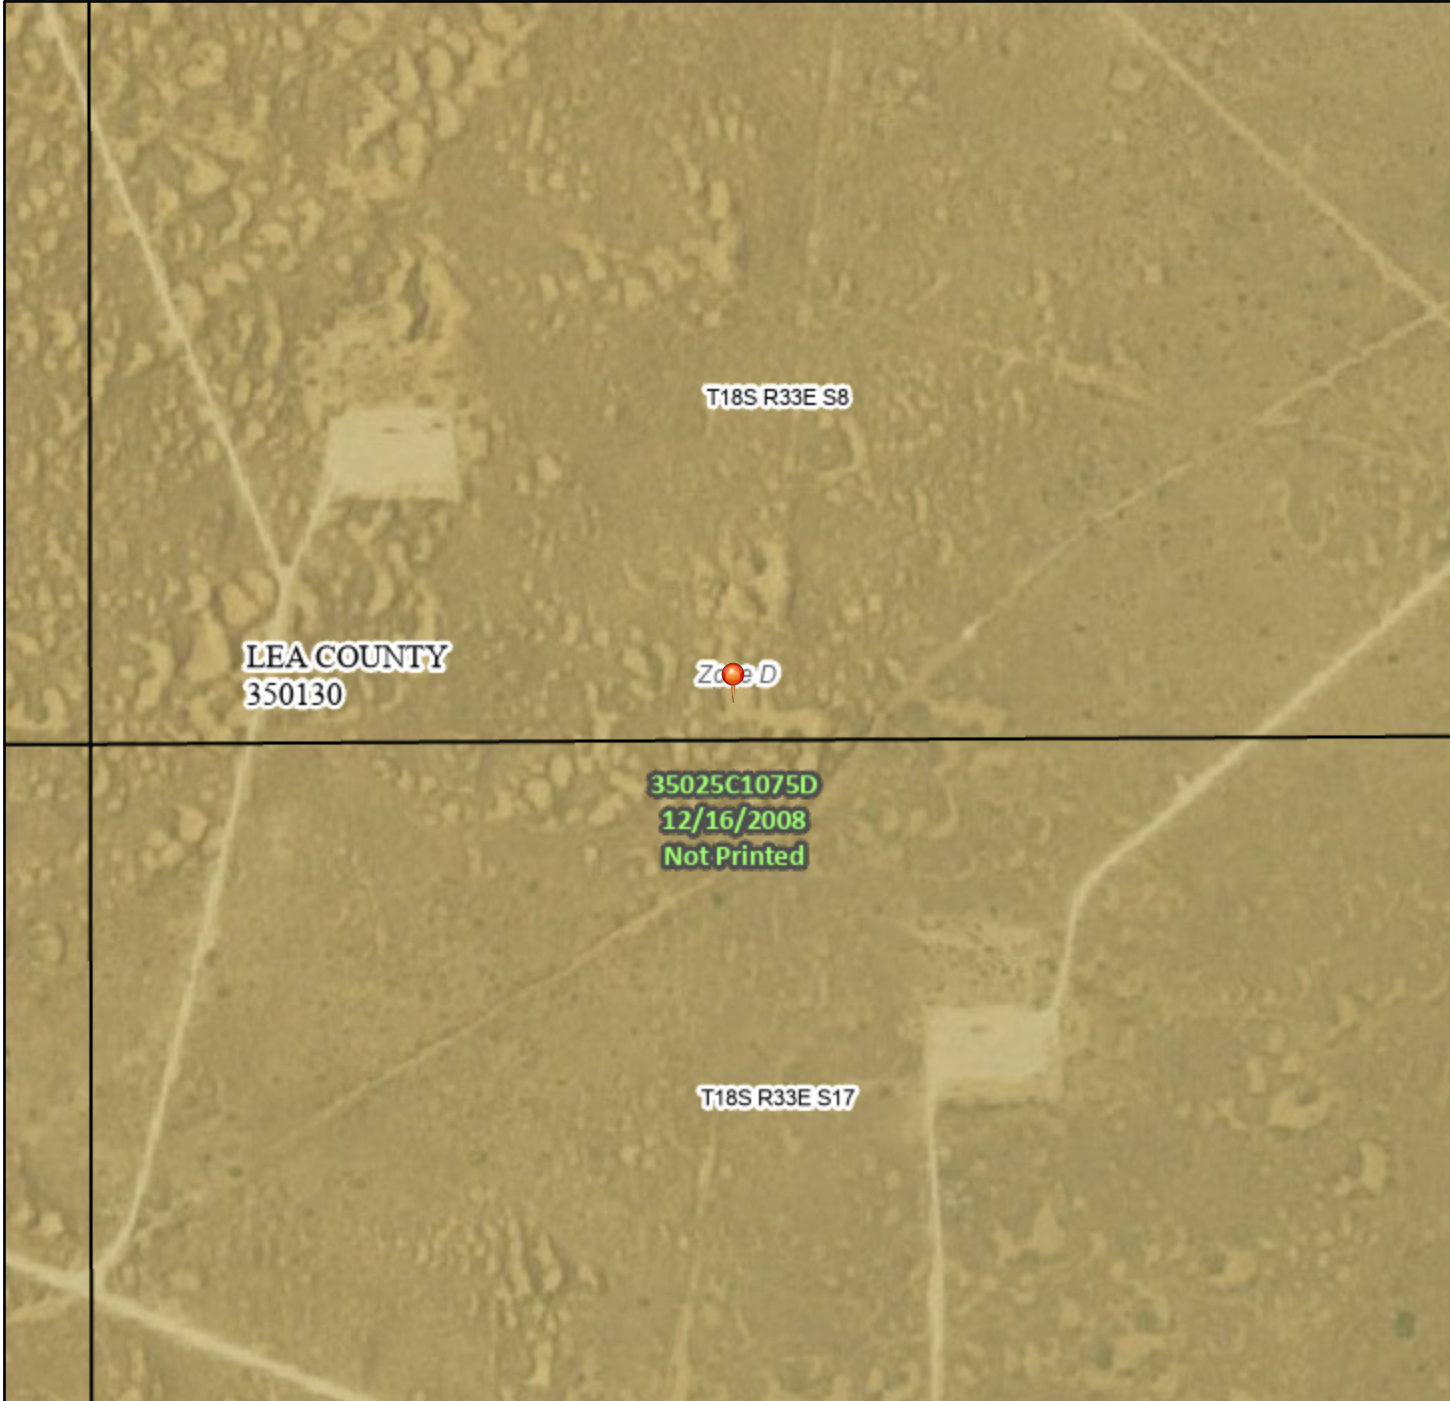
National Flood Hazard Layer FIRMMette

Review of flood map data published by the Federal Emergency Management Agency (FEMA) indicates the site is not located within a 100-year floodplain. A copy of the FEMA FIRMet Map can be found attached as Figure 4.

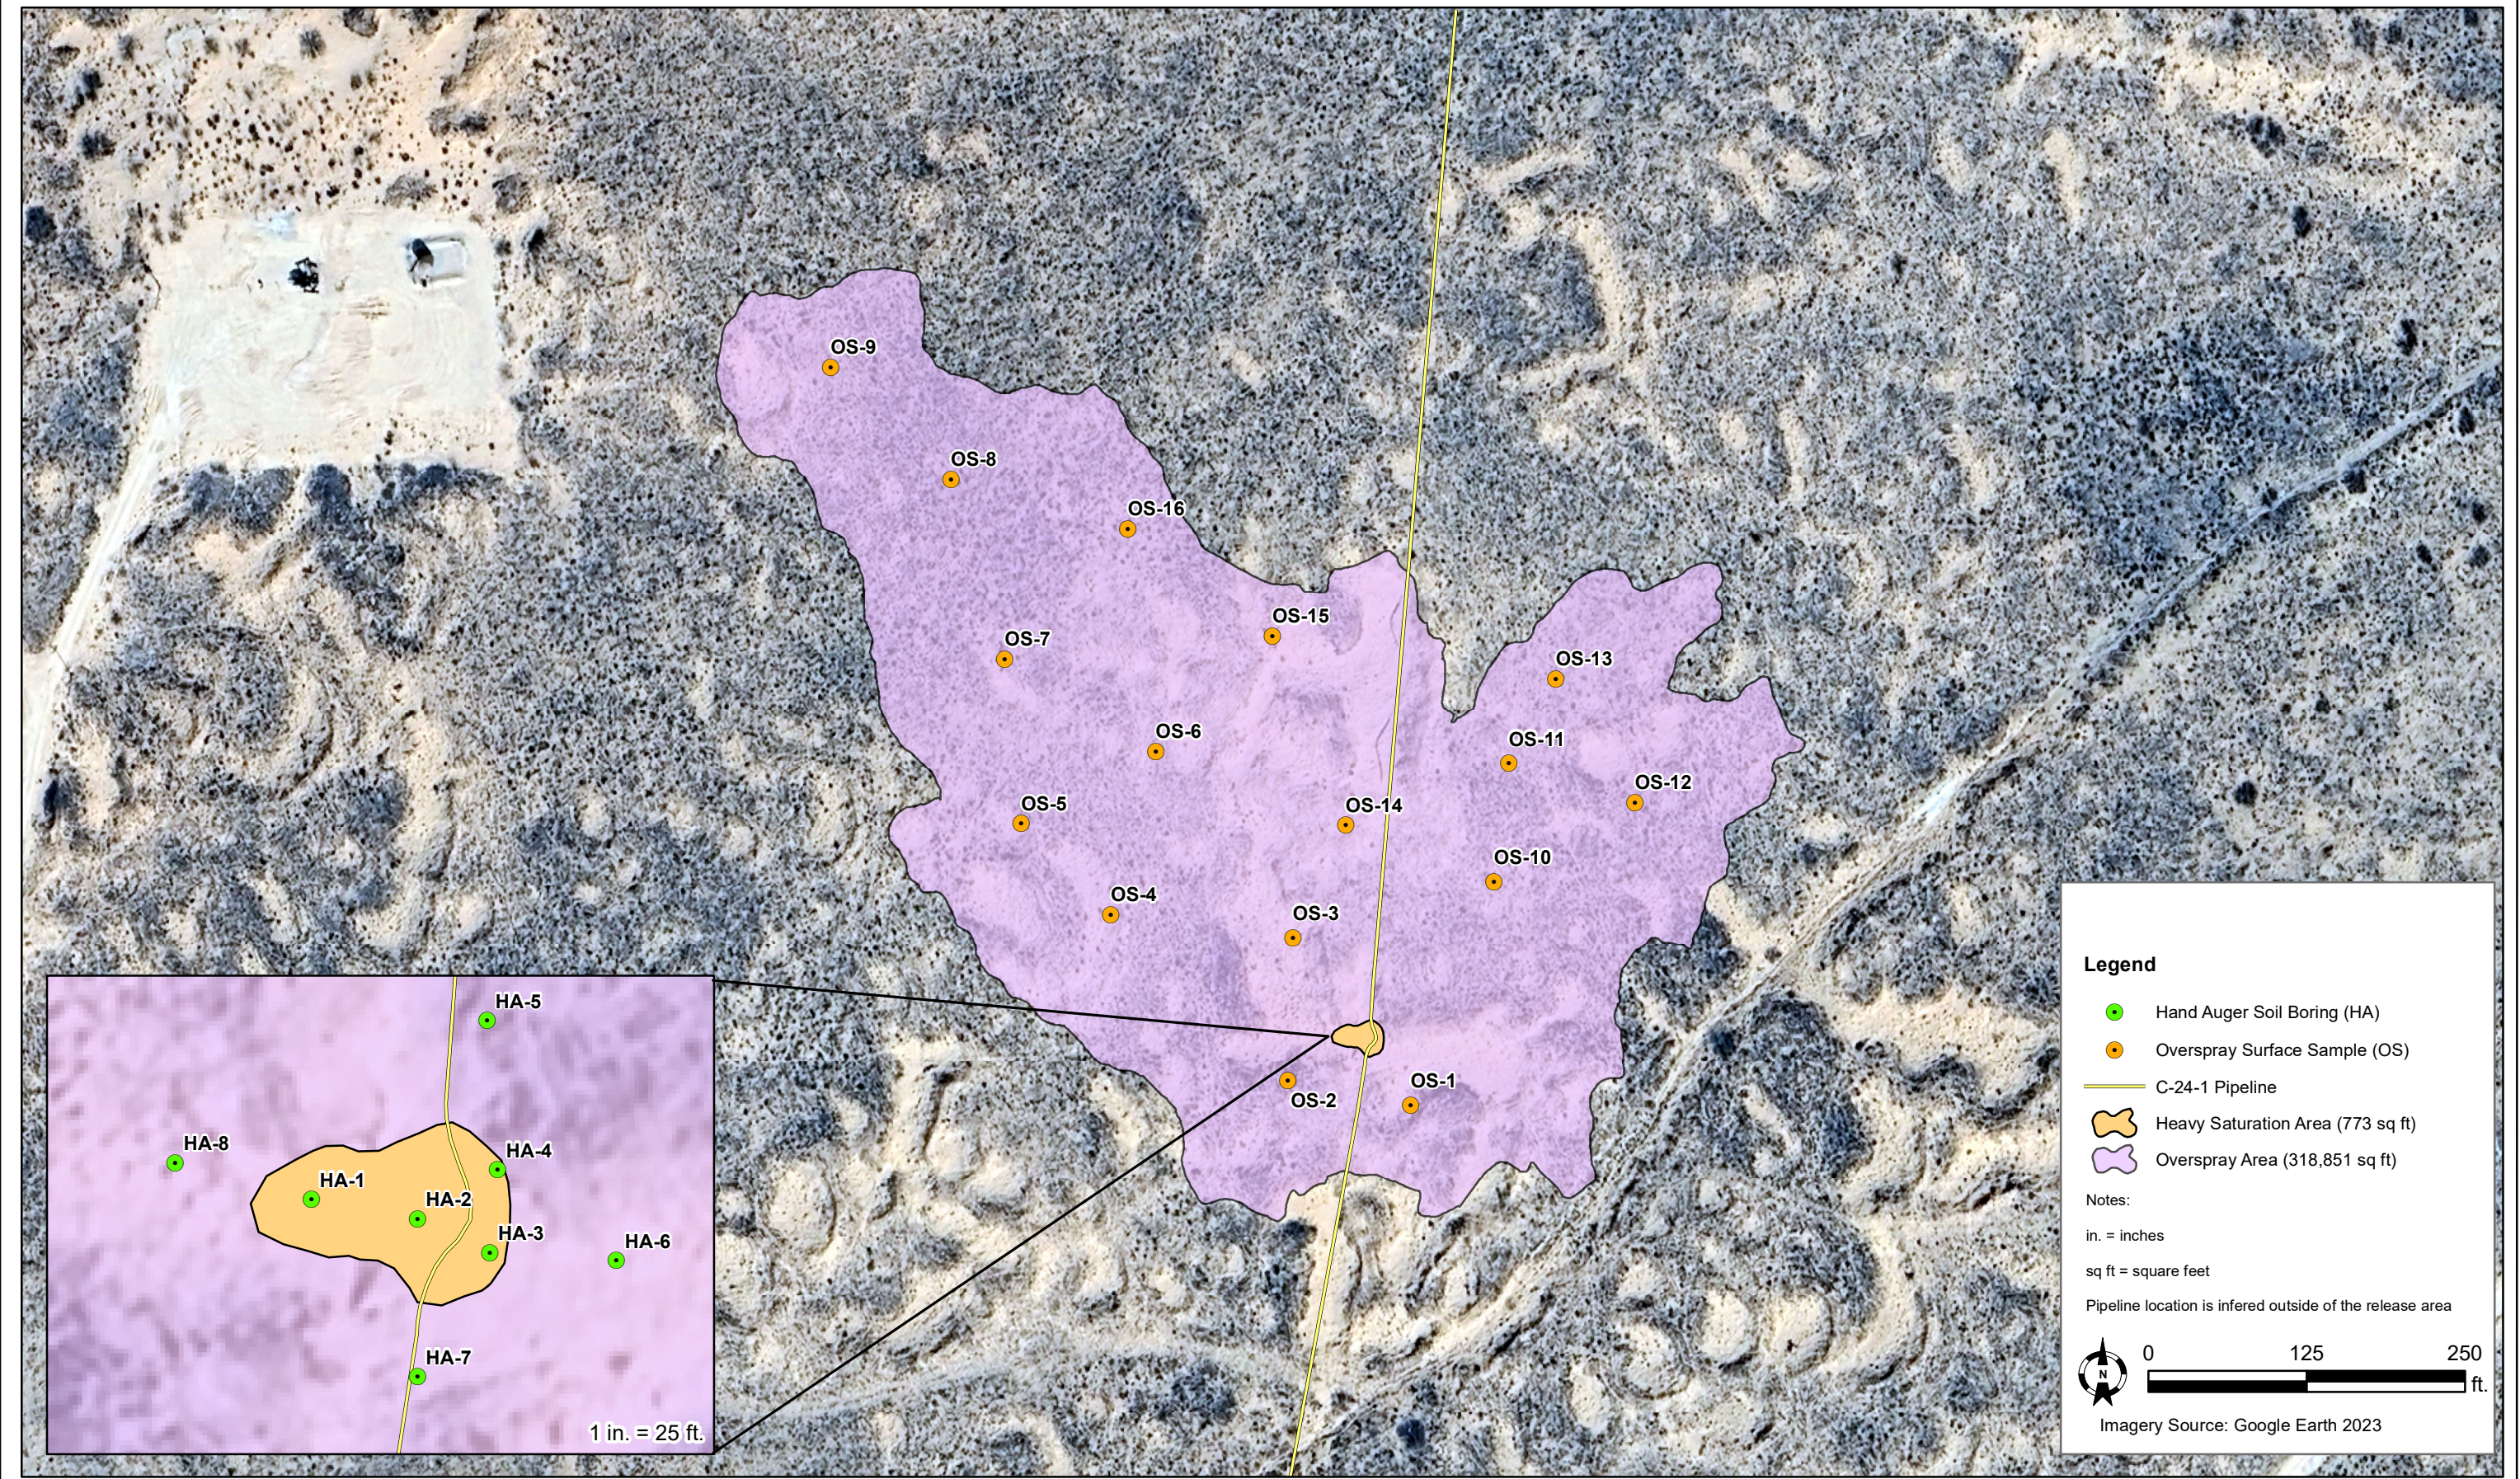
Figure
5

The attached Figures 5 and 6 illustrate the observed release area and overspray area and location of sample points.

Delineation Overview Map

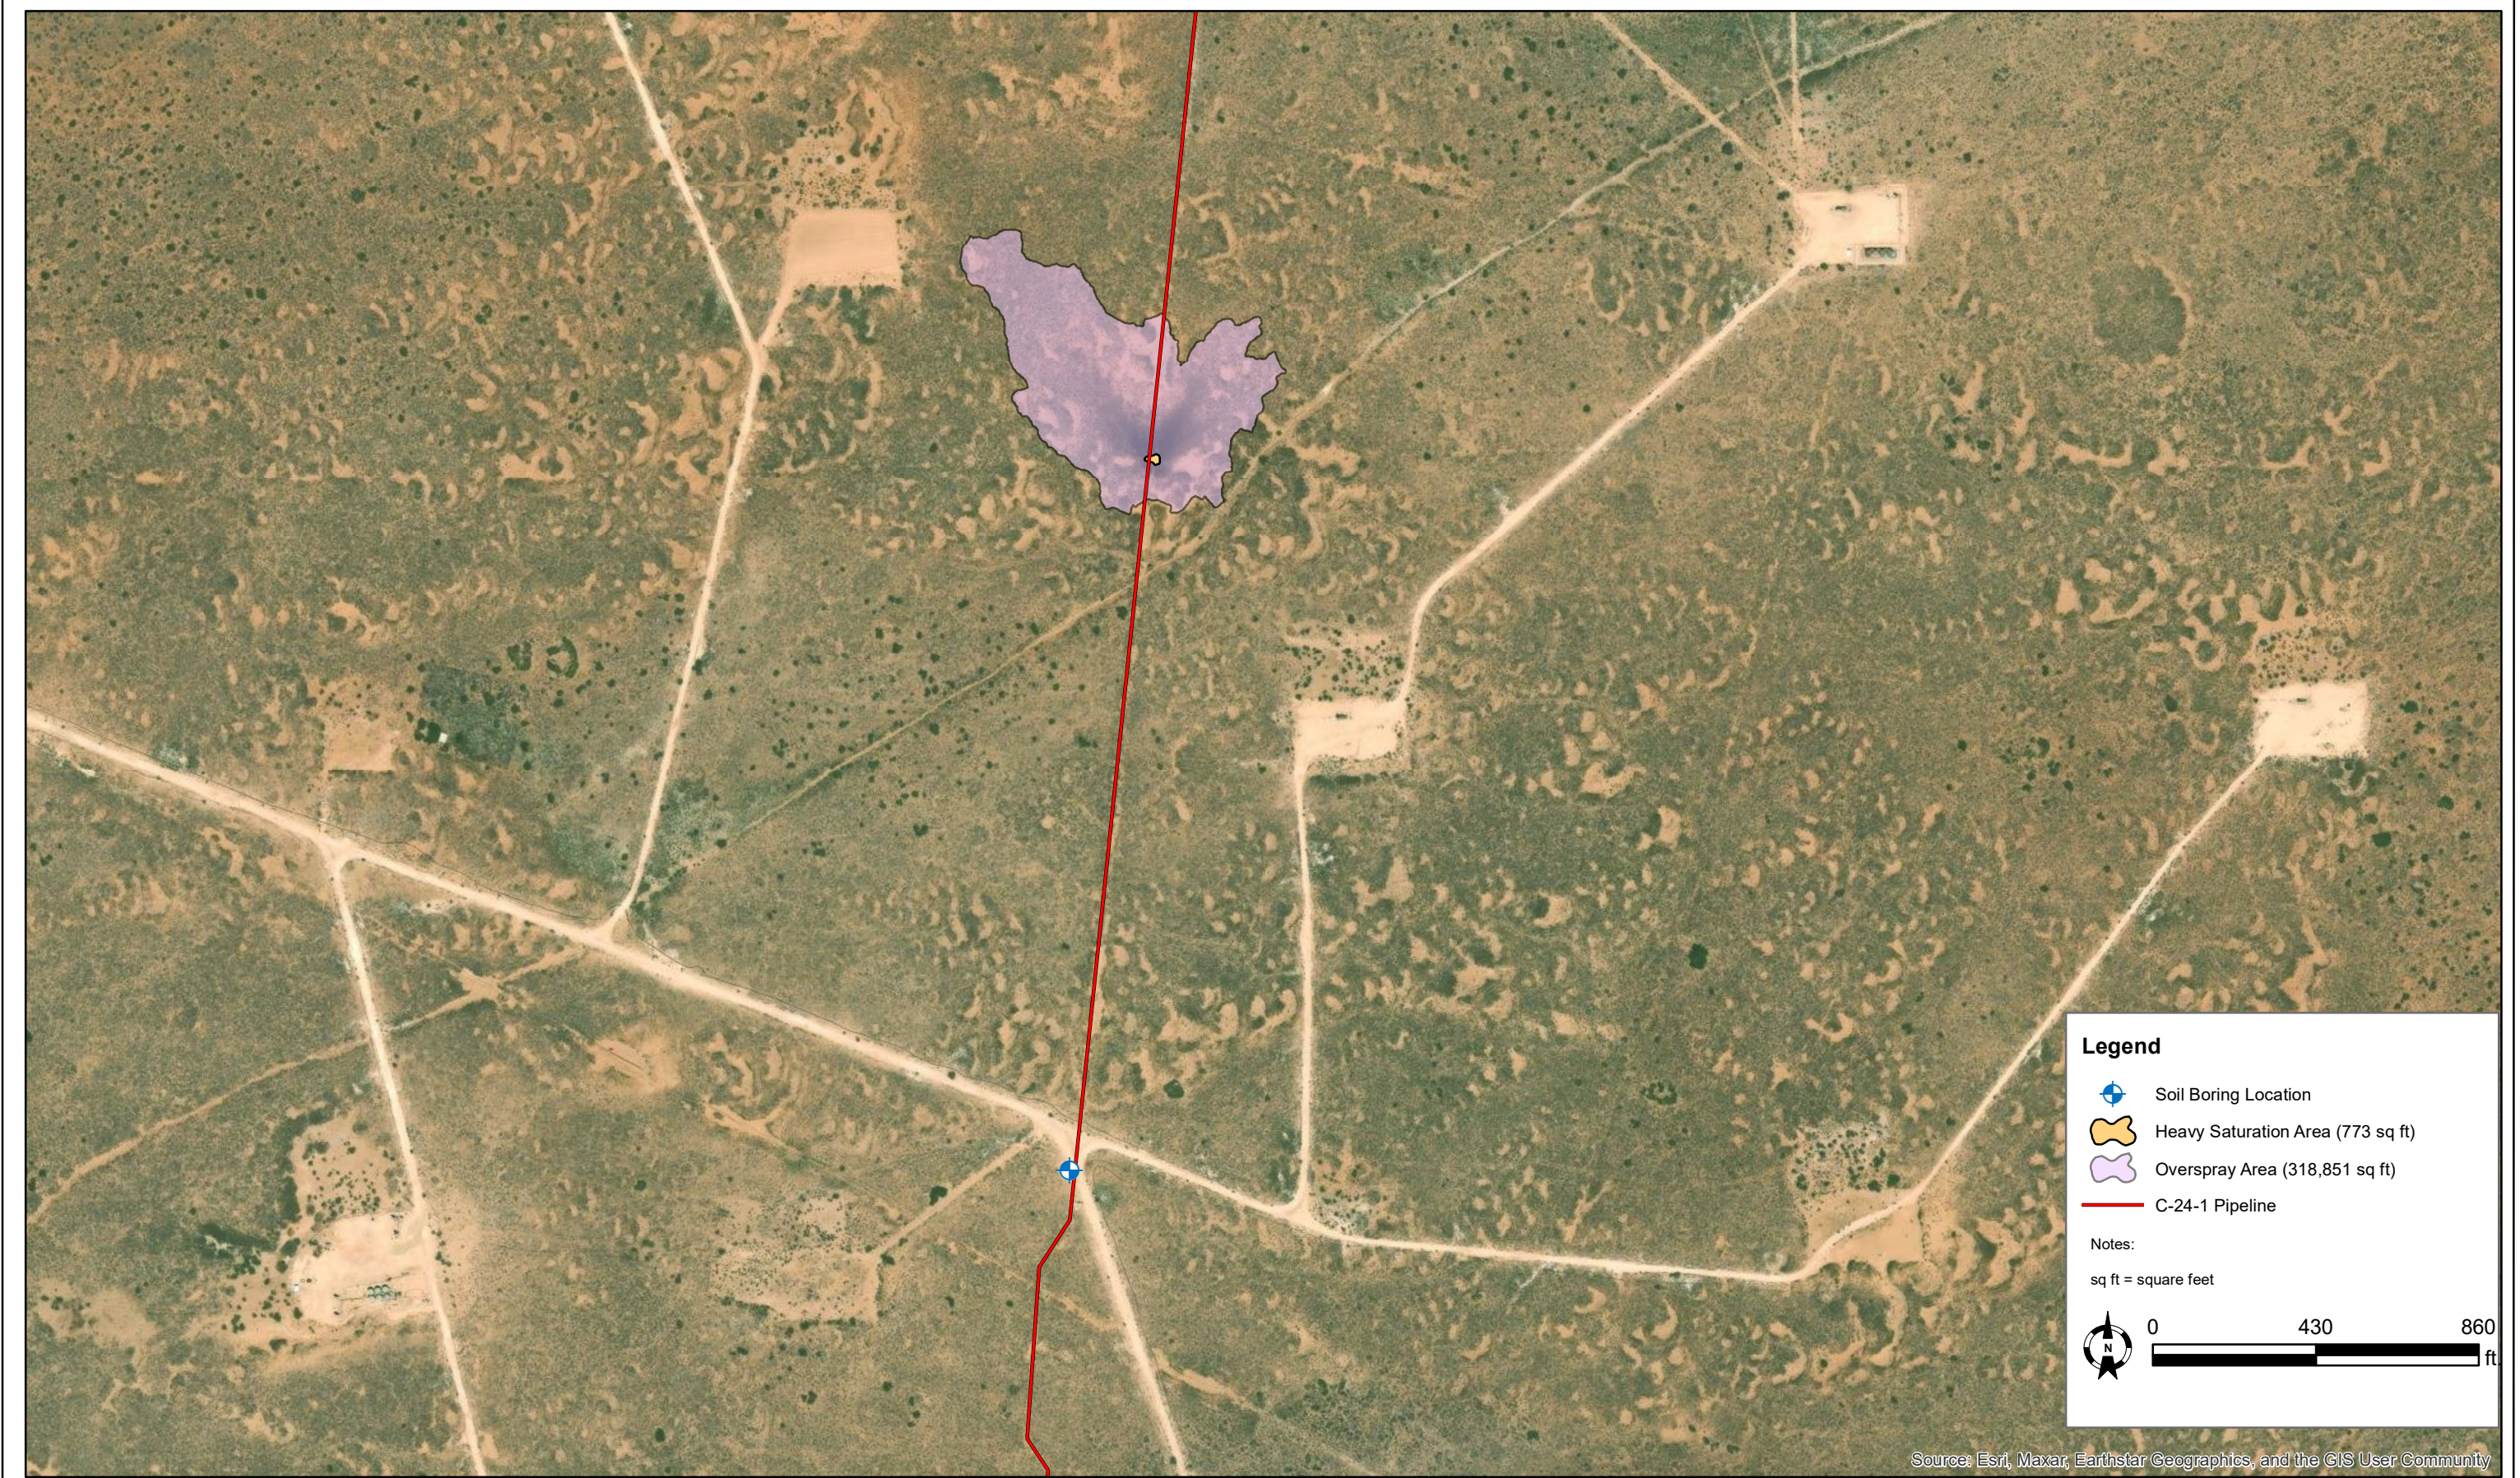
To verify depth to groundwater, on January 27, 2025, Tasman installed one groundwater determination soil boring, approximately 1,900 feet south of the site, to a depth of approximately 65 feet bgs. The soil boring was left open for a period of 72 hours. Tasman personnel then returned to the site on January 30, 2025, to measure the static water level. No groundwater was observed when measuring the soil boring. The bore hole was then plugged to the ground surface by NMOSE approved method. See the attached Figure 6 for the soil bore location and Appendix E for the Well Log.

Soil Bore Map
