**Closure Report
Ovation CTB
Incident ID: nAPP2333157003
Eddy County, New Mexico
Unit A Sec 14 T23S R28E
32.30853°, -104.05183°**

**Crude Oil Release
Point of Release: Flowline Rupture
Release Date: 11/14/23
Volume Released: 21.6 Barrels of Crude Oil
Volume Recovered: 19 Barrels of Crude Oil**

**Re: Closure Report
Ovation CTB
Permian Resources
Incident #: nAPP2333157003
Site Location: Unit A Sec 14 T23S R28E
(Lat 32.30853°, Long -104.05183°)
Eddy County, New Mexico**

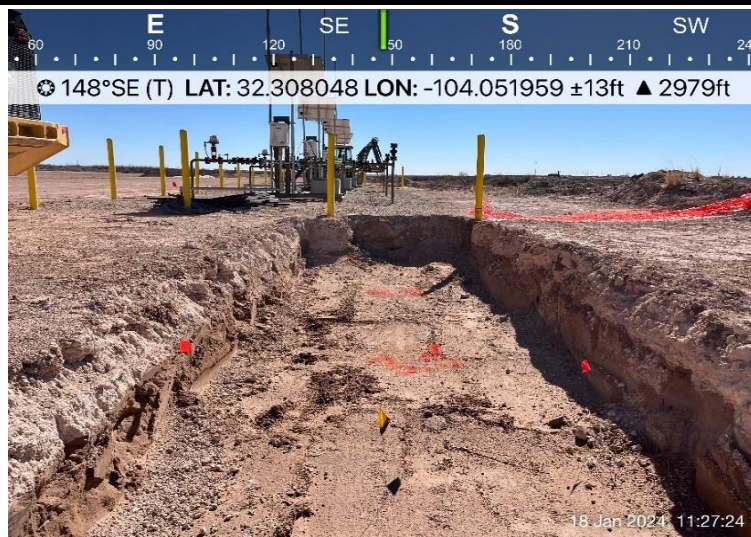
View Southeast, area of Floor 1 through Floor 3.

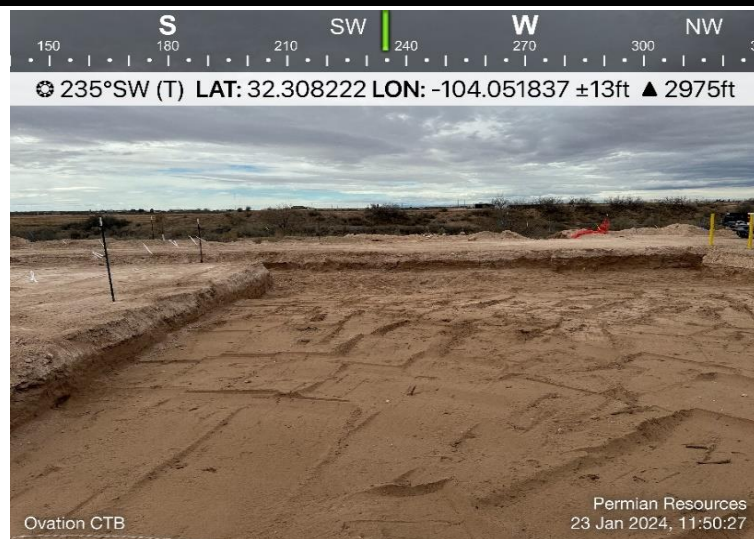
Photograph No. 5

View Southwest, area of CS-12 through CS-33.

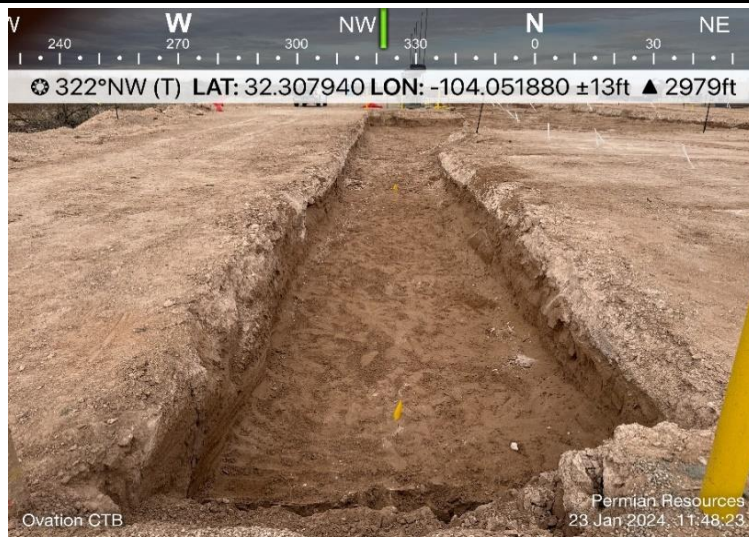
Photograph No. 6

View Northwest, area of CS-34 through CS-37
