CLOSURE REPORT

Lost Tank 3 Federal #015

**Unit E, S3, T22S, R31E
32.420826° N, 103.773545° W
Eddy County, New Mexico
API: 30-015-37951
NMOCD Incident ID: nAPP2415049012**

Ensolum Project No. 03B1417186

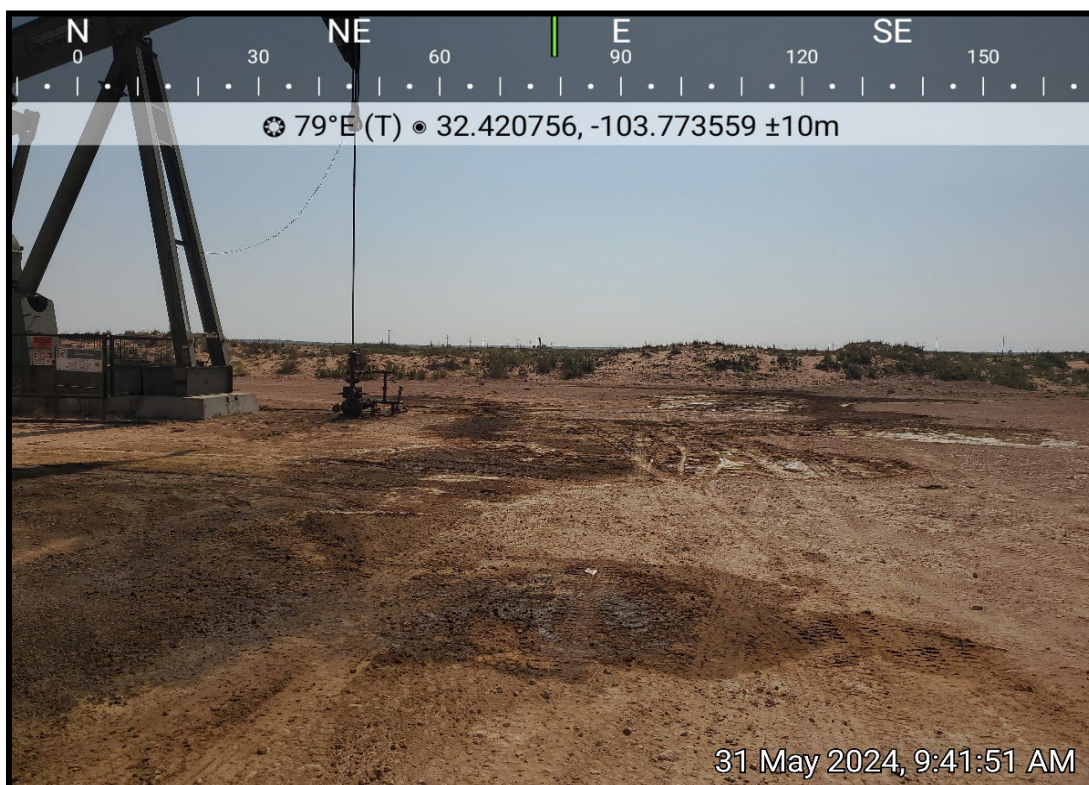
View of release extent prior to remediation activities, facing east (5/31/2024).

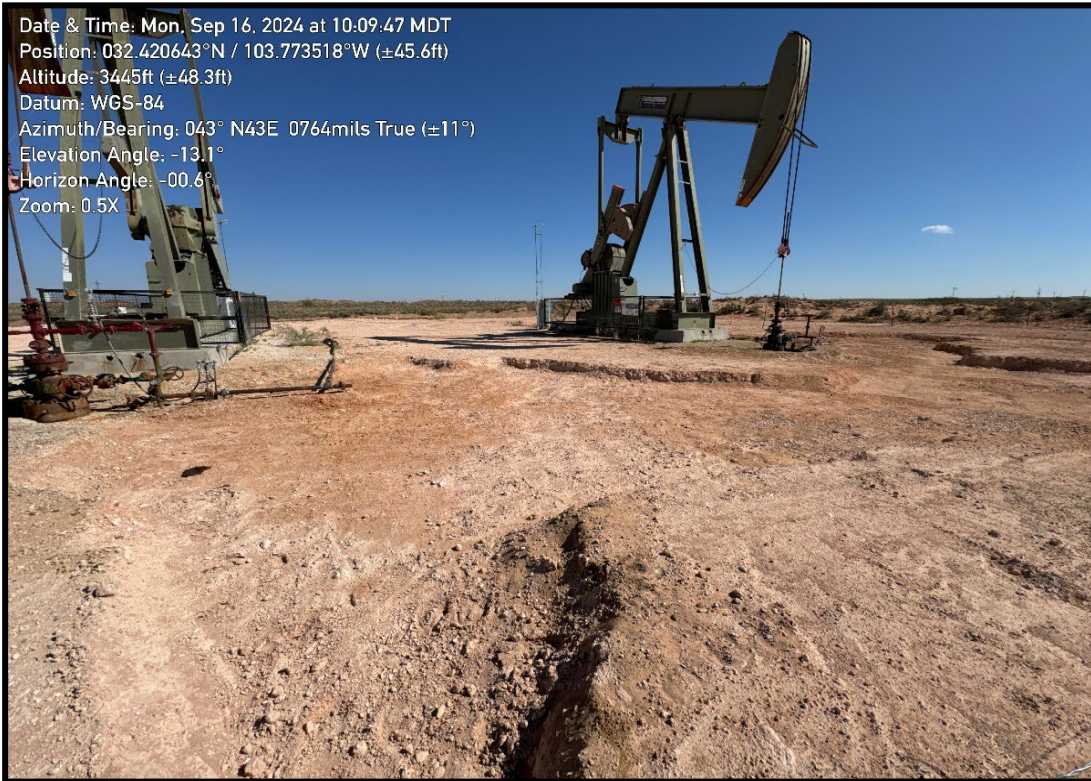
View of excavation during remediation activities, facing northeast (9/16/2024).

The excavation measured approximately 2,025 square feet in arial extent. A total of approximately 105 cubic yards (cy) of soil were excavated from the Site and hauled off for proper disposal at the Lea Land Facility located in Hobbs, New Mexico. After confirmation sampling was completed, the backfill of the excavation was completed utilizing material purchased locally from the Stacy Mills Pit (Mills Ranch Pit) and re-contoured to match pre-existing conditions.

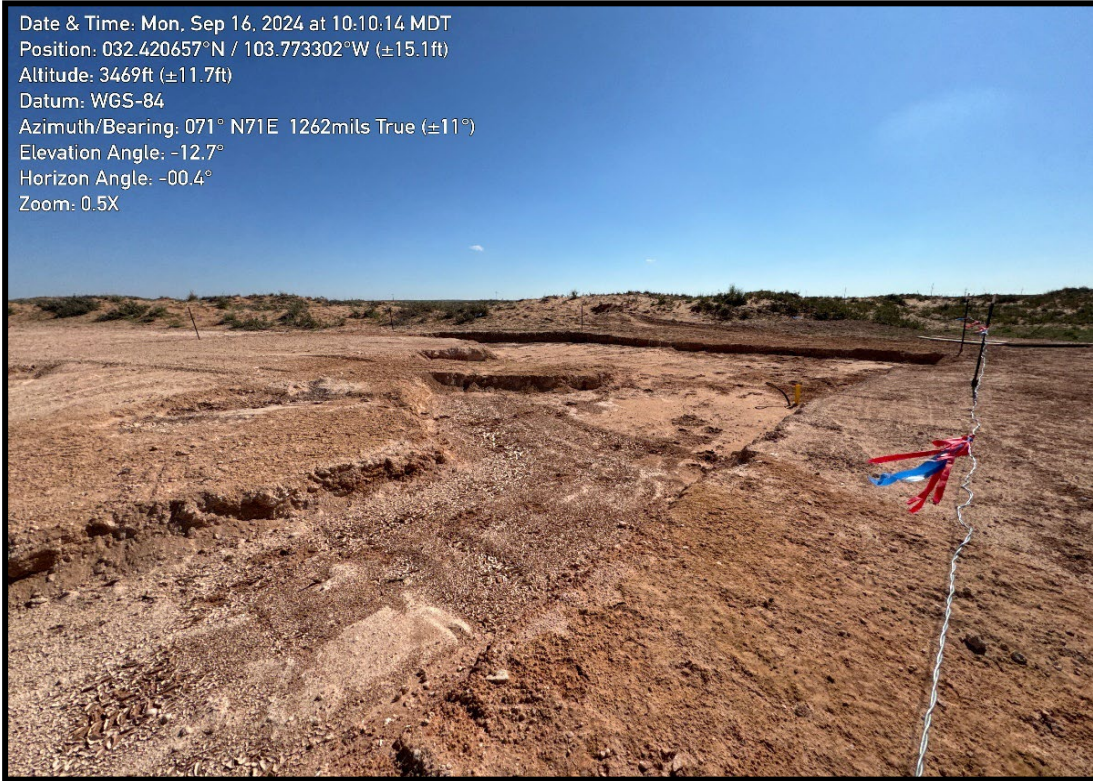
View of excavation during remediation activities, facing northeast (9/16/2024).

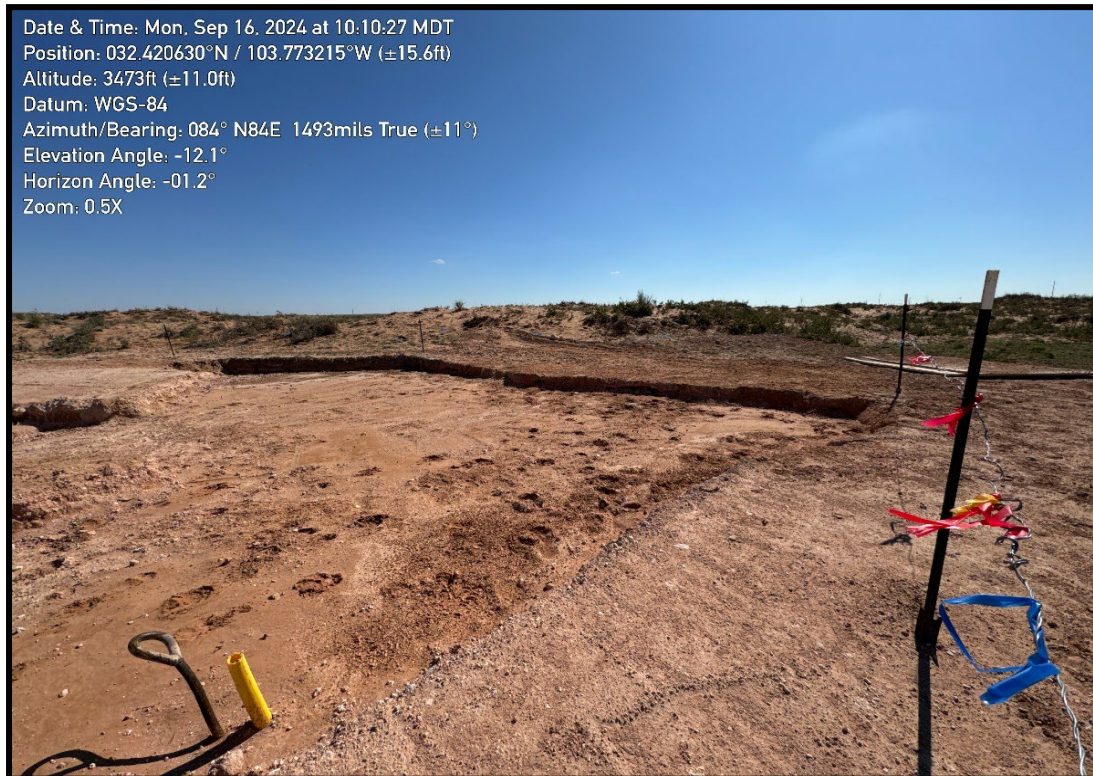
View of excavation during remediation activities, facing northeast (9/16/2024).

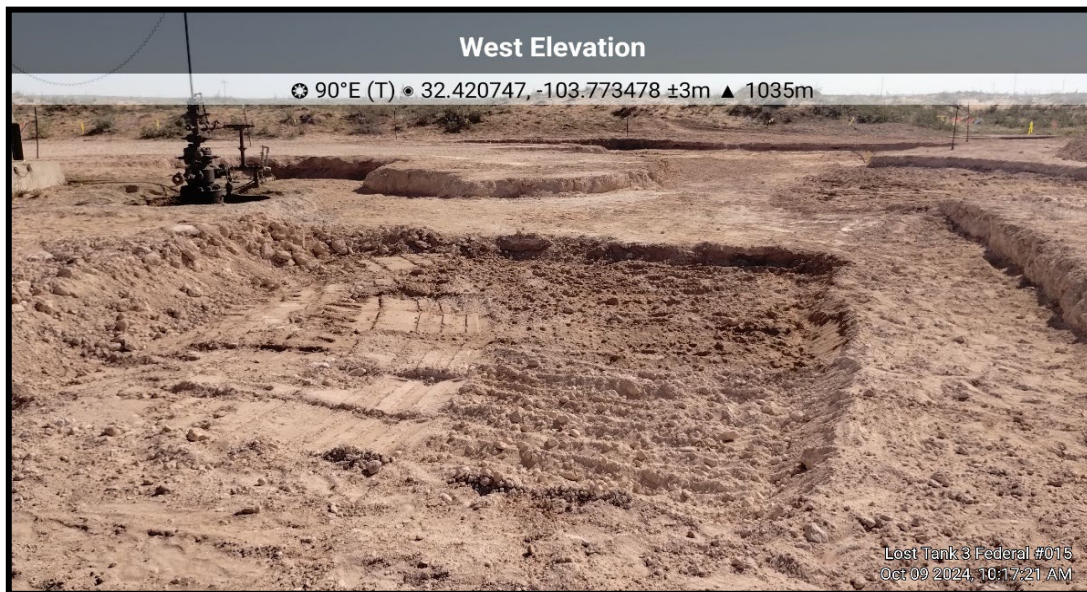
View of excavation during continued remediation activities, facing east (10/09/2024).

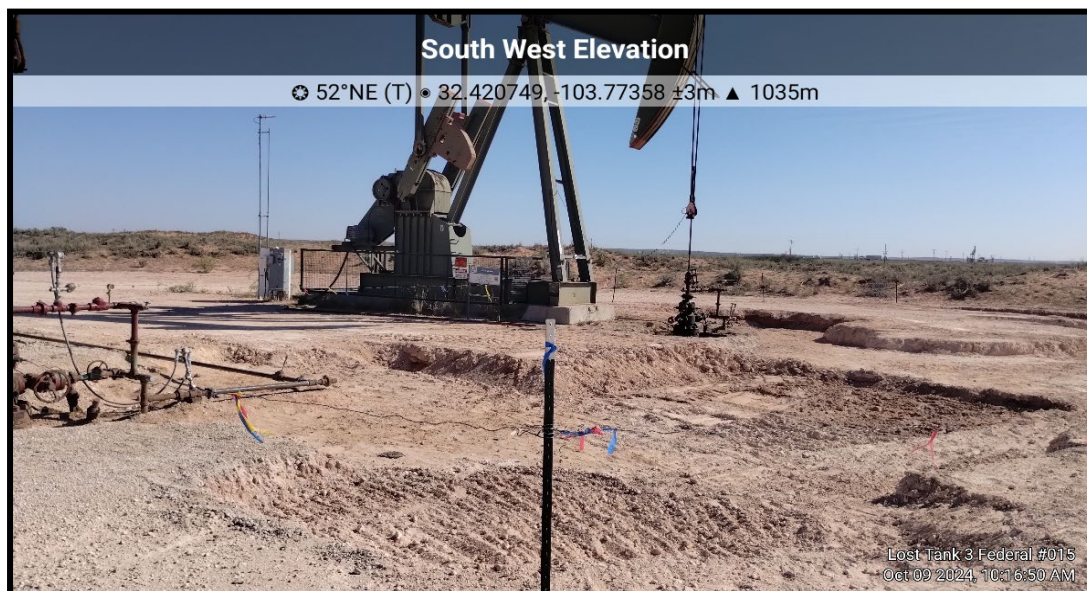
View of excavation during continued remediation activities, facing northeast (10/09/2024).

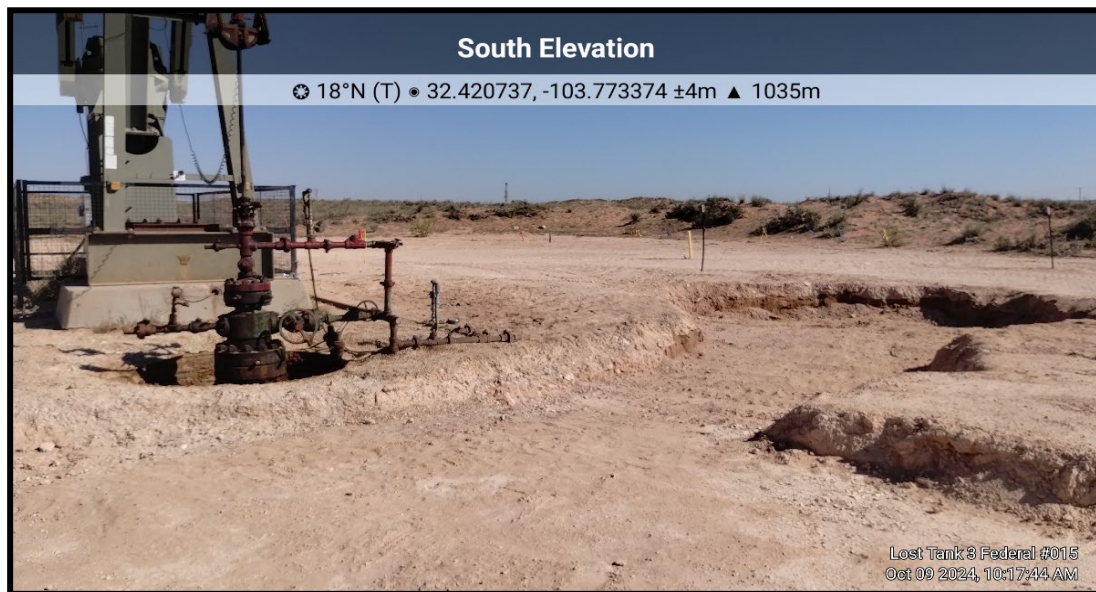
View of excavation during continued remediation activities, facing north (10/09/2024).

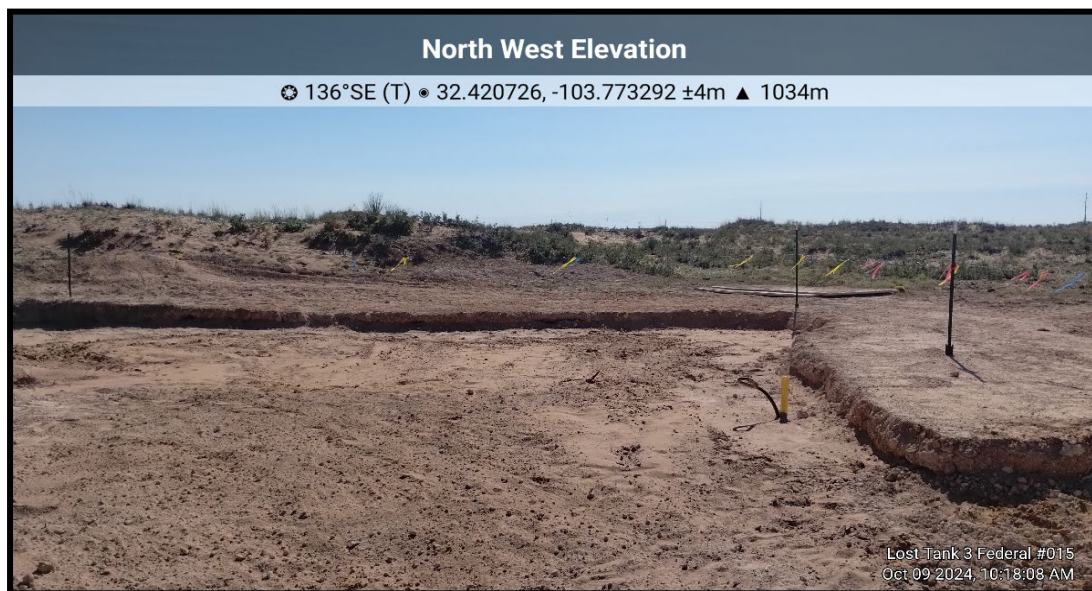
View of excavation during continued remediation activities, facing southeast (10/09/2024).

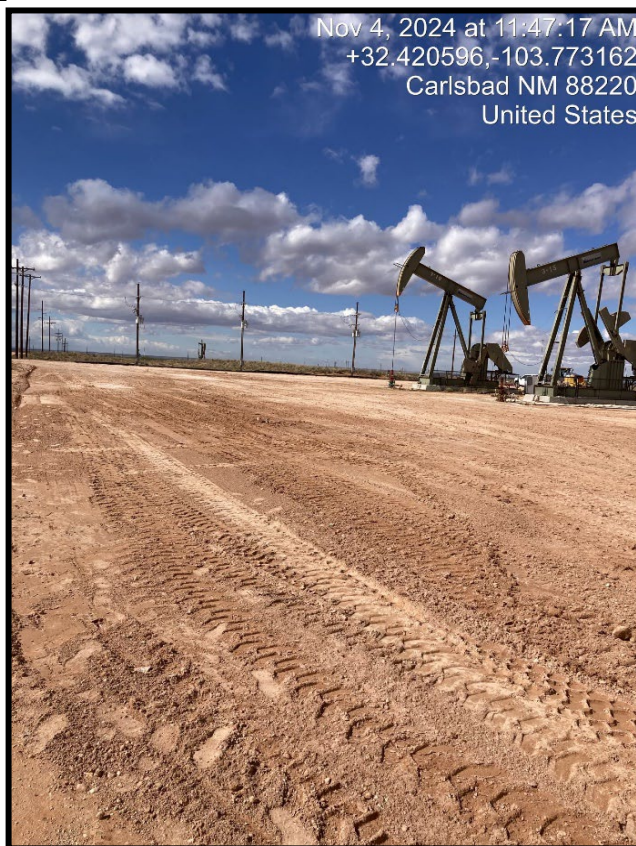
View of backfilled excavation extent, facing west (11/04/2024).

- After completion of confirmation sampling, the backfill of the excavation was completed utilizing material purchased locally from the Stacy Mills Pit (Mills Ranch Pit) and recontoured to match pre-existing conditions.

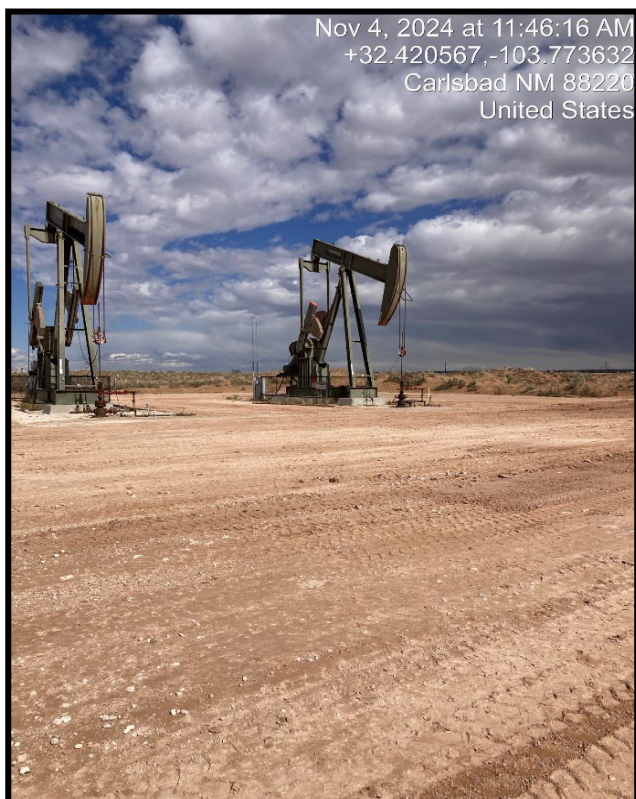
View of backfilled excavation extent, facing north (11/04/2024).
