Closure Report
Black River – John D. Forehand Road Crossing
Incident ID: nAPP2415878197
Eddy County, New Mexico
Unit H Sec 18 T24S R27E
32.21922°, -104.223181°

Point of Release:

Human error; Waste Management truck lost control on road and spilled drill cuttings

Volume Released: 72 Barrels of Oil-Based Drilling Mud/Fluid

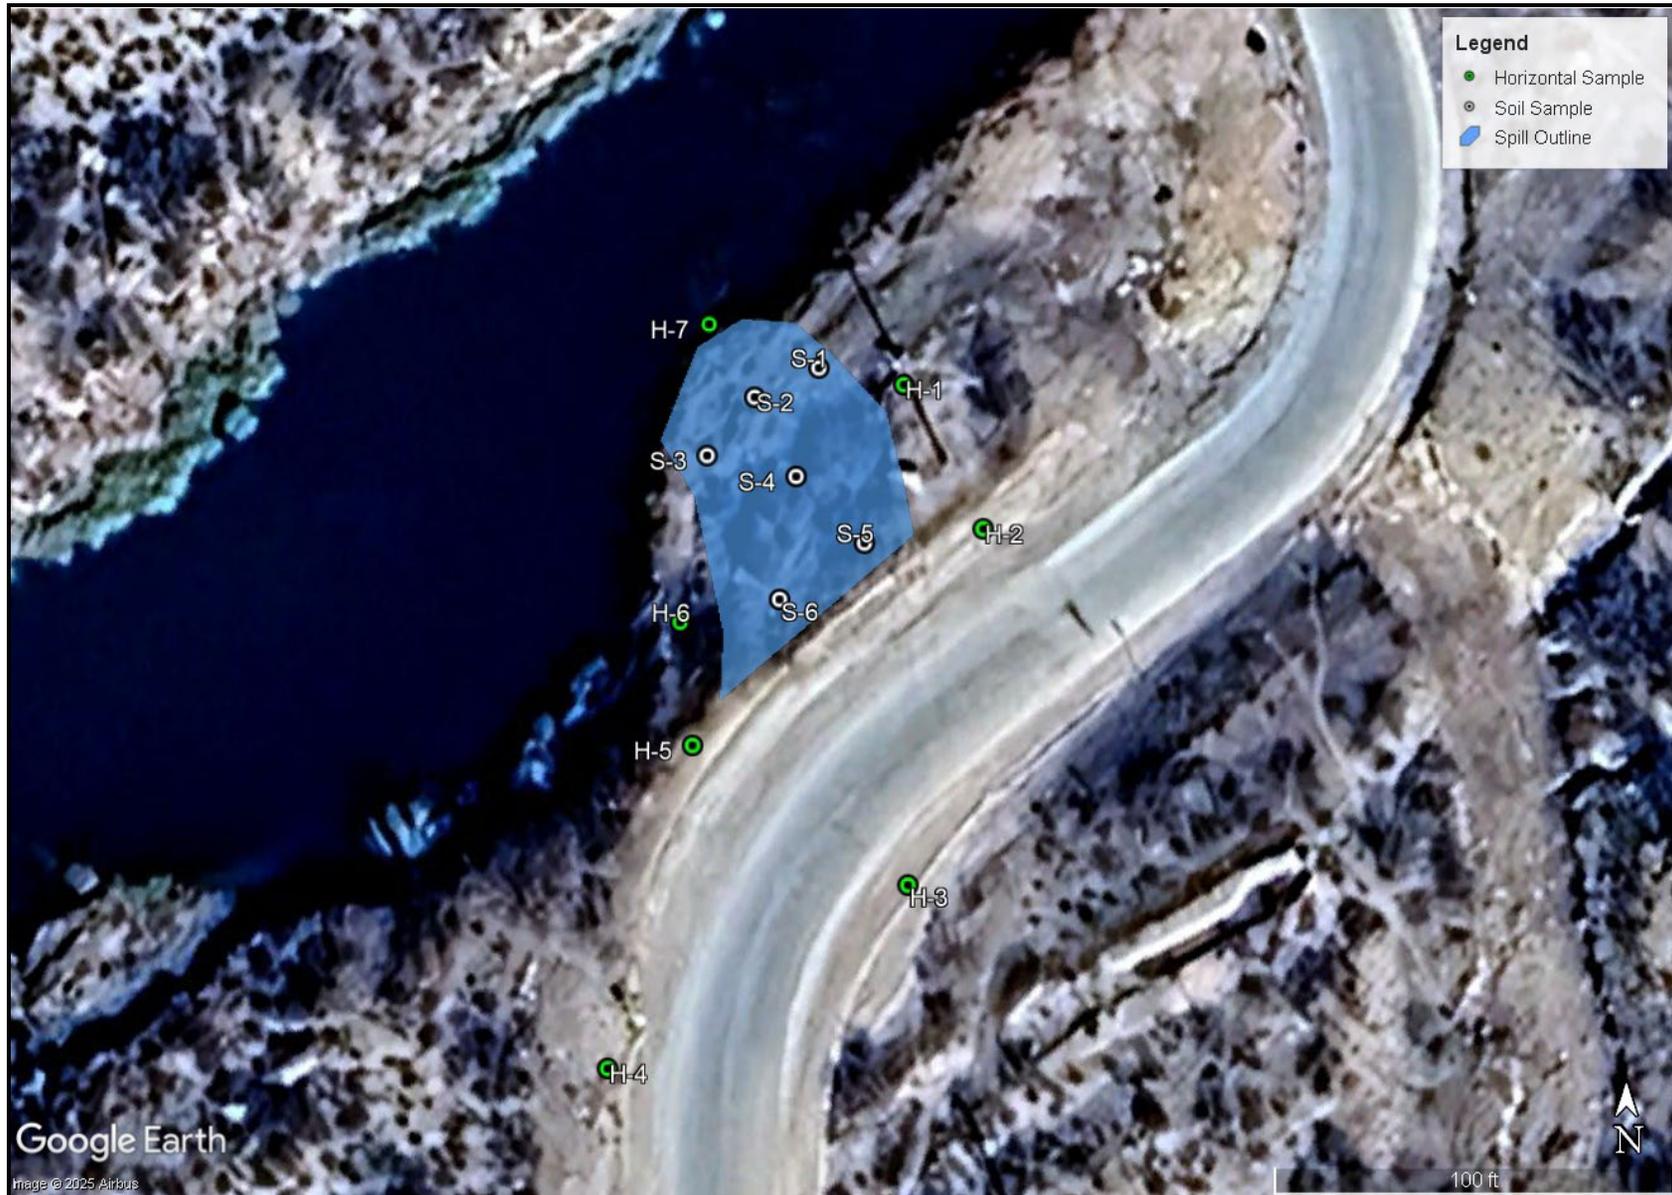
</p>	<p>FIGURE 3</p>
--	--	-----------------

<p>SAMPLE LOCATION MAP CIMAREX ENERGY CO. OF COLORADO BLACK RIVER – JOHN D. FOREHAND ROAD CROSSING EDDY COUNTY, NEW MEXICO 32.21922°, -104.223181°</p>	<p>CARMONA RESOURCES

Based on the initial C-141 obtained from the New Mexico Oil Conservation Division (NMOCD), the spill was discovered on June 6, 2024, caused by a waste management truck that lost control on John D. Forehand Road and spilled drill cuttings onto the shoulder of the road. It resulted in approximately seventy-two (72) barrels of drilling mud/fluid that was released, and seventy-two (72) barrels of drilling mud/fluid was recovered. The impacted area was in the pasture. Refer to Figure 3 for a spill overview. The Notice of Release is attached in Appendix C.

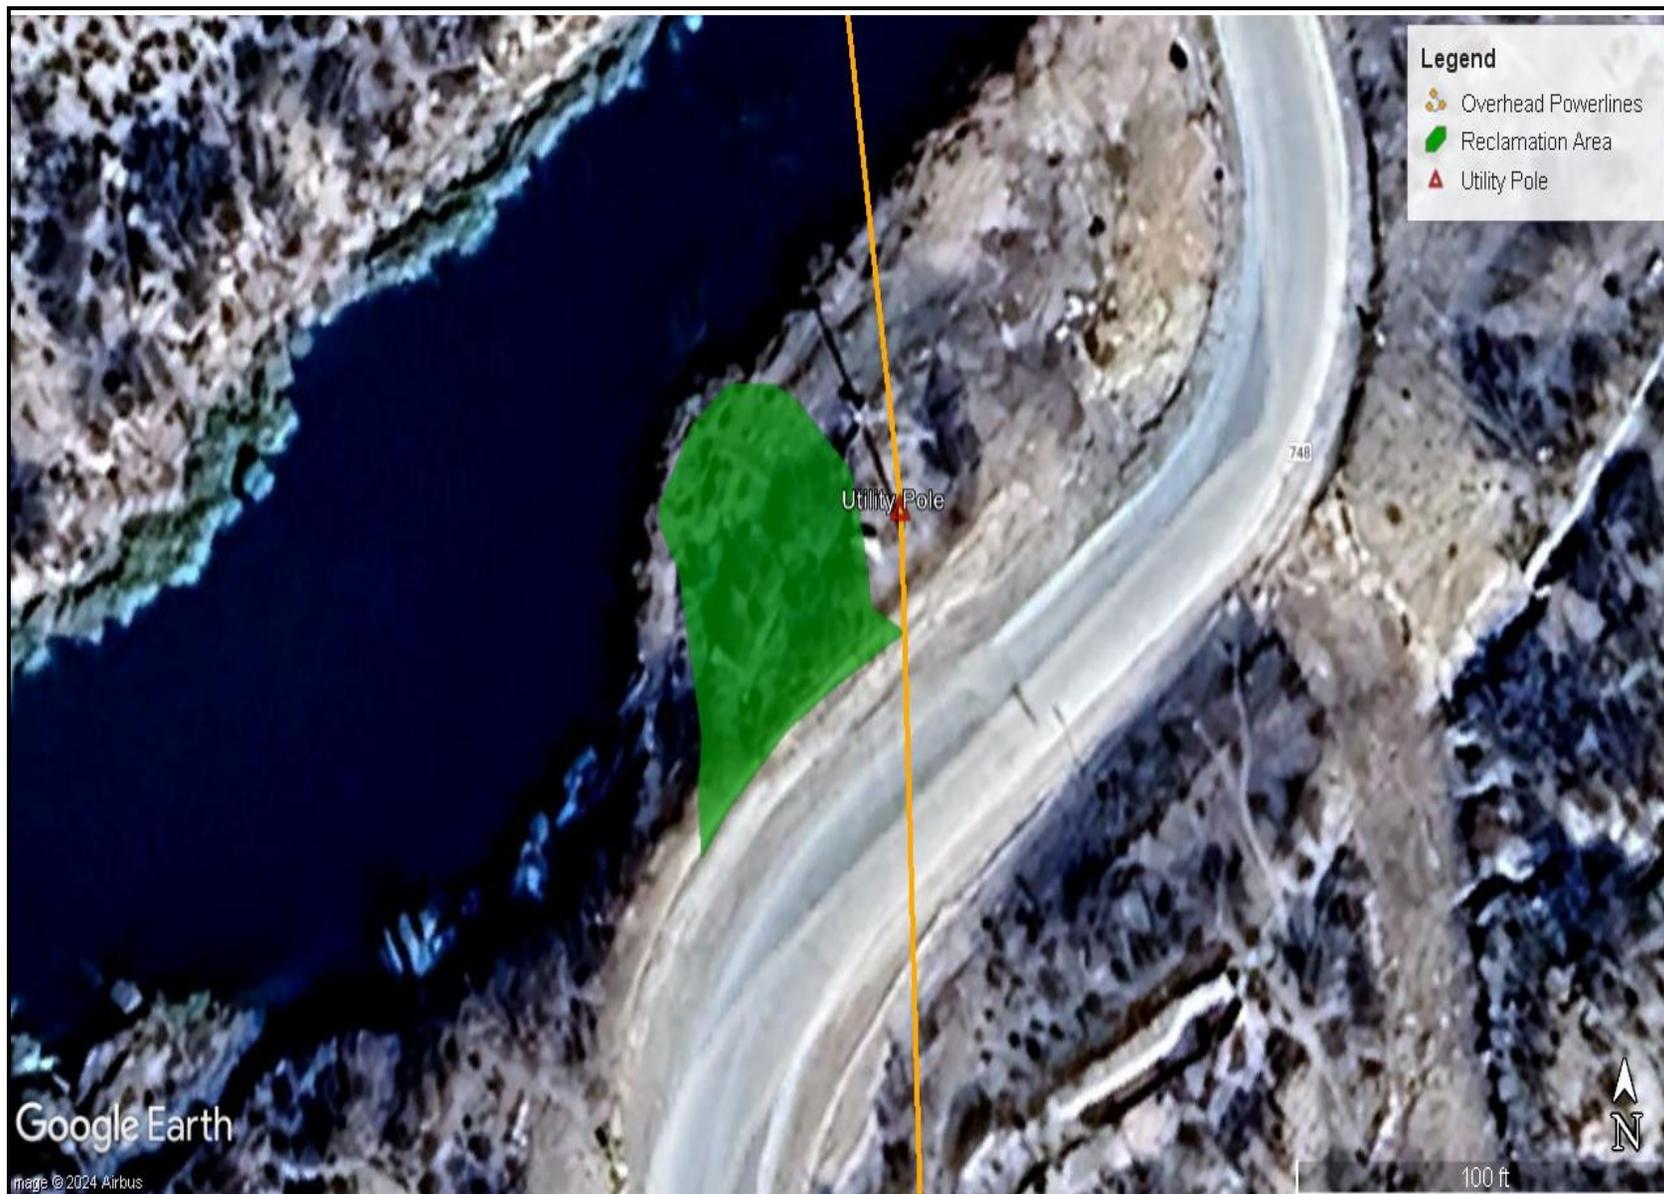
RECLAMATION MAP
CIMAREX ENERGY CO. OF COLORADO
BLACK RIVER – JOHN D. FOREHAND ROAD CROSSING
EDDY COUNTY, NEW MEXICO
32.21922°, -104.223181°

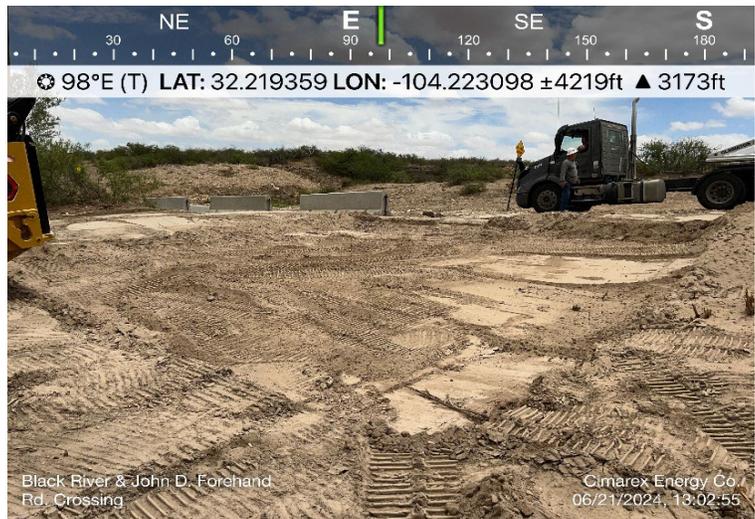
Description:
View East, area of CS-1 through CS-4.

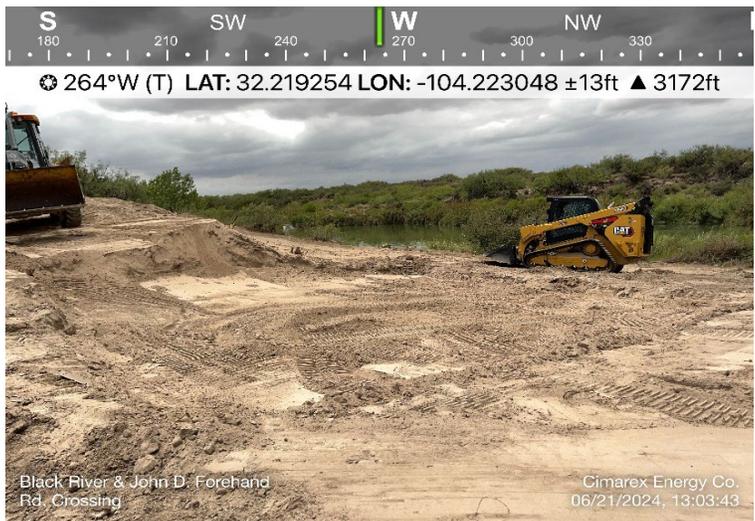
Photograph No. 2

Description:
View West, area of CS-1 through CS-4.

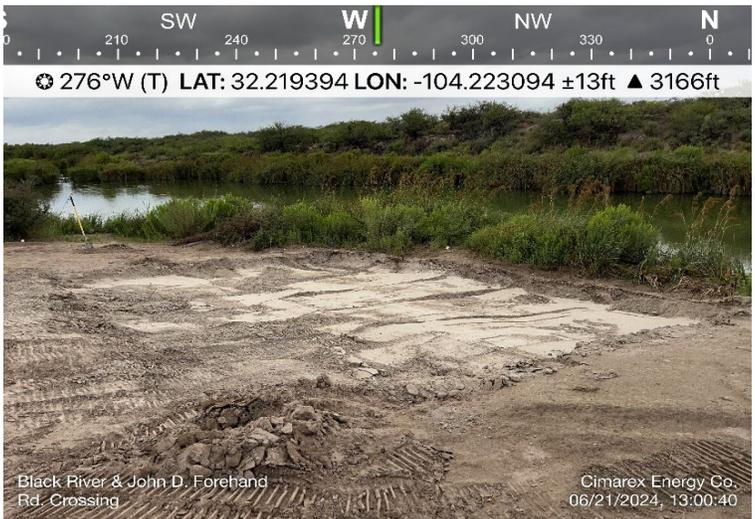
Photograph No. 3

Description:
View West, area of CS-5 through CS-7.

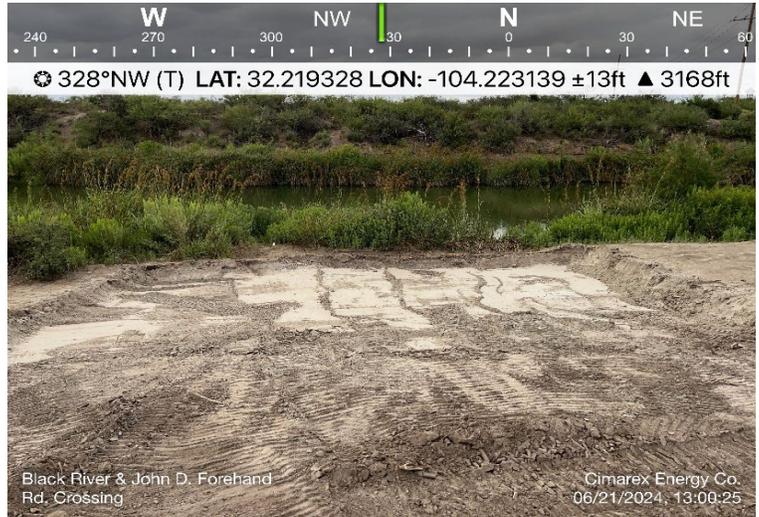
Description:
View Northwest, area of CS-5 through CS-7.

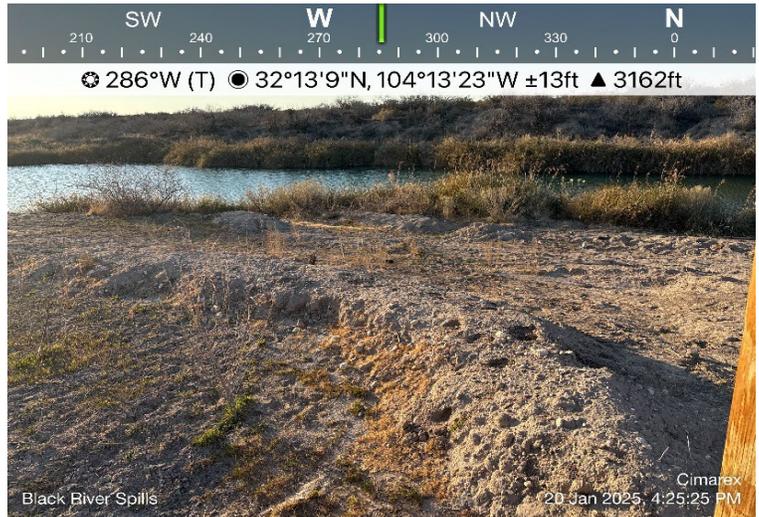
Photograph No. 5

Description:
View West, backfilled and reseeded area with berms added for erosion control.

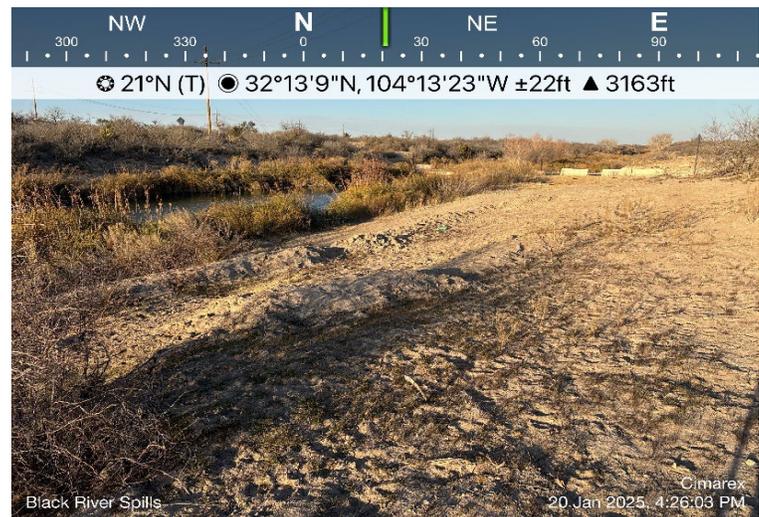
Photograph No. 6

Description:
View North, backfilled and reseeded area with berms added for erosion control.
