# Remediation Summary & Soil Closure Request

## Permian Resources Woody 22 Fed Com CTB #1

Lea County, New Mexico  
Unit Letter K, Section 22, Township 20 South, Range 35 East  
Latitude 32.55729 North, Longitude 103.44071 West  
NMOCD Reference No. nAPP2334564703

### Etech Environmental & Safety Solutions, Inc.

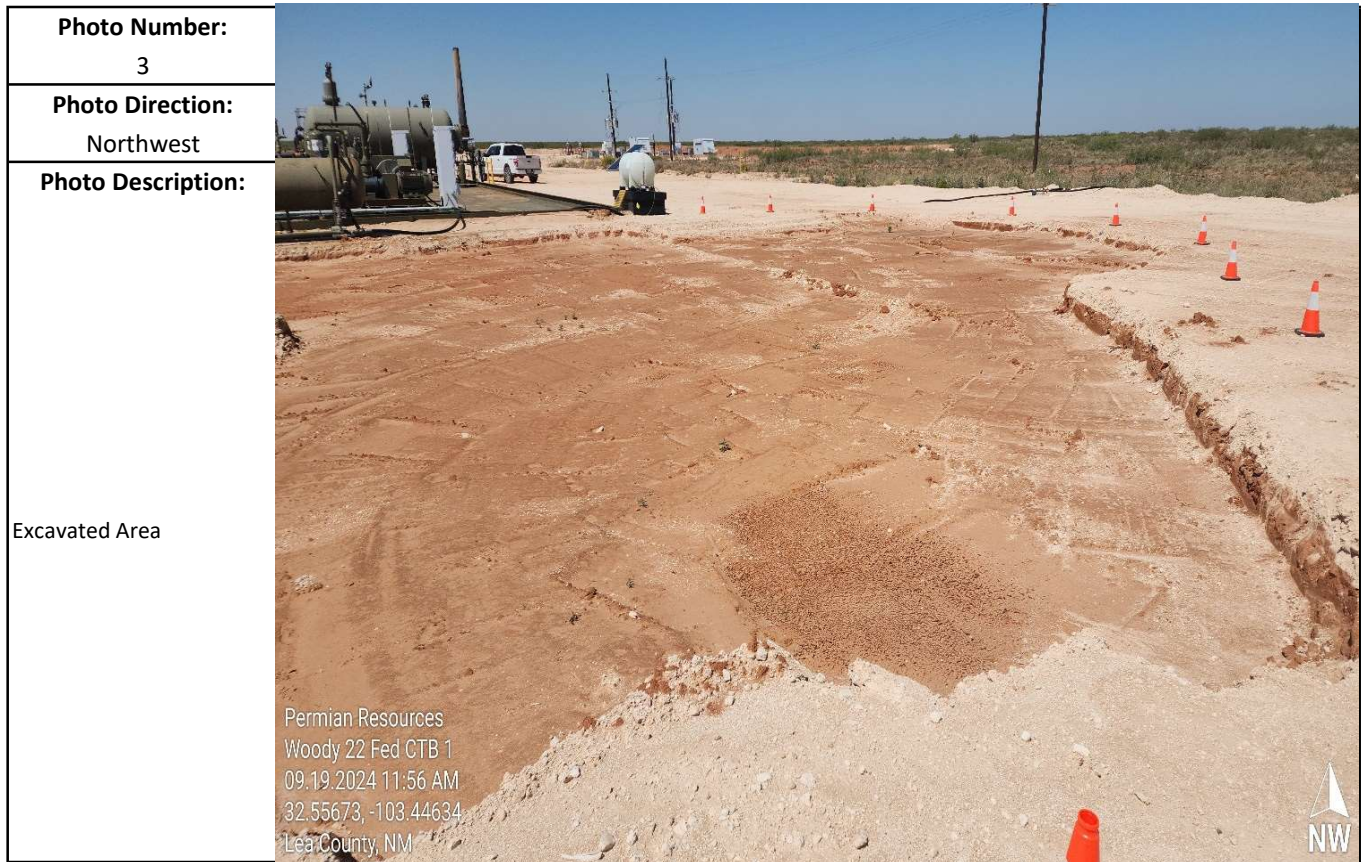
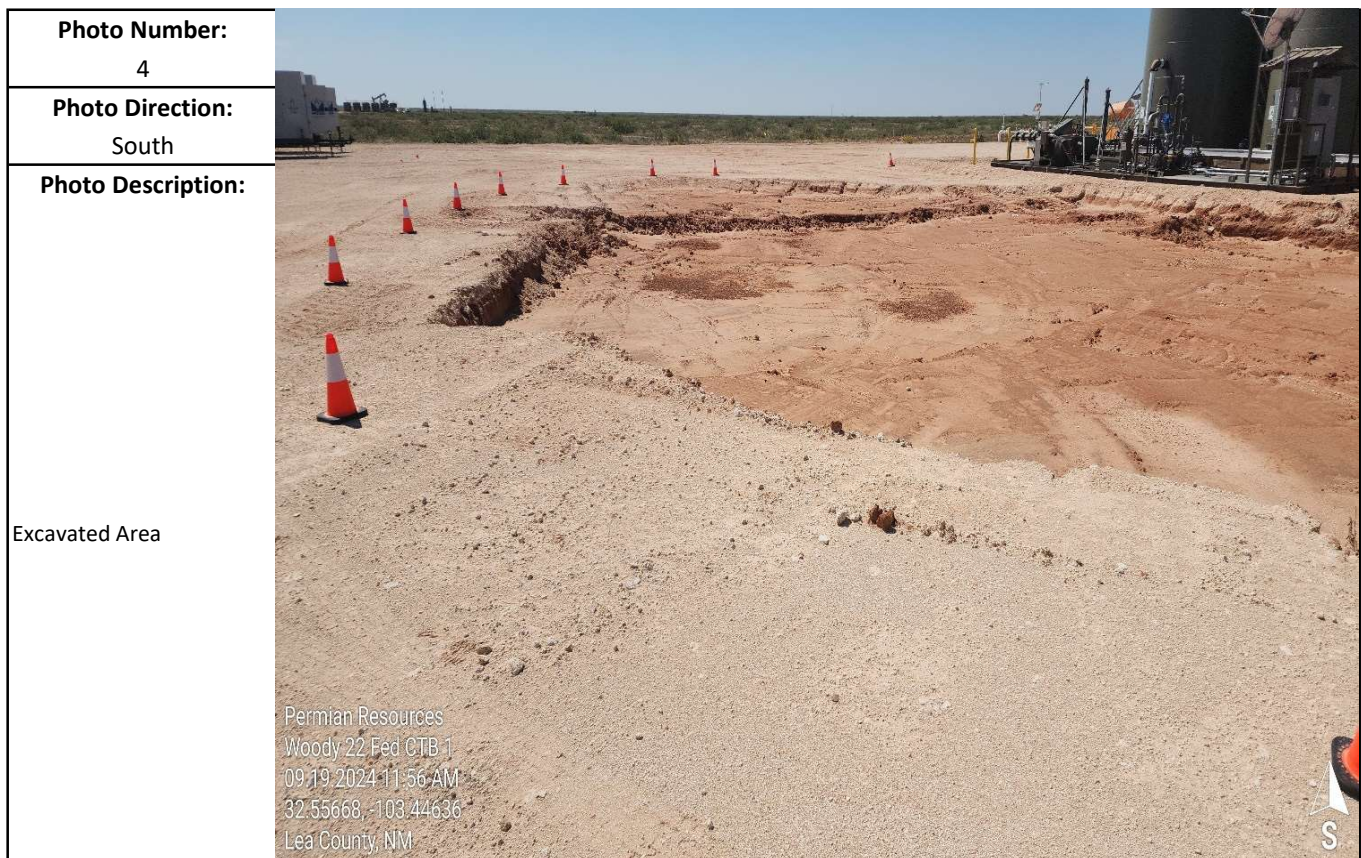
<b>Photo Number:</b> 5	<div>10/2/24, 3:05 PM +32.556444,-103.446383 NM,Eunice</div>   A photograph of an industrial site. In the foreground, there is a large, flat, sandy area with visible tire tracks, which is the backfilled area. In the background, there are several large, dark-colored storage tanks and a small structure with a satellite dish. The sky is clear and blue.
<b>Photo Direction:</b> North	
<b>Photo Description:</b>  Backfilled area
