**Re: Deferral Request
 Jayhawk 6 CTB 2
 Devon Energy Production Company
 Unit C, Section 06, Township 26S, Range 34E
 Site Coordinates: 32.07629704, -103.51193
 Lea County, New Mexico
 Incident ID: nAPP2415524417**

**SITE LOCATION MAP
DEFERRAL REQUEST**
DEVON ENERGY PRODUCTION COMPANY
JAYHAWK 6 CTB 2
LEA COUNTY, NEW MEXICO

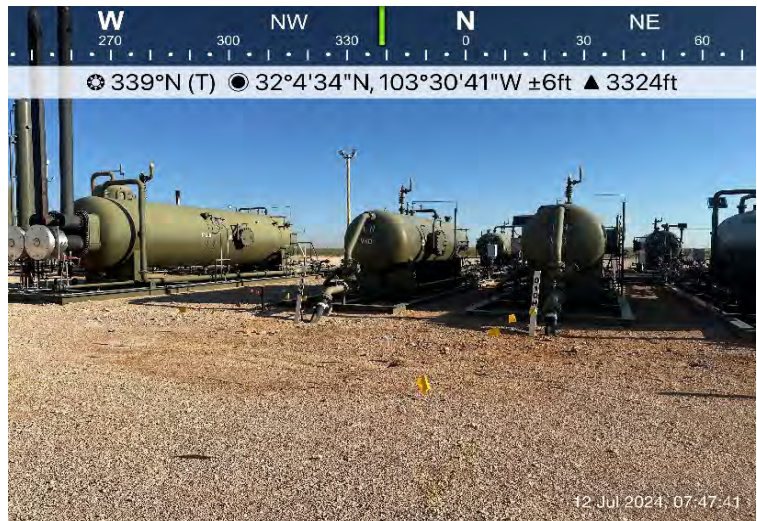
**Photograph No. 2**

Description:
Area of Concern

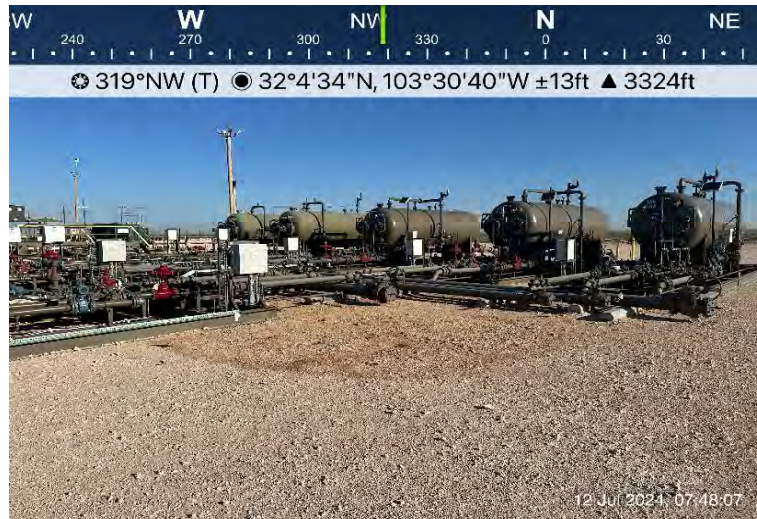
**Photograph No. 3**

Description:
Area of Concern

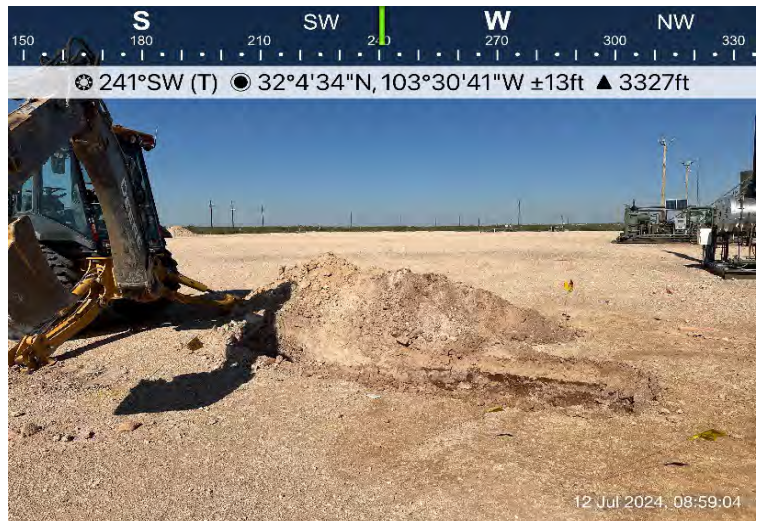
**Photograph No. 5****Facility:** Jayhawk 6 CTB 2**County:** Lea County, New Mexico**Description:**
Area of Concern

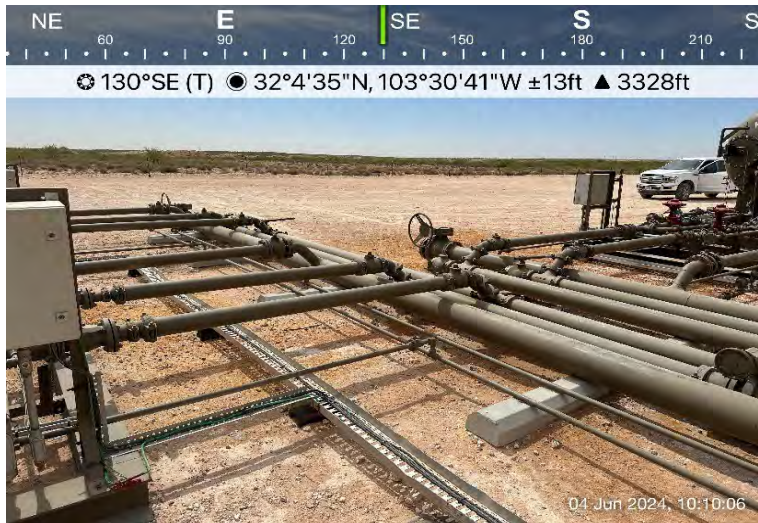
**Photograph No. 6****Facility:** Jayhawk 6 CTB 2**County:** Lea County, New Mexico**Description:**
Area of Concern

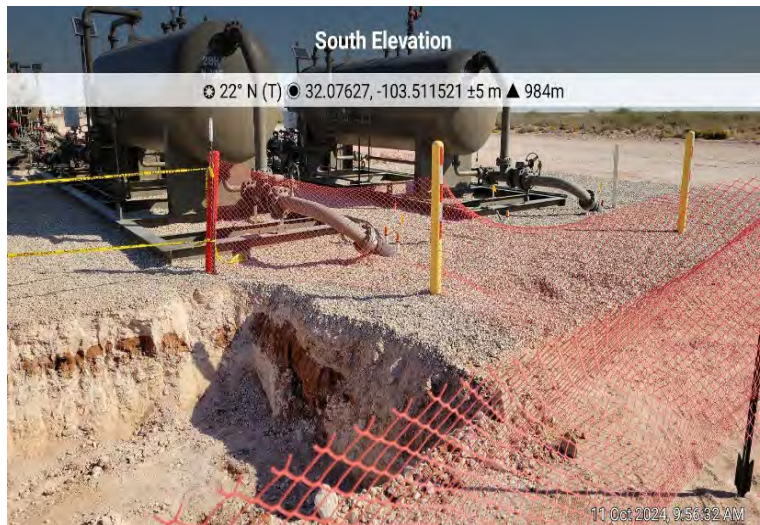
Photograph No. 10

Description:
View of Excavation

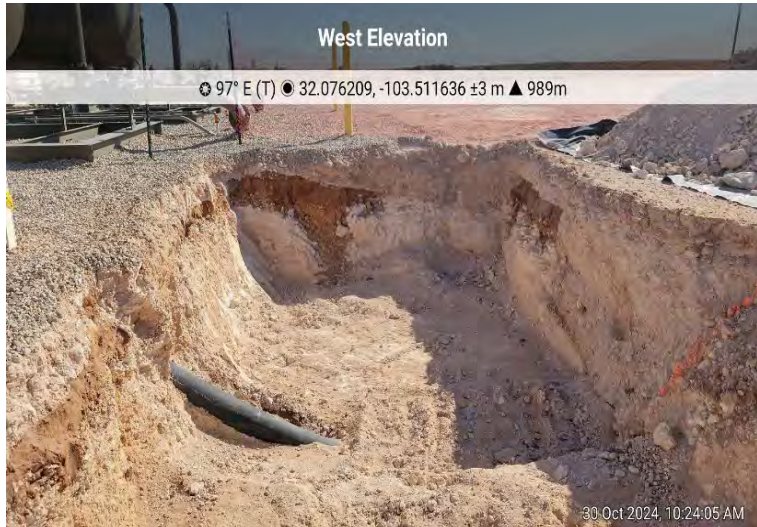
**Photograph No. 12**

Description:
View of Excavation
