SUBJECT: Remediation Workplan for the Lotus SWD #001 Release (NAPP2110953917), Lea County, New Mexico

On behalf of Owl SWD Operating LLC, Strata Resources (Strata) has prepared this Remediation Workplan that describes the delineation and proposed remediation for a release of liquids related to oil and gas production activities at the Lotus SWD #001. The site is in Unit A, Section 32, Township 22S, Range 32E, Lea County, New Mexico, on state land. Figure 1 illustrates the vicinity and site location on an USGS 7.5-minute quadrangle map.

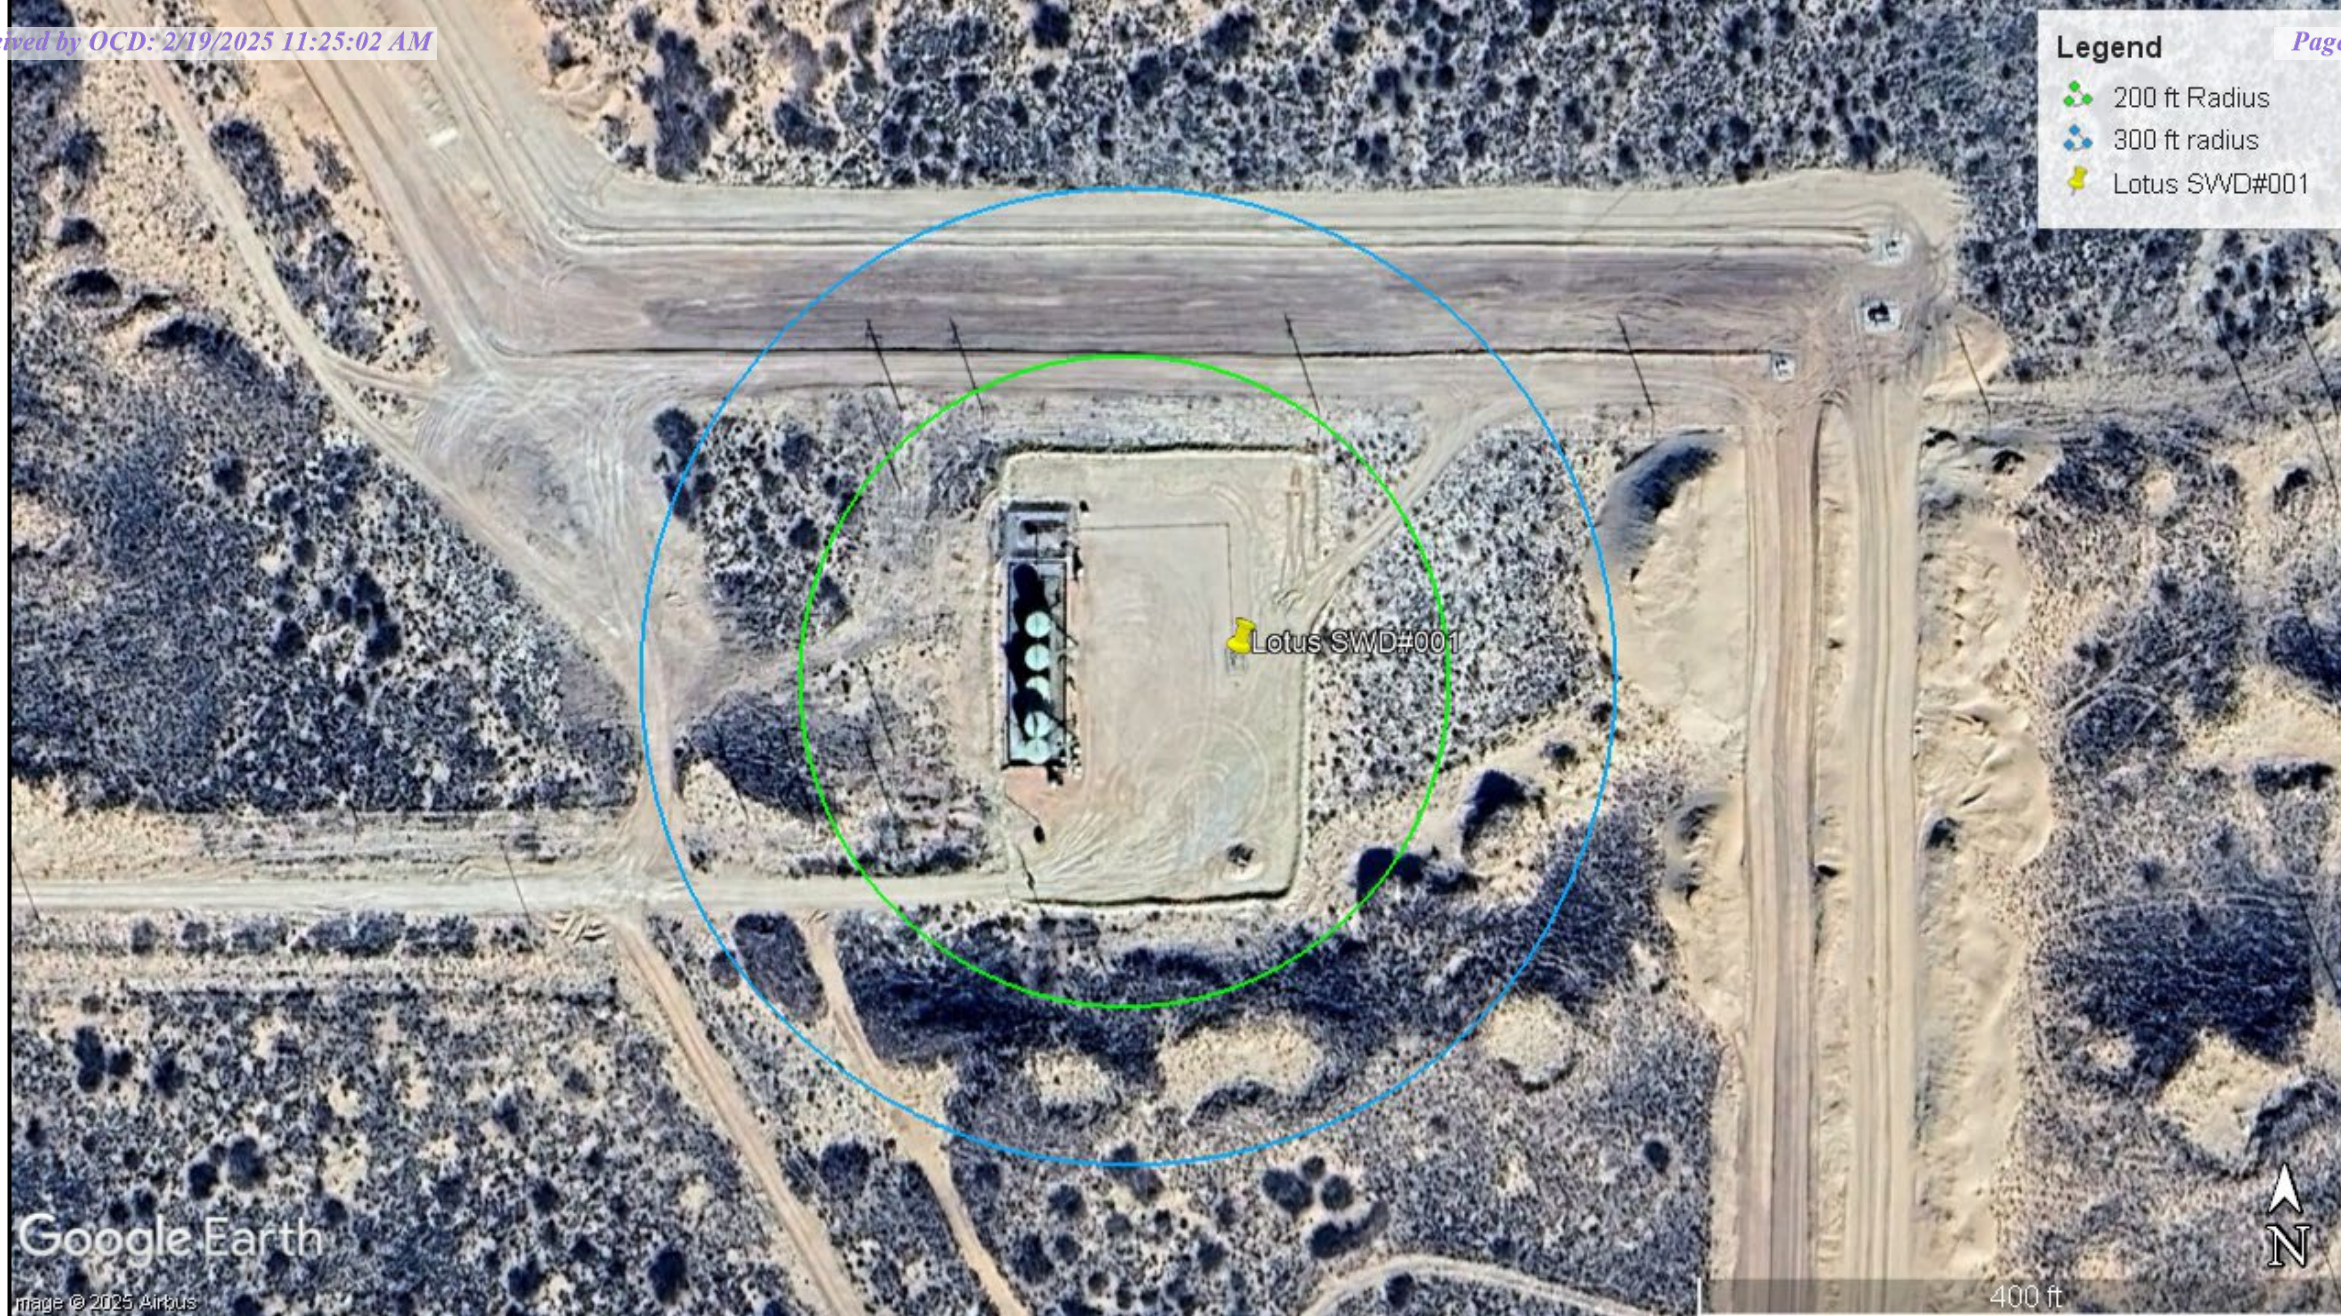
The nearest significant watercourse is an un-named draw that leads to Red Tank, located approximately 12,3245 feet northwest of the location. Figure 2 illustrates the site with 200 and 300-foot radii to indicate that it does not lie within a sensitive area as described in 19.15.29.12.C(4) NMAC.

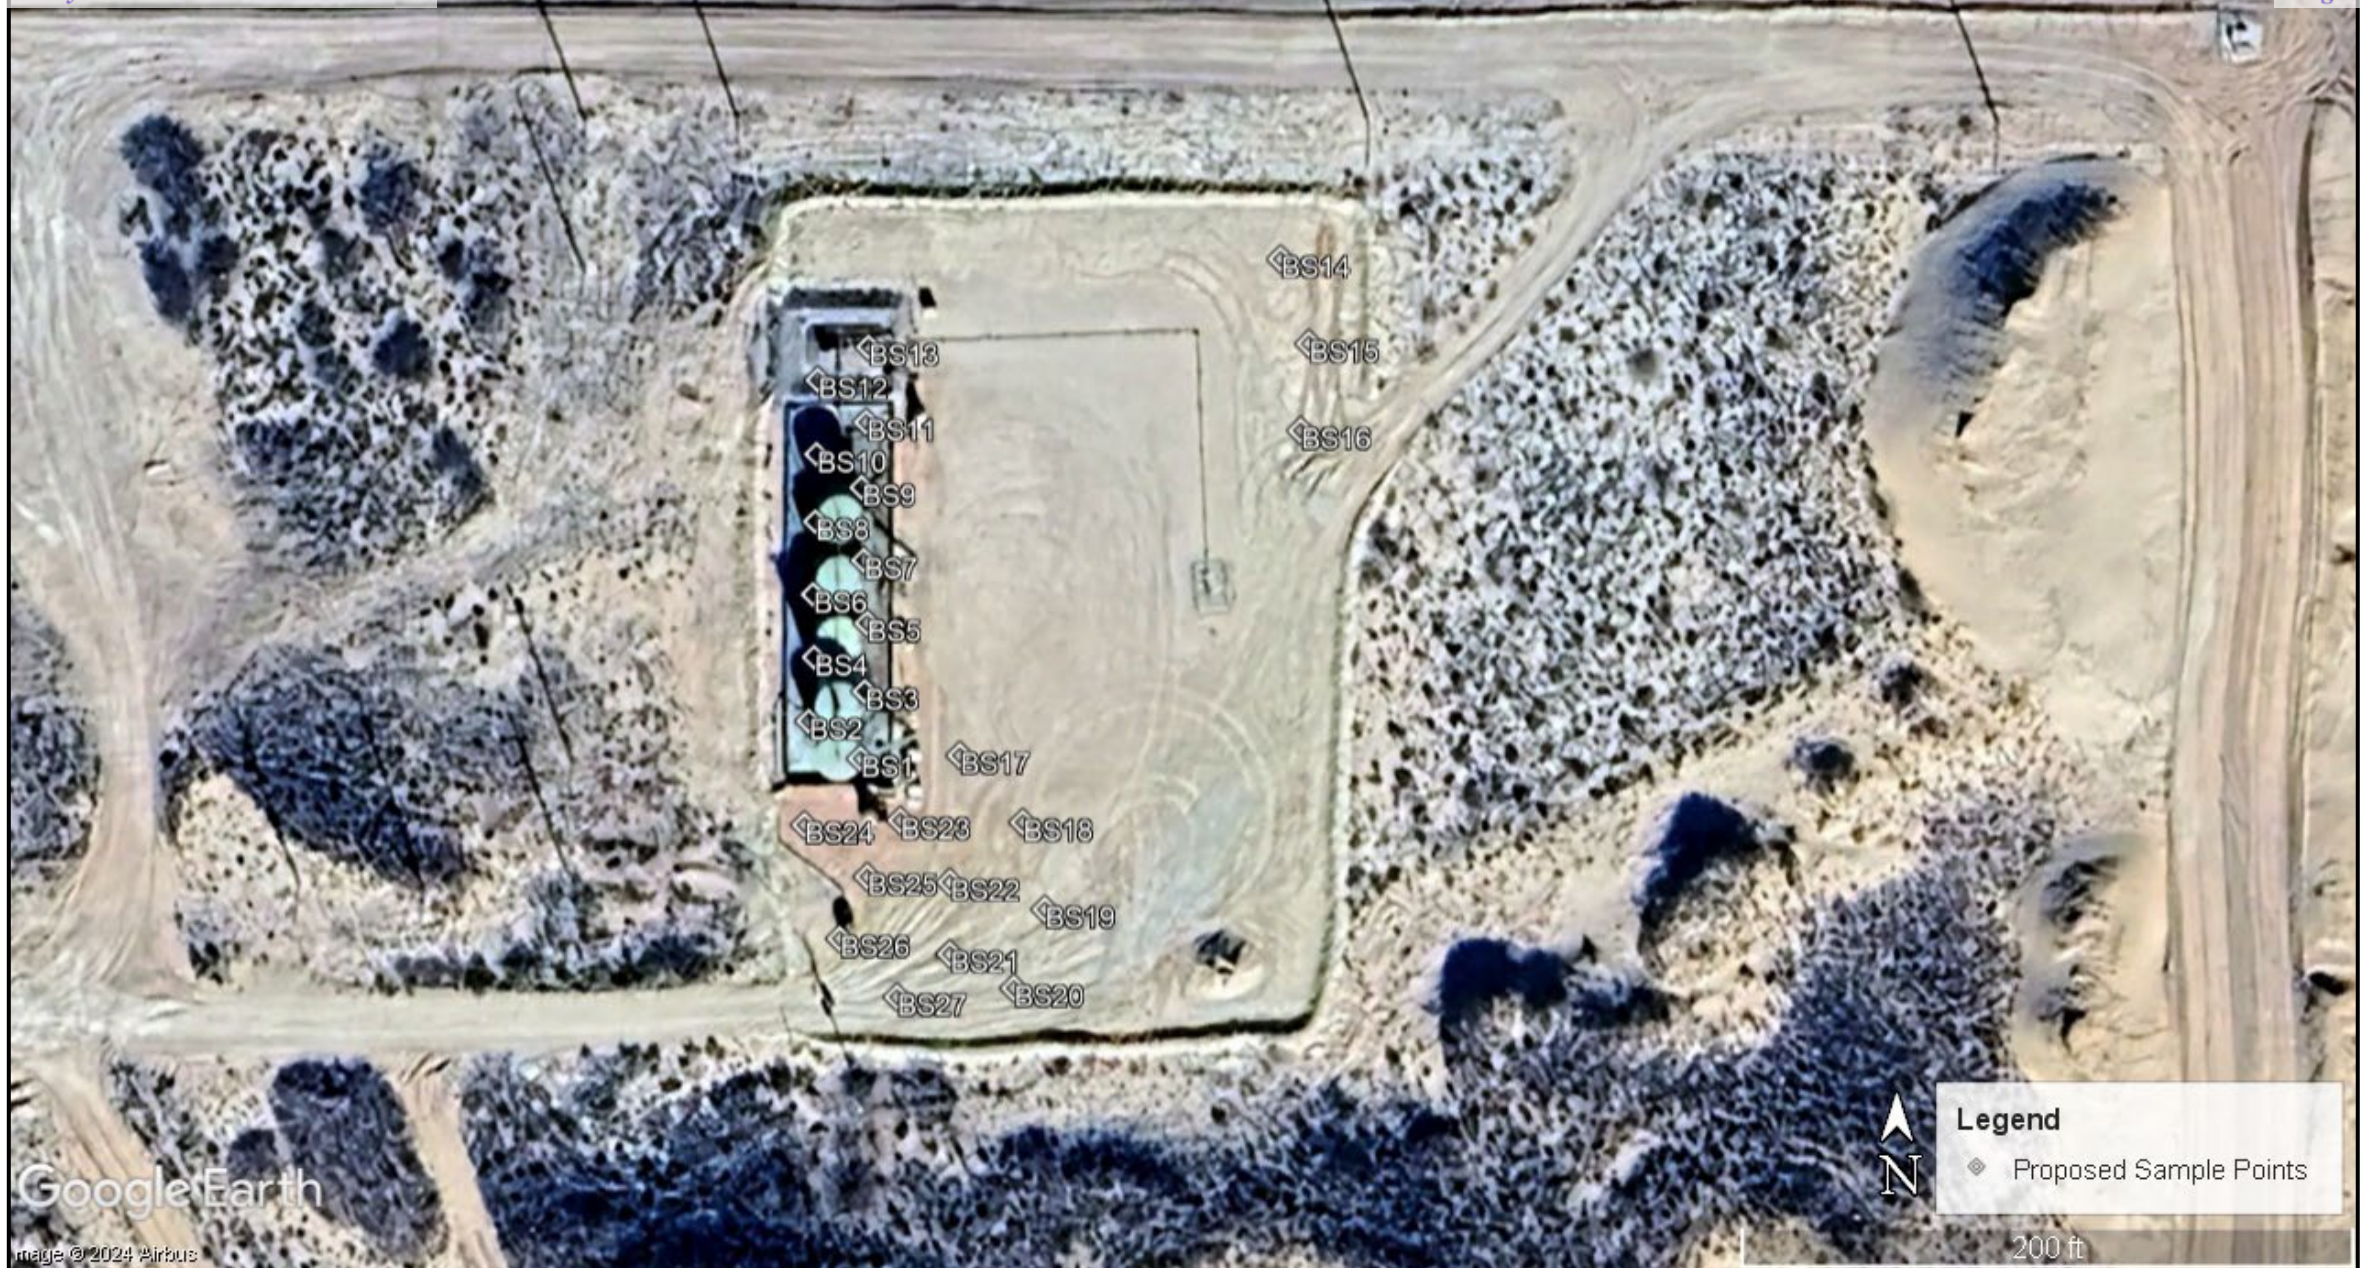
On April 14, 2021, a release was discovered at the Lotus SWD #001 after a check valve had malfunctioned. Initial response actions were conducted by the operator and included source elimination by means of repair, site stabilization, and release recovery. The release consisted of 20 barrels of produced water with no recoverable quantities. Figures 1 and 2 illustrate the vicinity and site location, while Figure 3a illustrates the release location.
