Land Reclamation Report

Zeus SWD Line

Incident Number: NRM2026231125

Land Reclamation Report
Zeus SWD Line
Incident Number: NRM2026231125

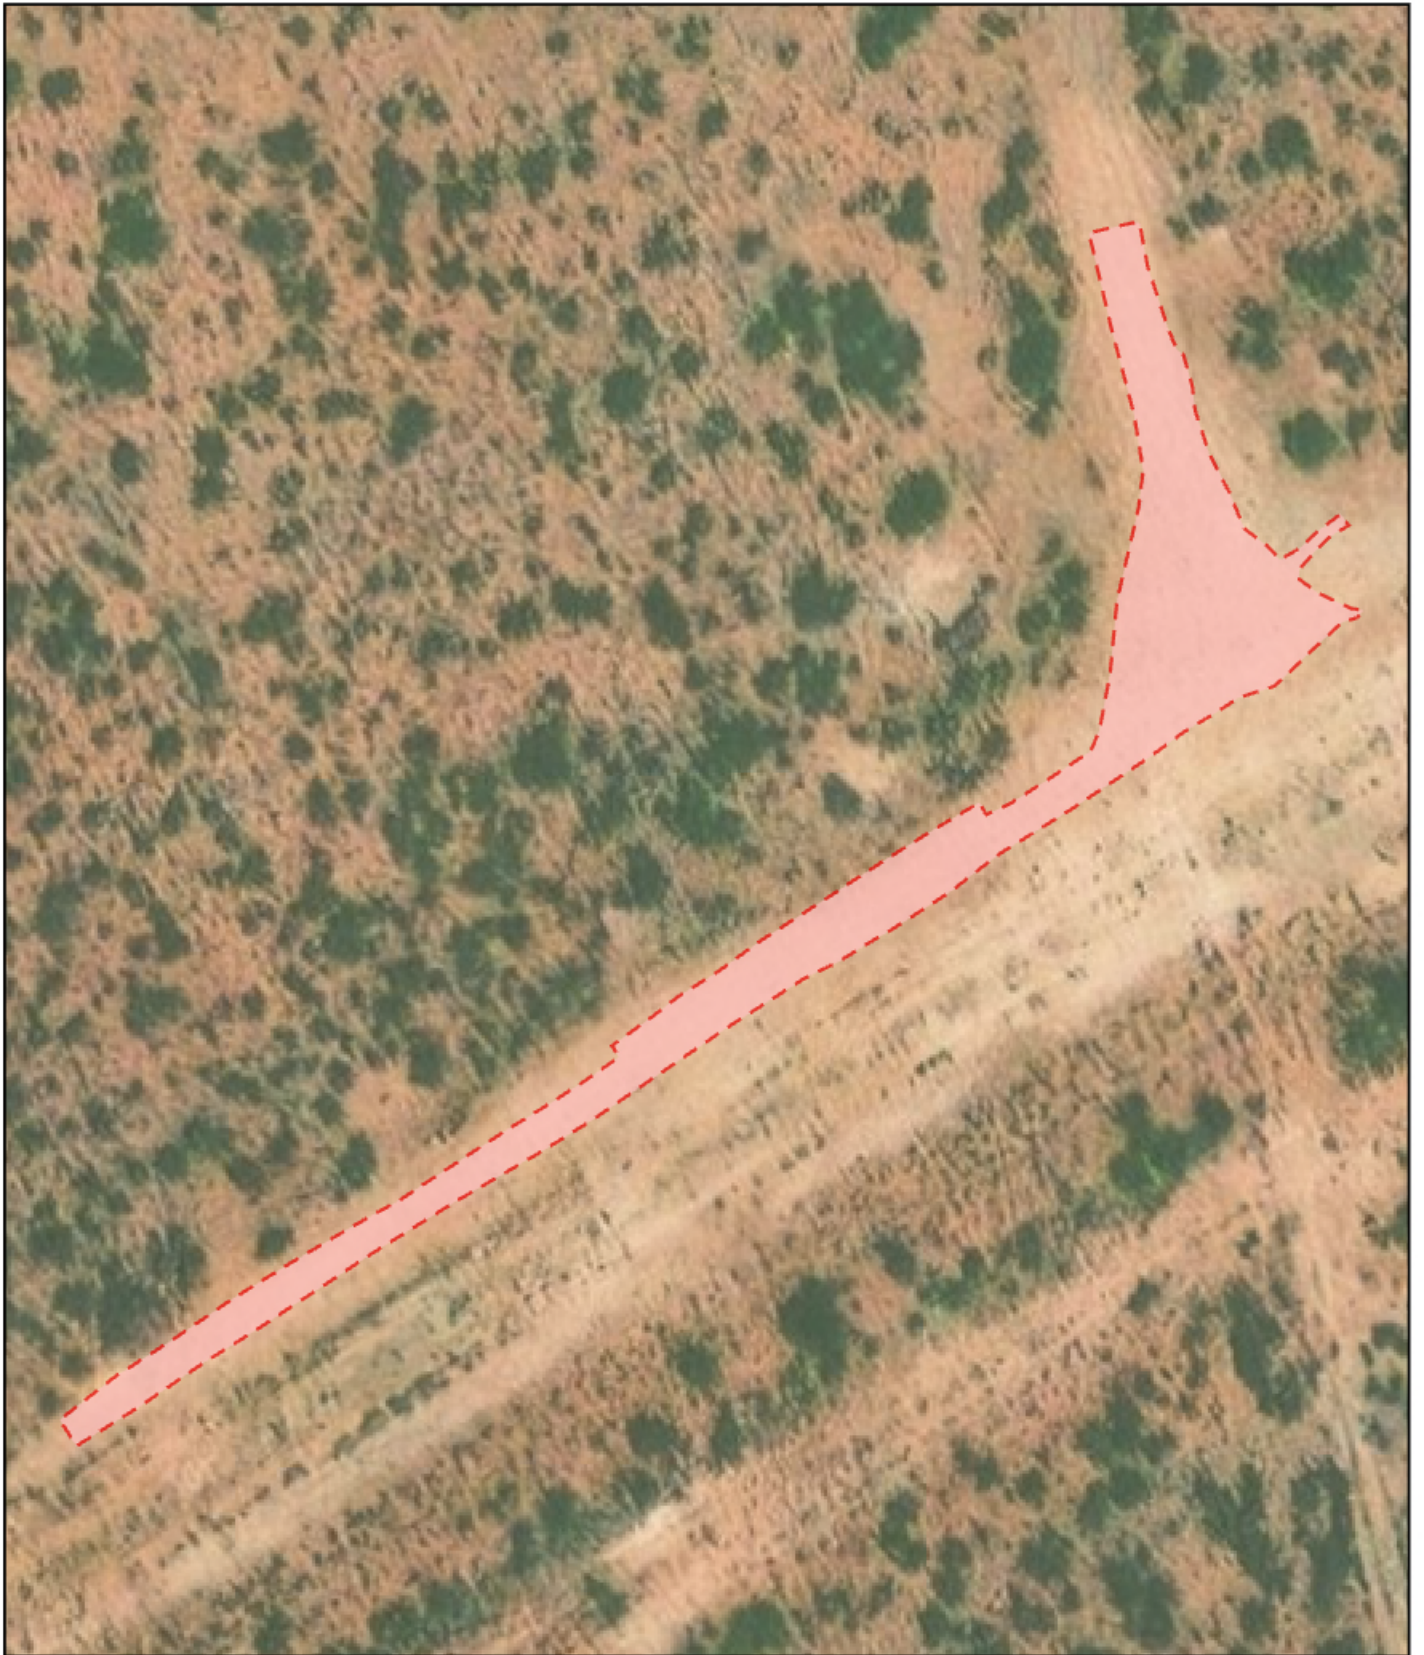
APPENDIX A – Scaled Site Schematic of Reclamation/Seeded Area

Reclamation Area (~10,488 sq.ft.)

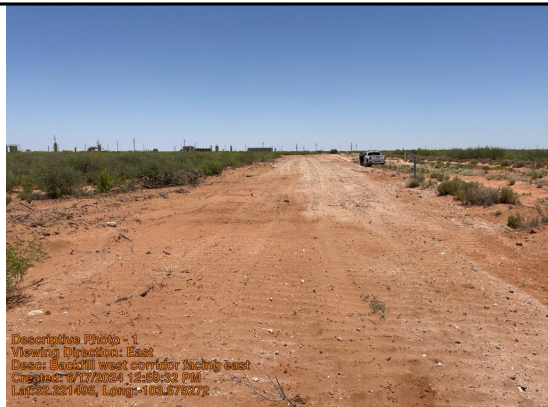
Descriptive Photo - 1
Viewing Direction: East
Desc: Backfill west corridor facing east
Created: 9/17/2024 12:55:32 PM
Lat:32.321486, Long:-103.575272

Backfill west corridor facing east

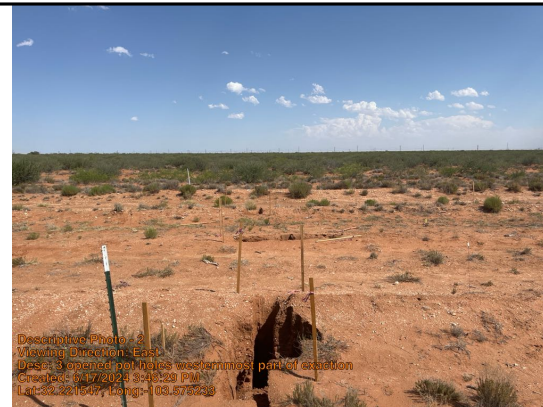
Viewing Direction: South

Descriptive Photo - 2
Viewing Direction: East
Desc: 3 opened pot holes westernmost part of exaction
Created: 9/17/2024 3:45:20 PM
Lat:32.321486, Long:-103.575272

3 opened pot holes westernmost part of exaction

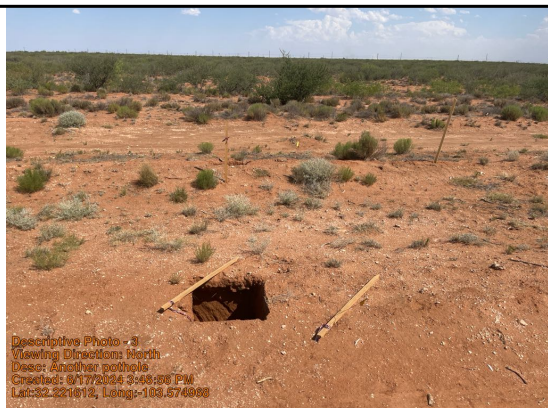
Descriptive Photo - 3
Viewing Direction: North
Desc: Another pothole
Created: 9/17/2024 3:45:50 PM
Lat:32.321486, Long:-103.575272

Another pothole

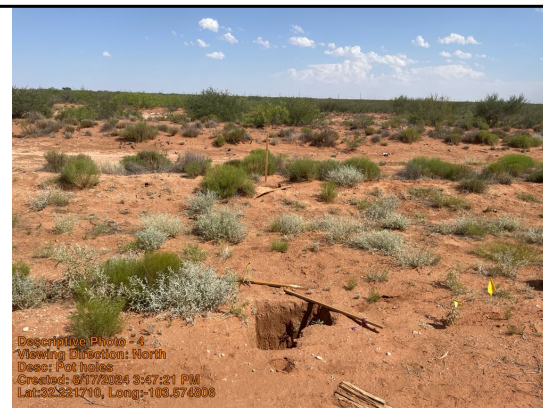
Descriptive Photo - 4
Viewing Direction: North
Desc: Pot holes
Created: 9/17/2024 3:47:21 PM
Lat:32.321486, Long:-103.575272

Pot holes

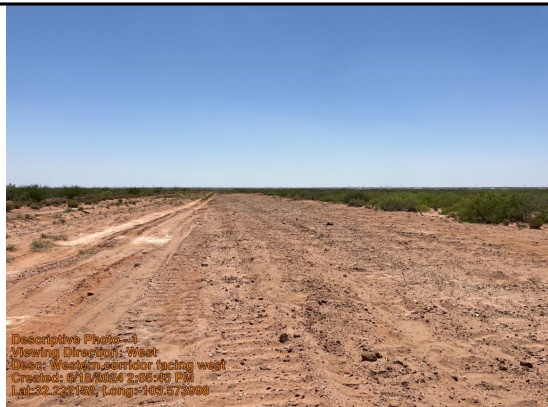
Viewing Direction: West

Western corridor facing west

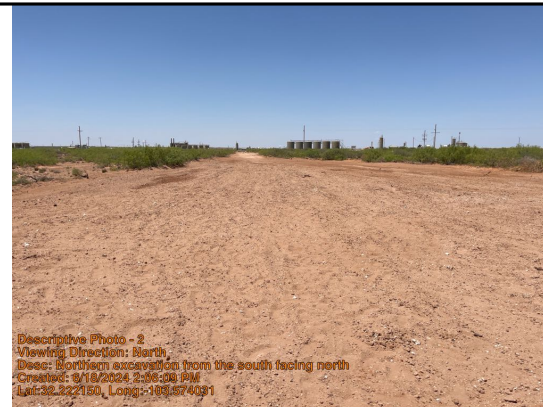
Viewing Direction: North

Northern excavation from the south facing north

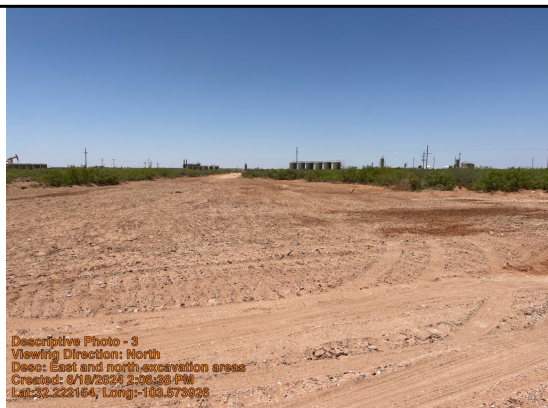
Viewing Direction: North

East and north excavation areas

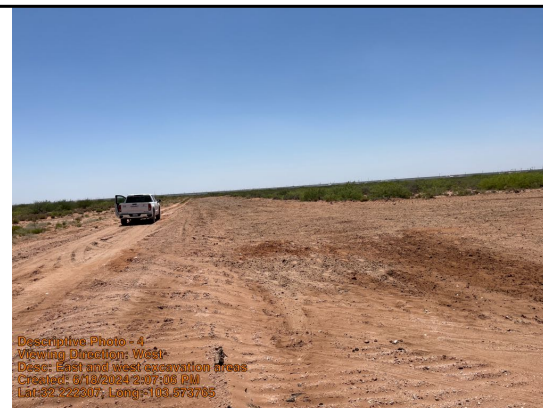
Viewing Direction: West

East and west excavation areas

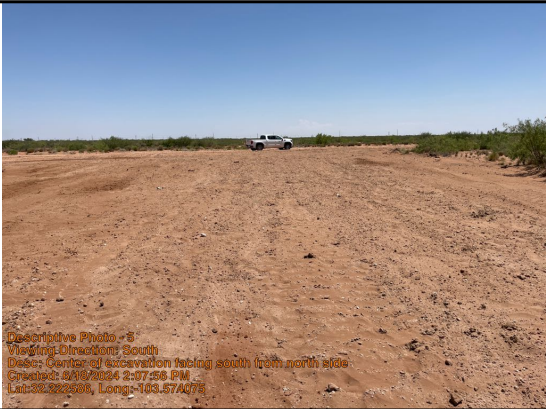
<p>Descriptive Photo - 5 Viewing Direction: South Desc: Center of excavation facing south from north side Created: 6/18/2024 2:07:56 PM Lat:32.222586, Long:-103.574275</p>

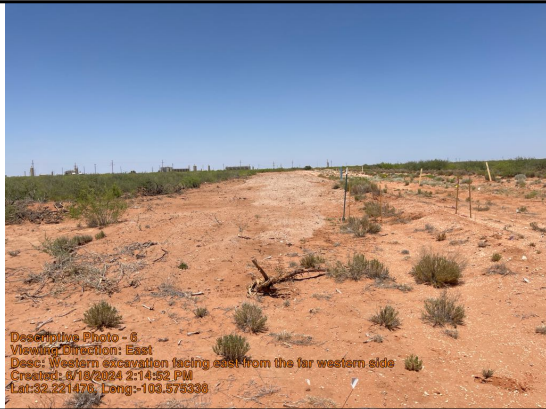
<p>Descriptive Photo - 6 Viewing Direction: East Desc: Western excavation facing east from the far western side Created: 6/18/2024 2:14:52 PM Lat:32.221475, Long:-103.576336</p>
Center of excavation facing south from north side	Western excavation facing east from the far western side
