Incident Number: NAPP2431846528

## Incident Closure

### Brushy Draw 30 – 31 Federal Battery

Vertex File Number: 24E-04918

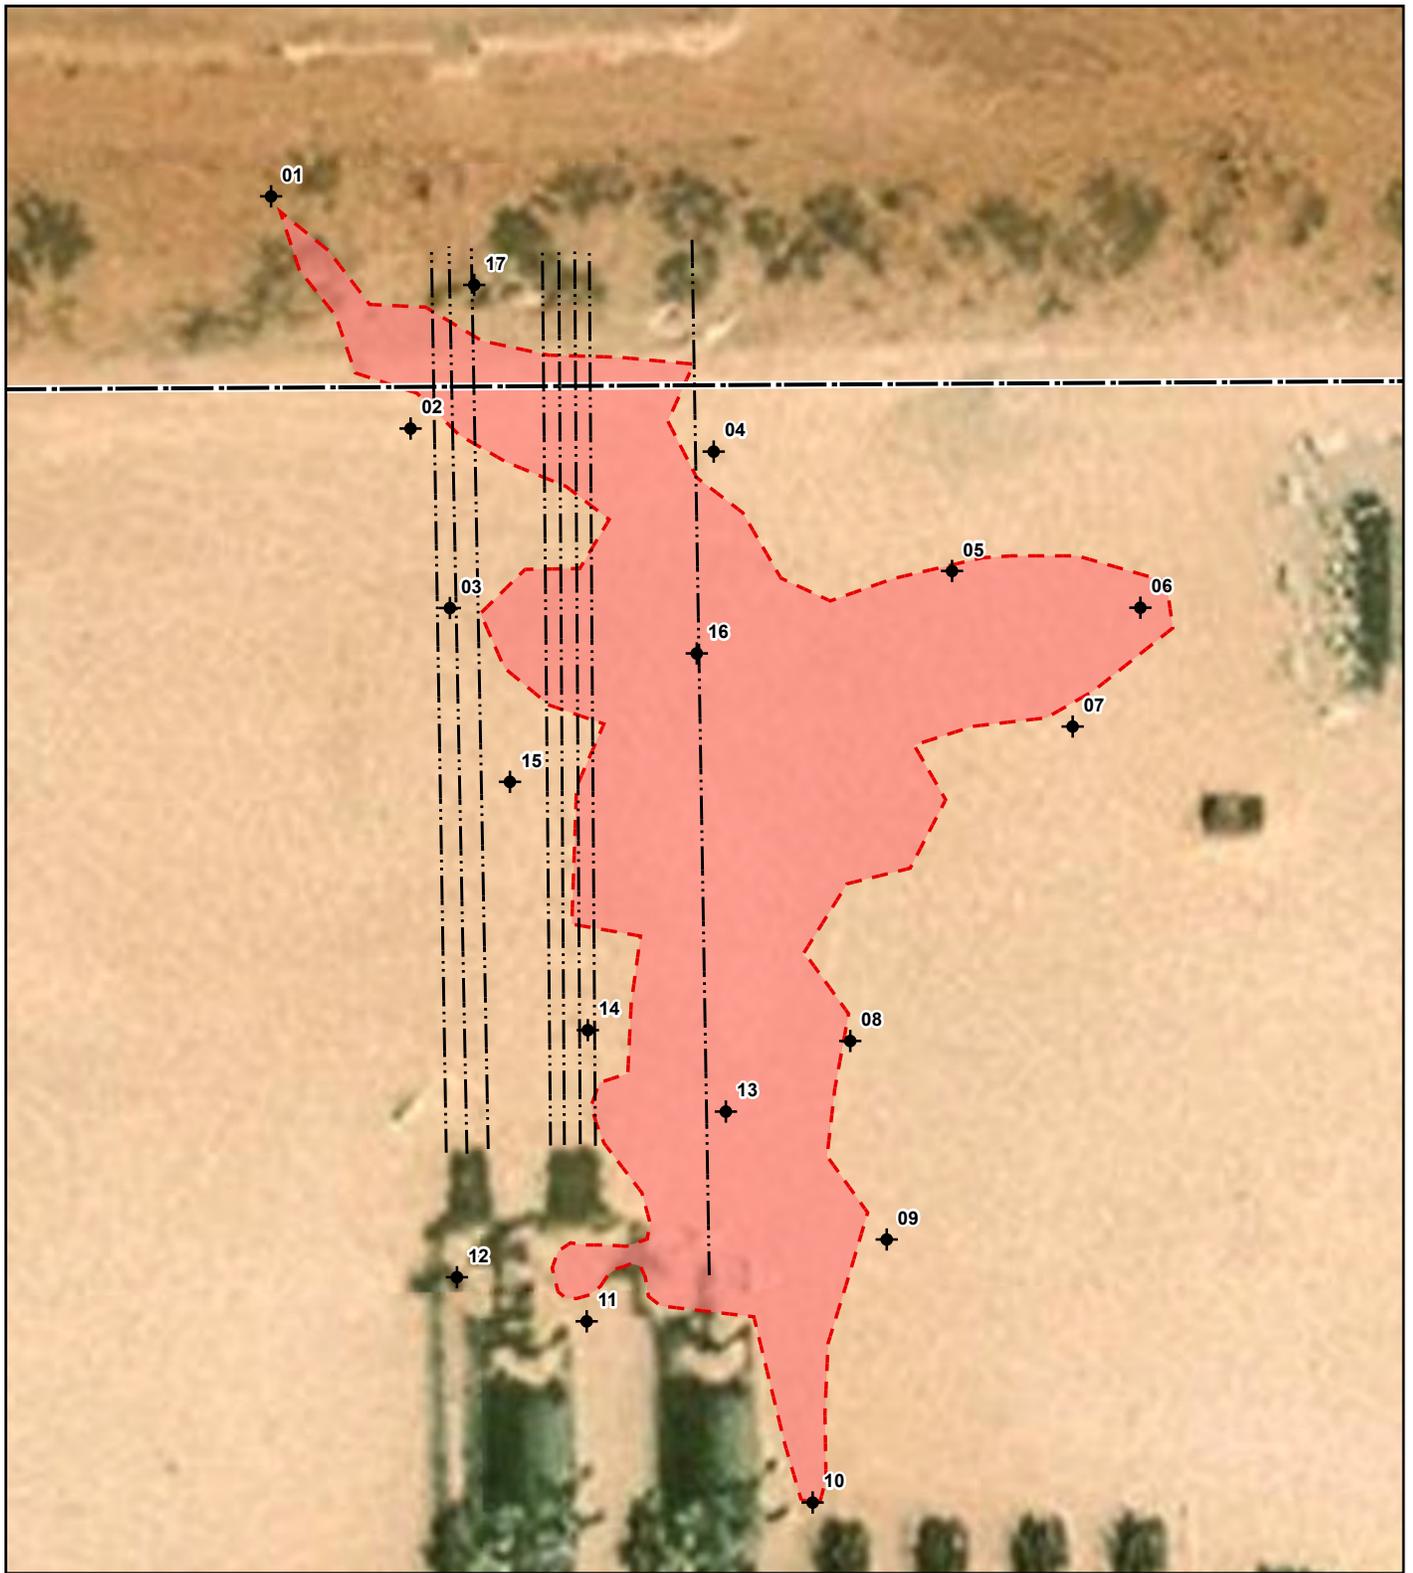
- ◆ Borehole (Prefixed by "BH24-")
- Pipeline (Underground)
- ▭ Release Area (~10,838 sq.ft.)
- ▭ Approximate Lease Boundary

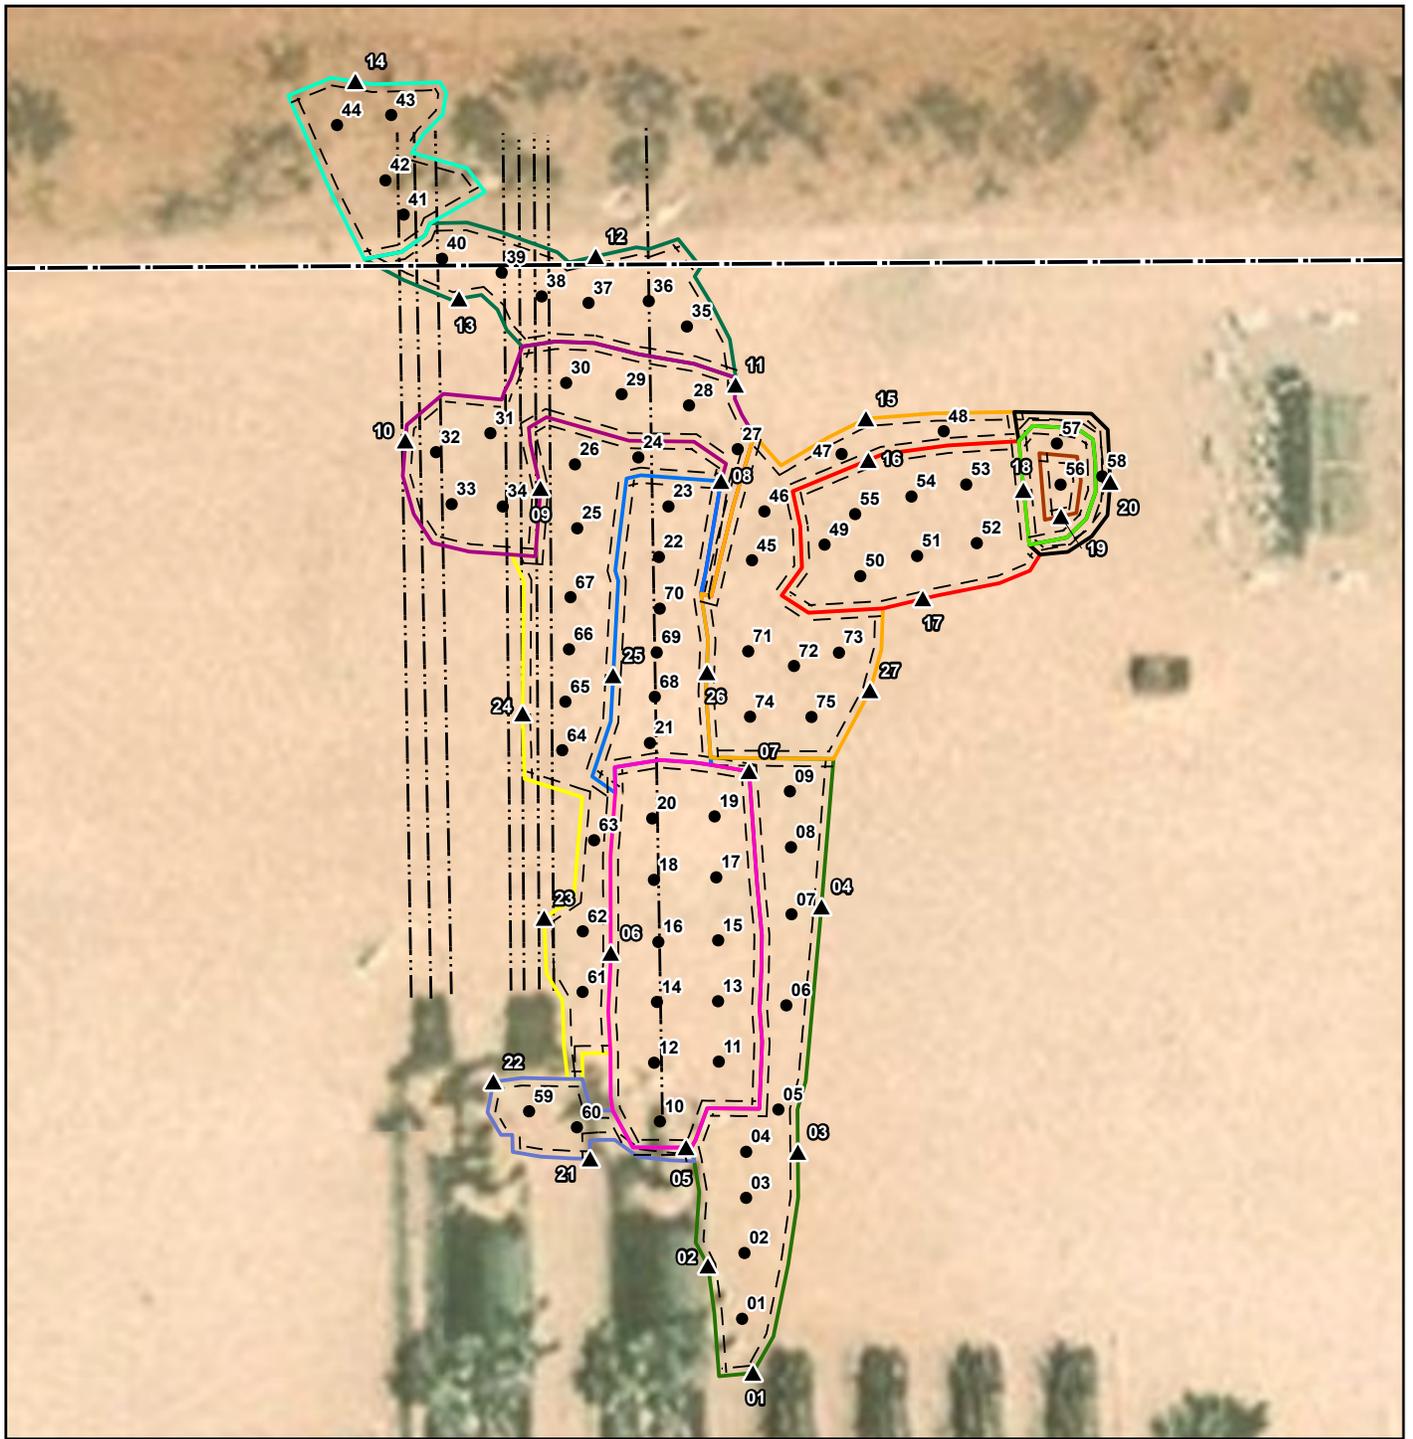
- Base Sample (Prefixed by "BS25-")
- ▲ Wall Sample (Prefixed by "WS25-")
- - - Pipeline (Underground)
- ▭ Approximate Lease Boundary
- ▭ East Excavation to 1.5' bgs (~148 sq.ft. | 107 ft.)
- ▭ East Excavation to 1' bgs (~1,269 sq.ft. | 146 ft.)
- ▭ East Excavation to 2' bgs (~1,633 sq.ft. | 274 ft.)
- ▭ Excavation to 5' bgs (~87 sq.ft. | 38 ft.)
- ▭ Excavation to 6' bgs (~2,065 sq.ft. | 199 ft.)
- ▭ North Excavation to 3' bgs (~1,048 sq.ft. | 164 ft.)
- ▭ North Excavation to 4' bgs (~199 sq.ft. | 66 ft.)
- ▭ Pasture Excavation to 1.5' bgs (~794 sq.ft. | 128 ft.)
- ▭ South Excavation to 3' bgs (~338 sq.ft. | 108 ft.)
- ▭ South Excavation to 4' bgs (~1,681 sq.ft. | 293 ft.)
- ▭ West Excavation to 1.5' bgs (~1,521 sq.ft. | 260 ft.)
- ▭ West Excavation to 1' bgs (~1,102 sq.ft. | 179 ft.)
- ▭ West Excavation to 2' bgs (~1,839 sq.ft. | 339 ft.)

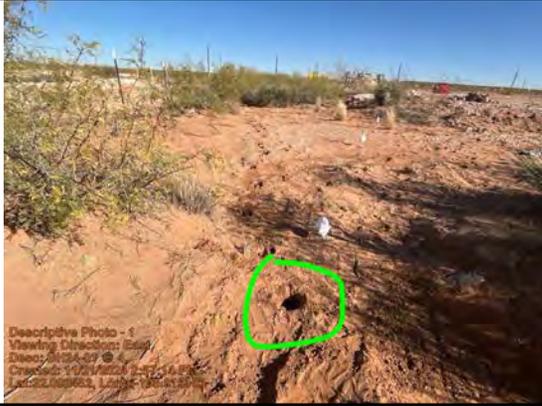
BH24-01 @ 4'

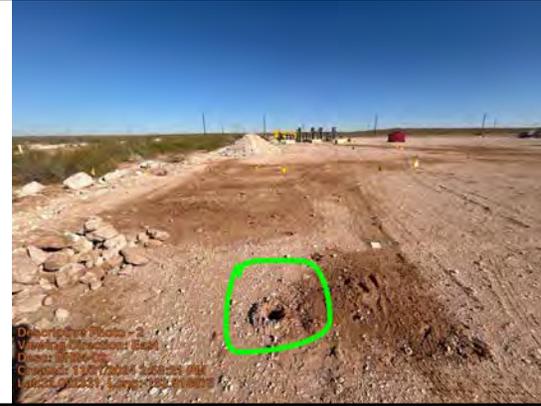
BH24-02 @ 4'

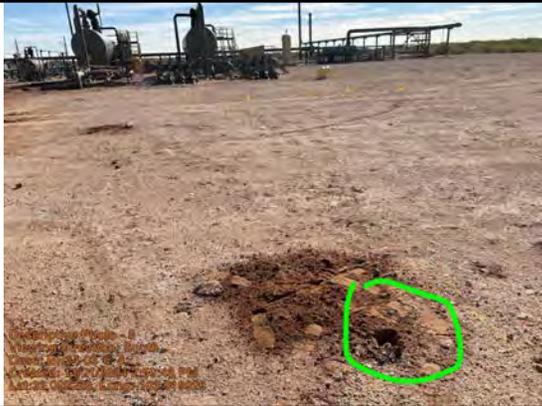
BH24-03 @ 4'

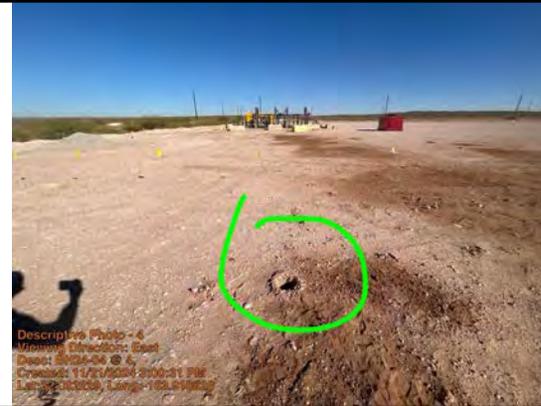
BH24-04 @ 4'

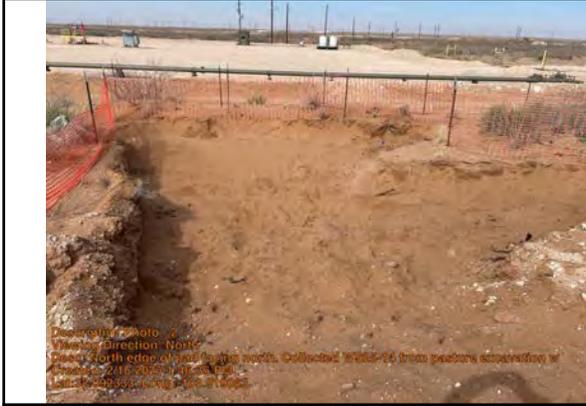
DESCRIPTION: Photo 2  
Viewing Direction: North  
Date: 2/16/2025 10:08:14 AM  
Location: 30-31 CTB  
Latitude: 32.29165 Longitude: -102.91855

North edge of pad facing north. Collected WS25-14 from pasture excavation wall to 1.5 feet bgs.

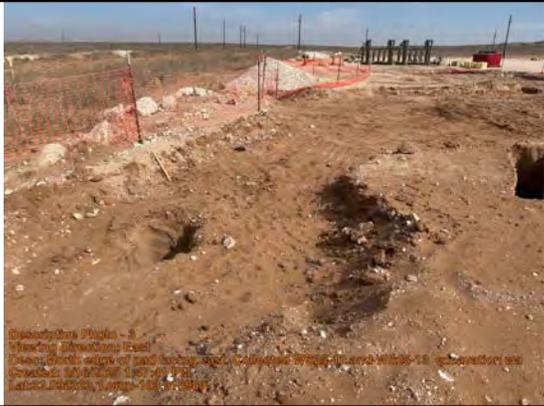
Geospatial Photo - 5  
Viewing Direction: East  
Edge: North edge of pad facing east. Collected WS25-12 and WS25-13 excavation wall to 1 feet bgs.  
Created: 2/17/2025 1:57:47 PM  
Lat: 32.99226, Long: -103.01807

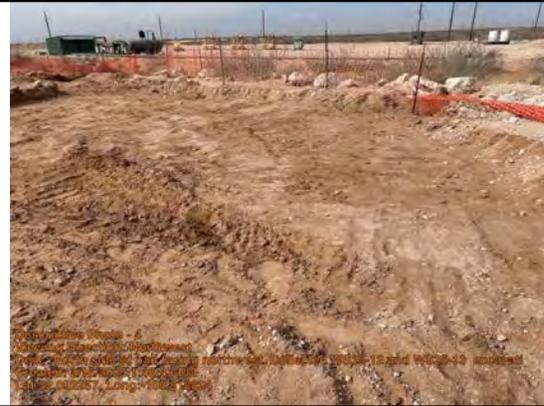
Geospatial Photo - 6  
Viewing Direction: Northwest  
Edge: North side of pad facing northwest. Collected WS25-12 and WS25-13 excavation wall to 1 feet bgs.  
Created: 2/17/2025 1:58:47 PM  
Lat: 32.99227, Long: -103.01807

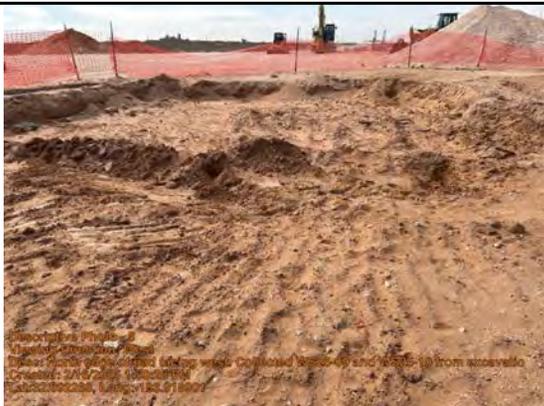
Geospatial Photo - 7  
Viewing Direction: West  
Edge: North side of pad facing west. Collected WS25-09 and WS25-10 from excavation walls to 2 and 1.5 feet bgs.  
Created: 2/17/2025 1:59:29 PM  
Lat: 32.99226, Long: -103.01807

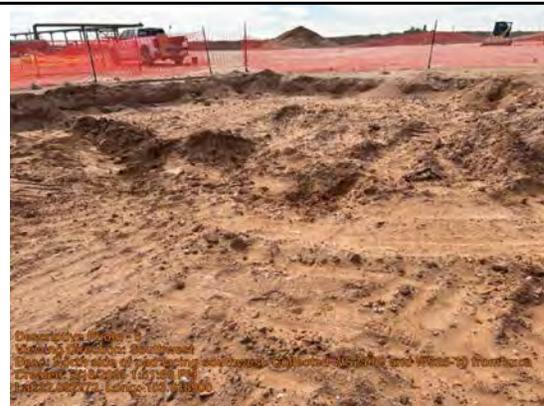
Geospatial Photo - 8  
Viewing Direction: Southwest  
Edge: North side of pad facing southwest. Collected WS25-09 and WS25-10 from excavation walls to 2 and 1.5 feet bgs.  
Created: 2/17/2025 1:59:47 PM  
Lat: 32.99227, Long: -103.01807

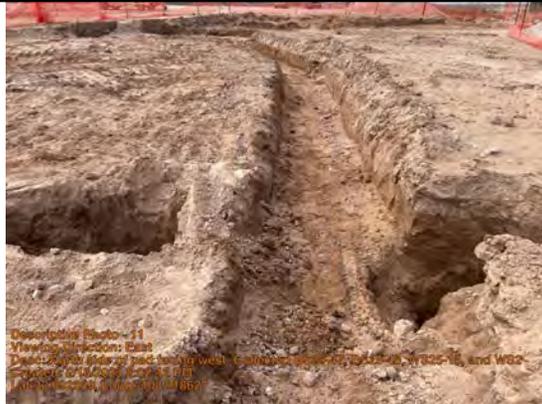
North side of pad facing west. Collected BS25-47, BS25-48, WS25-15, and WS25-16 from excavation to 2 feet bgs.

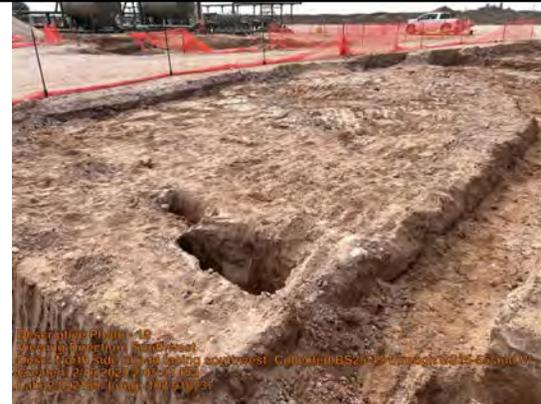
North side of pad facing southwest. Collected BS25-49 through BS25-55 and WS25-17 from excavation to 1 feet bgs.

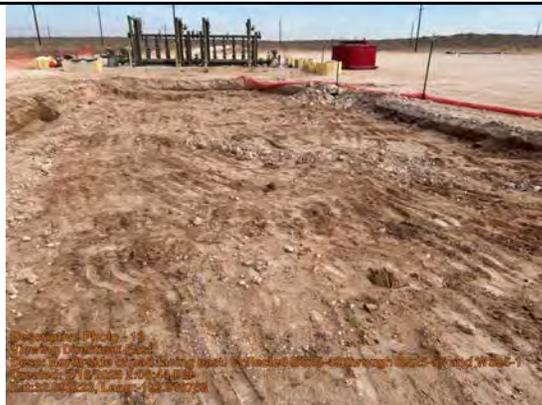
North side of pad facing east. Collected BS25-49 through BS25-55 and WS25-17 from excavation to 1 feet bgs.

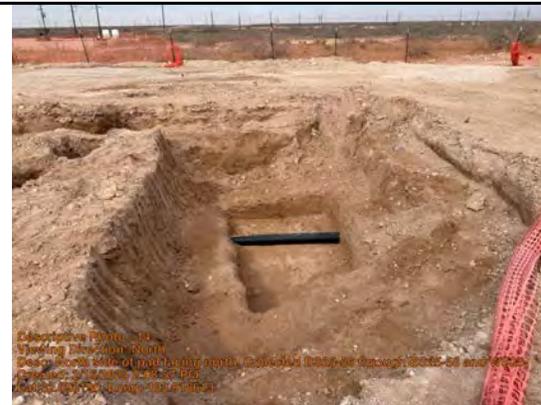
North side of pad facing north. Collected BS25-56 through BS25-58 and WS25-18 through WS25-20 from excavations to 1.5, 4, and 5 feet bgs.

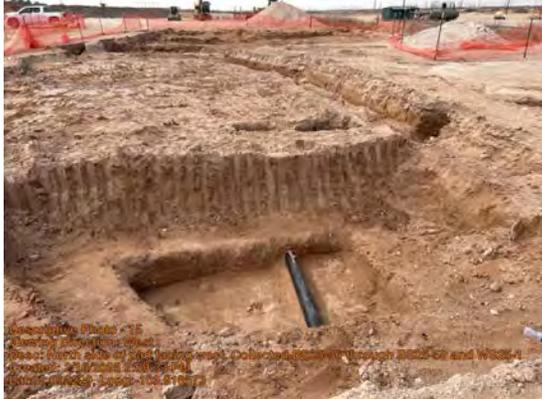
North side of pad facing west. Collected BS25-56 through BS25-58 and WS25-18 through WS25-20 from excavations to 1.5, 4, and 5 feet bgs.

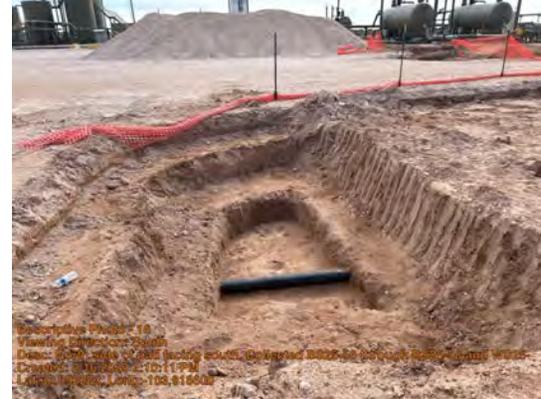
North side of pad facing south. Collected BS25-56 through BS25-58 and WS25-18 through WS25-20 from excavations to 1.5, 4, and 5 feet bgs.

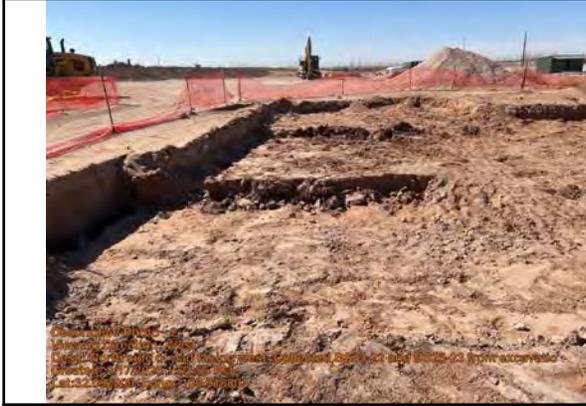
Descriptive Photo:  
Viewing Direction: West  
Date: 03/05/2025 7:44:30 AM  
Location: 30-31 CTB  
Latitude: 32.09185 Longitude: -103.918555

North side of pad facing west. Collected BS25-22 and BS25-23 from excavation to 3 feet bgs.

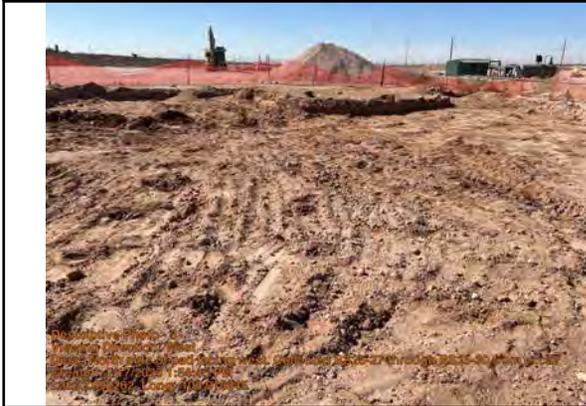
Descriptive Photo:  
Viewing Direction: West  
Date: 03/05/2025 7:44:30 AM  
Location: 30-31 CTB  
Latitude: 32.09185 Longitude: -103.918555

North side of pad facing west. Collected BS25-27 through BS25-30 from excavation to 1.5 feet bgs.

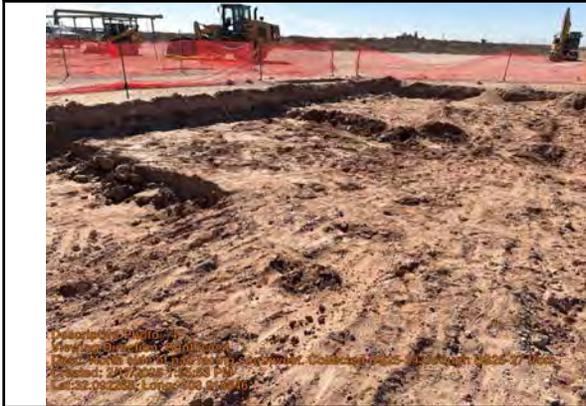
Descriptive Photo:  
Viewing Direction: Southwest  
Date: 03/05/2025 7:44:30 AM  
Location: 30-31 CTB  
Latitude: 32.09185 Longitude: -103.918555

North side of pad facing southwest. Collected BS25-24 through BS25-27 from excavation to 2 feet bgs.

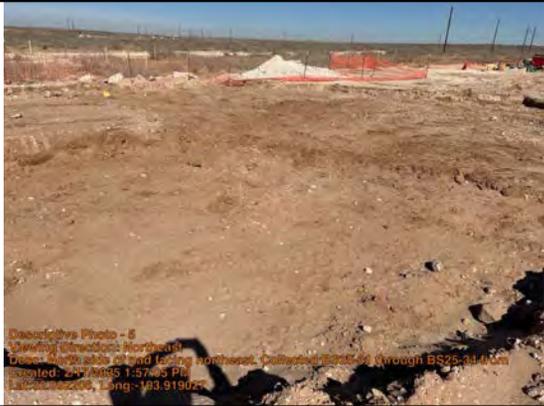
Descriptive Photo - 5  
Viewing Direction: Northeast  
Date: North side of pad facing northeast. Collected BS25-31 through BS25-34 from excavation to 1.5 feet bgs.  
Created: 2/17/2025 1:57:03 PM  
Lat: 33.092296, Long: -103.919078

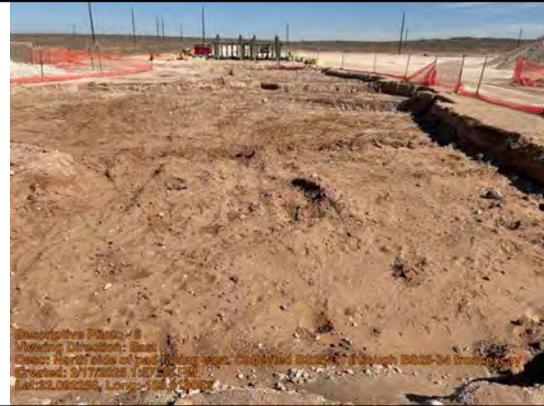
Descriptive Photo - 6  
Viewing Direction: East  
Date: North side of pad facing east. Collected BS25-31 through BS25-34 from excavation to 1.5 feet bgs.  
Created: 2/17/2025 1:57:52 PM  
Lat: 33.092296, Long: -103.919078

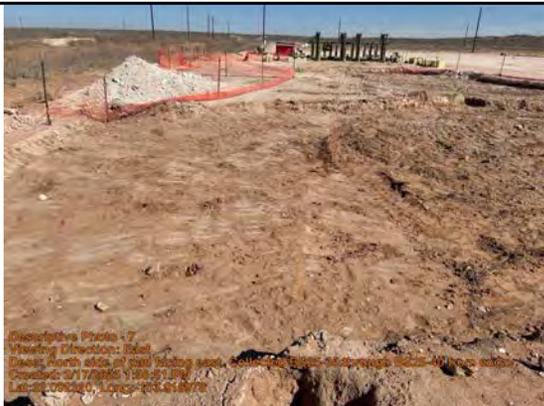
Descriptive Photo - 7  
Viewing Direction: East  
Date: North side of pad facing east. Collected BS25-35 through BS25-40 from excavation to 1 feet bgs.  
Created: 2/17/2025 1:58:51 PM  
Lat: 33.092296, Long: -103.919078

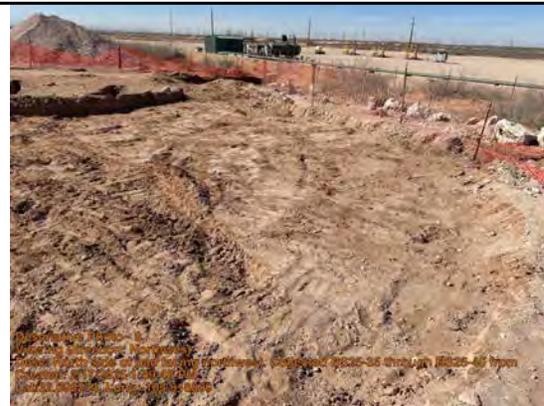
Descriptive Photo - 8  
Viewing Direction: Northwest  
Date: North side of pad facing northwest. Collected BS25-35 through BS25-40 from excavation to 1 feet bgs.  
Created: 2/17/2025 1:59:40 PM  
Lat: 33.092296, Long: -103.919078

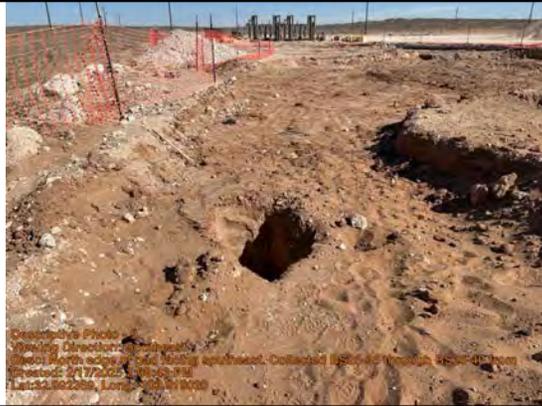
Descriptive Photo - 9  
Viewing Direction: Southeast  
View: North edge of pad facing southeast. Collected BS25-35 through BS25-40 from excavation to 1 feet bgs.  
Created: 2/17/2025 2:03:57 PM  
Lat: 31.92288, Long: -103.91909

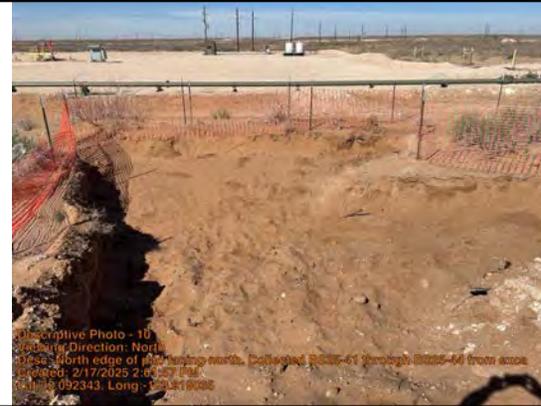
Descriptive Photo - 10  
Viewing Direction: North  
View: North edge of pad facing north. Collected BS25-41 through BS25-44 from excavation in pasture to 1.5 feet bgs.  
Created: 2/17/2025 2:03:57 PM  
Lat: 31.92343, Long: -103.91909

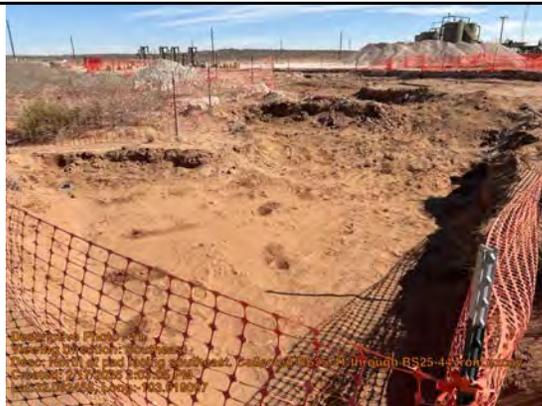
Descriptive Photo - 11  
Viewing Direction: Southeast  
View: North of the pad facing southeast. Collected BS25-45 through BS25-48 from excavation in pasture to 1.5 feet bgs.  
Created: 2/17/2025 2:03:57 PM  
Lat: 31.92288, Long: -103.91909

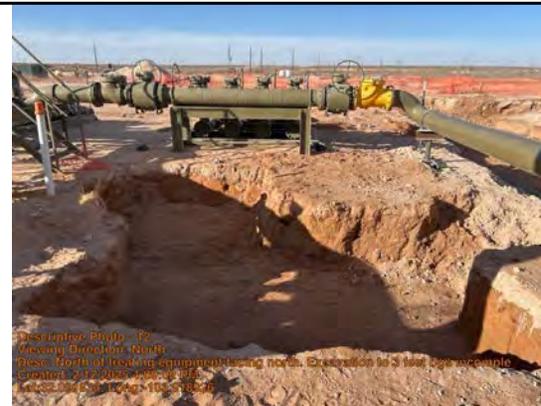
Descriptive Photo - 12  
Viewing Direction: North  
View: North of treating equipment facing north. Excavation to 3 feet bgs incomplete.  
Created: 2/17/2025 2:03:57 PM  
Lat: 31.92343, Long: -103.91909

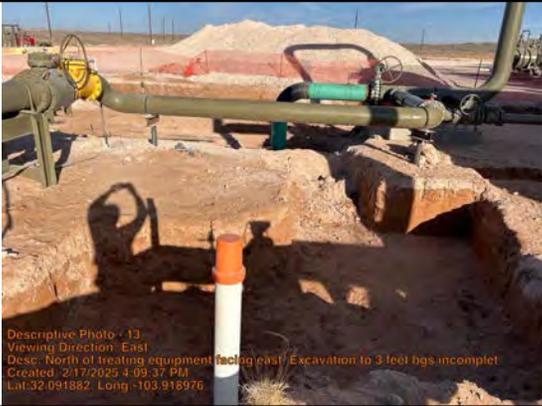
Descriptive Photo - 13  
Viewing Direction - East  
Desc: North of treating equipment facing east. Excavation to 3 feet bgs incomplete.  
Created: 2/17/2025 4:09:37 PM  
Lat: 32.091882, Long: -103.918976

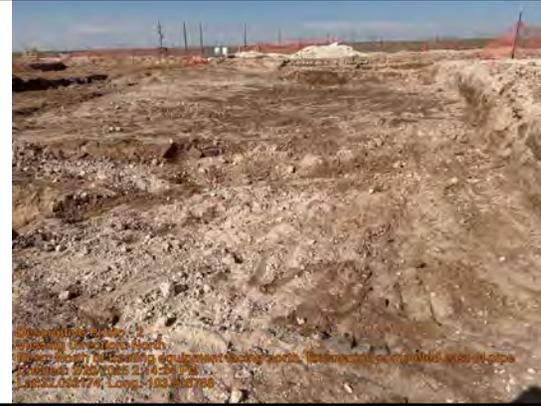
Description Photo - 2  
Viewing Direction: North  
Dist: North of treating equipment facing north. Excavation completed east of pipelines.  
Created: 2/22/2025 2:14:24 PM  
Lat: 32.091774, Long: -103.918798

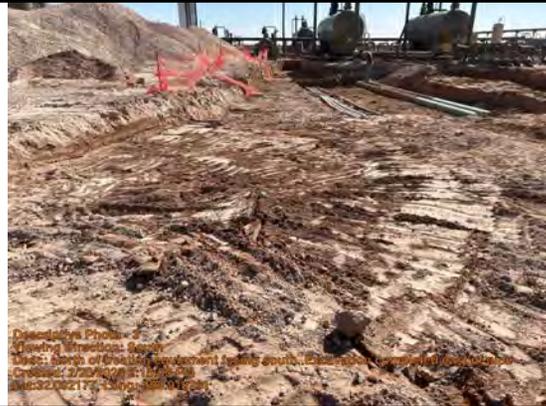
Description Photo - 3  
Viewing Direction: South  
Dist: North of treating equipment facing south. Excavation completed east of pipelines.  
Created: 2/22/2025 11:14:53 AM  
Lat: 32.092177, Long: -103.918798

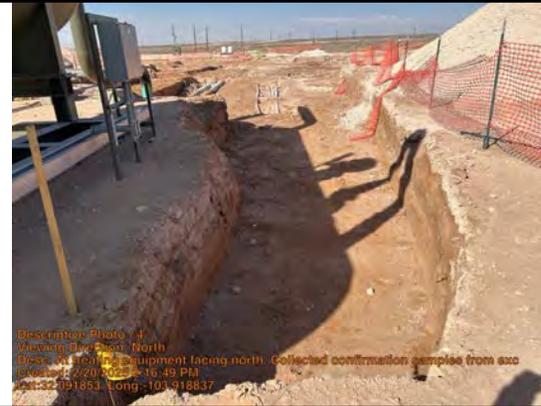
Description Photo - 4  
Viewing Direction: North  
Dist: At treating equipment facing north. Collected confirmation samples from excavations to 4 and 6 feet bgs.  
Created: 2/20/2025 10:16:49 PM  
Lat: 32.091654, Long: -103.918837

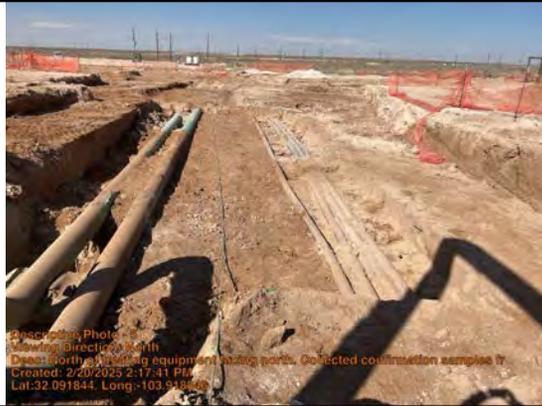
Descriptive Photo:  
Viewing Direction: North  
North of treating equipment facing north. Collected confirmation samples from excavations to 4 and 6 feet bgs.  
Created: 2/20/2025 2:17:41 PM  
Lat:32.091844, Long:-103.91844

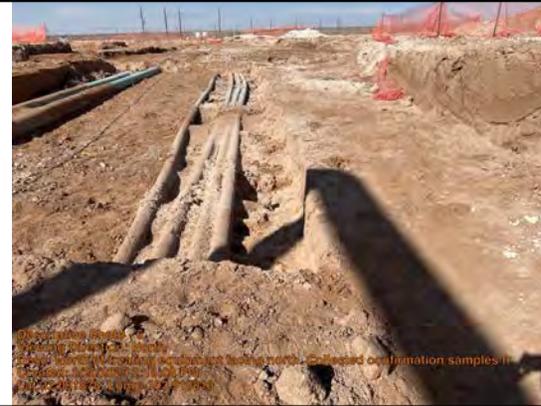
Descriptive Photo:  
Viewing Direction: North  
North of treating equipment facing north. Collected confirmation samples from excavations to 4 and 6 feet bgs.  
Created: 2/20/2025 2:17:41 PM  
Lat:32.091844, Long:-103.91844

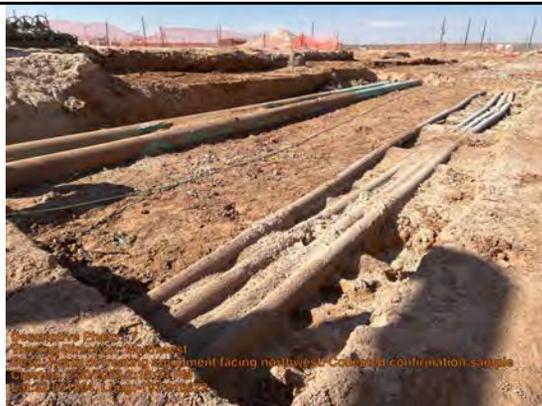
Descriptive Photo:  
Viewing Direction: Northwest  
North of treating equipment facing northwest. Collected confirmation samples from excavations to 4 and 6 feet bgs.  
Created: 2/20/2025 2:17:41 PM  
Lat:32.091844, Long:-103.91844

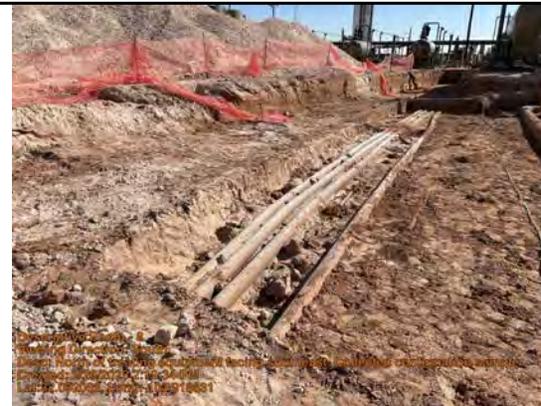
Descriptive Photo:  
Viewing Direction: South  
North of treating equipment facing southeast. Collected confirmation samples from excavations to 4 and 6 feet bgs.  
Created: 2/20/2025 2:17:41 PM  
Lat:32.091844, Long:-103.91844

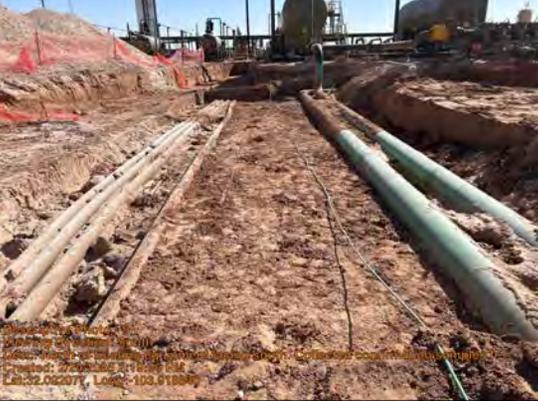
North of treating equipment facing south. Collected confirmation samples from excavations to 4 and 6 feet bgs.

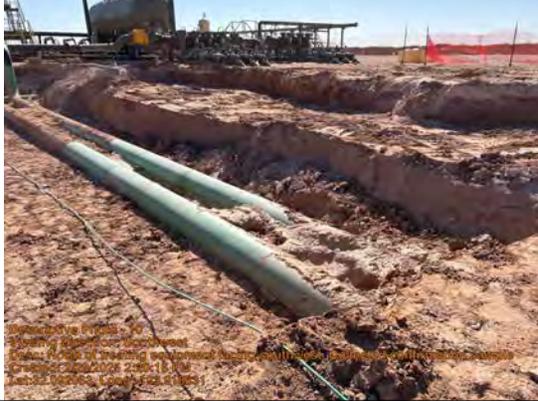
North of treating equipment facing southwest. Collected confirmation samples from excavations to 4 and 6 feet bgs.

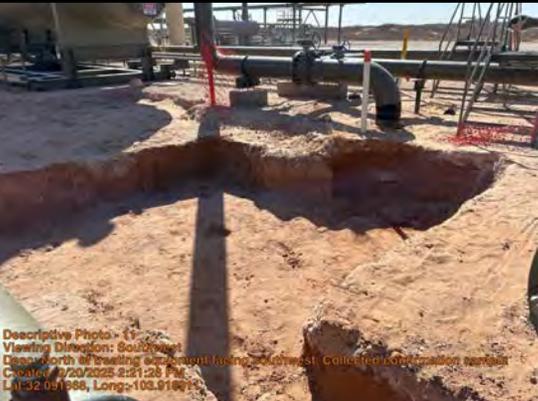
North of treating equipment facing southwest. Collected confirmation samples from excavations to 3 feet bgs between pipes.

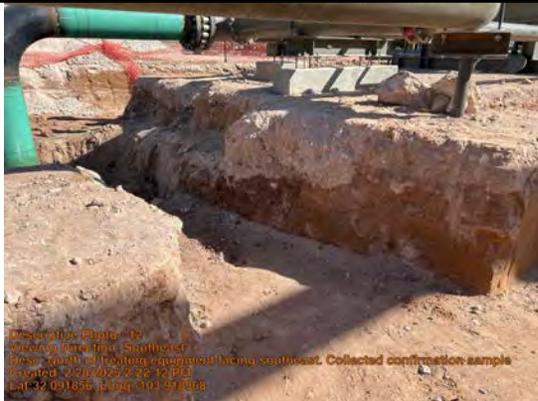
North of treating equipment facing southeast. Collected confirmation samples from excavations to 3 feet bgs between pipes.

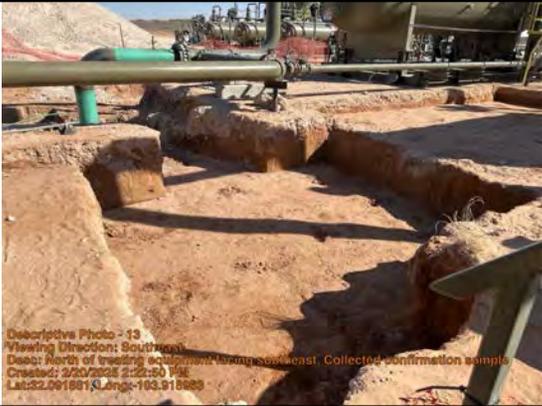
Descriptive Photo - 13  
Viewing Direction: Southeast  
Desc: North of treating equipment facing southeast. Collected confirmation sample  
Created: 2/20/2025 2:22:50 PM  
Lat:32.061881,Long:-103.91888

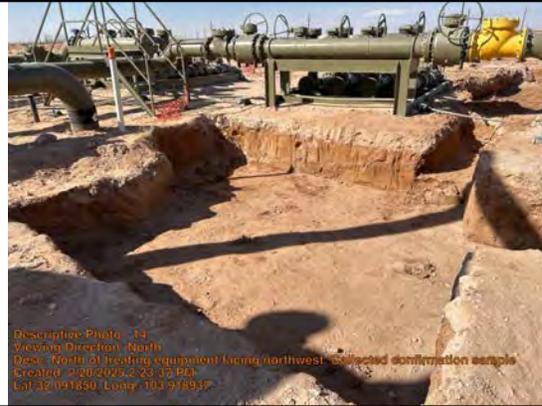
Descriptive Photo - 14  
Viewing Direction: North  
Desc: North of treating equipment facing northwest. Collected confirmation sample  
Created: 2/20/2025 2:23:35 PM  
Lat:32.049850,Long:-103.918937

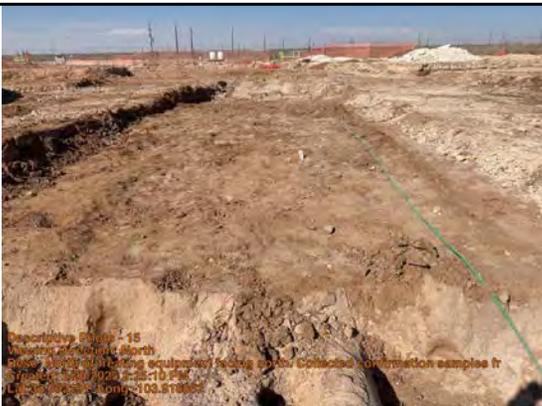
Descriptive Photo - 15  
Viewing Direction: North  
Desc: North of treating equipment facing north. Collected confirmation sample fr  
Created: 2/20/2025 2:25:10 PM  
Lat:32.062337,Long:-103.91888

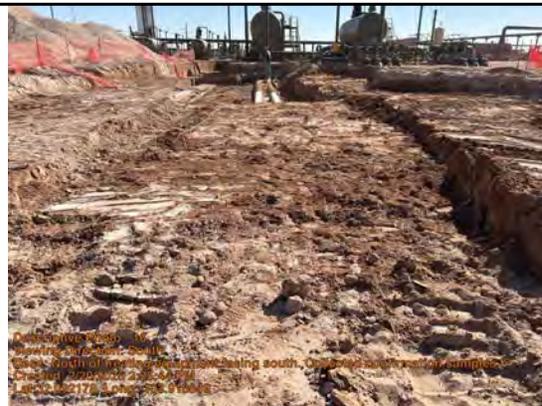
Descriptive Photo - 16  
Viewing Direction: South  
Desc: North of treating equipment facing south. Collected confirmation sample  
Created: 2/20/2025 2:25:44 PM  
Lat:32.062178,Long:-103.91888

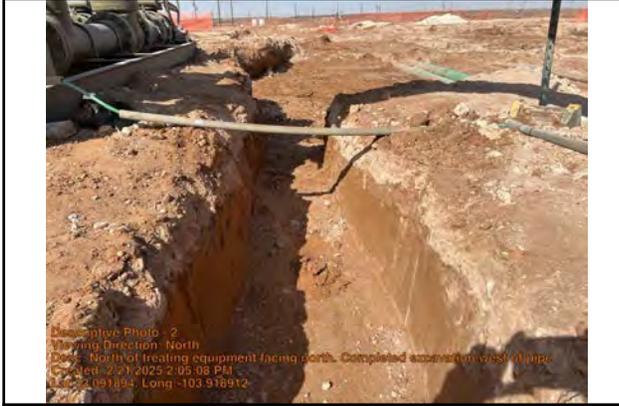
North of treating equipment facing north. Completed excavation west of pipelines to 2 feet bgs.

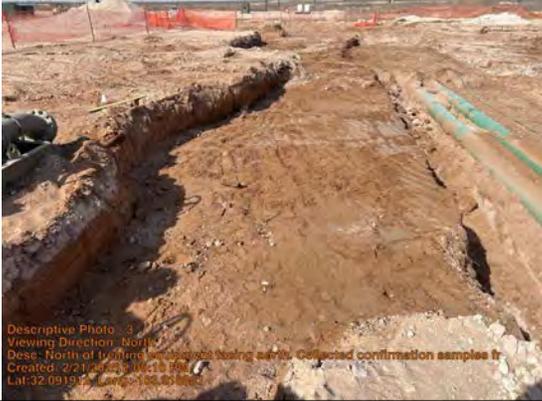
Descriptive Photo  
Viewing Direction: North  
Desc: North of treating equipment facing north. Collected confirmation samples from excavation west of pipelines to 2 feet bgs.  
Created: 2/21/2025 10:18 PM  
Lat:32.091957, Long:-103.518279

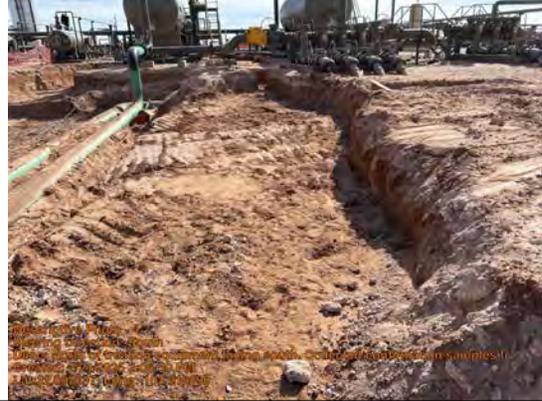
Descriptive Photo  
Viewing Direction: South  
Desc: North of treating equipment facing south. Collected confirmation samples from excavation west of pipelines to 2 feet bgs.  
Created: 2/21/2025 2:06 PM  
Lat:32.092195, Long:-103.518279

North of treating equipment facing south. Collected confirmation samples from excavation west of pipelines to 2 feet bgs.

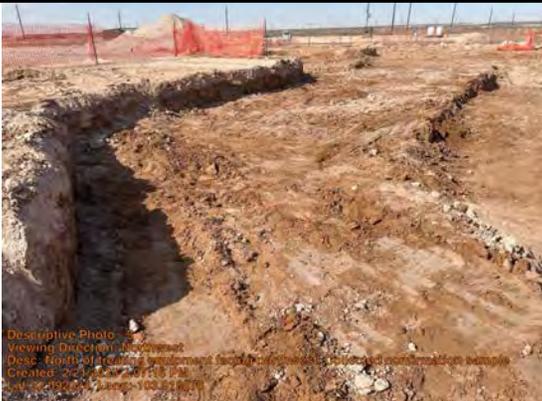
Descriptive Photo  
Viewing Direction: Northwest  
Desc: North of treating equipment facing northwest. Collected confirmation samples from excavation west of pipelines to 2 feet bgs.  
Created: 2/21/2025 10:18 PM  
Lat:32.091957, Long:-103.518279

North of treating equipment facing northwest. Collected confirmation samples from excavation west of pipelines to 2 feet bgs.

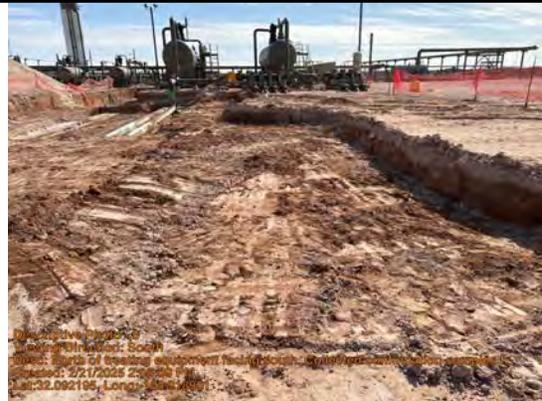
Descriptive Photo  
Viewing Direction: South  
Desc: North of treating equipment facing south. Collected confirmation samples from excavation west of pipelines to 2 feet bgs.  
Created: 2/21/2025 2:06 PM  
Lat:32.092195, Long:-103.518279

North of treating equipment facing south. Collected confirmation samples from excavation west of pipelines to 2 feet bgs.

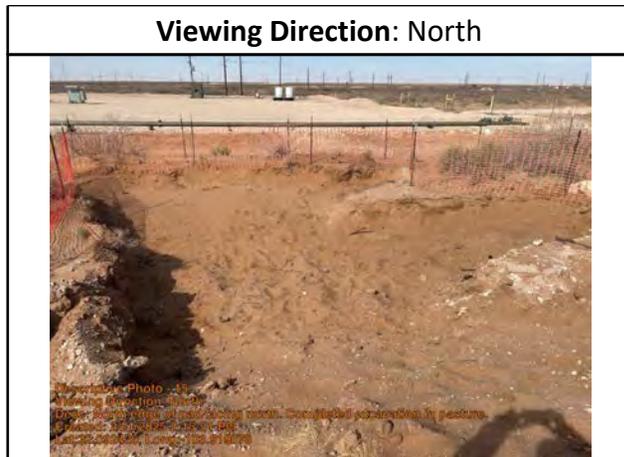
North edge of pad facing north. Completed excavation in pasture.

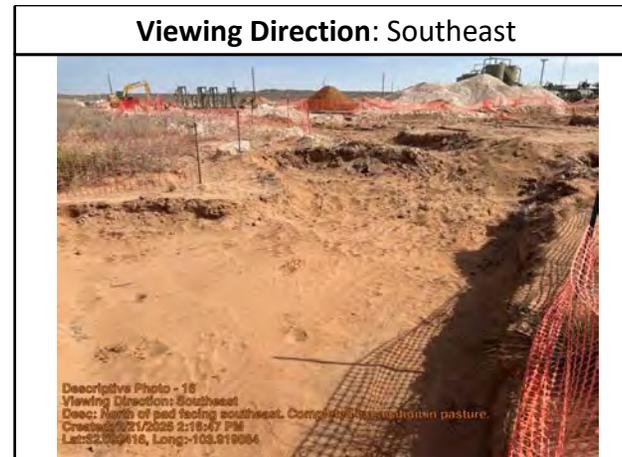
North of pad facing southeast. Completed excavation in pasture.

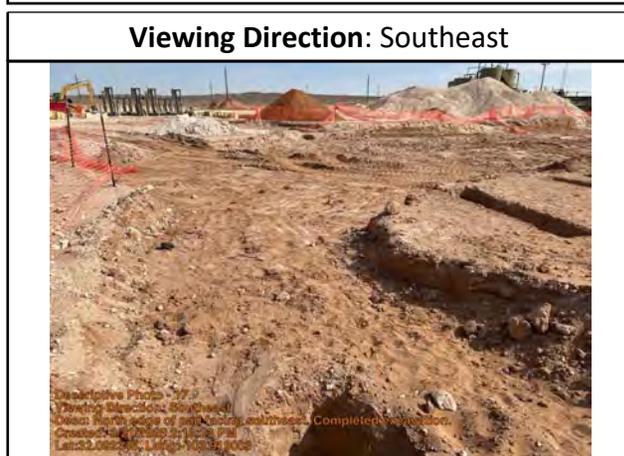
North edge of pad facing southeast. Completed excavation.

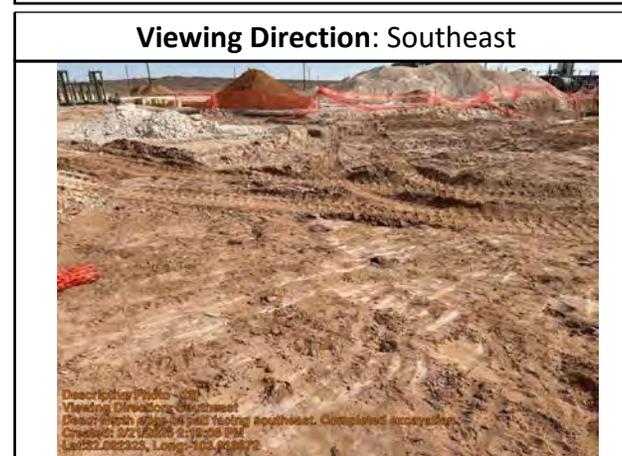
North edge of pad facing southeast. Completed excavation.

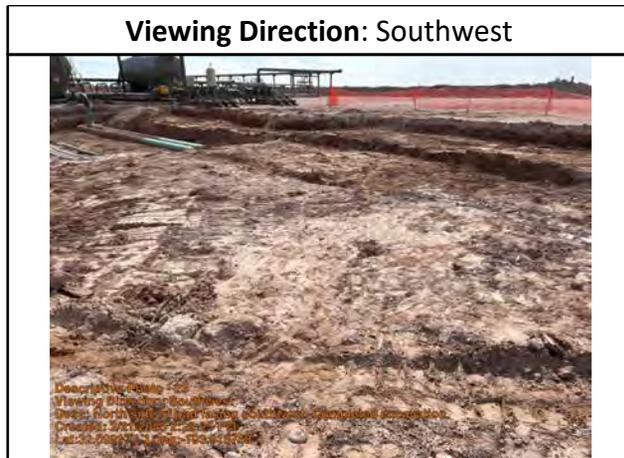
North side of pad facing southwest. Completed excavation.

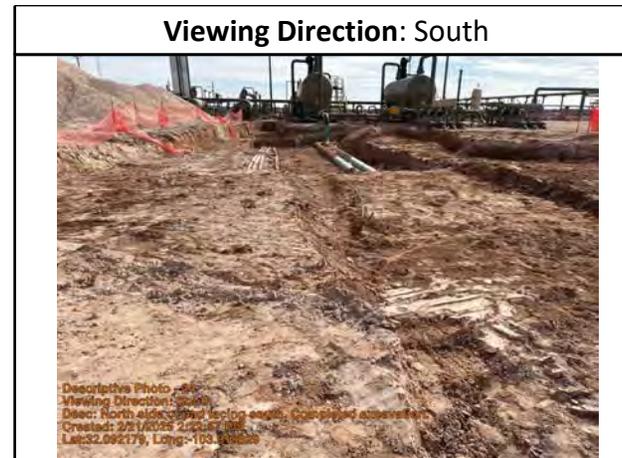
North side of pad facing south. Completed excavation.

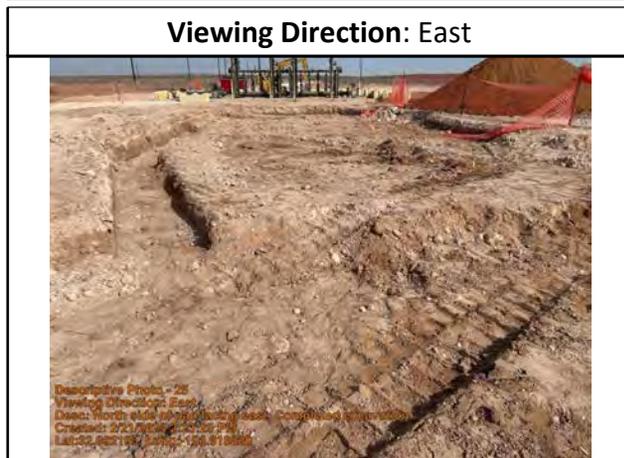
North side of pad facing east. Completed excavation.

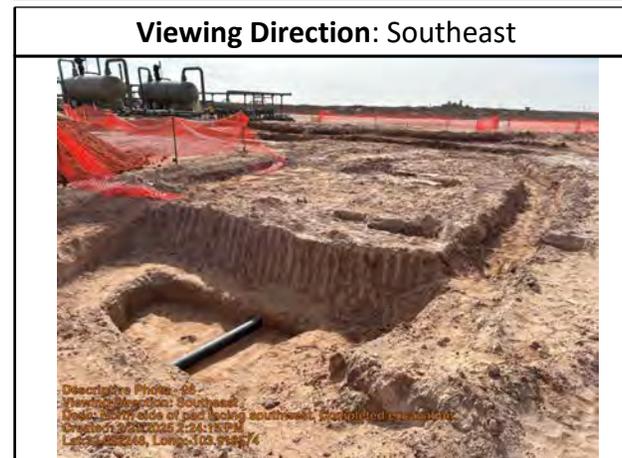
North side of pad facing southwest. Completed excavation.

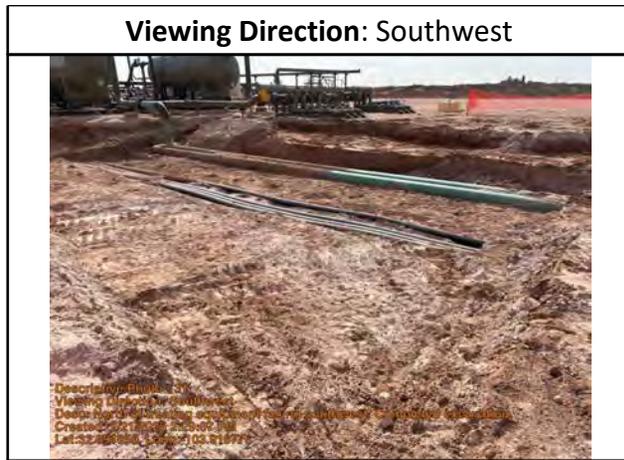
North of treating equipment facing southwest. Completed excavation.

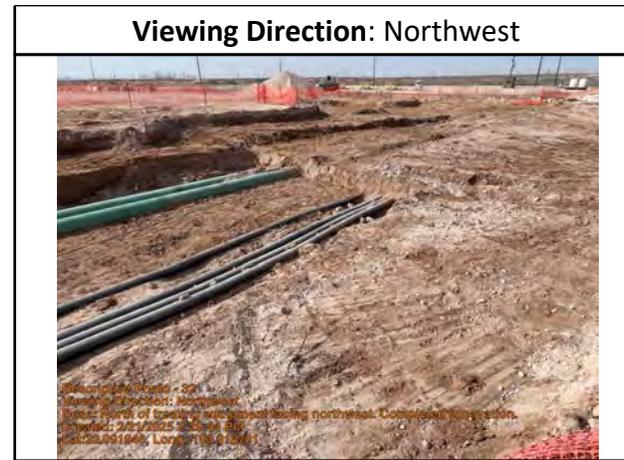
North of treating equipment facing northwest. Completed excavation.

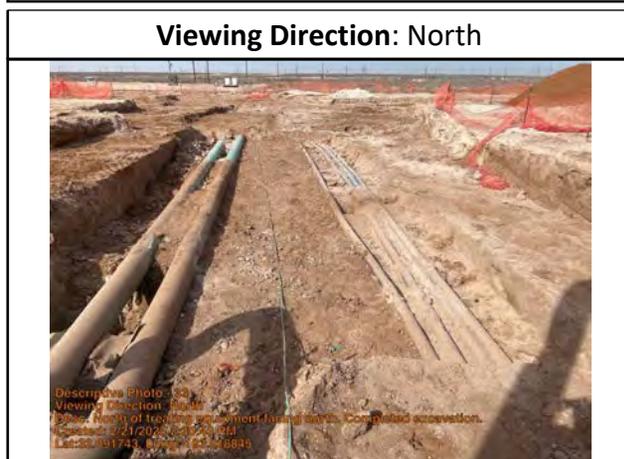
North of treating equipment facing north. Completed excavation.

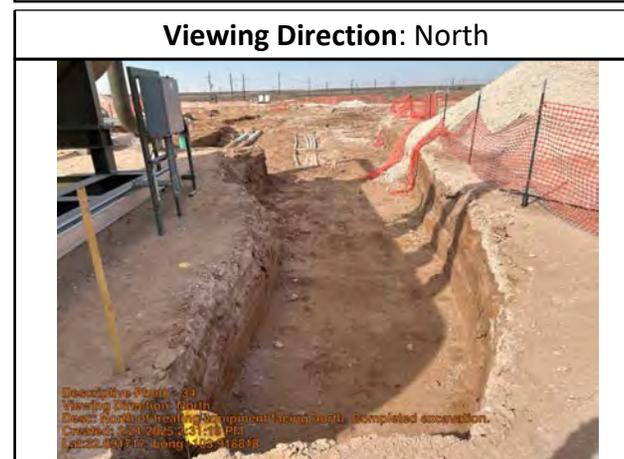
At treating equipment facing north. Completed excavation.

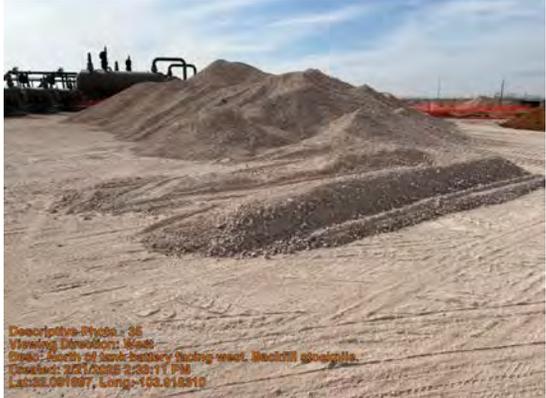
Descriptive Photo - 35  
Viewing Direction: West  
Date: North of tank battery facing west. Backfill stockpile.  
Created: 2/21/2025 2:33:17 PM  
Lat:32.061897, Long:-103.016910

North of tank battery facing west. Backfill stockpile.

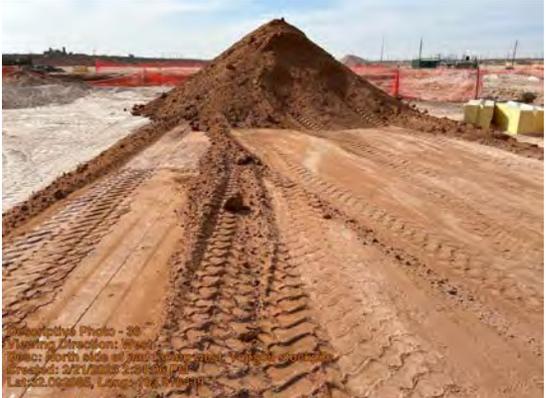
Descriptive Photo - 36  
Viewing Direction: West  
Date: North side of pad facing west. Topsoil stockpile.  
Created: 2/21/2025 2:34:00 PM  
Lat:32.062005, Long:-103.016910

North side of pad facing west. Topsoil stockpile.
