Environmental Site Remediation Work Plan

Date: 3/14/2025

Site Location: Laguna Salado 22 Federal #004H

Project #: 23E-01414-01

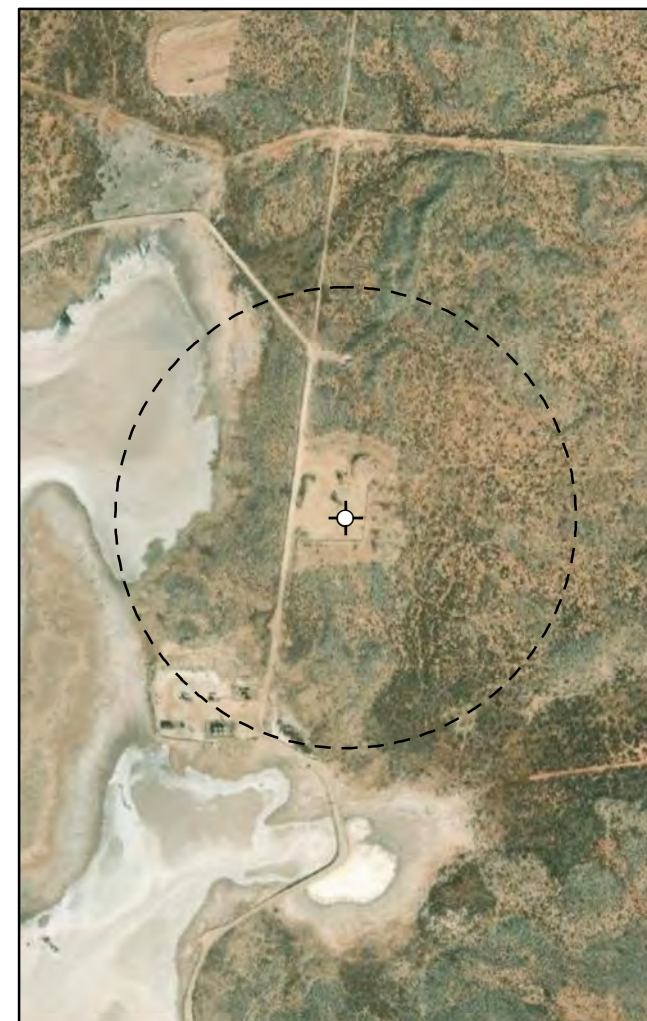
Karst Potential

- Critical
- High
- Medium
- Low

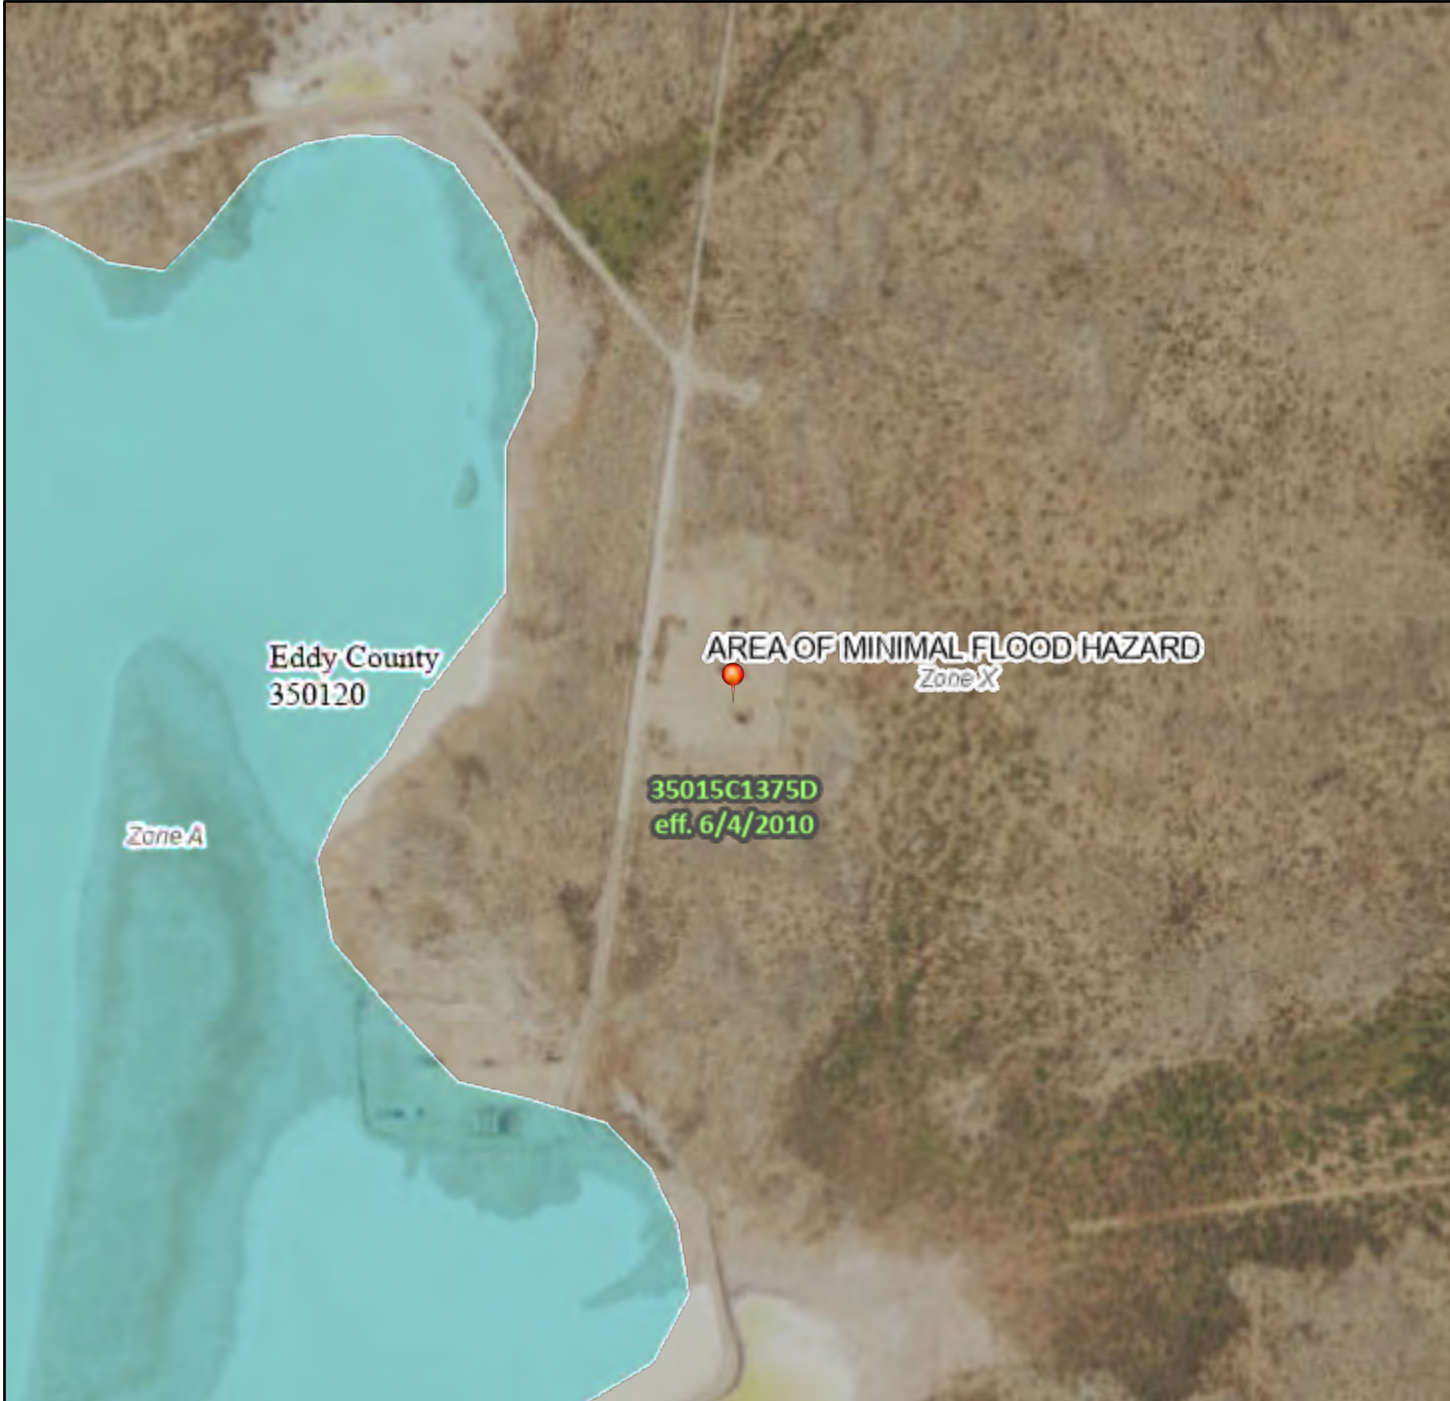
National Flood Hazard Layer FIRMette

The flood hazard information is derived directly from the authoritative NFHL web services provided by FEMA. This map was exported on 3/21/2023 at 1:35 PM and does not reflect changes or amendments subsequent to this date and time. The NFHL and effective information may change or become superseded by new data over time.

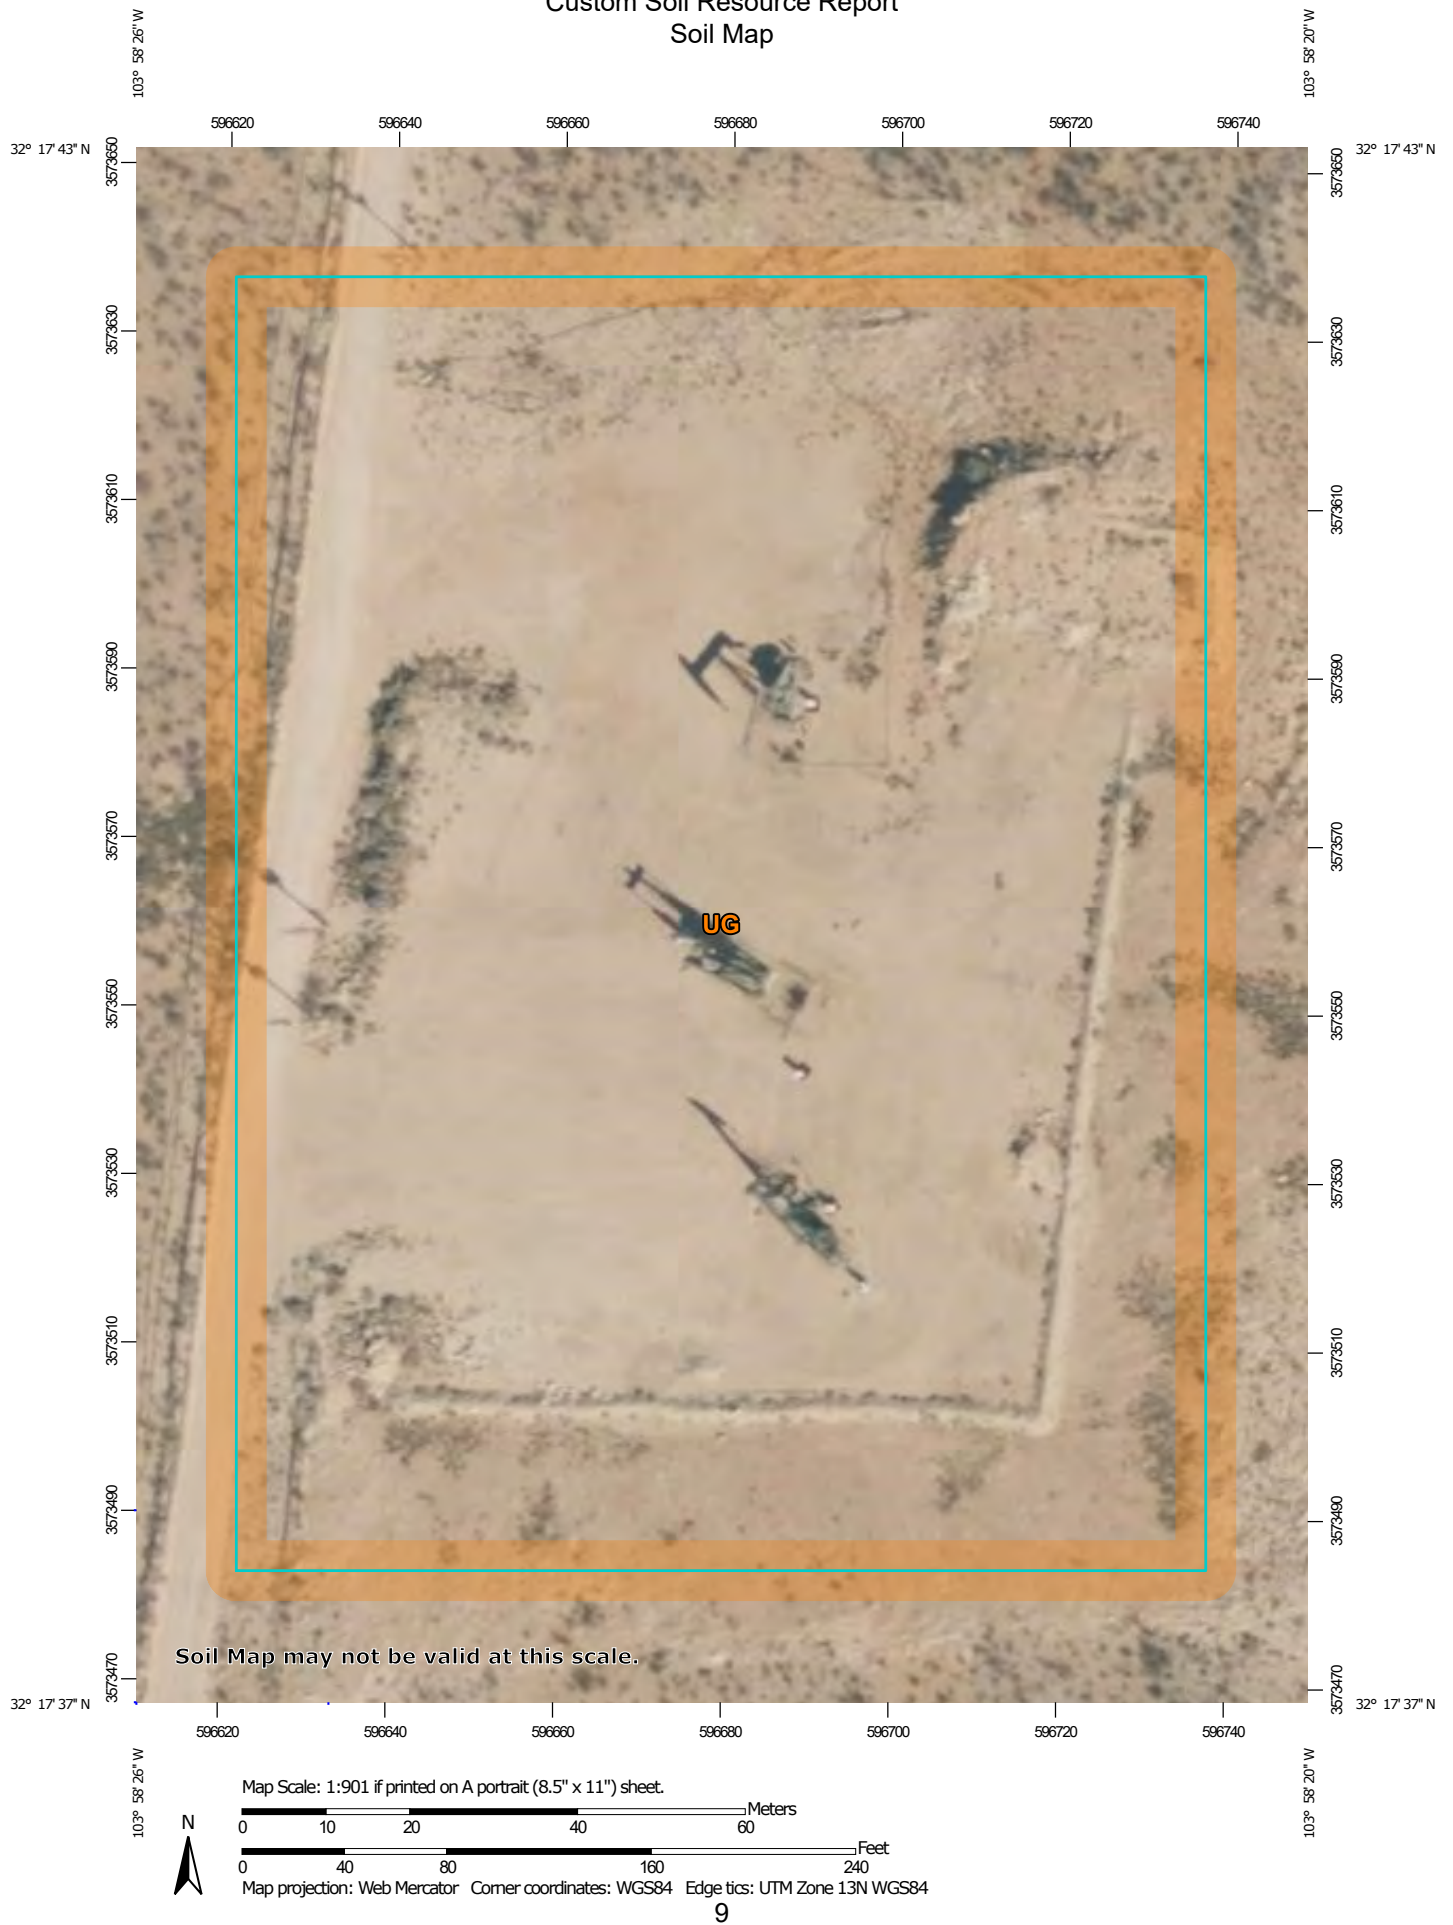
Custom Soil Resource Report Soil Map

The soil map section includes the soil map for the defined area of interest, a list of soil map units on the map and extent of each map unit, and cartographic symbols displayed on the map. Also presented are various metadata about data used to produce the map, and a description of each soil map unit.

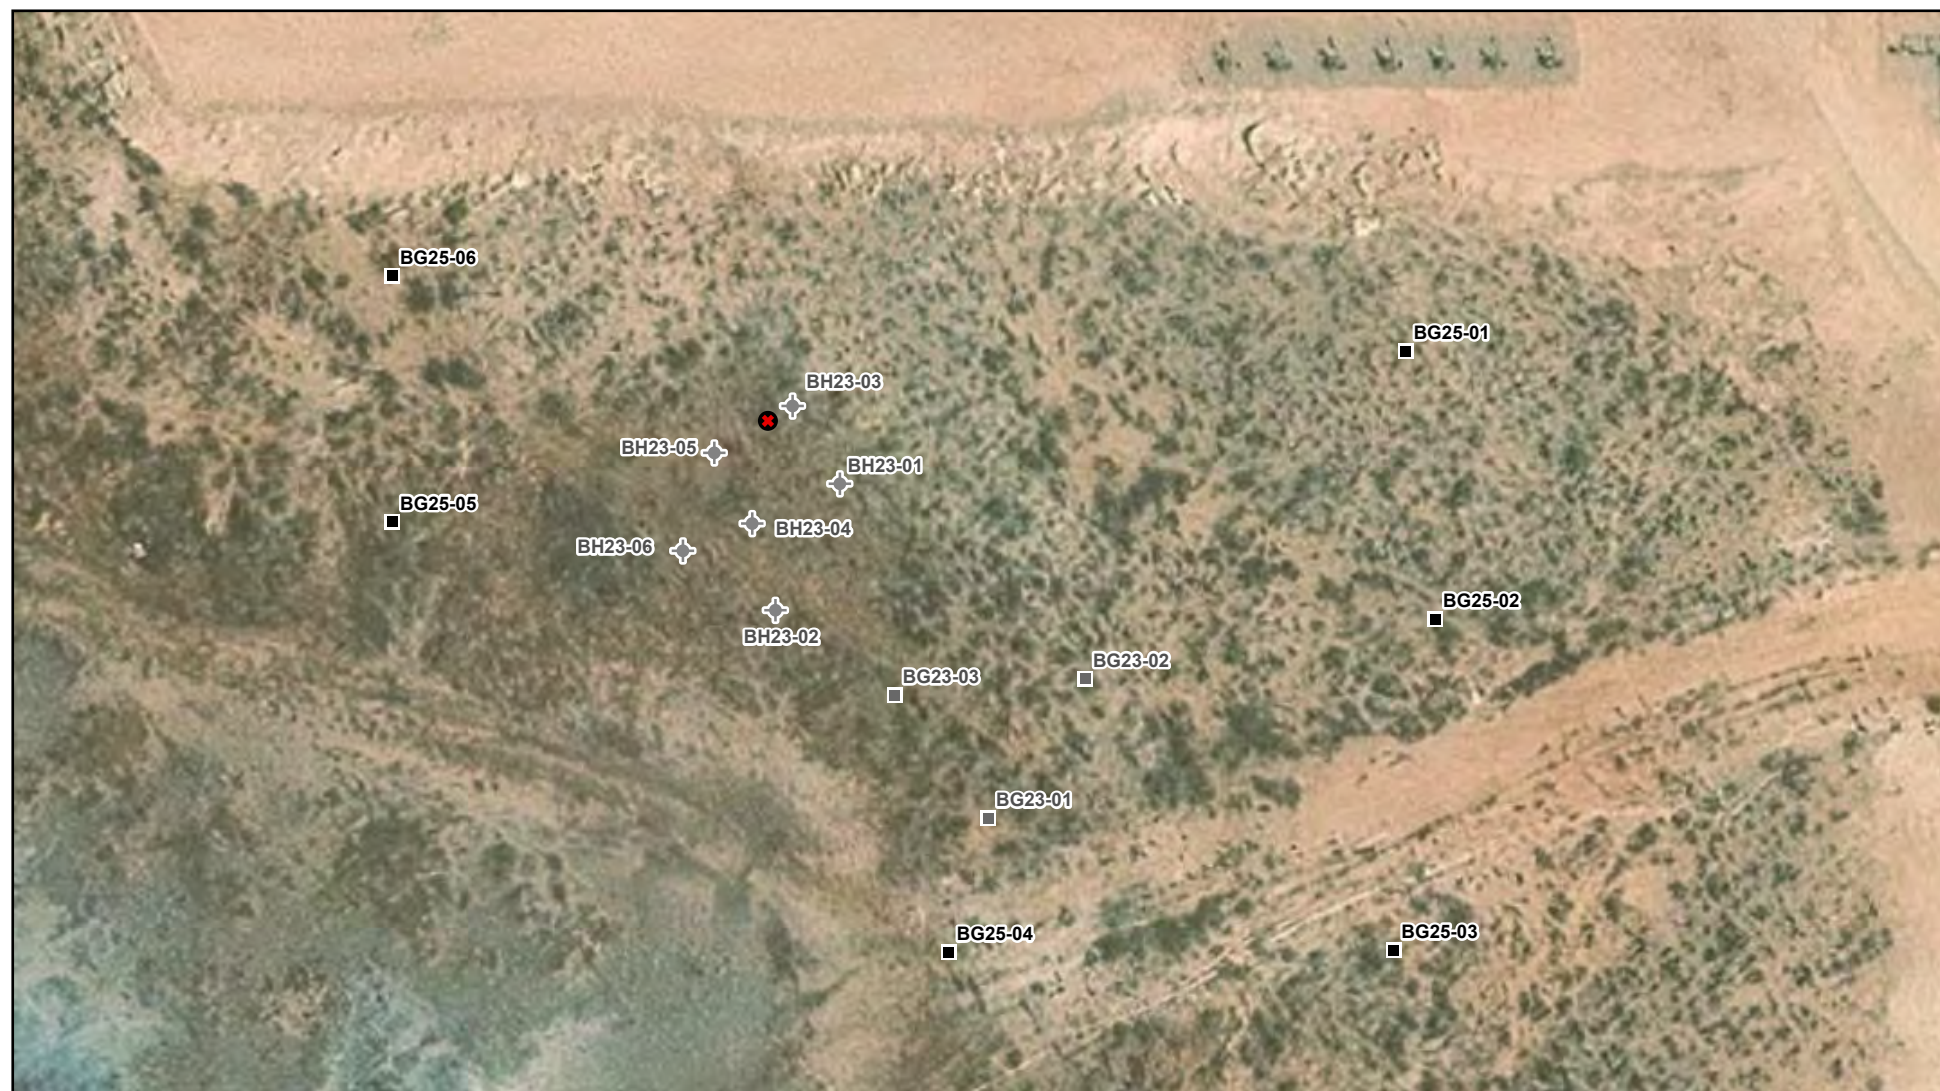
ATTACHMENT 3

- 2025 Background Sample
- 2023 Background Sample
- ✚ 2023 Borehole
- ★ Release Point

Note: Georeferenced image from Esri, 2024. Site features from GPS by Vertex Professional Services Ltd. (Vertex), 2023 and 2025.

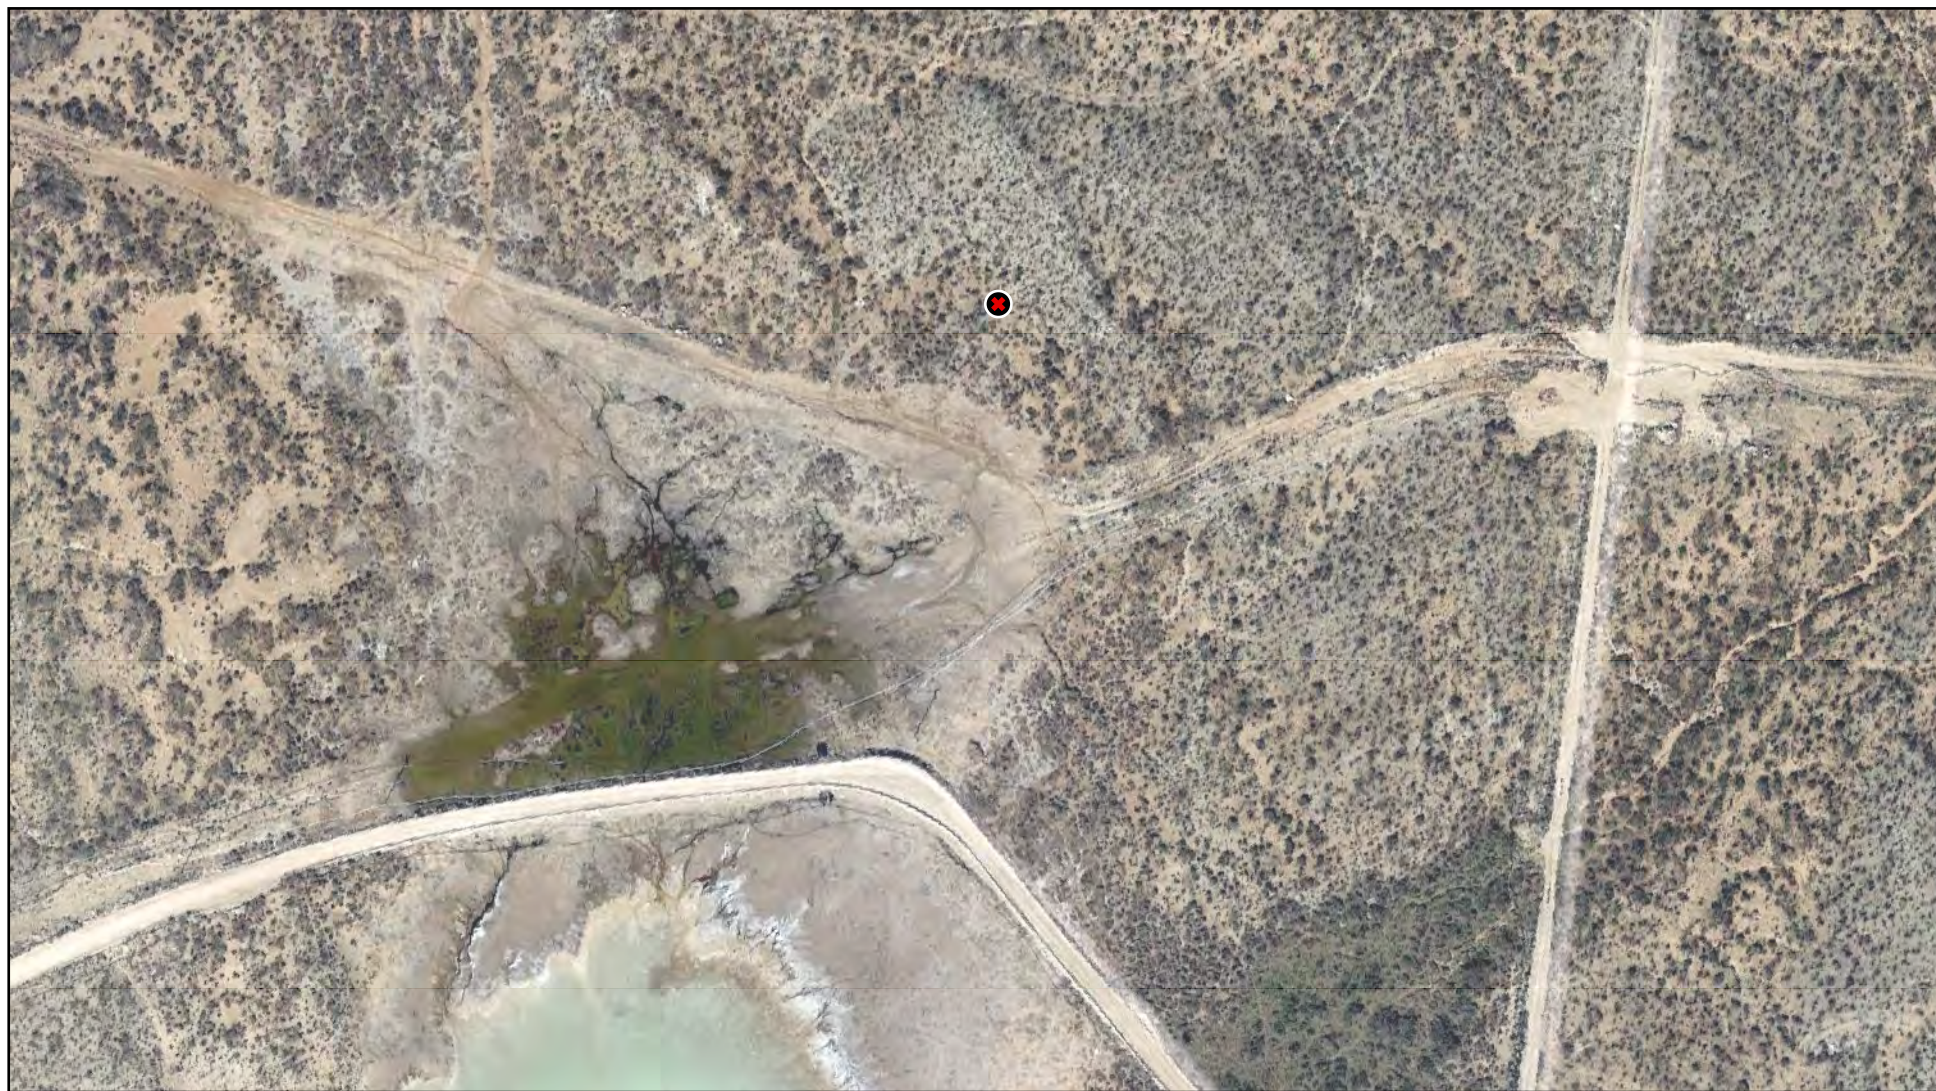
Release Point

Note: Georeferenced image from Google Earth, 2017. Site features from GPS by Vertex Professional Services Ltd. (Vertex), 2025.
