## REMEDiation CLOSURE REPORT

PREPARED FOR:  
DEVON ENERGY PRODUCTION, LP.

PREPARED BY:  
PIMA ENVIRONMENTAL SERVICES, LLC.

**RE:** Remediation Closure Report  
**LOCATION:** Roche Federal #001  
**WELL API #:** 30-015-25972  
**GPS:** 32.7556763, -103.9067688  
**INCIDENT LOCATION:** O-7-T18S-R31E  
**COUNTY:** Eddy  
**NMOCD REF. NO.** nJMW1301749383

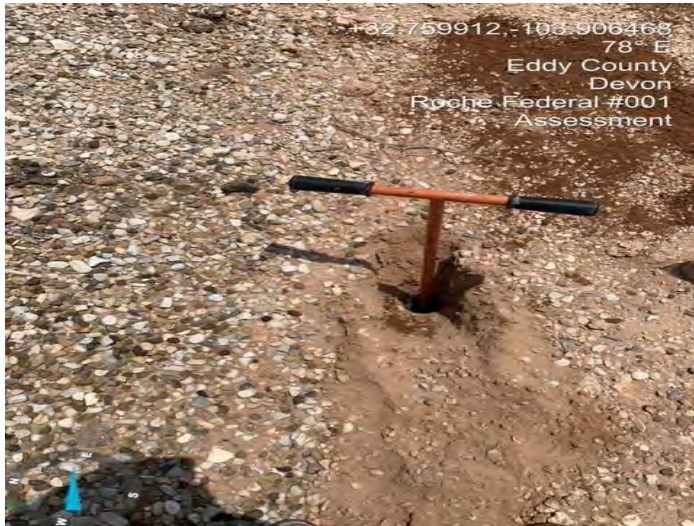
Northwest side looking southeast

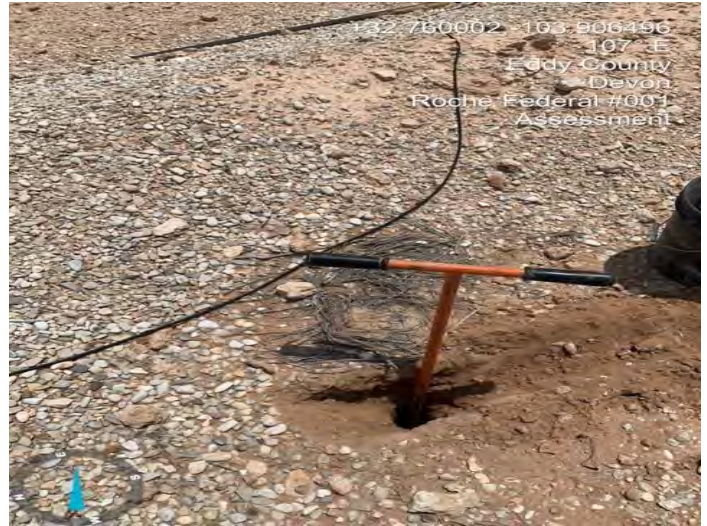
Southwest side looking east

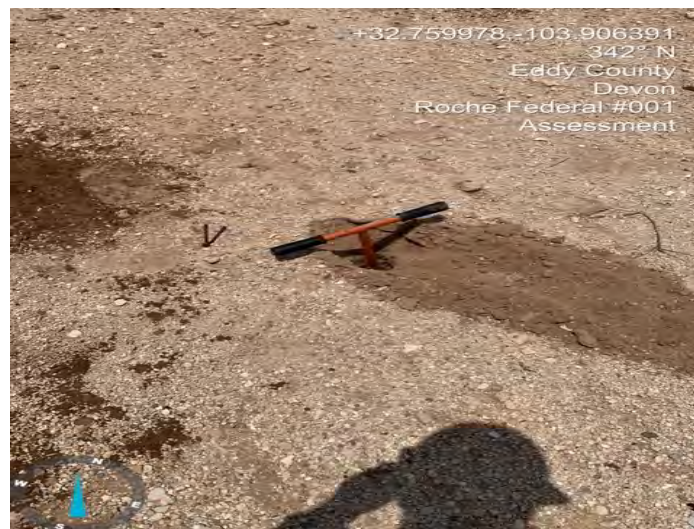
Borehole Installation

On February 5, 2025, Devon contracted H&R Enterprises to install a borehole at the battery site to obtain new groundwater data. A borehole was installed at 32 degrees, 45 minutes, 36.9 seconds N latitude, and -103 degrees, 54 minutes, 23.8 seconds W longitude in section 7, township 18S, range 31E in Eddy County, New Mexico. The borehole was drilled with a truck-mounted air rotary drill to a depth of 55 feet bgs. A temporary well casing was installed, and the borehole was left open for no less than 72 hours. Photographic Documentation can be found in Appendix D.

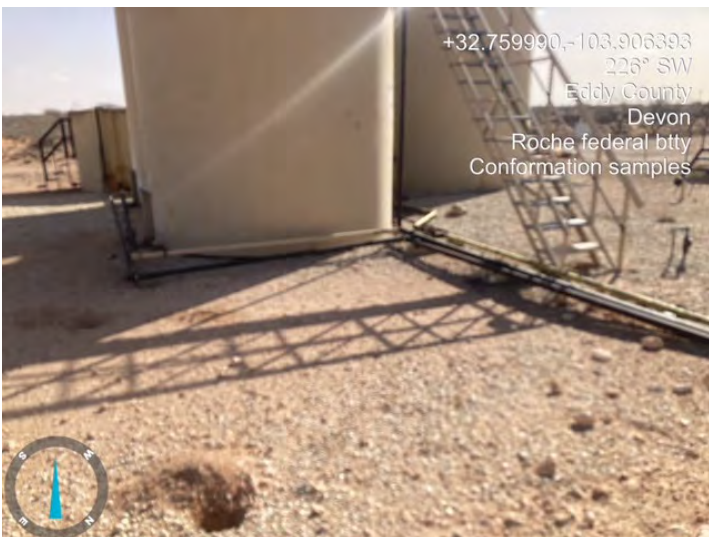
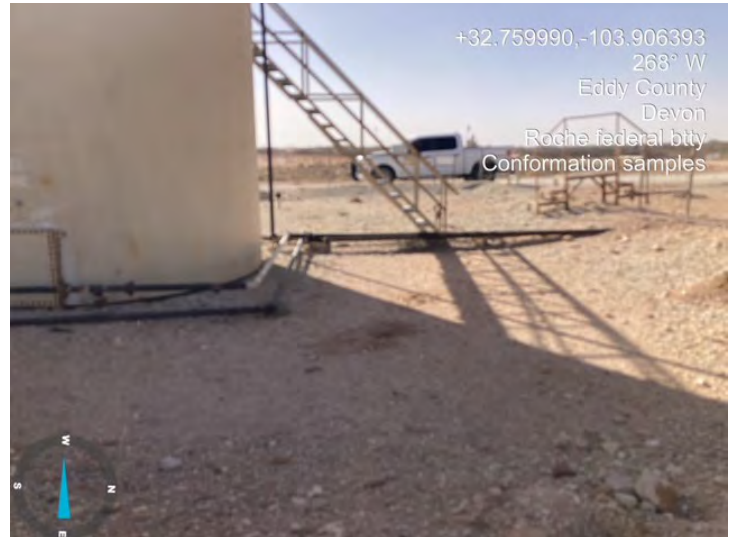
Confirmation Surface Samples

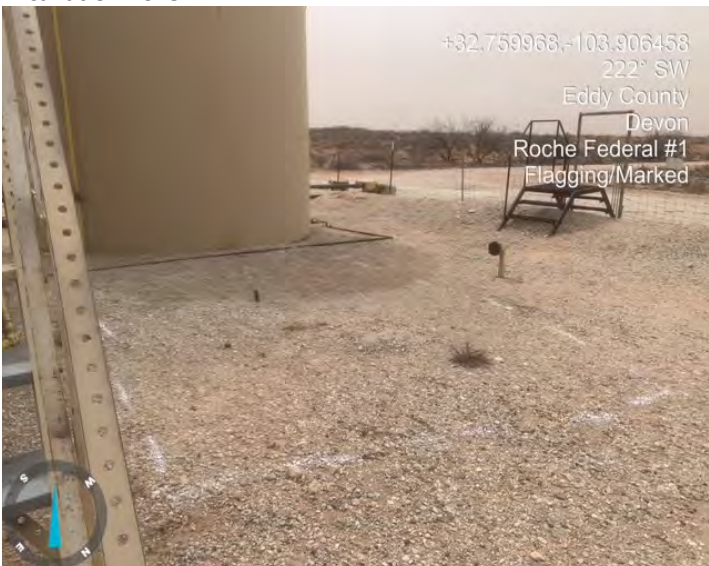
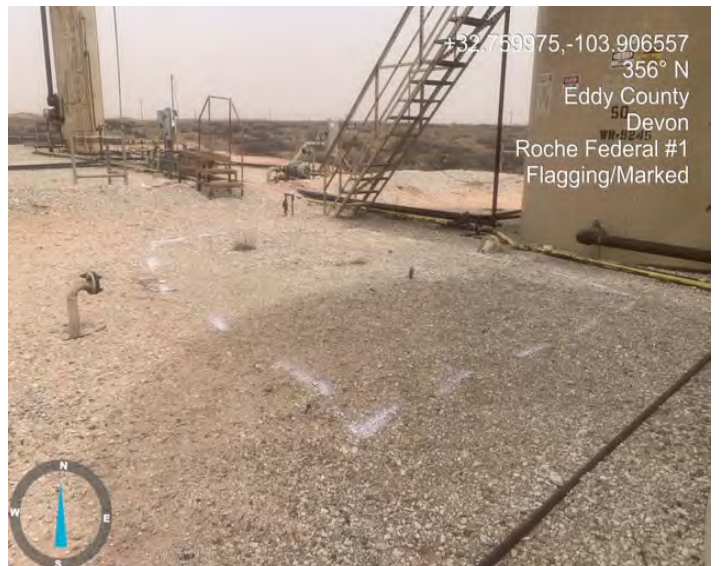
Excavation 2025
