PERMIAN RESOURCES

TOSTADA 7 STATE COM 302H

Remediation/Reclamation Closure Report

NAPP2502746955

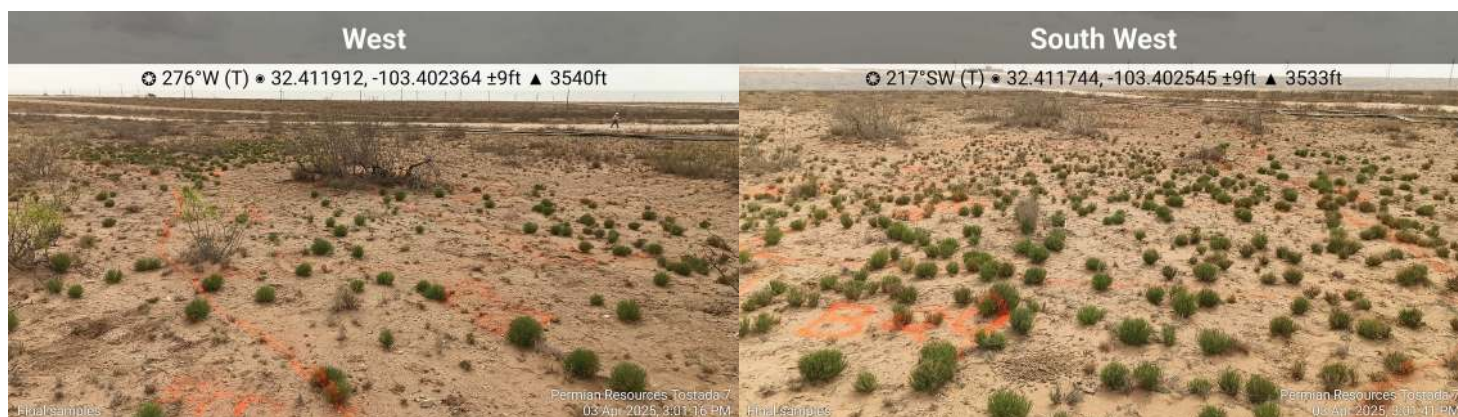
Figure 3

Figure 4

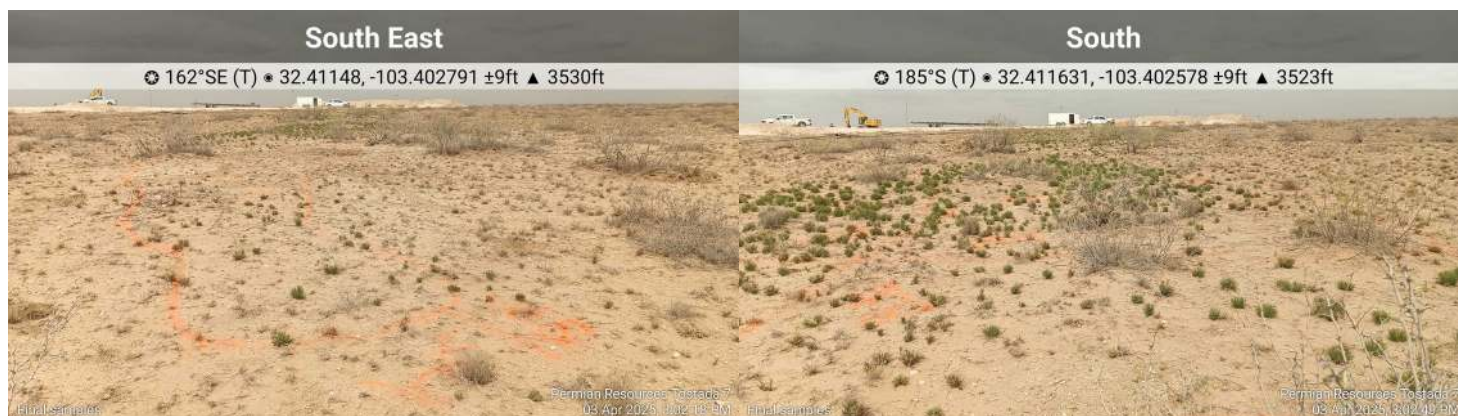
Figure 5

Figure 6
