EAST VACUUM (GSA) UNIT #001

nOY1803031043

## **Proposed Sampling and Remediation Work Plan**

Re: Proposed Sampling and Remediation Work Plan  
 NMOCD Incident Number: **nOY1803031043**  
 East Vacuum (GSA) Unit #001 API No. 30-025-26658  
 Unit N, Section 33, Township 17S, Range 35E 300 FSL 2500 FWL Lea County, NM  
 GPS Coordinates: Latitude 32.7849197 Longitude -103.4631271 NAD83

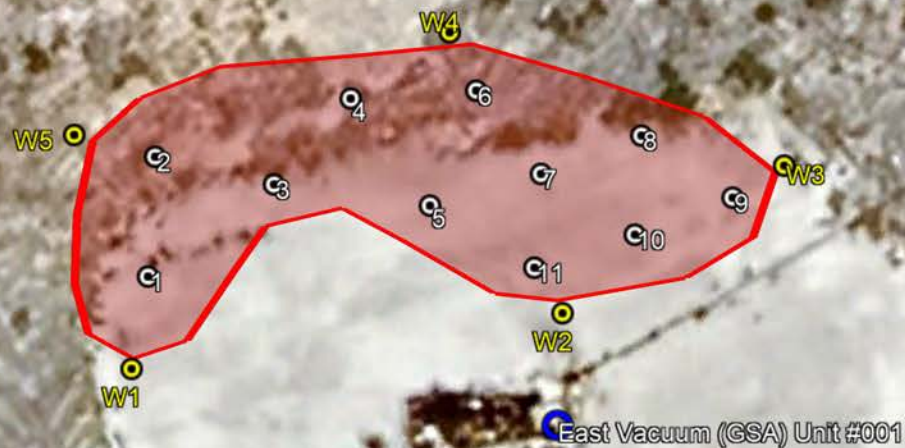
Maverick Permian  
API #30-025-26658  
Lea County, NM  
nOY1803031043  
Proposed Sample Map

- The area of concern measures approximately 5182 square feet and is partially on the pad surface and in the pasture.
- Collect discrete samples from within and around the edges of the release area to evaluate the presence of contaminants. Fifty-five (55) samples will be collected from 11 different sample points within the release area from depths of surface, 1', 2', 3', and 4' bgs. Twenty-five (25) samples will be collected from 5 different sample points around the edges of the release area from depths of surface, 1', 2', 3', and 4' bgs.

- A 48-hour sampling notification will be issued to the NMOCD for these sampling events. A variance request is included below for permission to use the delineation samples as confirmations samples depending on the sample results of the soil. A Proposed Sample Map can be found in Figure 1.

- East Vacuum (GSA) Unit #001
- Proposed horizontal samples
- Proposed vertical samples
- Release area - 5182 sqft

- If any samples do not verify delineation, then the "step-out" method will be used for horizontal delineation samples until sample results can confirm delineation. Also, for vertical delineation samples, any samples not verifying delineation will be advanced deeper until sample results can confirm delineation.

- Sample results from that are over the regulatory limits of the less than 50-foot depth to groundwater section of Table 1 will be measured for total area and affected volume then removed via mechanical excavation means. The contaminated soil will be hauled to an NMOCD-approved disposal facility and clean, like material will be brought to the Site for backfilling the excavated area.

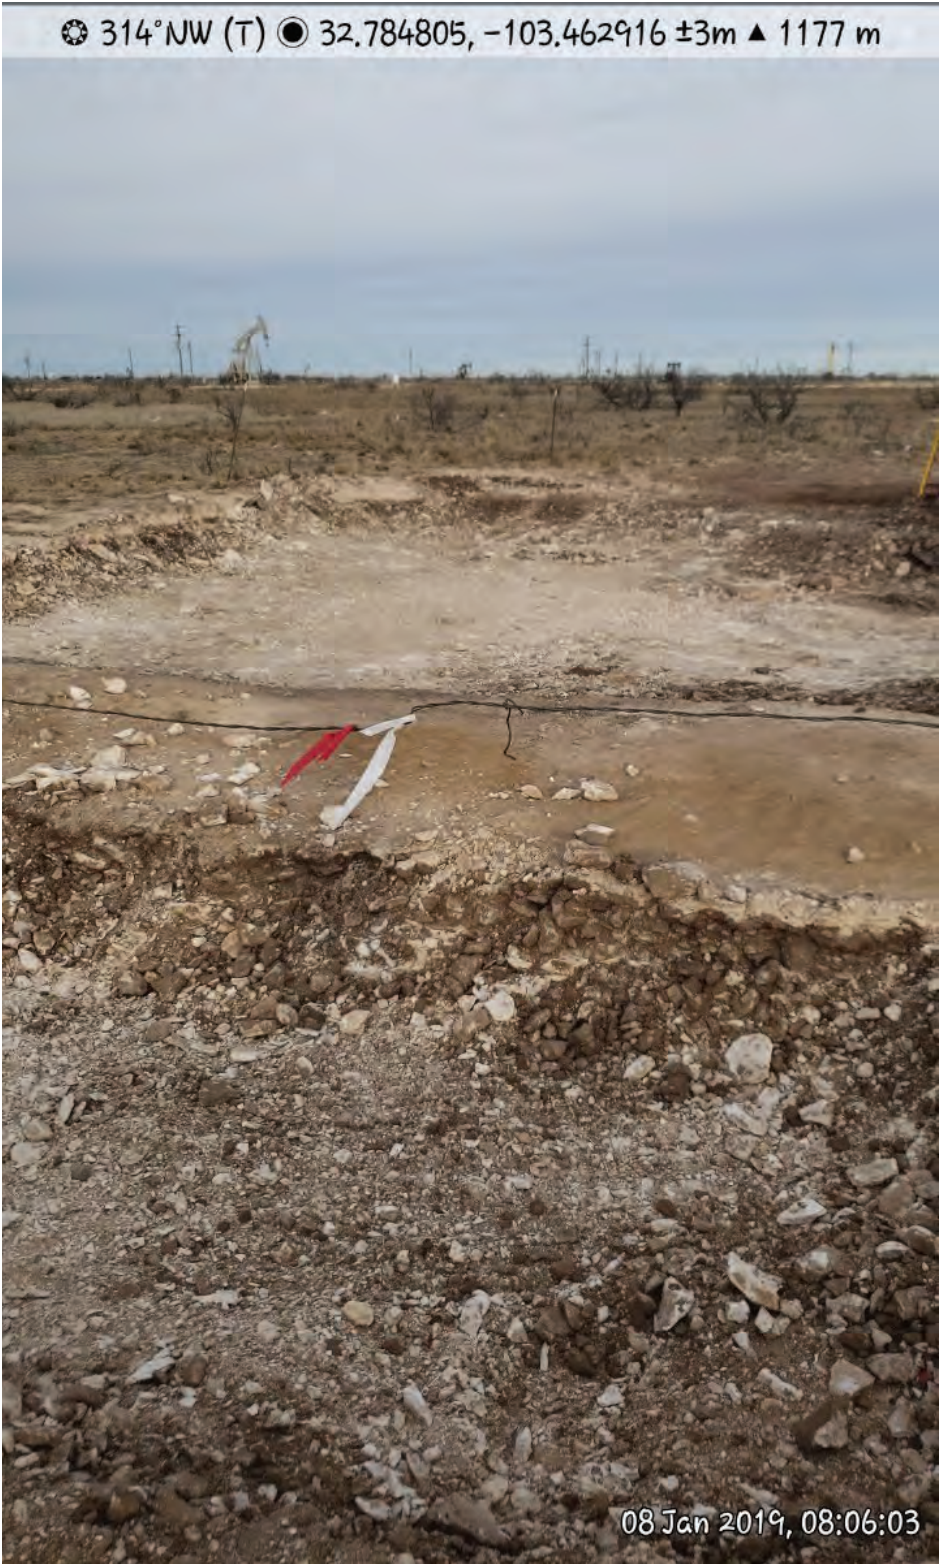
TETRA TECH, INC. PROJECT NO. 212C-MD-01796	DESCRIPTION	View northwest over excavated area in footprint of formerly impacted pad area.	1
	SITE NAME	EVGSAU 3345-001 Release	01/08/2019

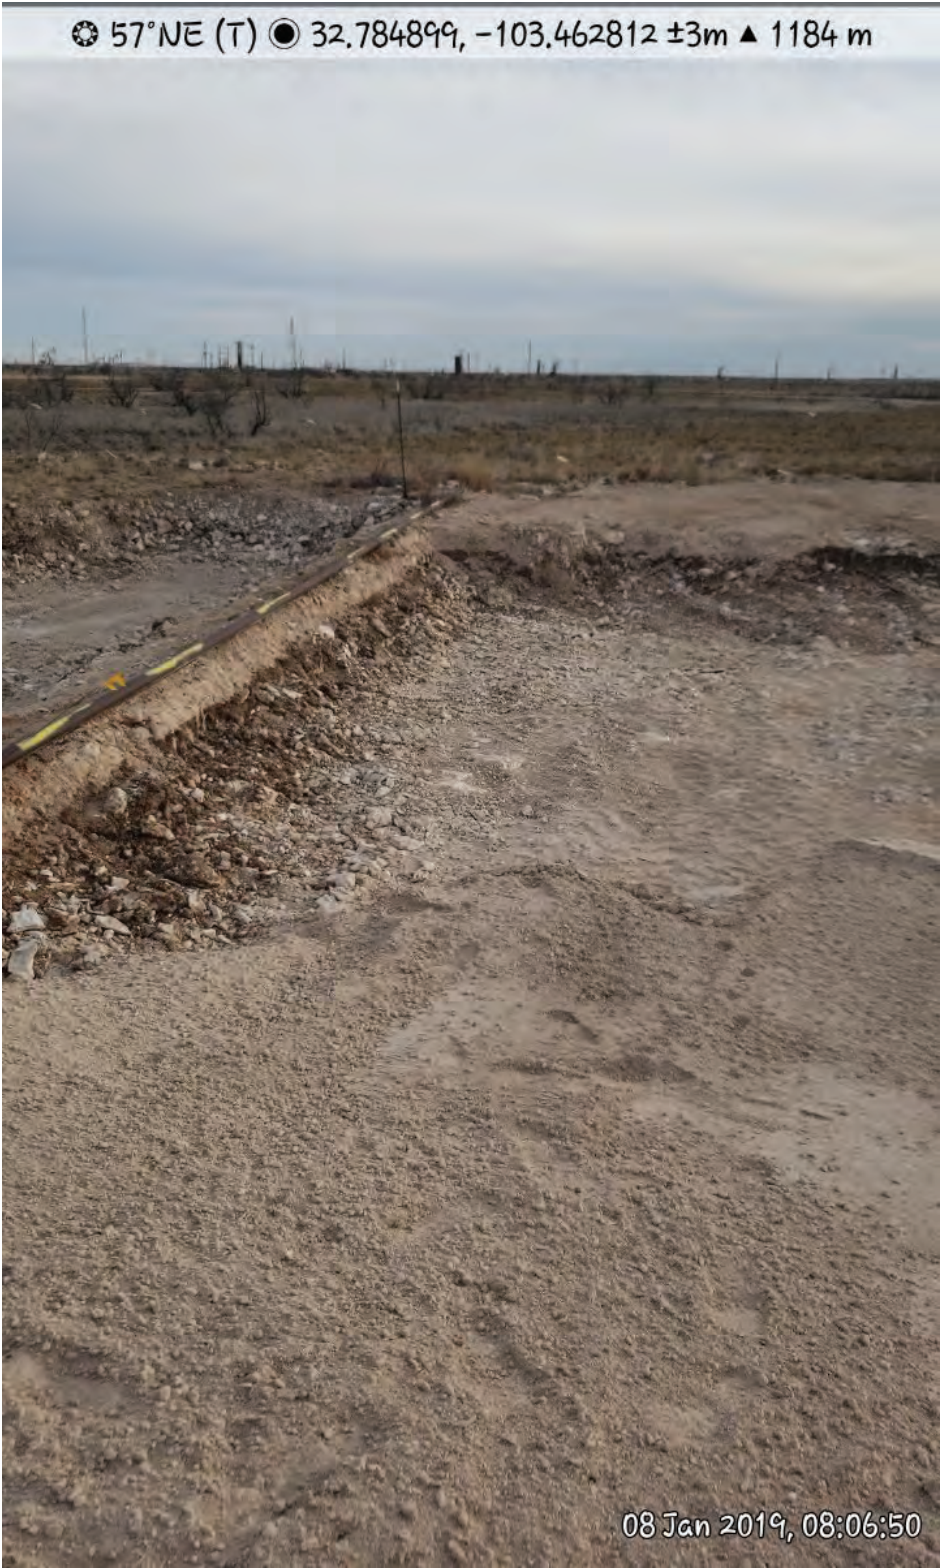
TETRA TECH, INC. PROJECT NO. 212C-MD-01796	DESCRIPTION	View northeast over excavation in progress in footprint of formerly impacted pad area.	2
	SITE NAME	EVGSAU 3345-001 Release	01/08/2019

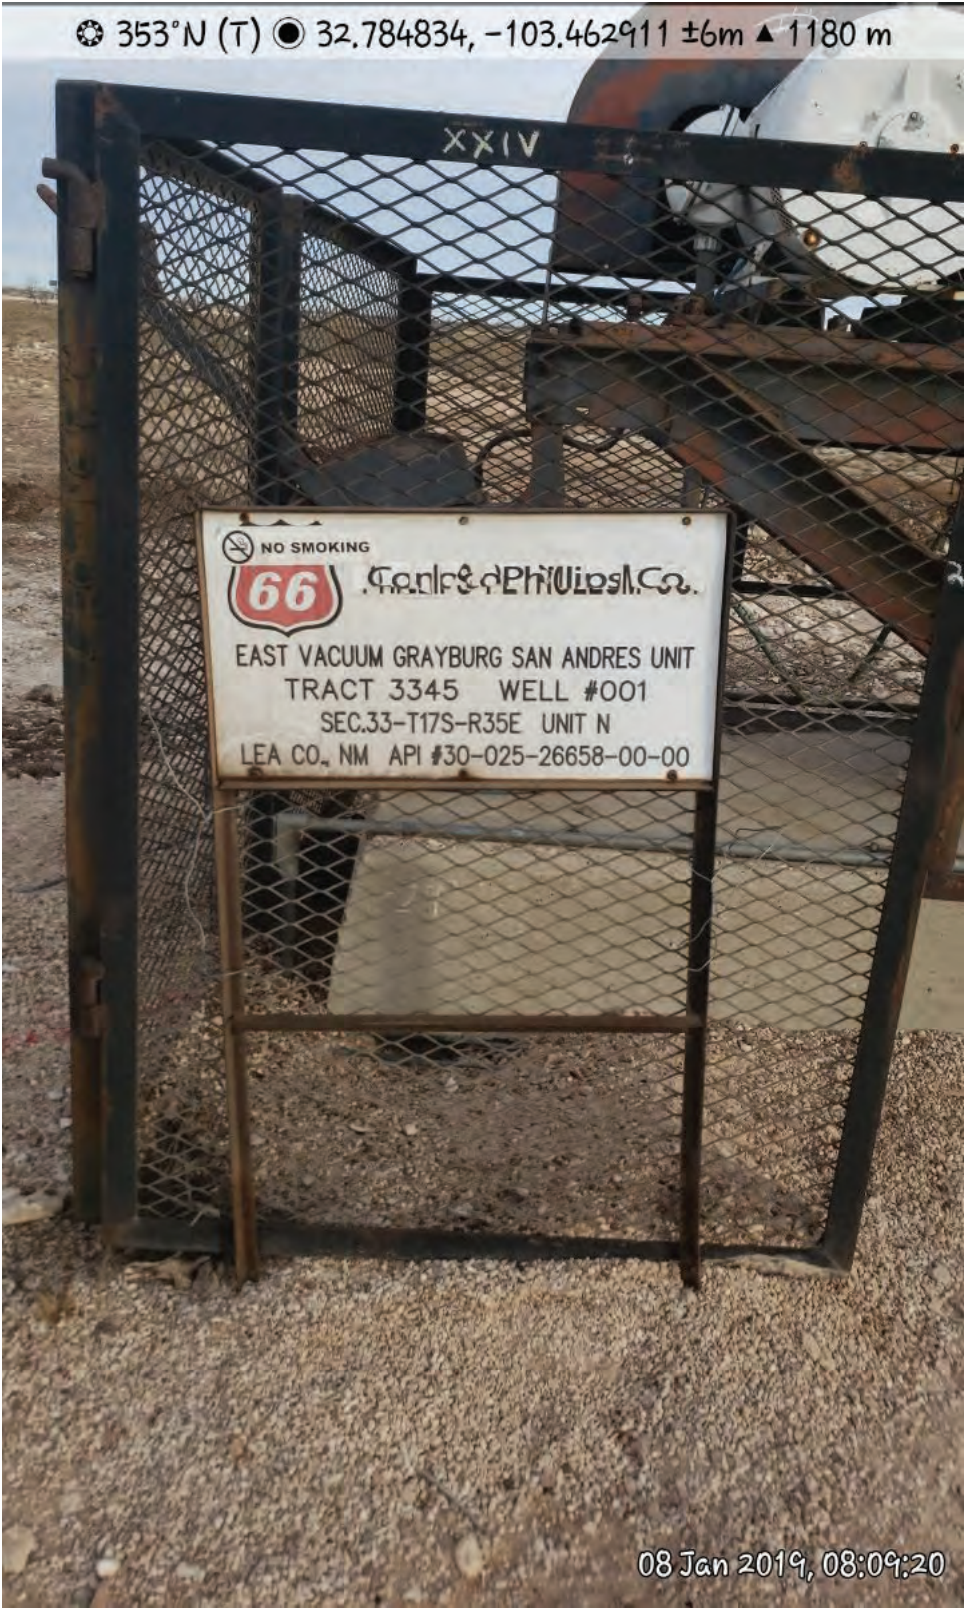
TETRA TECH, INC. PROJECT NO. 212C-MD-01796	DESCRIPTION	View of site signage with georeferenced information on photograph.	3
	SITE NAME	EVGSAU 3345-001 Release	01/08/2019

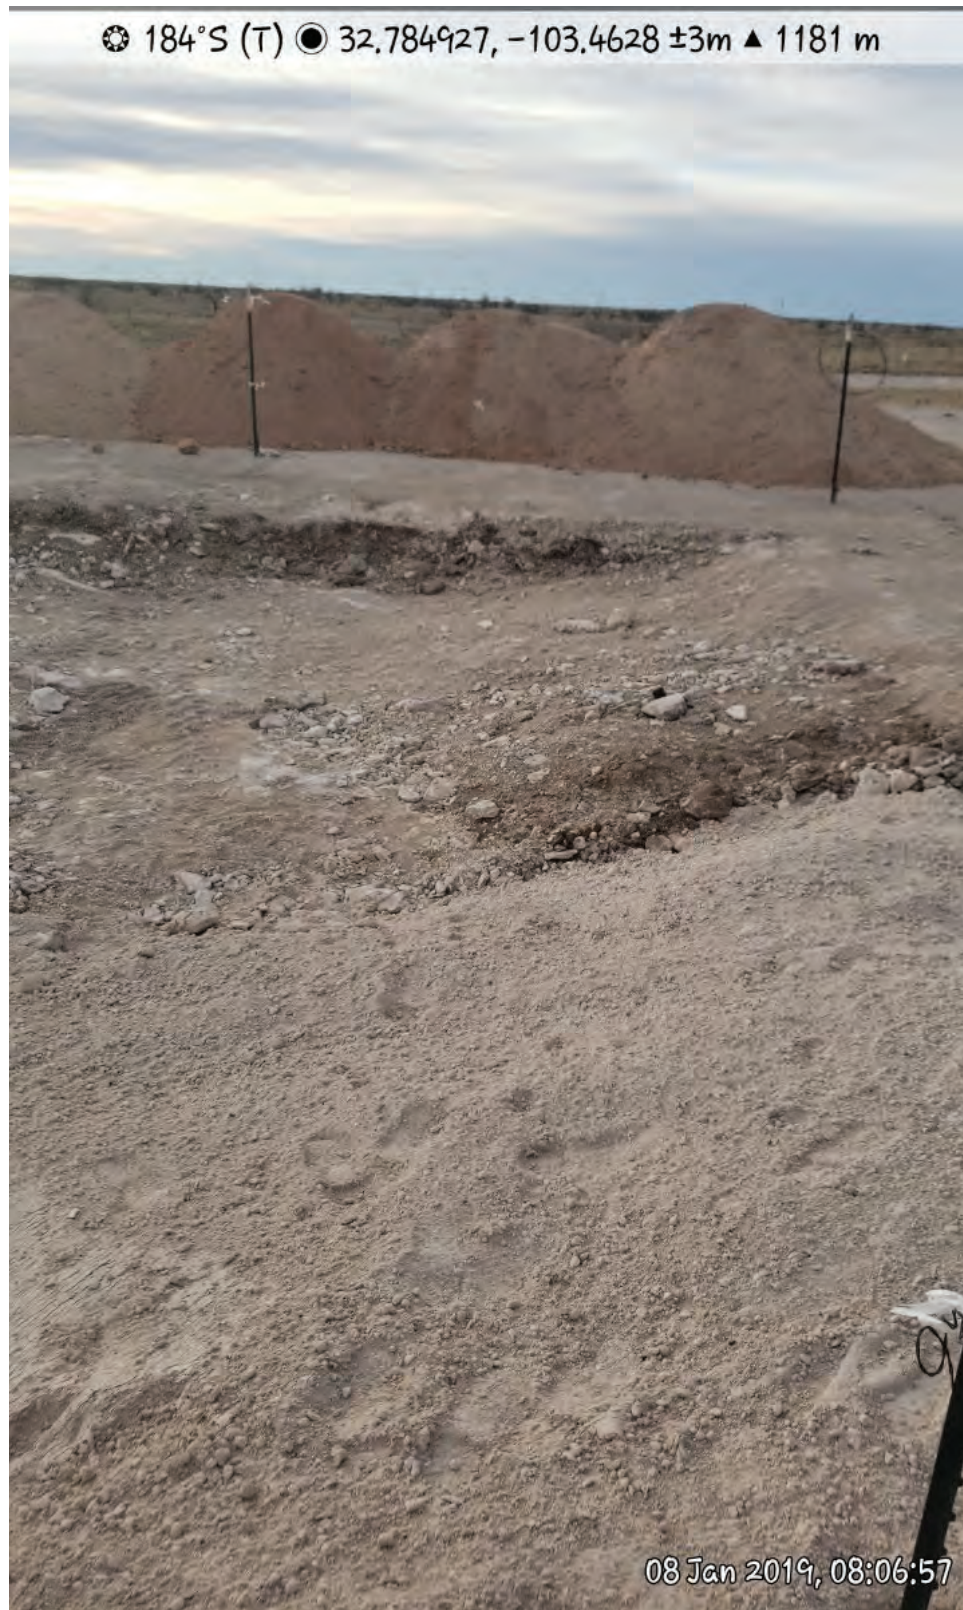
TETRA TECH, INC. PROJECT NO. 212C-MD-01796	DESCRIPTION	View south over excavated area in footprint of formerly impacted pad area.	4
	SITE NAME	EVGSAU 3345-001 Release	01/08/2019

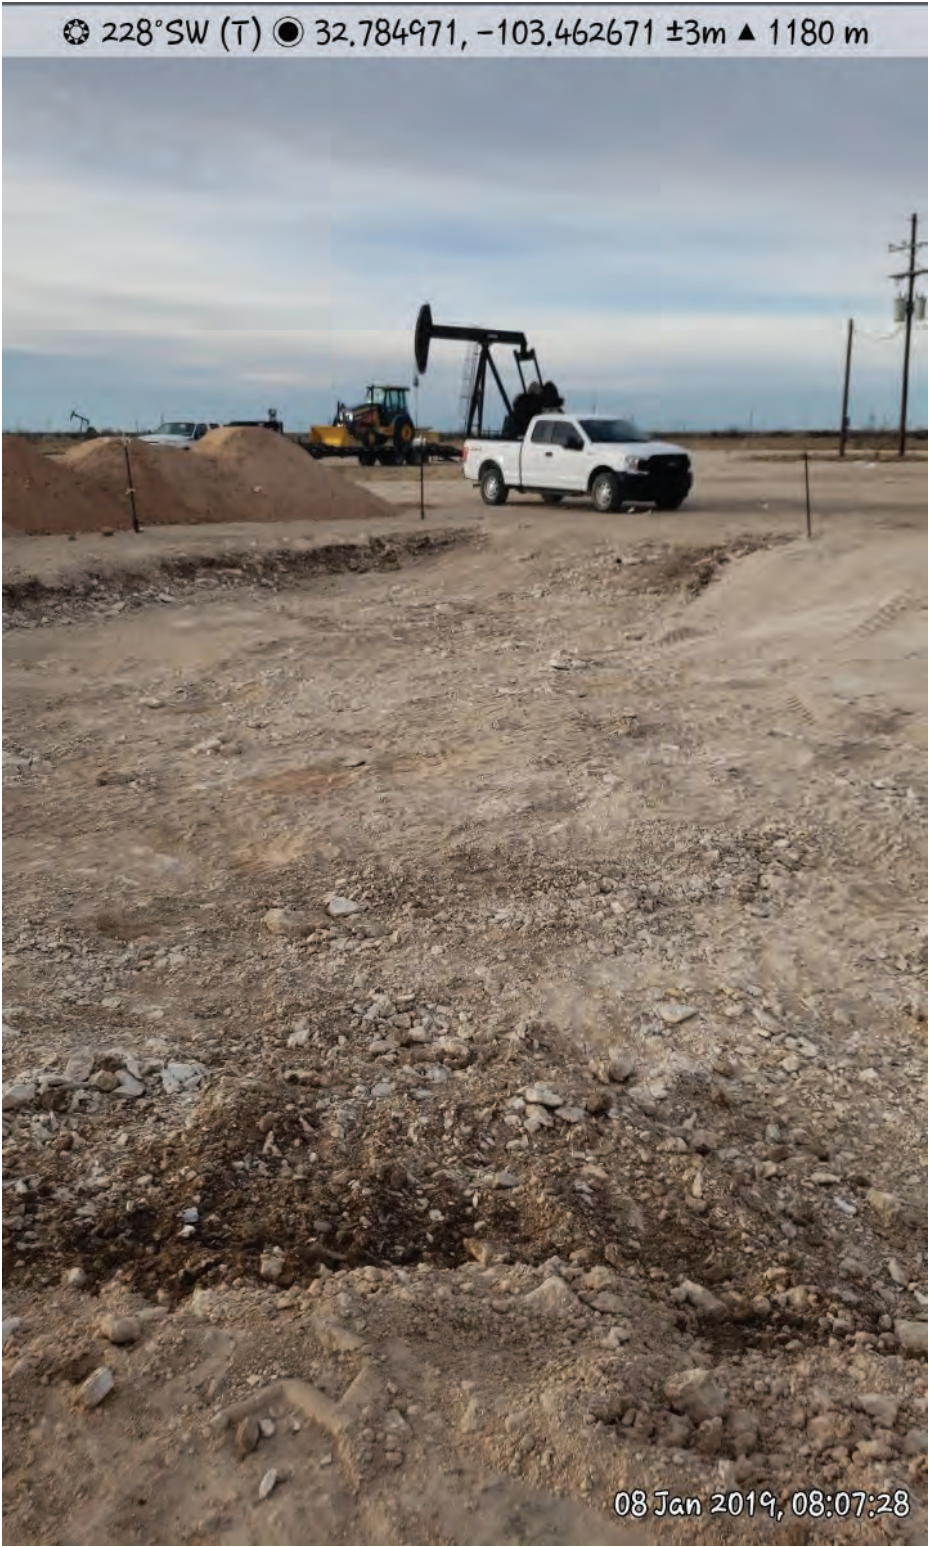
TETRA TECH, INC. PROJECT NO. 212C-MD-01796	DESCRIPTION	View southwest over excavation in progress, in footprint of impacted pad area.	5
	SITE NAME	EVGSAU 3345-001 Release	01/08/2019

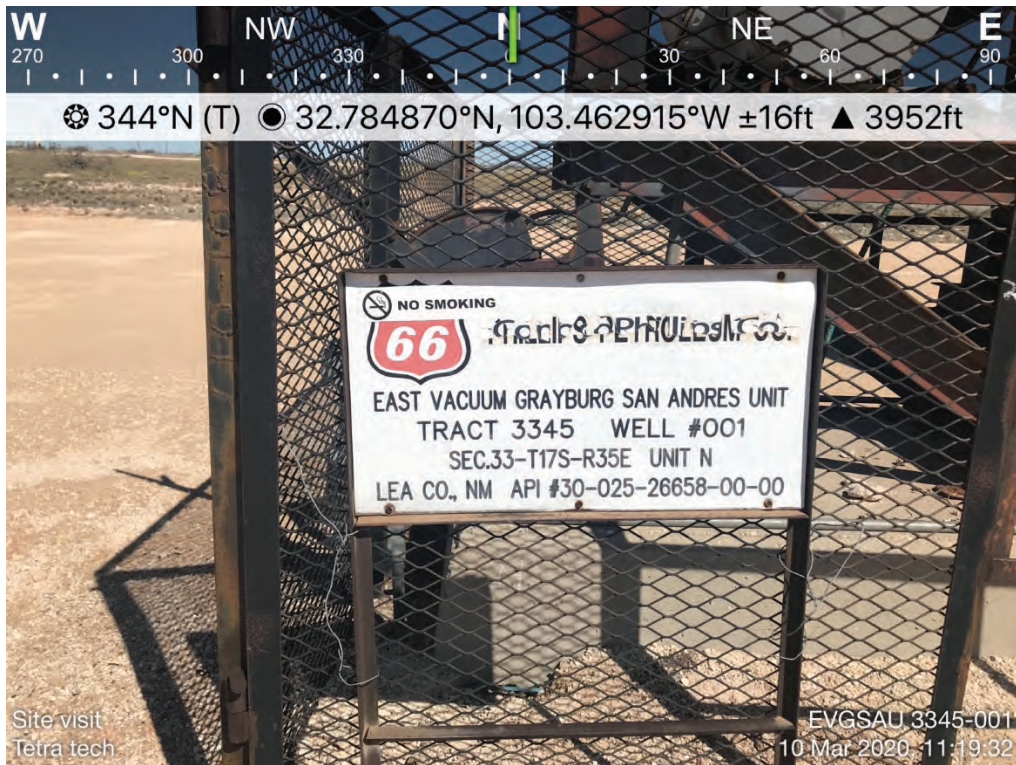
TETRA TECH, INC. PROJECT NO. 212C-MD-01796	DESCRIPTION	View of site signage with georeferenced information on photograph.	6
	SITE NAME	EVGSAU 3345-001 Release	03/10/2020

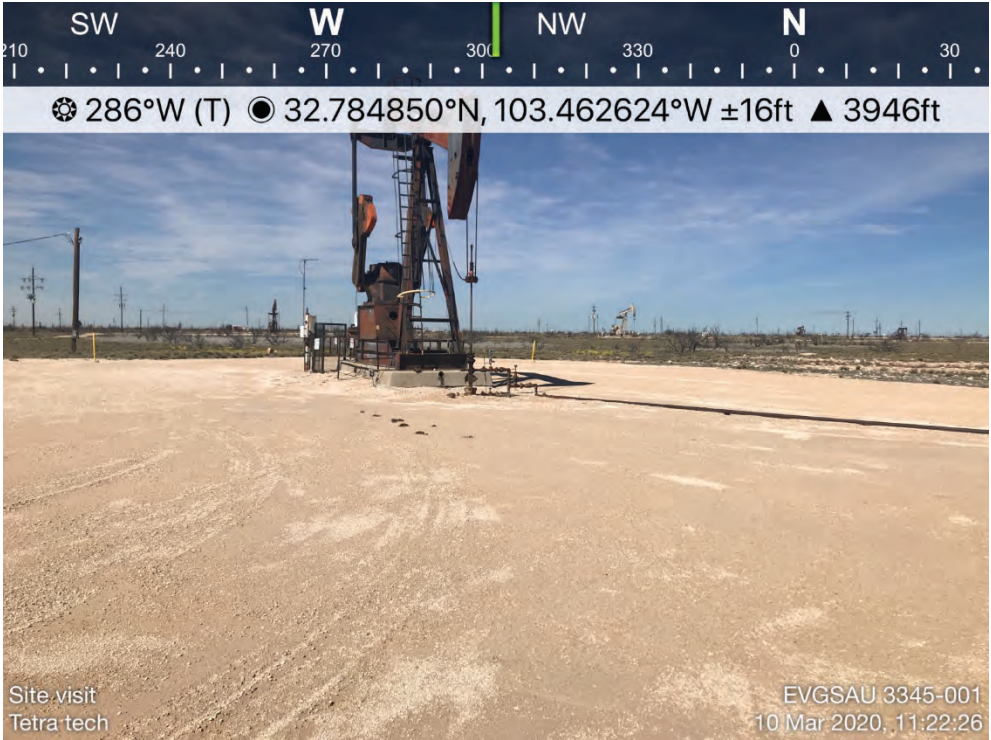
TETRA TECH, INC. PROJECT NO. 212C-MD-01796	DESCRIPTION	View west over well pad and former impacted area, with pumping unit and flowline visible.	10
	SITE NAME	EVGSAU 3345-001 Release	03/10/2020

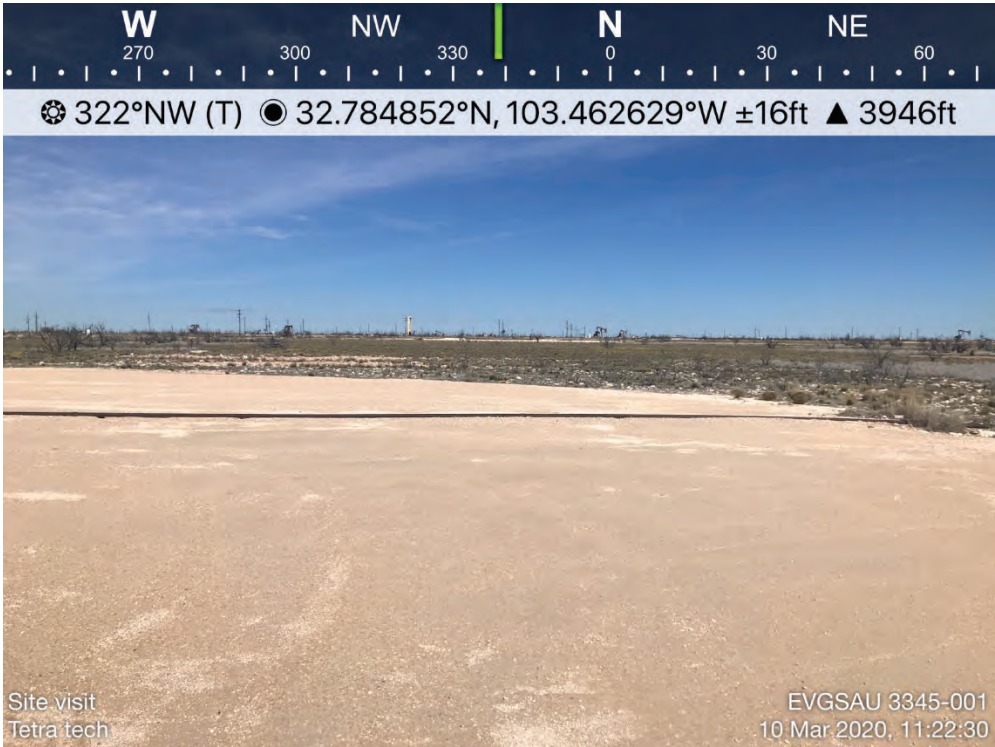
TETRA TECH, INC. PROJECT NO. 212C-MD-01796	DESCRIPTION	View north over well pad and former impacted area, with flowline visible.	11
	SITE NAME	EVGSAU 3345-001 Release	03/10/2020

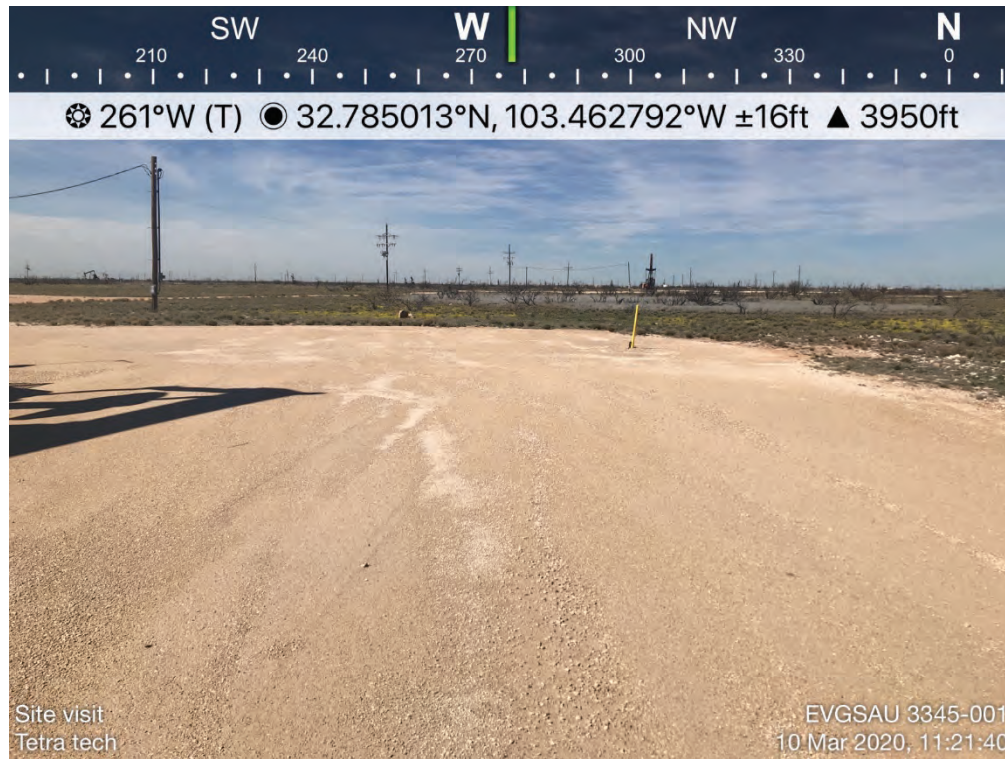
TETRA TECH, INC. PROJECT NO. 212C-MD-01796	DESCRIPTION	View west over well pad and former impacted area.	12
	SITE NAME	EVGSAU 3345-001 Release	03/10/2020

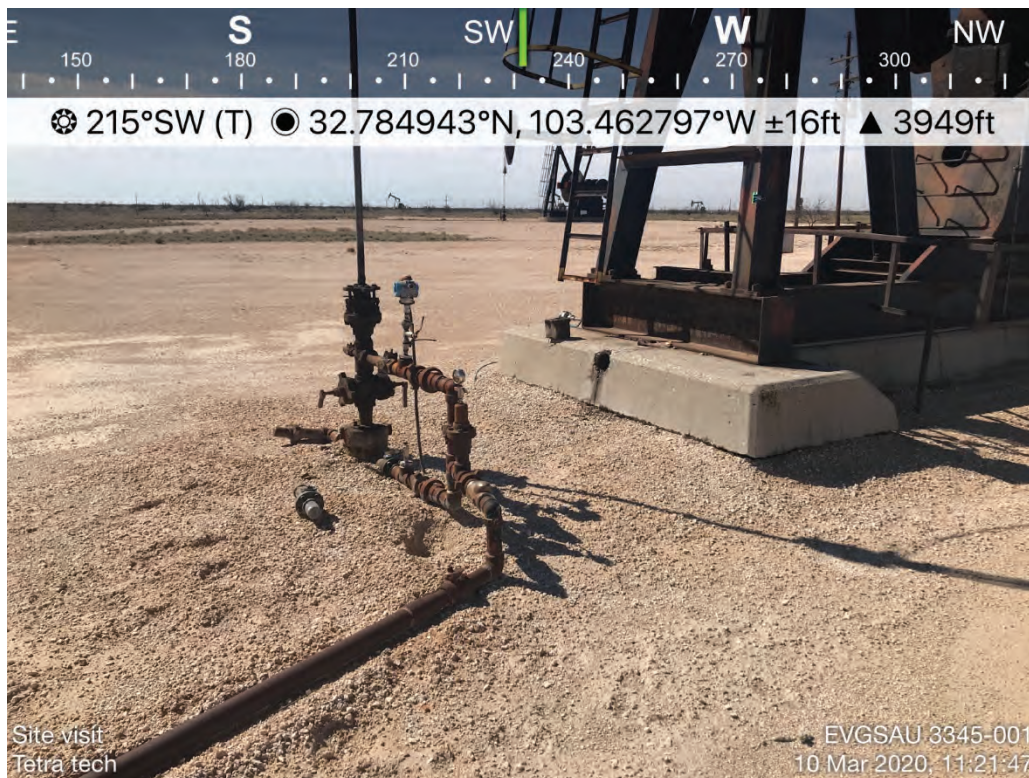
TETRA TECH, INC. PROJECT NO. 212C-MD-01796	DESCRIPTION	View of well head (approximate release point).	13
	SITE NAME	EVGSAU 3345-001 Release	03/10/2020
