Environmental Site Remediation Work Plan

NMOCD District:	District 2 - Artesia	Incident ID:	nJMW1231248032,nJMW1317034502, nAB1516753239
Landowner:	Bureau of Land Management	RP Reference:	2RP-1391, 2RP-1686, 2RP-3051
Client:	Devon Energy Production Company, LP	Site Location:	Todd 24 B Federal #002
Date:	July 4, 2023	Project #:	21E-02816-016
Client Contact:	Dale Woodall	Phone #:	405.318.4697
Vertex PM:	Kent Stallings	Phone #:	346.814.1413

The objective of the Environmental Site Remediation Work Plan is to identify areas of exceedance for constituents of concern delineated during spill assessment and site characterization activities, and propose appropriate remediation techniques to address the open release at Todd 24 B Federal #002 (hereafter referred to as "Todd 24"). This incident is composed of three separate incidents. The most recent occurred when a transfer pump failure resulted in the release of approximately 80 barrels (bbl) of produced water inside the unlined, earthen containment on the pad. Upon discovery, a hydrovac truck was dispatched to the site to recover free fluids. Approximately 75 bbl of oil were recovered and removed for disposal off-site. The second incident o

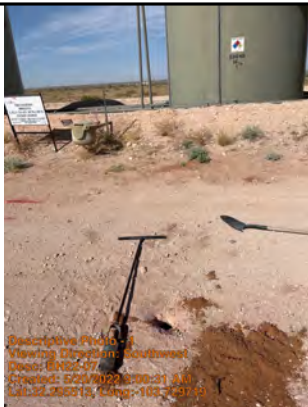
Descriptive Photo - 2
Viewing Direction: Southwest
Date: 5/12/22
Created: 5/22/2022 4:00:21 AM
Lat: 32.295226, Long: -103.728721

BH22-07, stepped out 10' from BH22-02

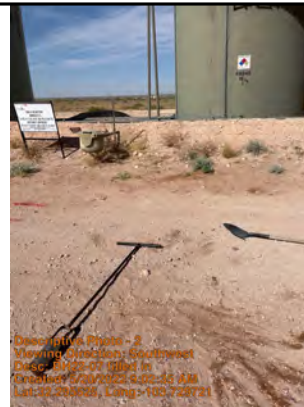
Descriptive Photo - 2
Viewing Direction: Southwest
Date: 5/12/22
Created: 5/22/2022 4:00:40 AM
Lat: 32.295226, Long: -103.728721

BH22-07 filled in

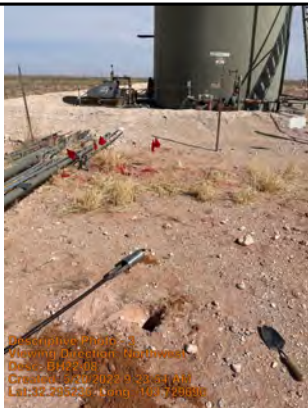
Descriptive Photo - 3
Viewing Direction: Northwest
Date: 5/12/22
Created: 5/22/2022 4:00:40 AM
Lat: 32.295226, Long: -103.728721

BH22-08

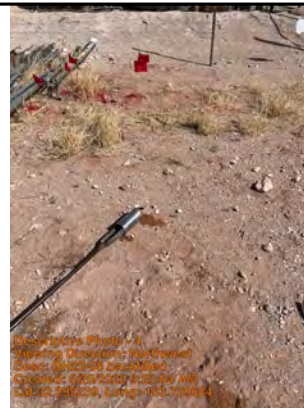
Descriptive Photo - 4
Viewing Direction: Northwest
Date: 5/12/22
Created: 5/22/2022 4:00:40 AM
Lat: 32.295226, Long: -103.728721

BH22-08 backfilled

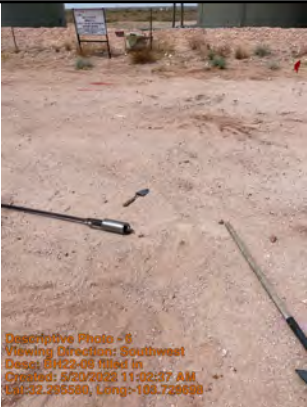
<p>Descriptive Photo #9 Viewing Direction: Southwest Date: 5/20/22 Filled in Created: 5/20/2022 11:32:37 AM Lat: 32.295580, Long: -103.729688</p>
BH22-09	BH22-09 filled in

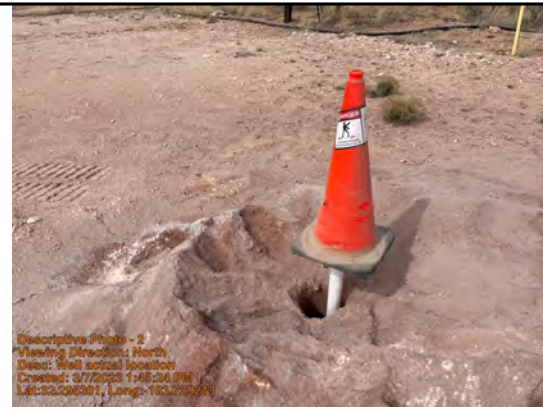
Viewing Direction: North

Well actual location

13:56 Well reading at 13:40 PM, 72 hours after drilling and initial measurement occurred, measured with Solinst model 122. Pipe height above ground is 3 foot. Well depth bottom reading at 60 ft and 6 inches with water detected at 59 ft. (Well is 57 ft and 6 inches total depth and 56 ft depth to meter observed ground water).
Coordinates of well location: (32.2953261, -103.7291990)
Well is approximately 36 ft SE of pump jack and 57 ft east of separators' fence at SE corner of pad.

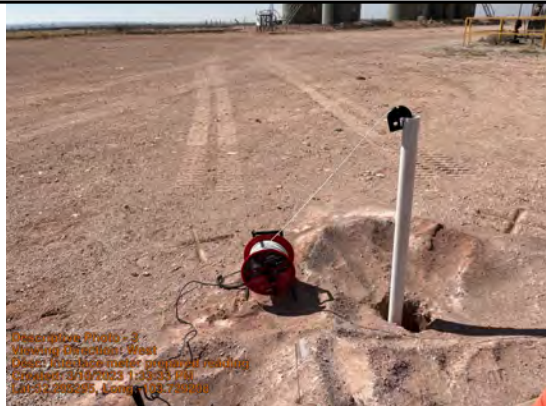
Viewing Direction: West

Interface meter prepared reading

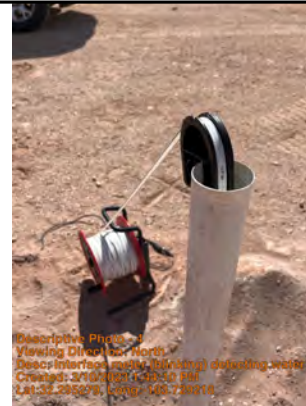
Viewing Direction: North

Interface meter (blinking) detecting water at measurement of 59 ft (with pipe)
