EAST VACUUM (GSA) UNIT #006

nGRL0916233108

PREPARED BY SAPEC-ECO, LLC.  
PREPARED FOR MAVERICK PERMIAN, LLC.

## **Proposed Sampling and Remediation Work Plan**

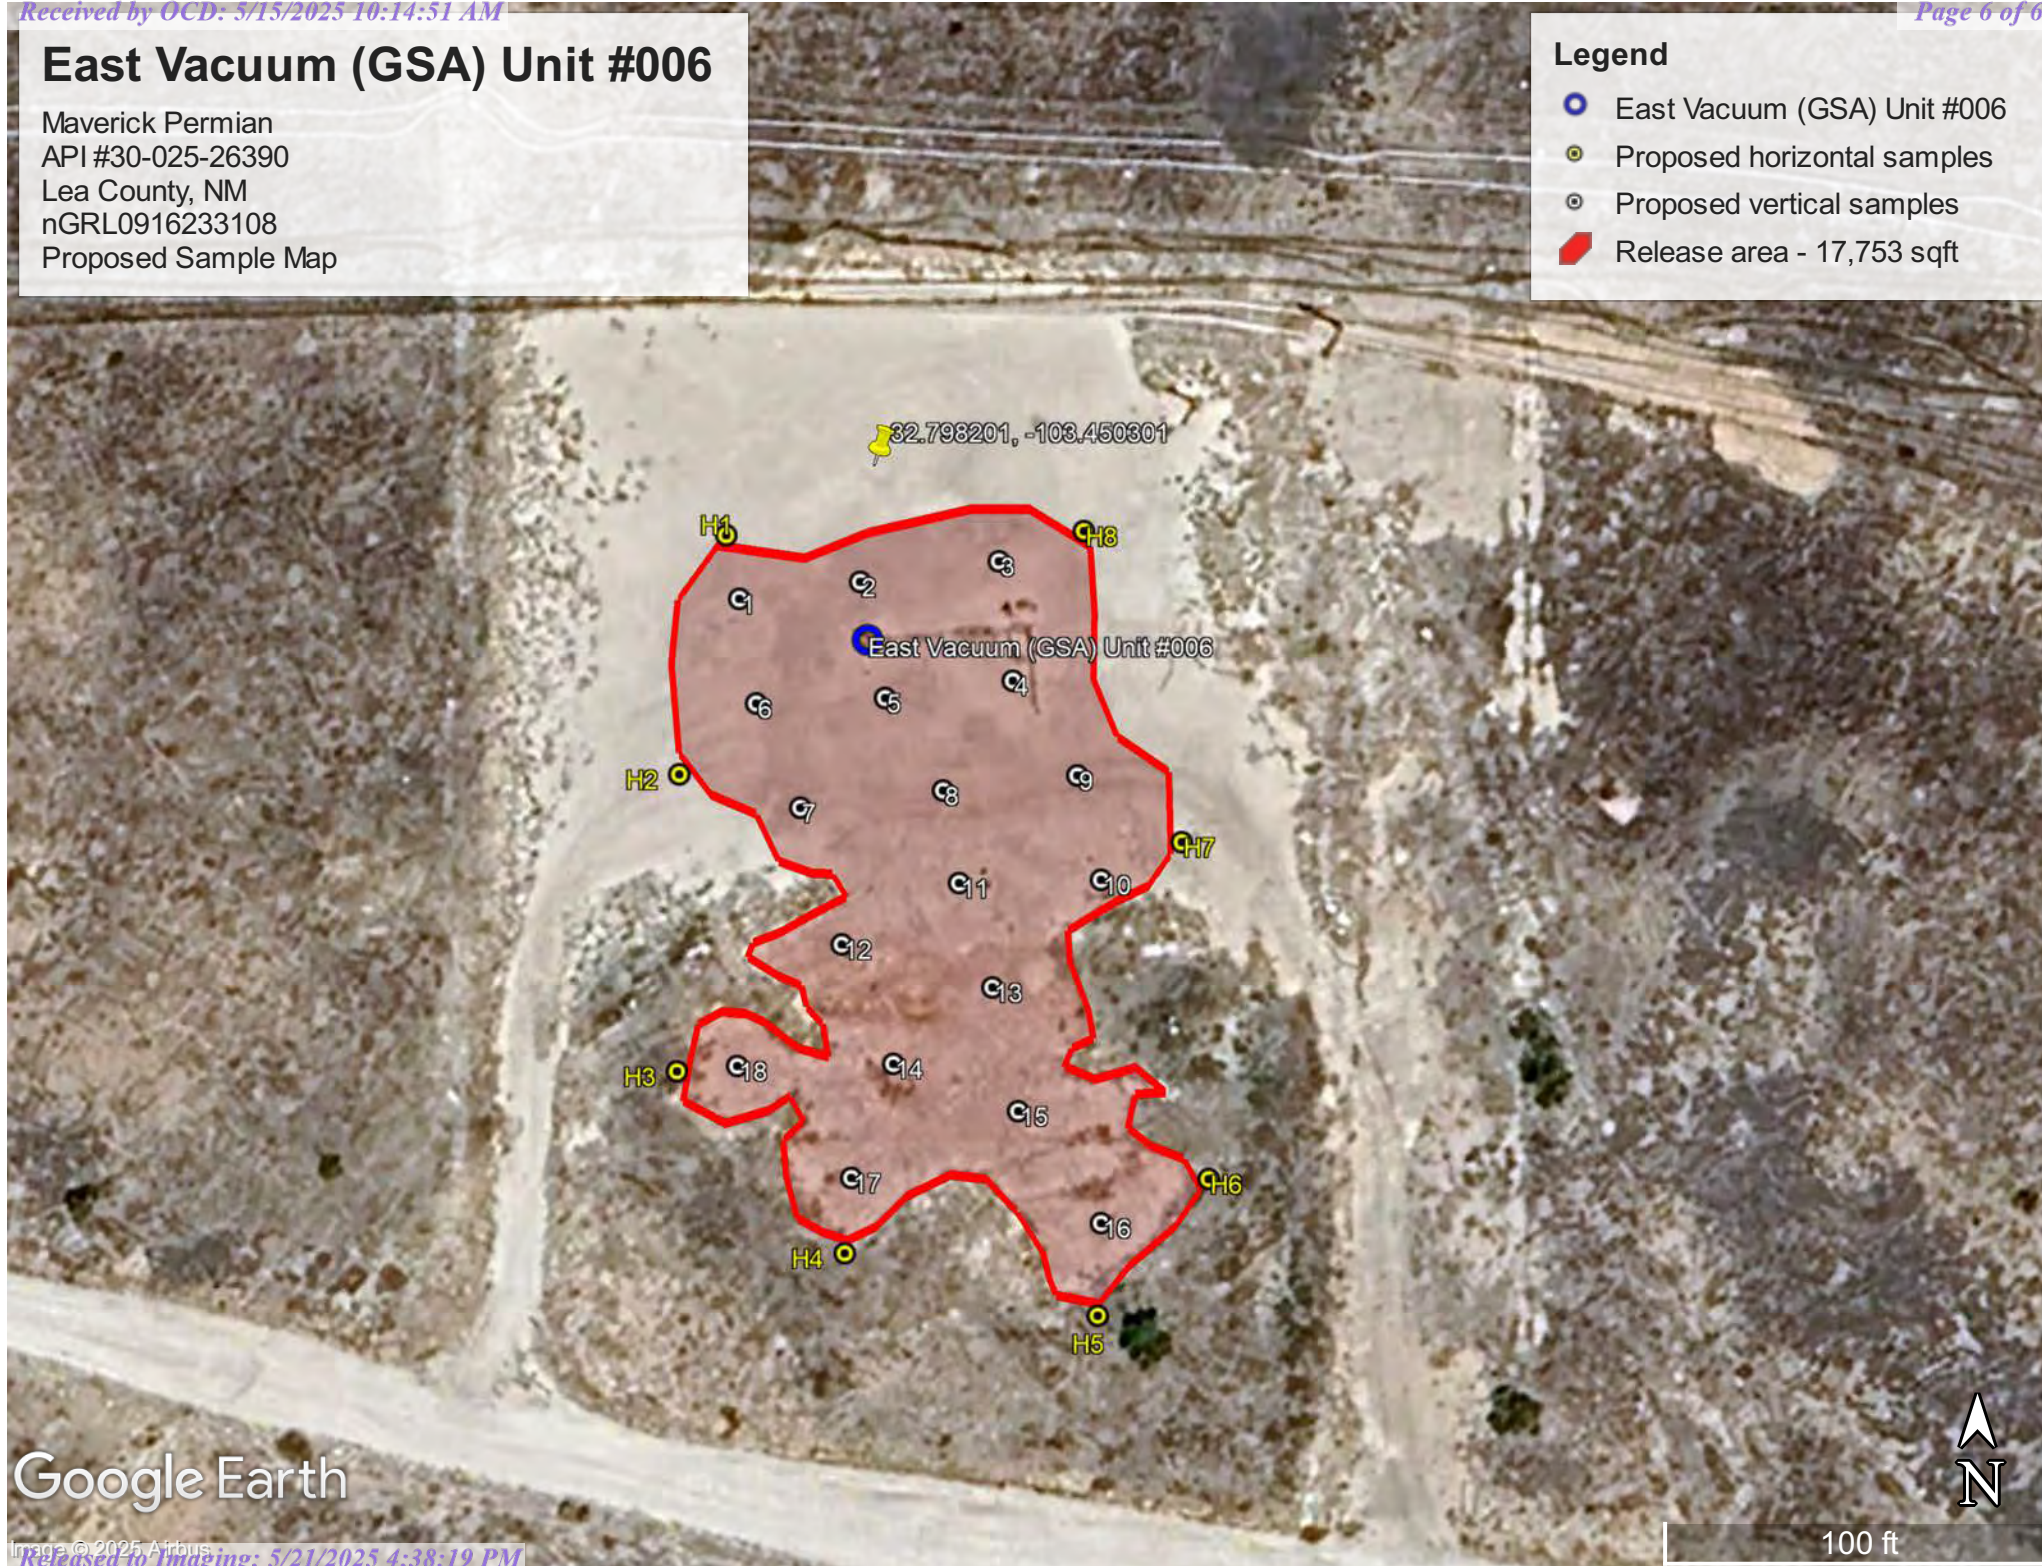
### Legend

- East Vacuum (GSA) Unit #006
- Proposed horizontal samples
- Proposed vertical samples
- Release area - 17,753 sqft

- The area of concern measures approximately 17,753 square feet and is on the pad surface and in the pasture.
- Collect discrete samples from within and around the edges of the release area to evaluate the presence of contaminants. Eighty-five (85) samples will be collected from 17 different sample points within the release area from depths of surface, 1', 2', 3', and 4' bgs. Forty (40) samples will be collected from 8 different sample points around the edges of the release area from depths of surface, 1', 2', 3', and 4' bgs.

- A 48-hour sampling notification will be issued to the NMOCD for these sampling events. A variance request is included below for permission to use the delineation samples as confirmation samples depending on the sample results of the soil. A Proposed Sample Map can be found in Figure 1.

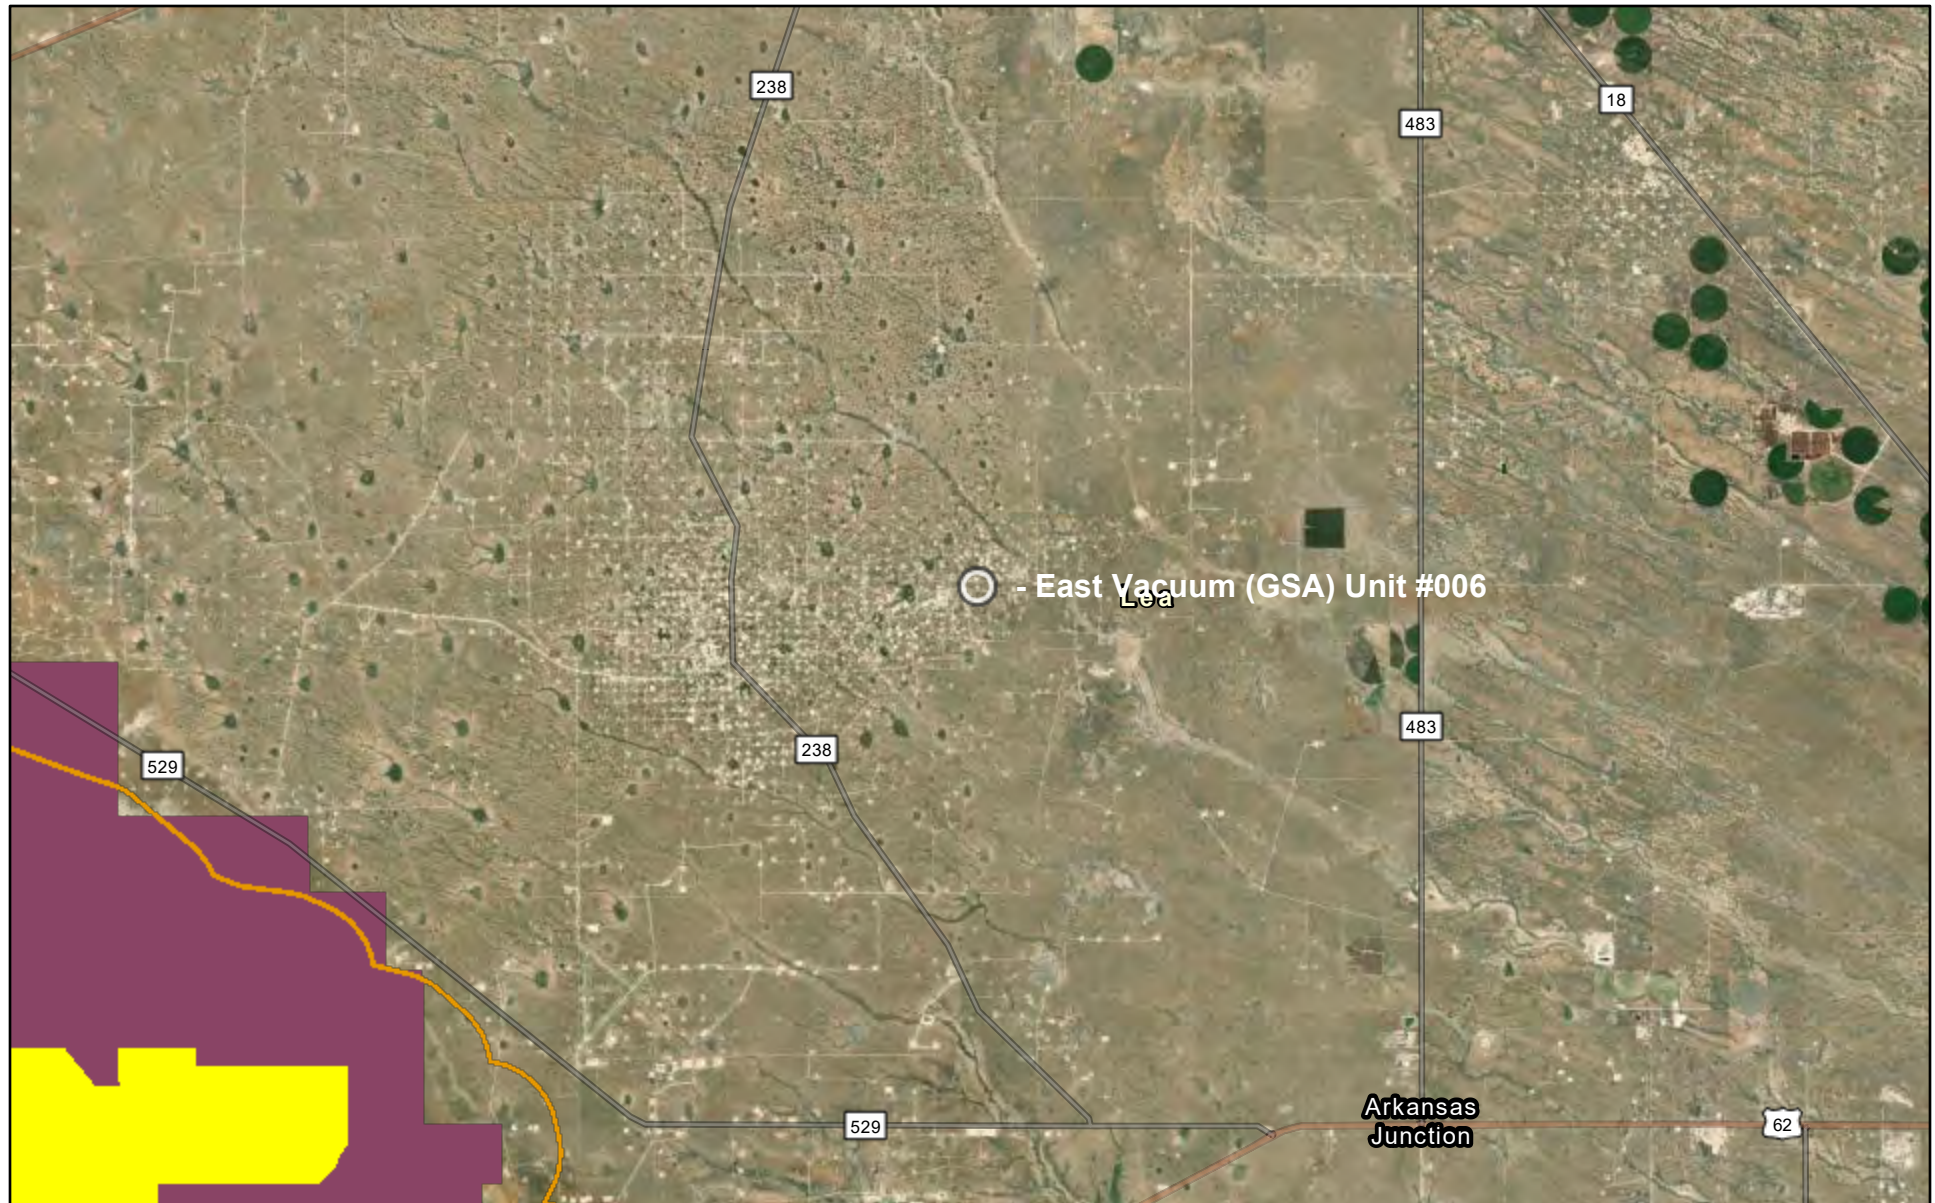
## Special Status Plant/Wildlife Map

- Dunes Sage Brush Lizard Habitat
- Lesser Prairie Chicken Habitat
- Habitat Evaluation Area
- Isolated Population Area

at the Site. The Site is not identified to be within biologically sensitive areas where remediation/reclamation would impact sensitive plant or wildlife habitats. A Special Status Plant/Wildlife Map is included in Figure 2.

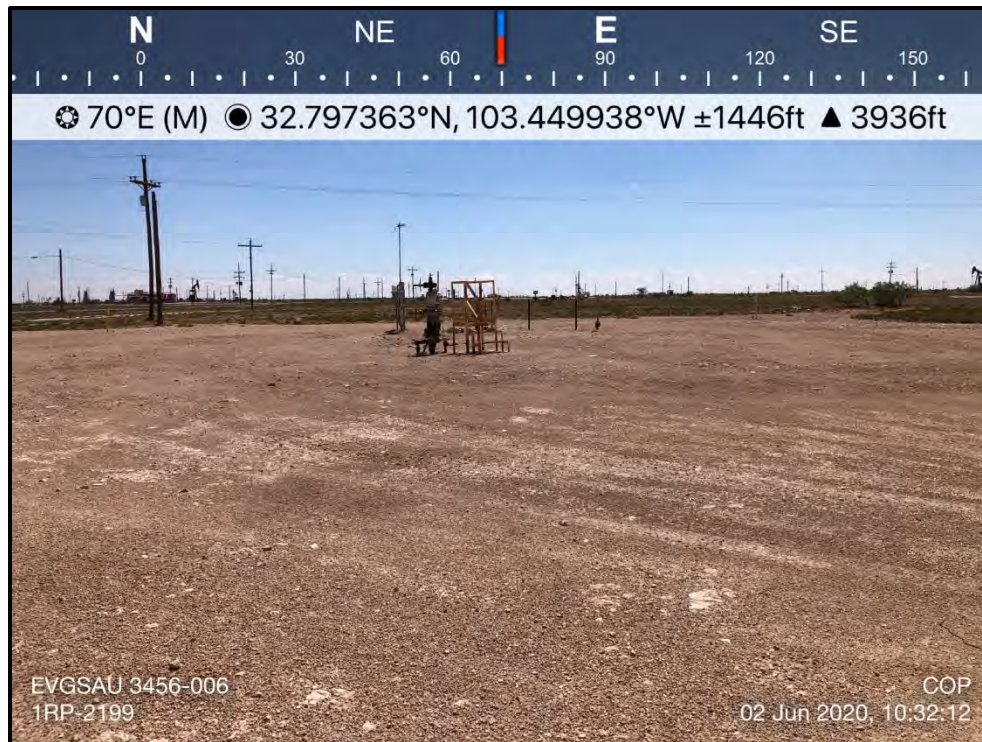
TETRA TECH, INC. PROJECT NO. 212C-MD-02152	DESCRIPTION	View facing northeast of well pad. Wellhead in background.	1
	SITE NAME	EVGSAU 3456-006 Wellhead Release	6/2/2020

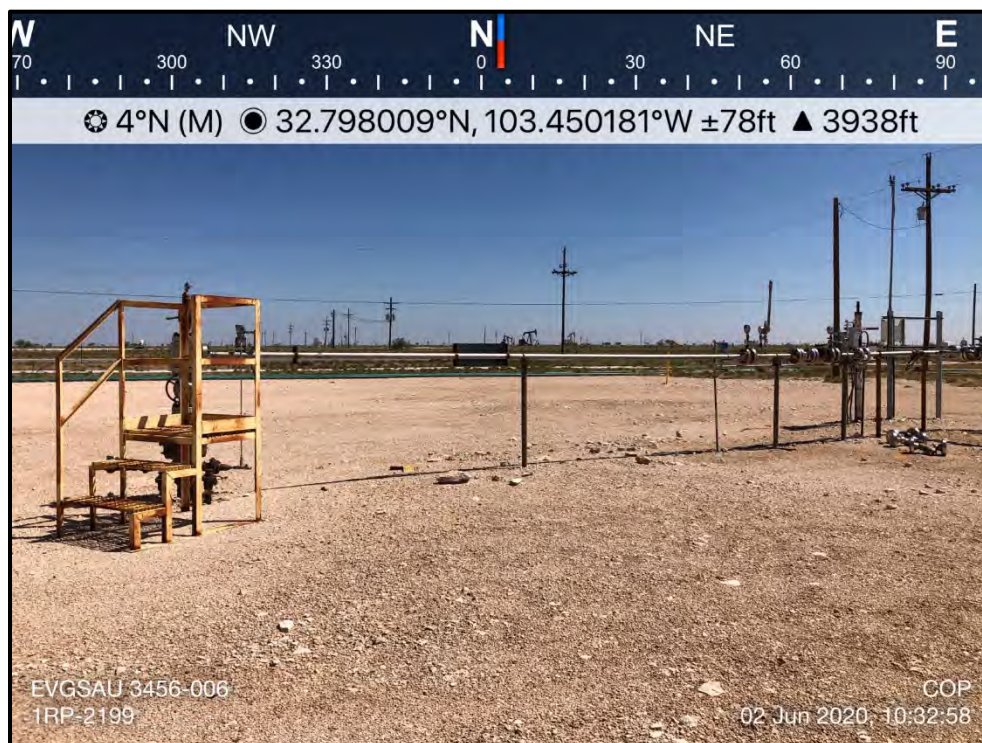
TETRA TECH, INC. PROJECT NO. 212C-MD-02152	DESCRIPTION	View facing north of well head and pipeline on well pad.	2
	SITE NAME	EVGSAU 3456-006 Wellhead Release	6/2/2020

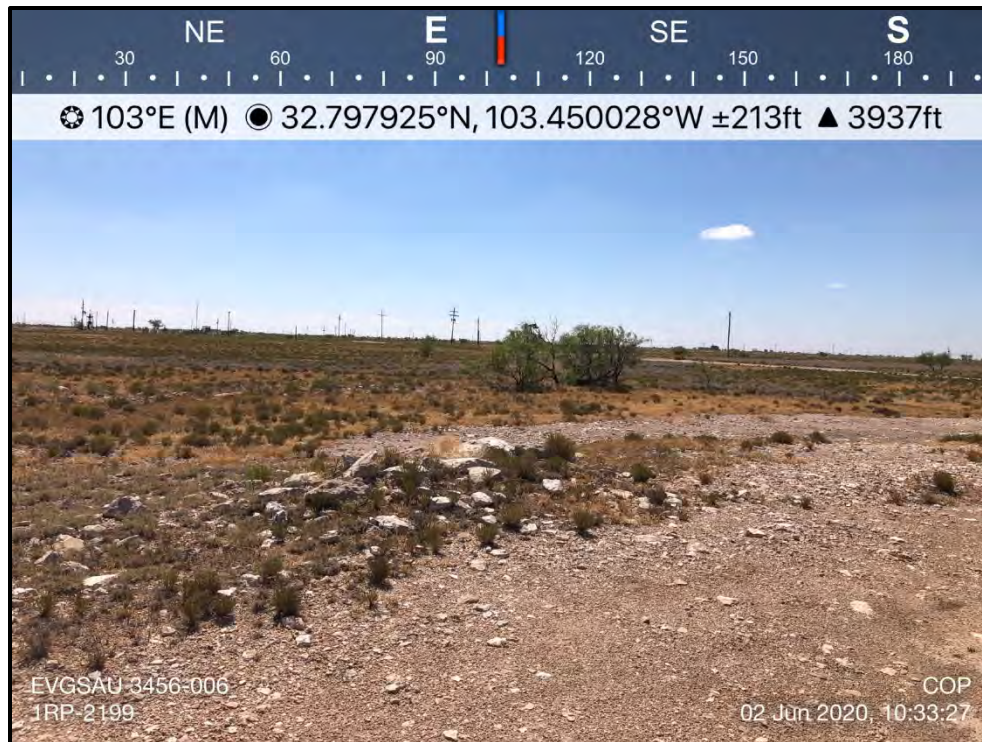
TETRA TECH, INC. PROJECT NO. 212C-MD-02152	DESCRIPTION	View facing east on the eastern end of the well pad area.	3
	SITE NAME	EVGSAU 3456-006 Wellhead Release	6/2/2020

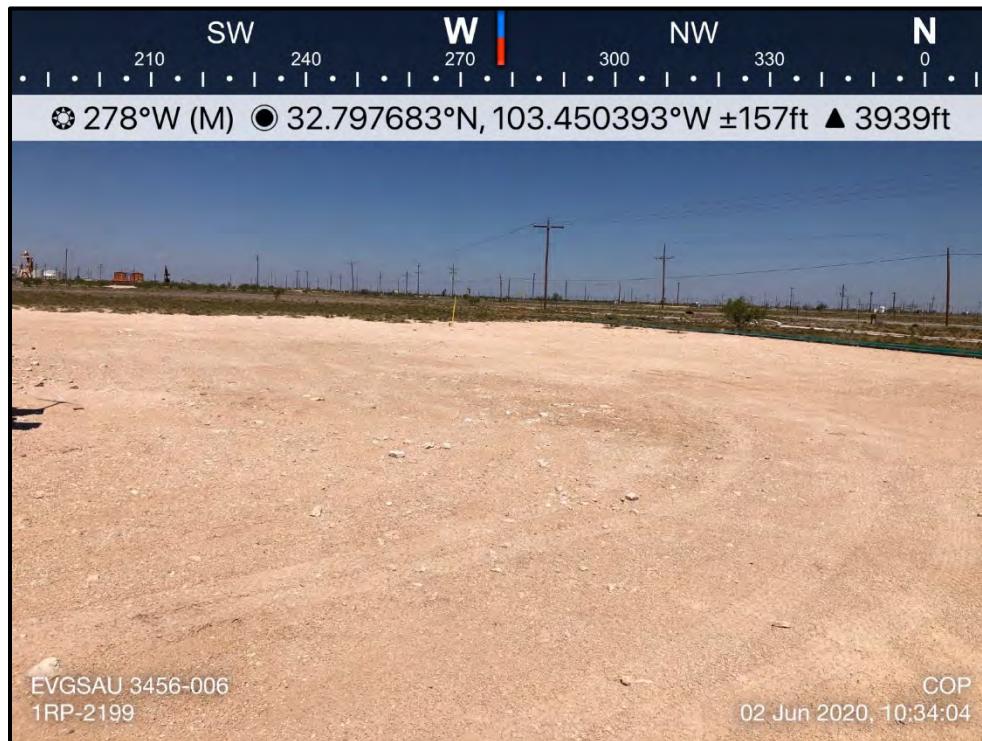
TETRA TECH, INC. PROJECT NO. 212C-MD-02152	DESCRIPTION	View facing west on the well pad.	5
	SITE NAME	EVGSAU 3456-006 Wellhead Release	6/2/2020
