**Re: Closure Request  
James Ranch Unit DI 1A Battery  
Incident Number NAPP2421529493  
Eddy County, New Mexico**

XTO Energy, Inc  
Closure Request  
James Ranch Unit DI 1A Battery

# **Environmental Karst Study Report James Ranch Unit DI 1A Battery Release Eddy County, New Mexico**

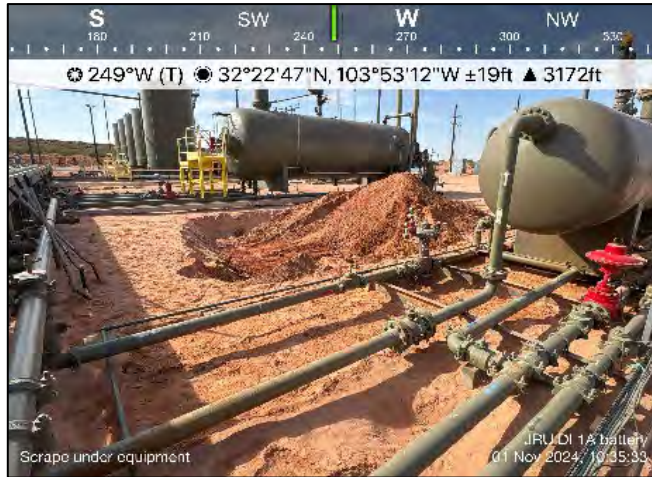
Photograph: 1      Date: 11/01/2024  
Description: Excavation activities  
View: West

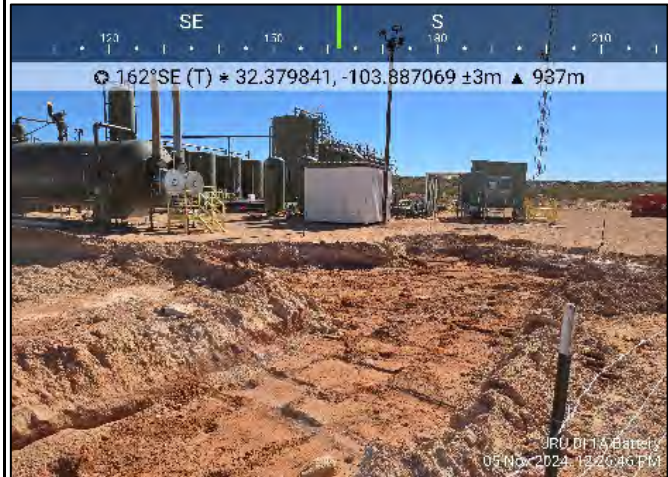
Photograph: 2      Date: 11/05/2024  
Description: Excavation activities  
View: Southeast

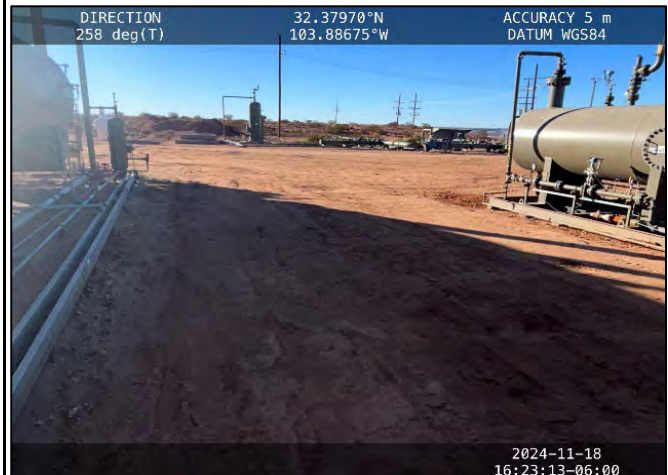
Photograph: 4      Date: 11/18/2024  
Description: Backfill  
View: West

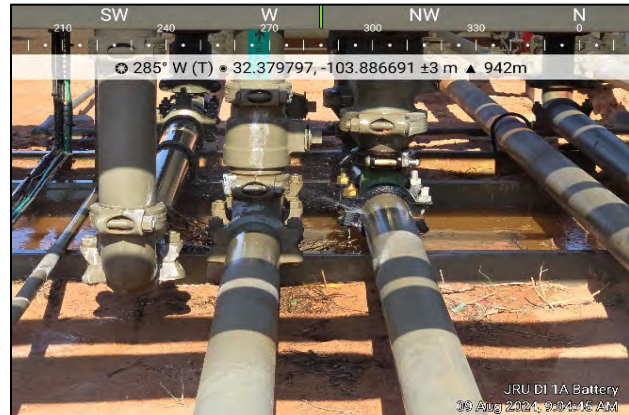
Photograph: 2 Date: 8/9/2024  
Description: Active leak  
View: Northwest

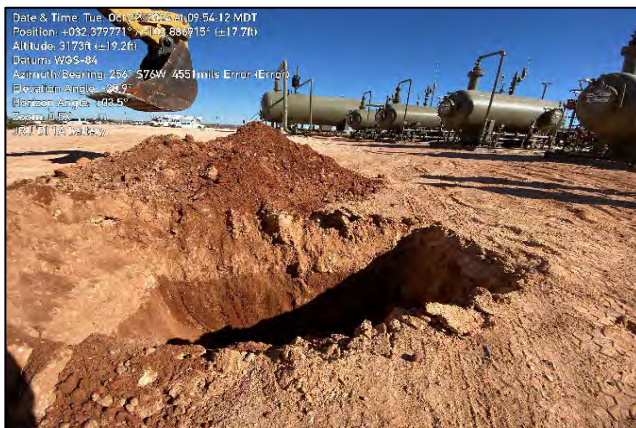
Photograph: 3 Date: 10/22/24  
Description: Pothole activities  
View: Southwest

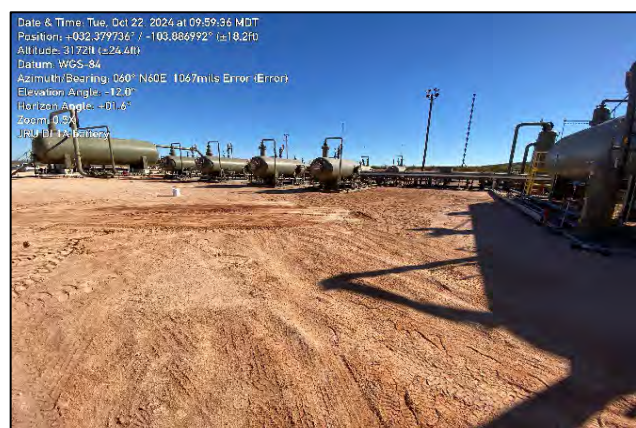
Photograph: 4 Date: 10/22/2024  
Description: Remediation activities  
View: Northeast

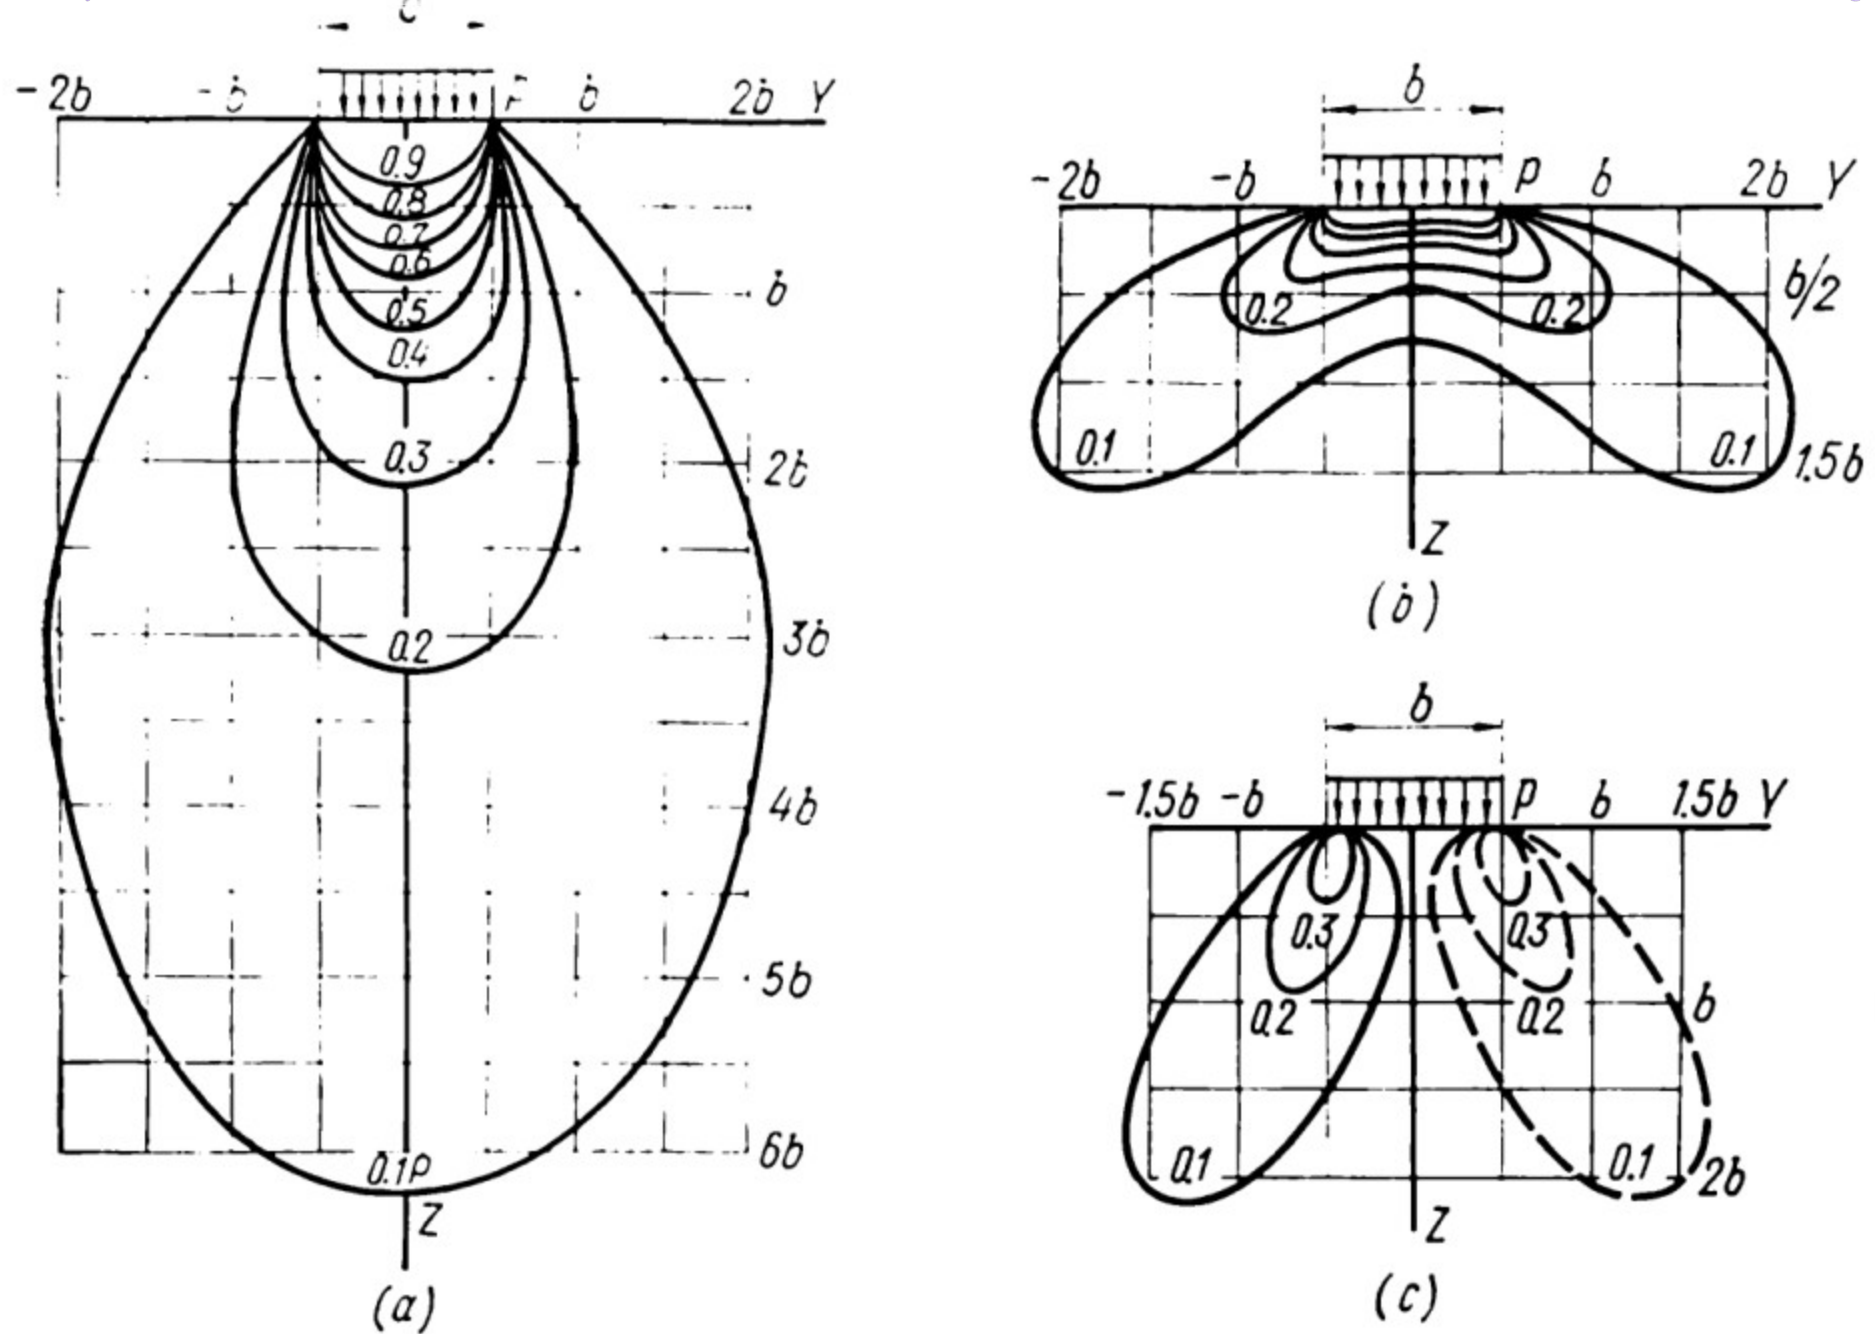
**Fig. 49.** Lines of equal stresses in a linearly deformable massif for the planar problem

(a) isobars  $\sigma_z$ ; (b) lateral pressure  $\sigma_y$ ; (c) shears  $\tau_{zx}$
