SEMU EUMONT #042  
nLWJ1032639357

PREPARED BY SAPEC-ECO, LLC.  
PREPARED FOR MAVERICK PERMIAN, LLC.

## **Proposed Sampling and Remediation Work Plan**

Re: Proposed Sampling and Remediation Work Plan  
 NMOCD Incident Number: **nLWJ1032639357**  
 SEMU Eumont #042 API No. 30-025-06089  
 Unit N, Section 13, Township 20S, Range 37E 660 FSL 1980 FWL Lea County, NM  
 GPS Coordinates: Latitude 32.5676537 Longitude -103.2071686 NAD83

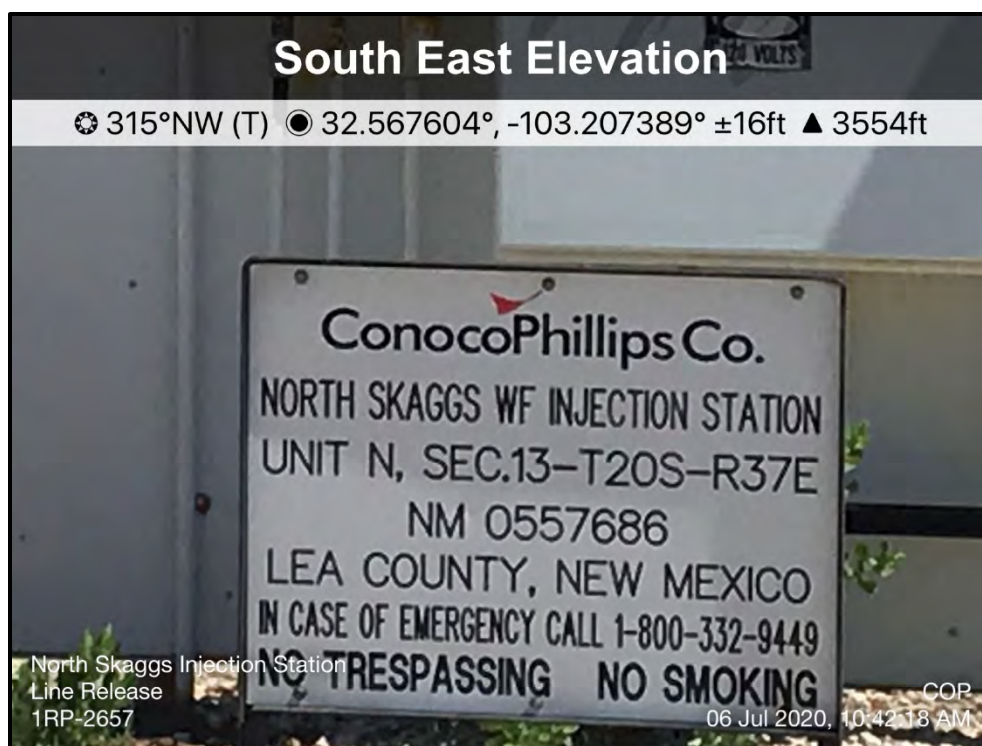
TETRA TECH, INC. PROJECT NO. 212C-MD-02152	DESCRIPTION	View facing northwest of lease signage.	1
	SITE NAME	North Skaggs Injection Station Injection Line Release	7/6/2020

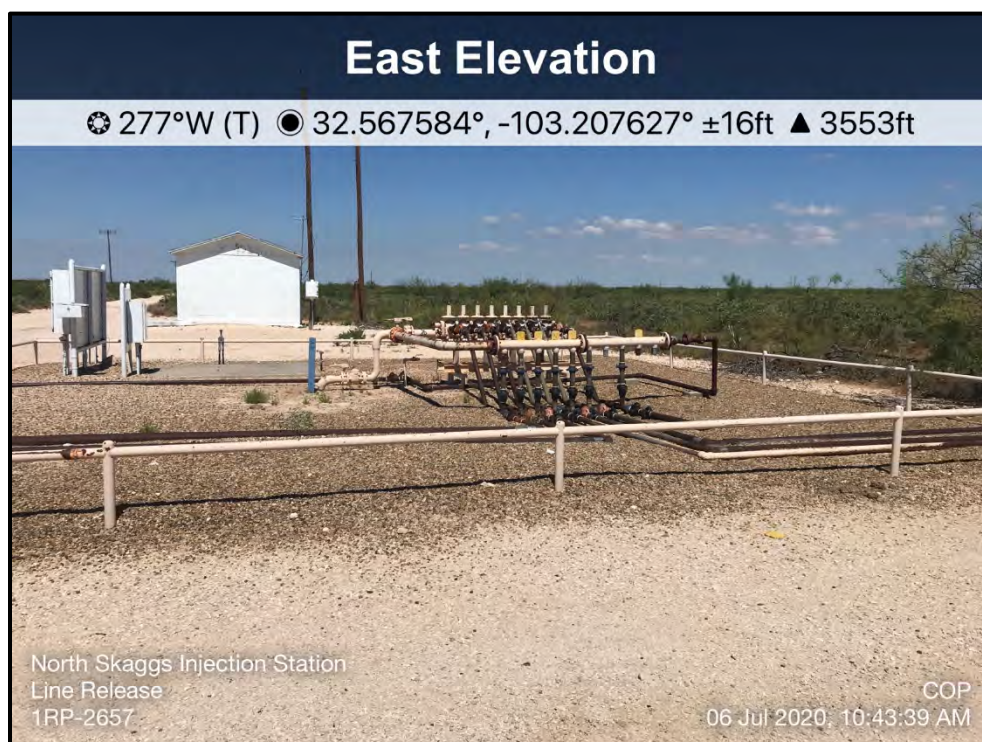
TETRA TECH, INC. PROJECT NO. 212C-MD-02152	DESCRIPTION	View facing west of injection station manifold.	2
	SITE NAME	North Skaggs Injection Station Injection Line Release	7/6/2020

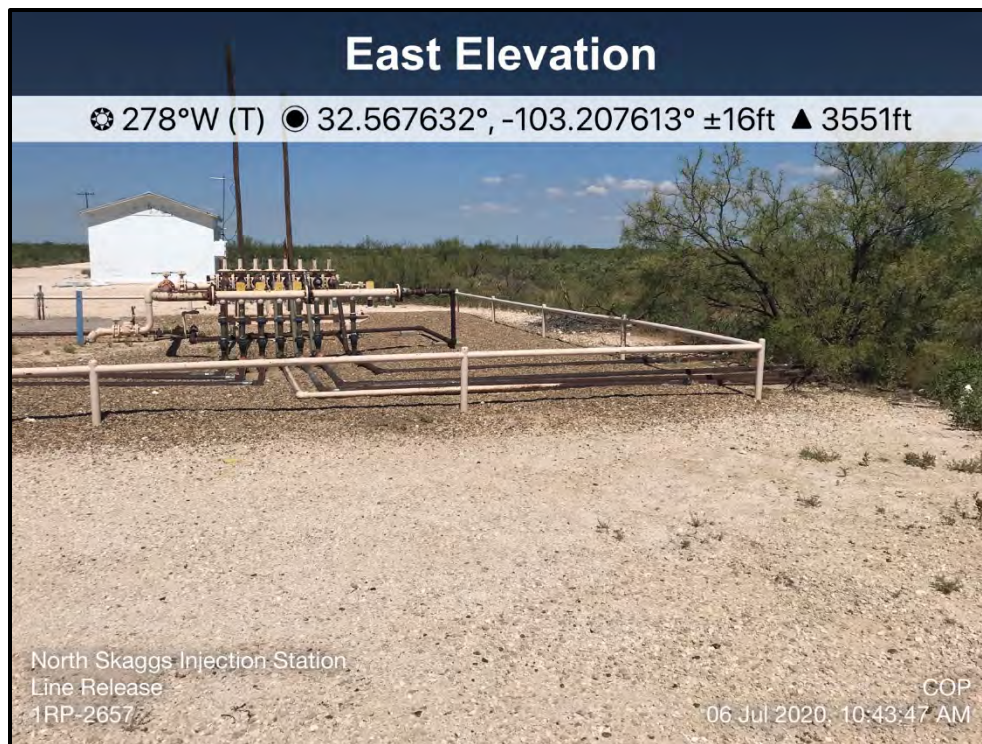
TETRA TECH, INC. PROJECT NO. 212C-MD-02152	DESCRIPTION	View facing west of injection station manifold.	3
	SITE NAME	North Skaggs Injection Station Injection Line Release	7/6/2020

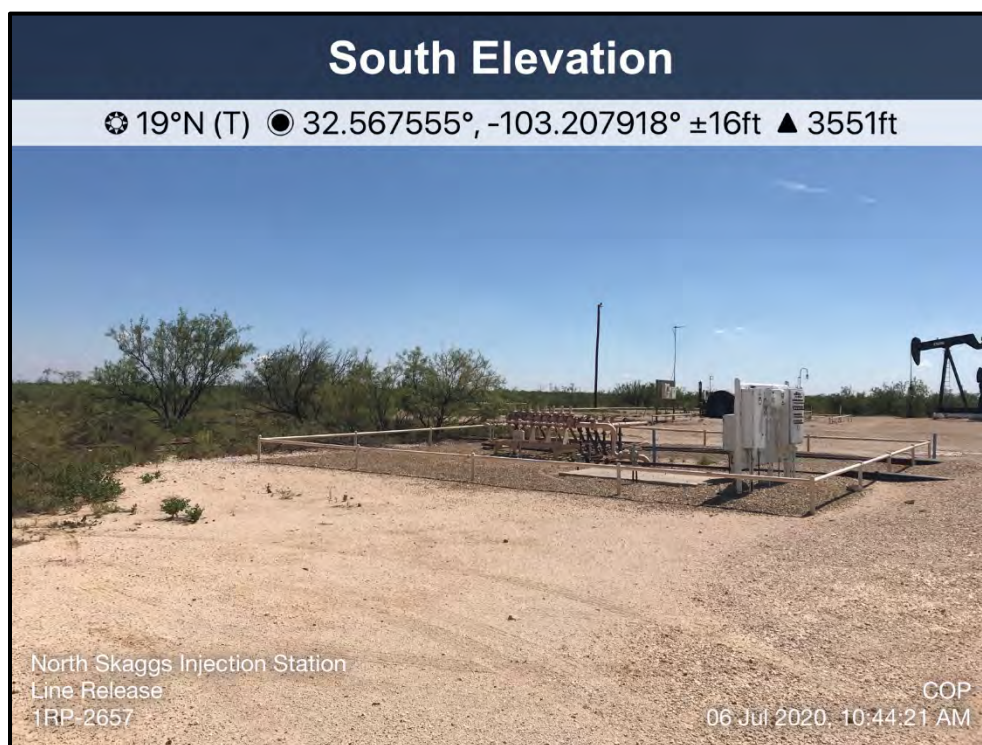
TETRA TECH, INC. PROJECT NO. 212C-MD-02152	DESCRIPTION	View facing north of injection station manifold.	4
	SITE NAME	North Skaggs Injection Station Injection Line Release	7/6/2020

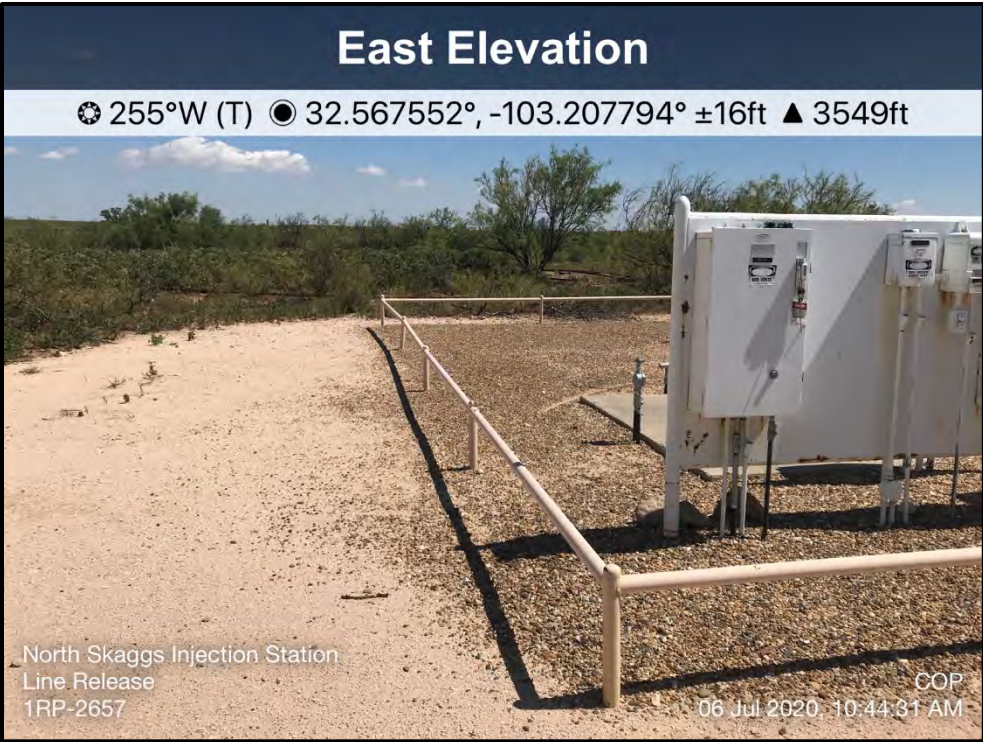
TETRA TECH, INC. PROJECT NO. 212C-MD-02152	DESCRIPTION	View facing west of injection station manifold control panels.	5
	SITE NAME	North Skaggs Injection Station Injection Line Release	7/6/2020

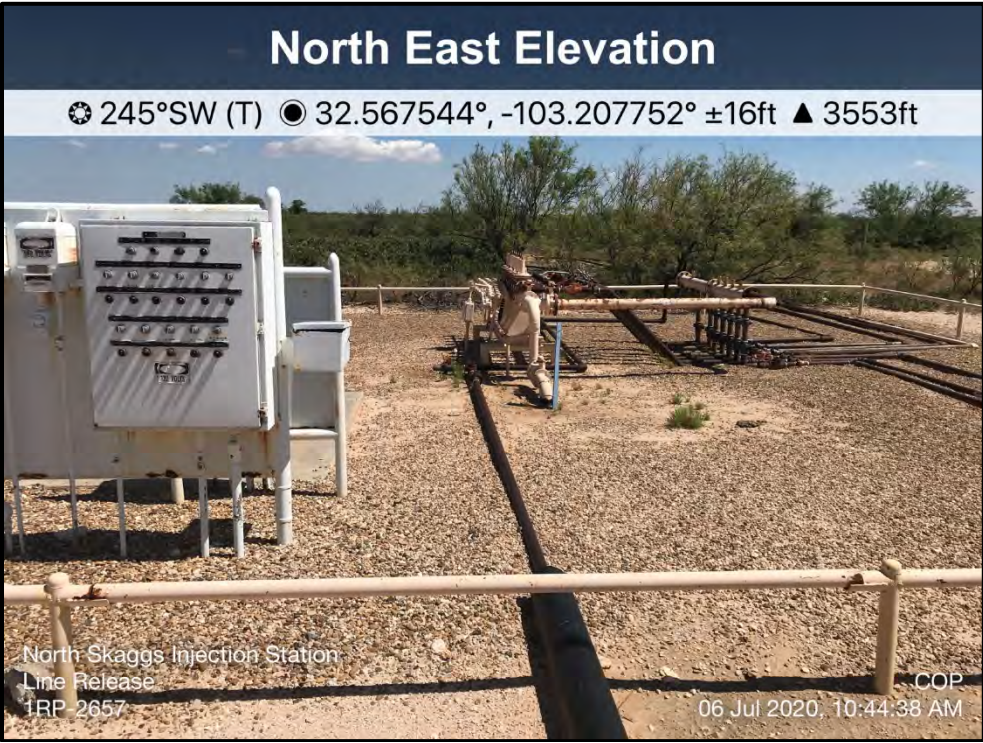
TETRA TECH, INC. PROJECT NO. 212C-MD-02152	DESCRIPTION	View facing southwest of injection station manifold control panels.	6
	SITE NAME	North Skaggs Injection Station Injection Line Release	7/6/2020

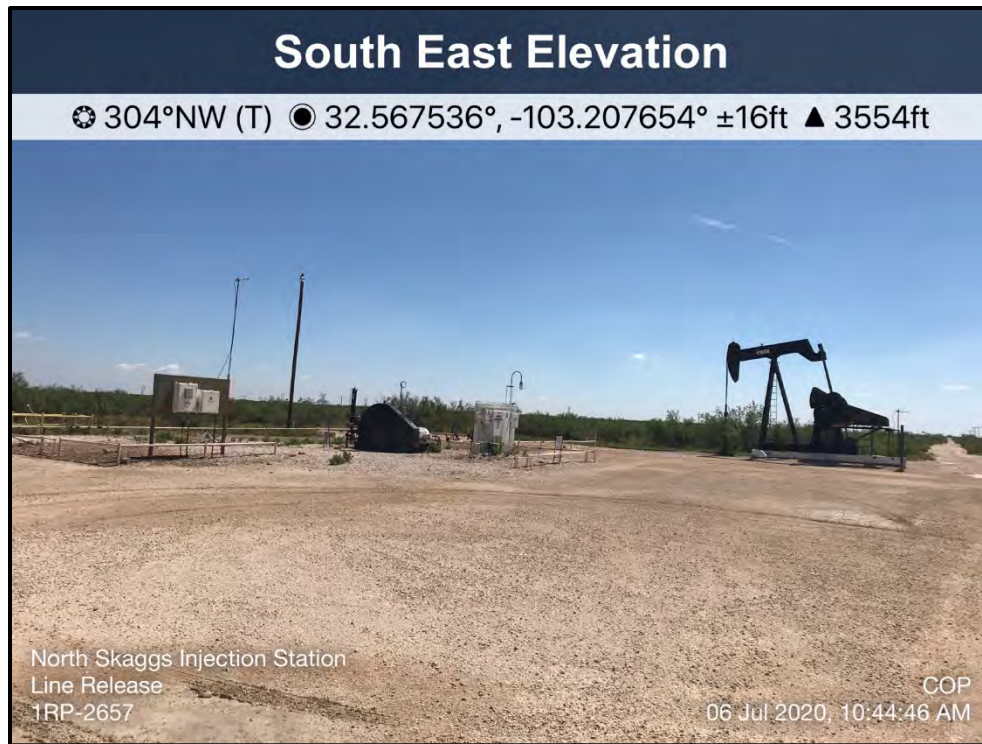
- Review of available historical aerial imagery revealed no evidence of the release in the vicinity of the injection station.
- No staining was noted on the injection station lease pad or in the adjacent pasture areas during the July 2020 visual Site inspection.

TETRA TECH, INC. PROJECT NO. 212C-MD-02152	DESCRIPTION	View facing northwest of injection station area.	7
	SITE NAME	North Skaggs Injection Station Injection Line Release	7/6/2020

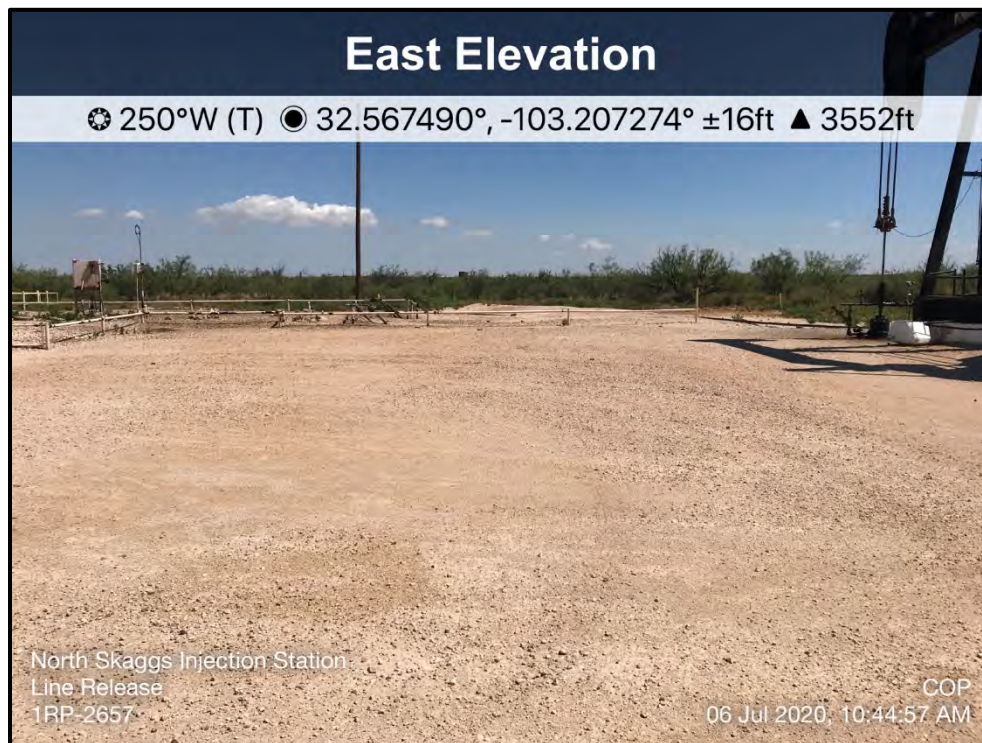
TETRA TECH, INC. PROJECT NO. 212C-MD-02152	DESCRIPTION	View facing west of well pad.	8
	SITE NAME	North Skaggs Injection Station Injection Line Release	7/6/2020

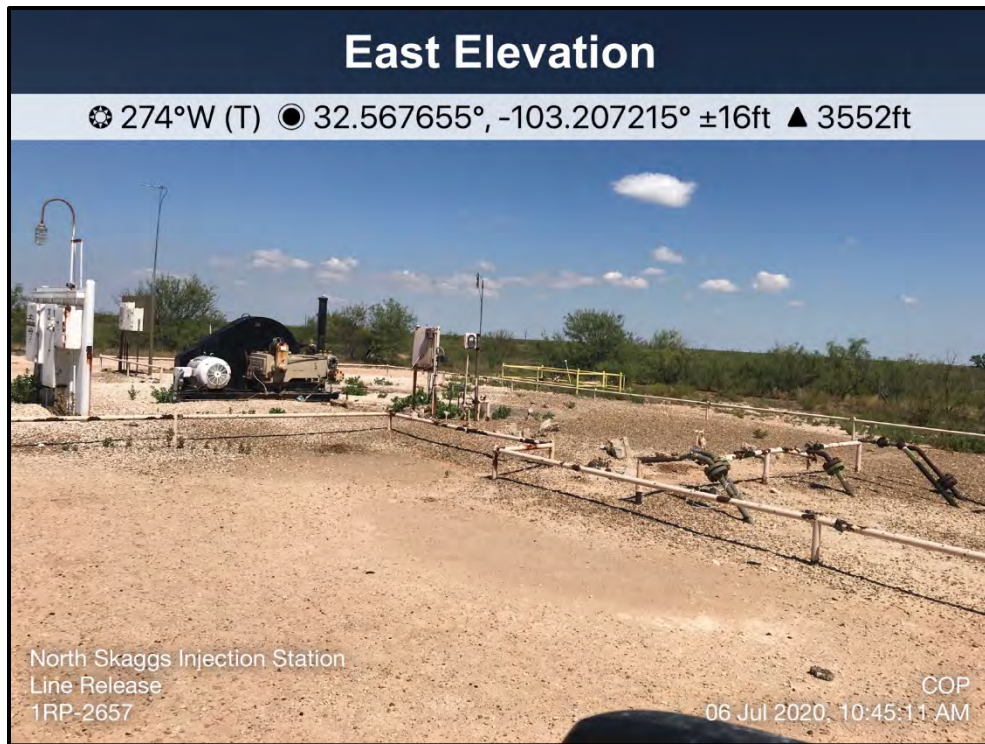
TETRA TECH, INC. PROJECT NO. 212C-MD-02152	DESCRIPTION	View facing west of injection station piping.	9
	SITE NAME	North Skaggs Injection Station Injection Line Release	7/6/2020

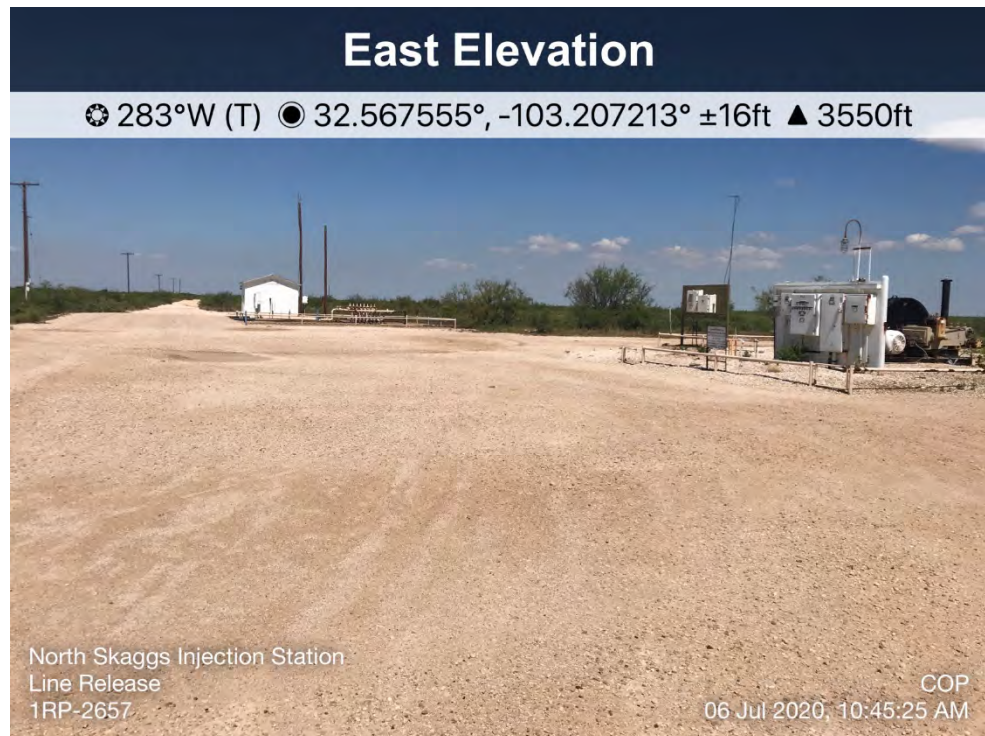
TETRA TECH, INC. PROJECT NO. 212C-MD-02152	DESCRIPTION	View facing west of injection station area.	10
	SITE NAME	North Skaggs Injection Station Injection Line Release	7/6/2020
