O-1 LINE LEAK

Remediation Action Plan

NMOCD Incident No. nAPP2230128101
UL "I", Sec. 36, T17S, R31E
32.78793°, -103.81779°
Eddy County, New Mexico

May 19, 2025

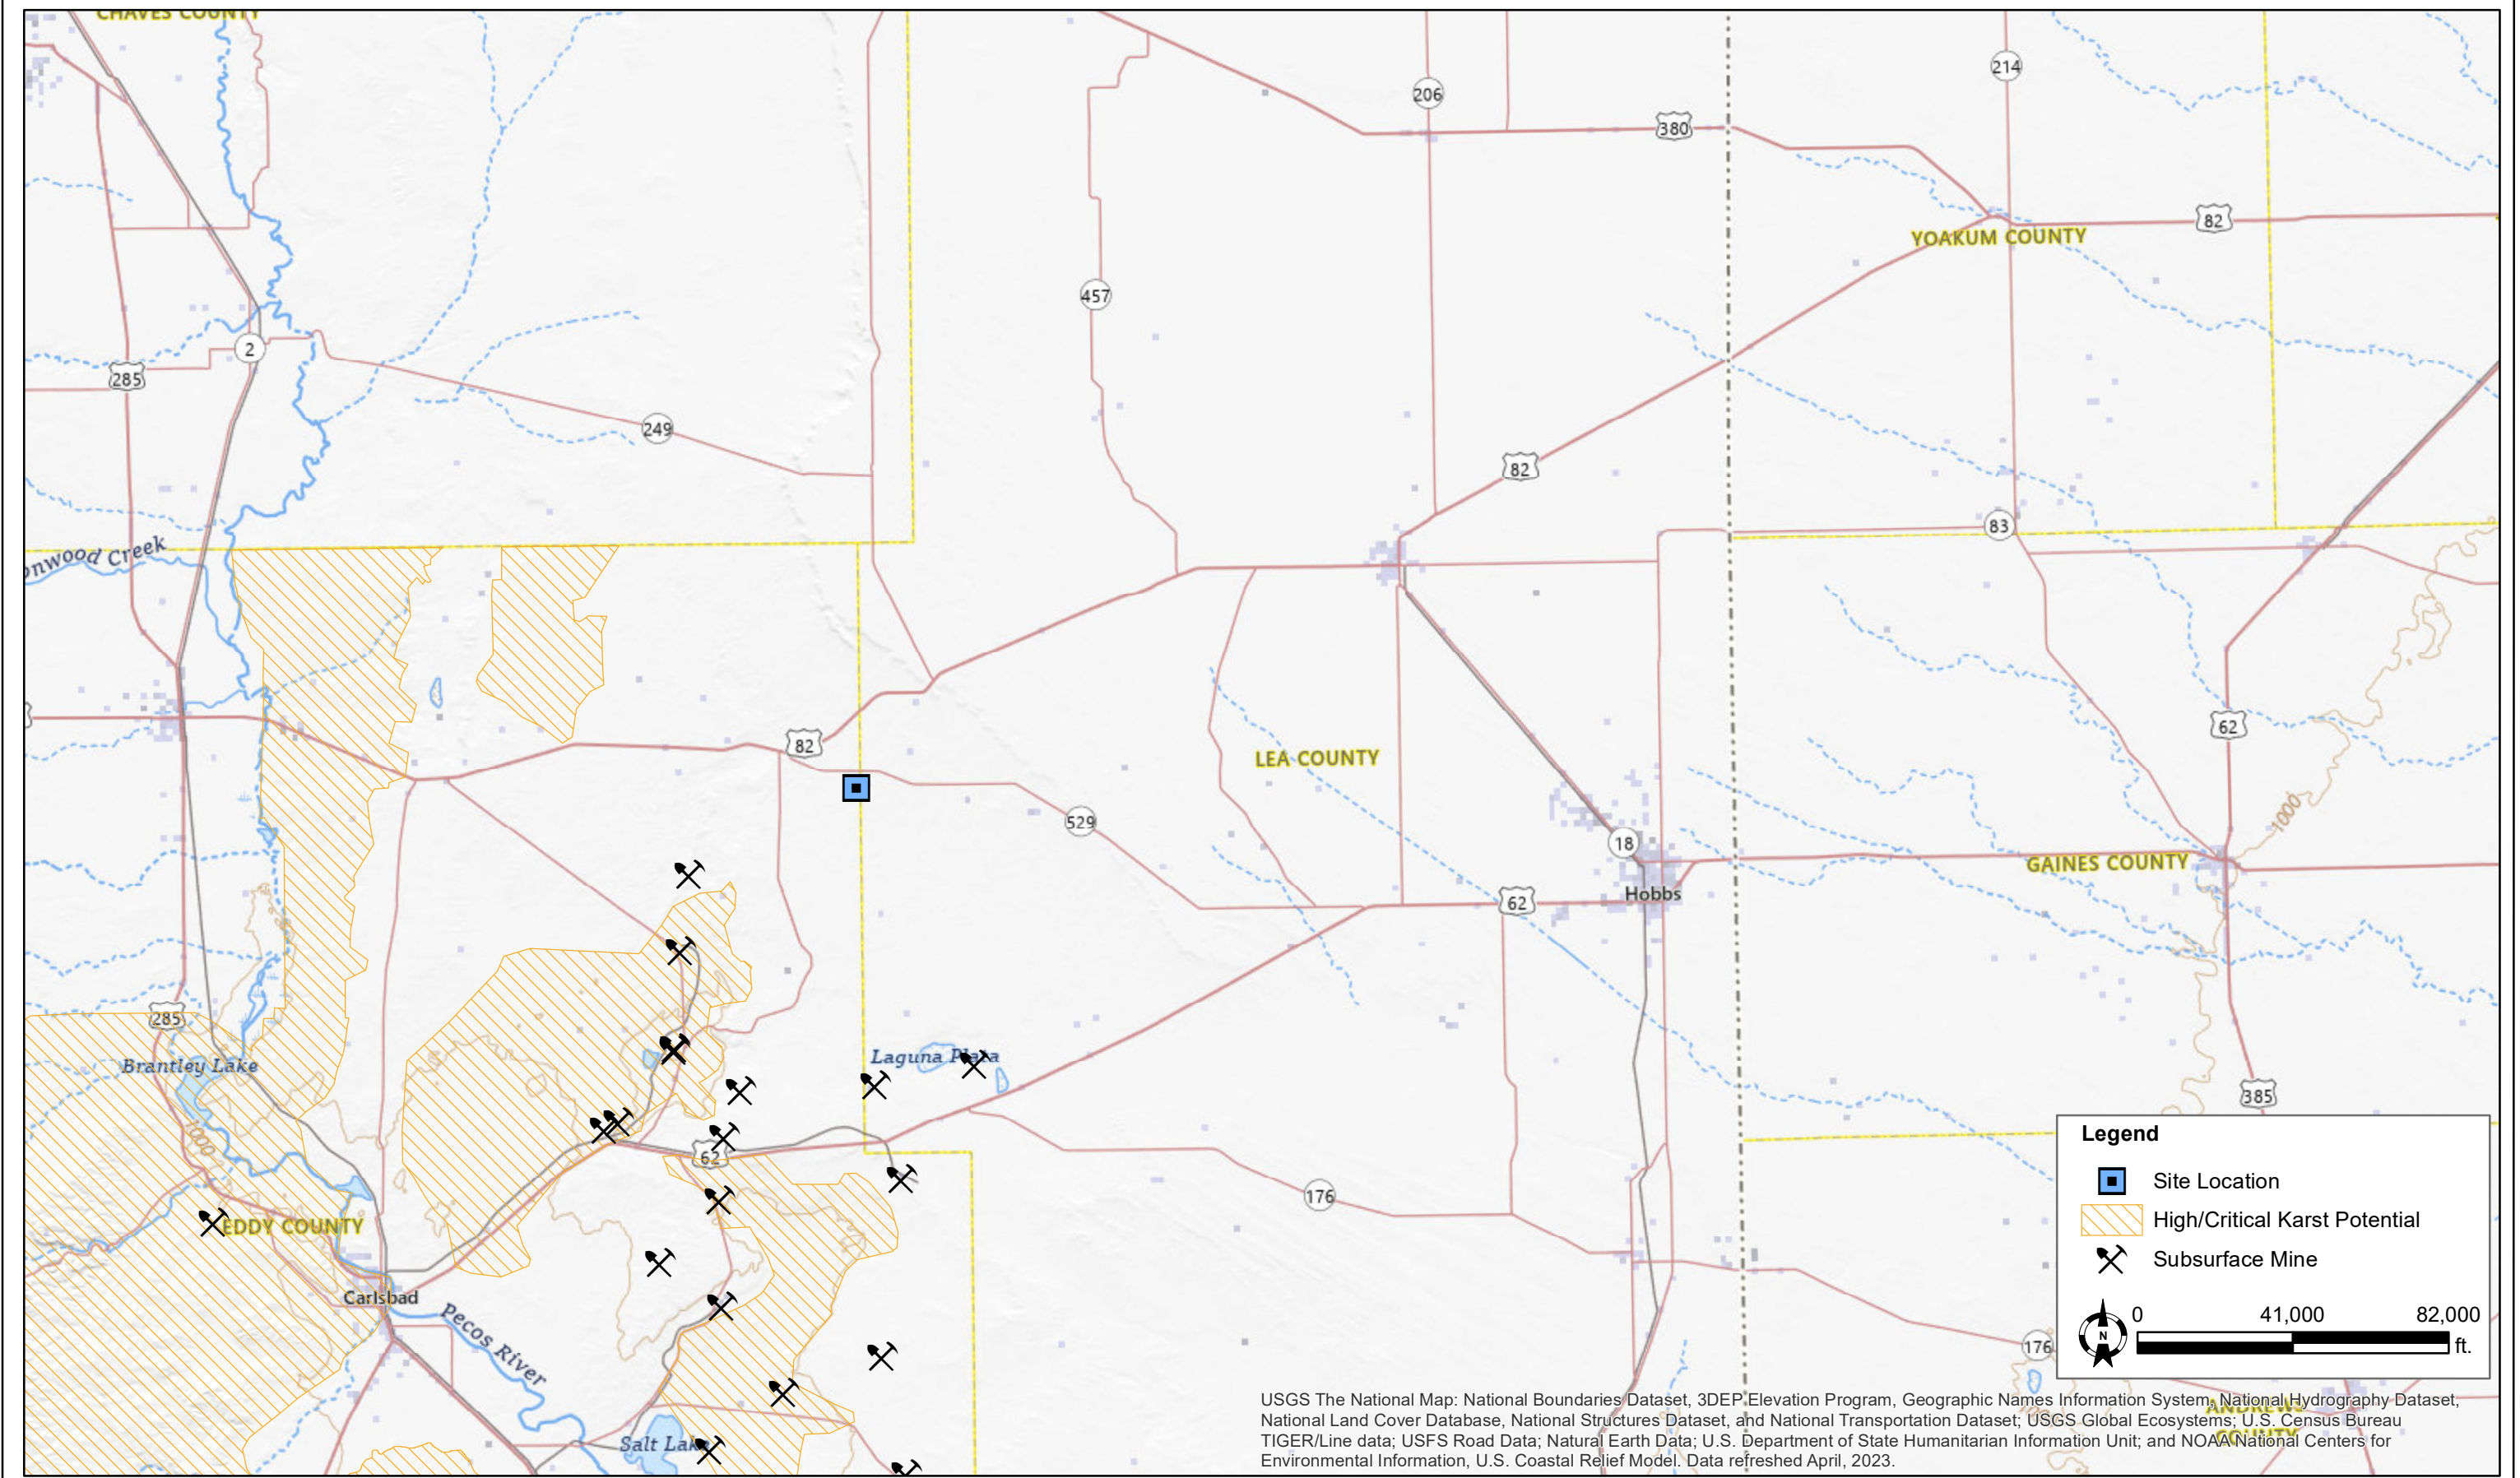
Figure
2

Karst Potential & Subsurface
Mine Map

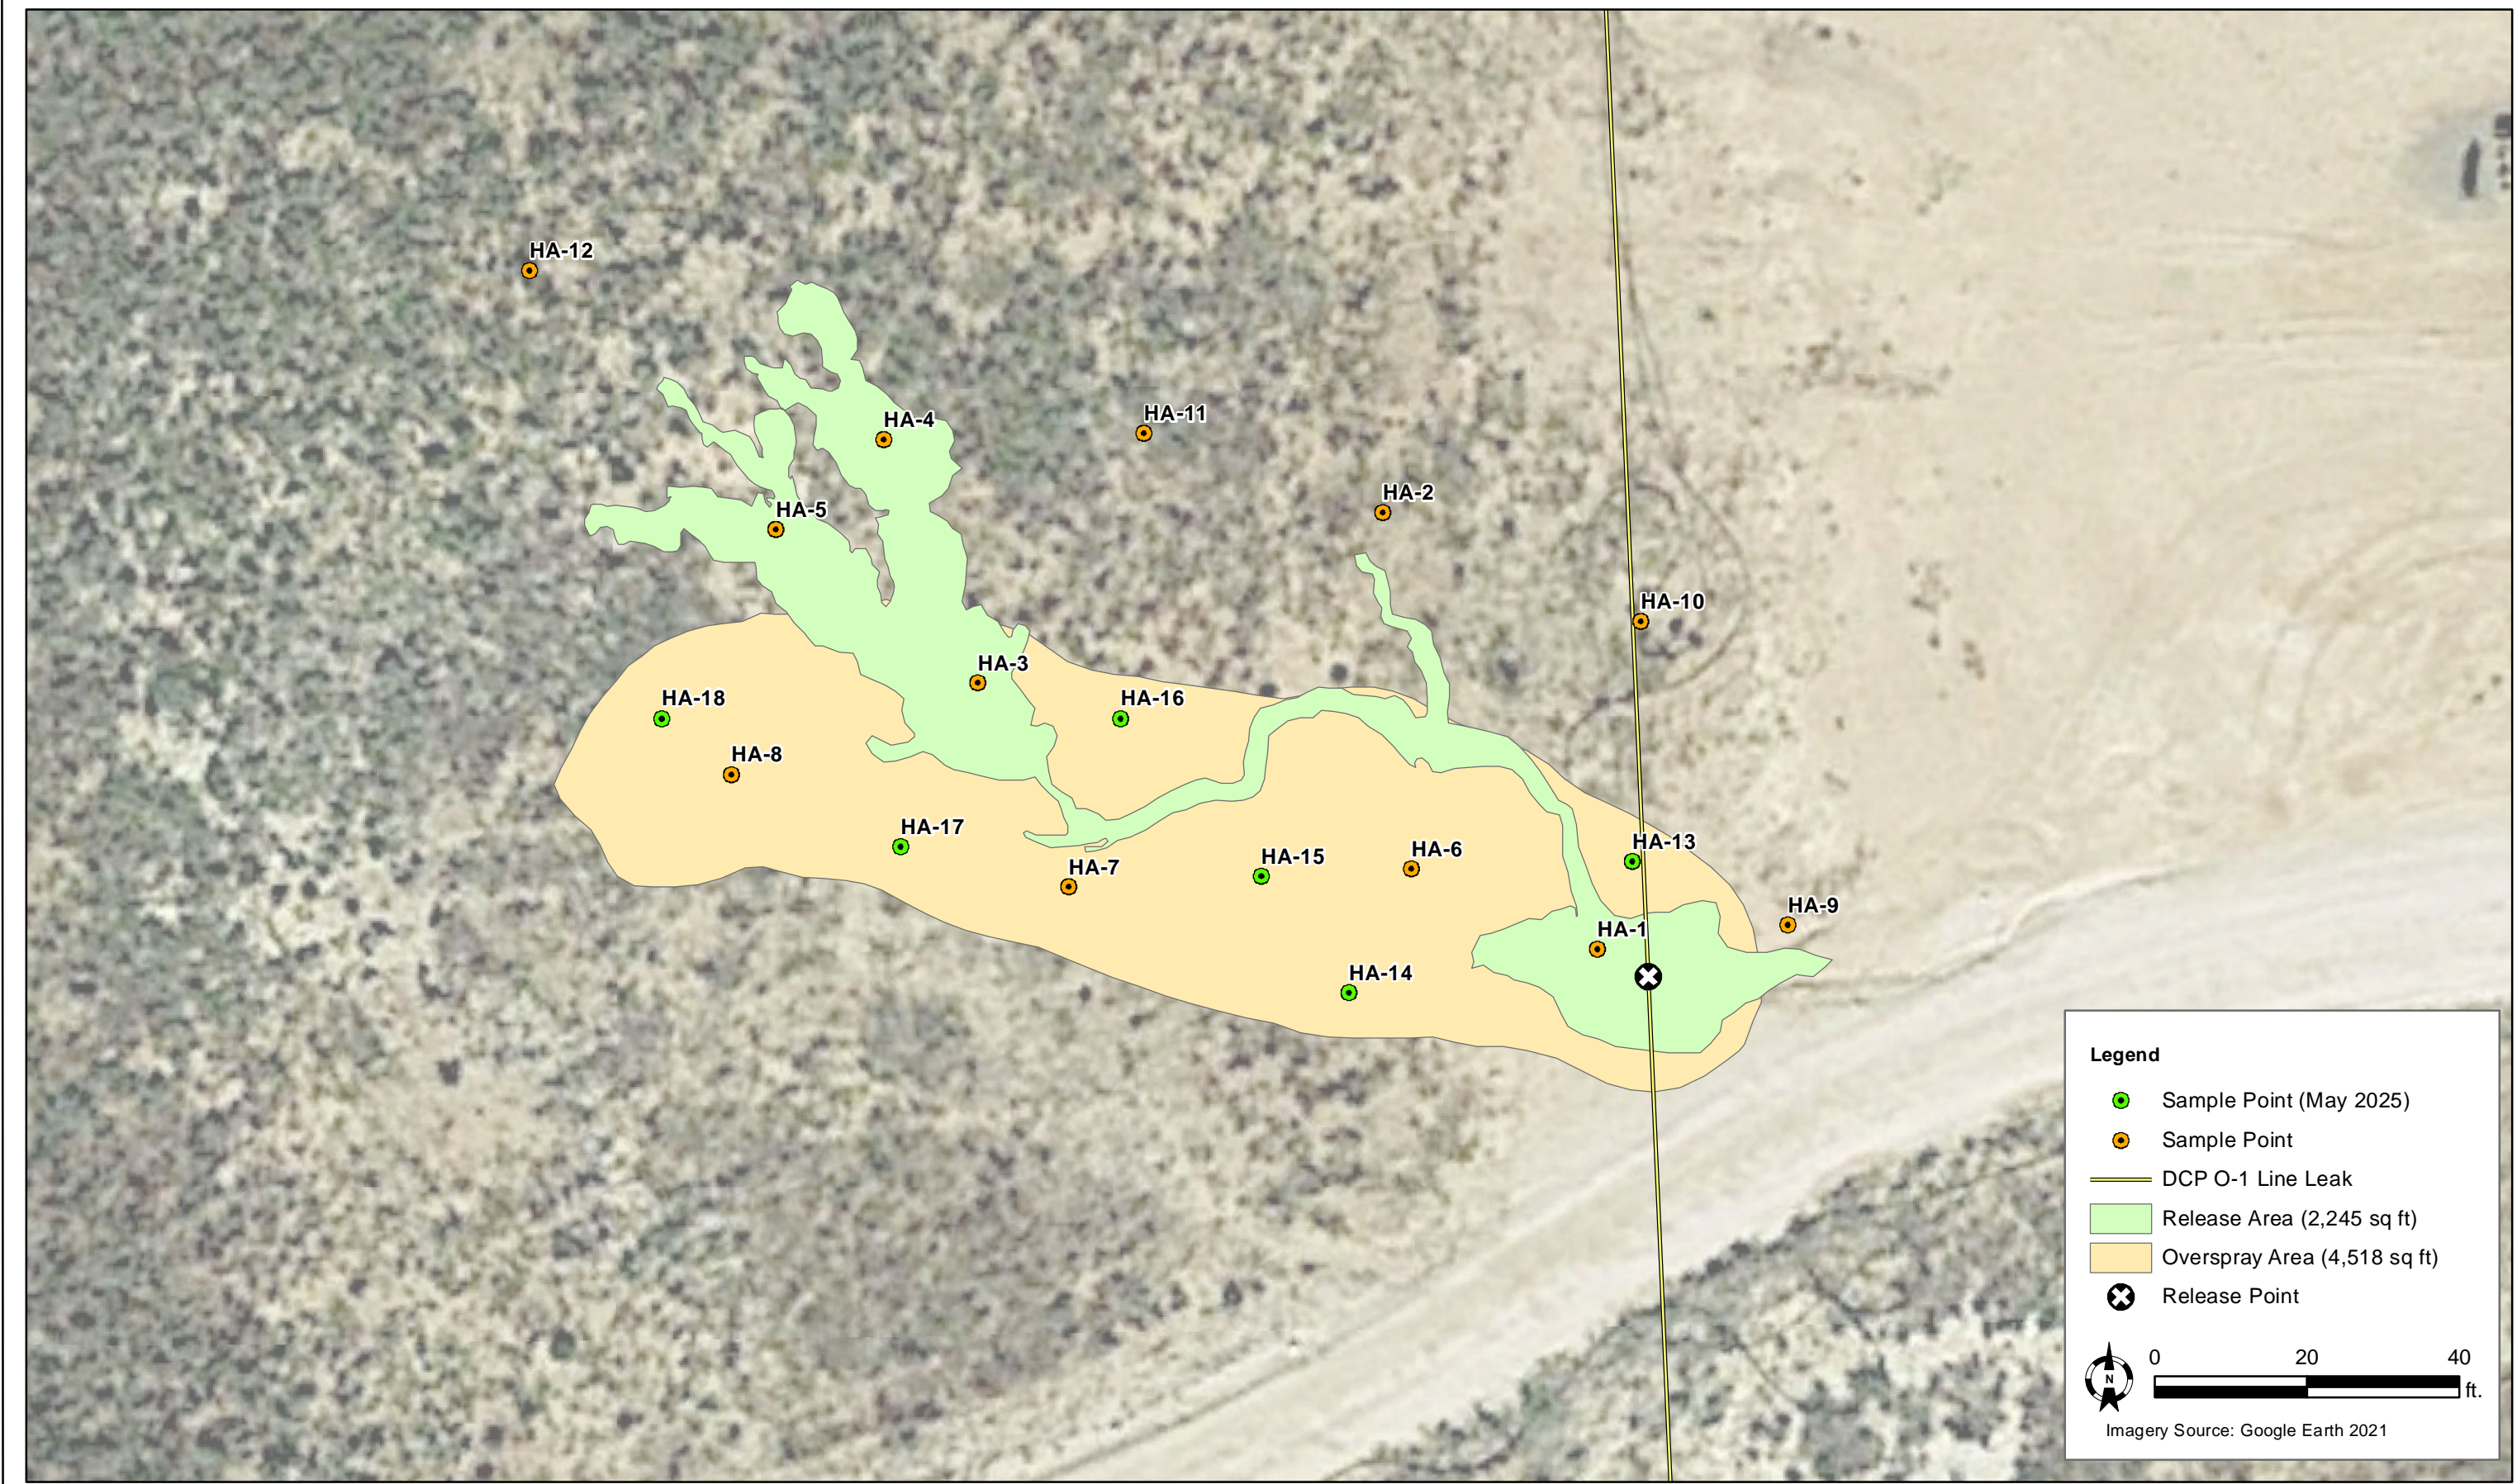
The attached Figure 5 illustrates the observed release and overspray area and location of soil sample locations.

On February 6, 2023, Tasman advanced twelve soil borings (HA-1 through HA-12) via hand auger to delineate the release area (HA-1 through HA-5 and HA-9 through HA-12) and overspray area (HA-6, HA-7, and HA-8) vertically. Each of these soil borings were advanced within the observed release area to depths ranging from 3 feet bgs to 6 feet bgs.
