December, 2024

SUBJECT: Closure Report for the Dagger Lake Zeus Pond Release, NAPP2222961063 Lea County,

New Mexico

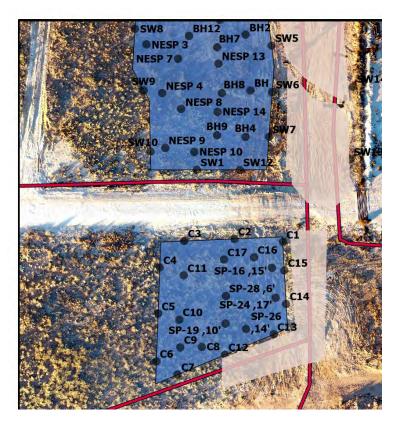
As shown in figure 4 there is approximately 863 yards from the southern release area that is Chloride impacted in and around the area pipelines. The pond impoundment and neighboring SWD pad to the north and east are upgradient to the release area, as shown in contours in figure 6.

The general site drainage was from north to south, starting at the northern pond and eastern SWD pad down to the fee pasture across the lease road and out onto the BLM surface to the south. This north-to-south flow is the spill path that both releases followed. Because of the multiple releases (three 3) and the volume of produced water the site handles AEA requested from the landowner the ability to change the surface contorts to reduce the leaching potential of any current and future chloride both latterly and horizontally.

The deferred areas have been bounded by four-to-five-foot (4-5 ft) ft soil berms, and the culvert that ran north to south bisecting the lease road has been removed.
