BRITT B #027
nTO1422532945

PREPARED BY SAPEC-ECO, LLC.
PREPARED FOR MAVERICK PERMIAN, LLC.

Proposed Sampling and Remediation Work Plan

Re: Proposed Sampling and Remediation Work Plan
NMOCD Incident Number: **nT01422532945**
Britt B #027 API No. 30-025-26941
Unit G, Section 15, Township 20S, Range 37E 1980 FNL 1980 FEL Lea County, NM
GPS Coordinates: Latitude 32.5749016 Longitude -103.2371902 NAD83

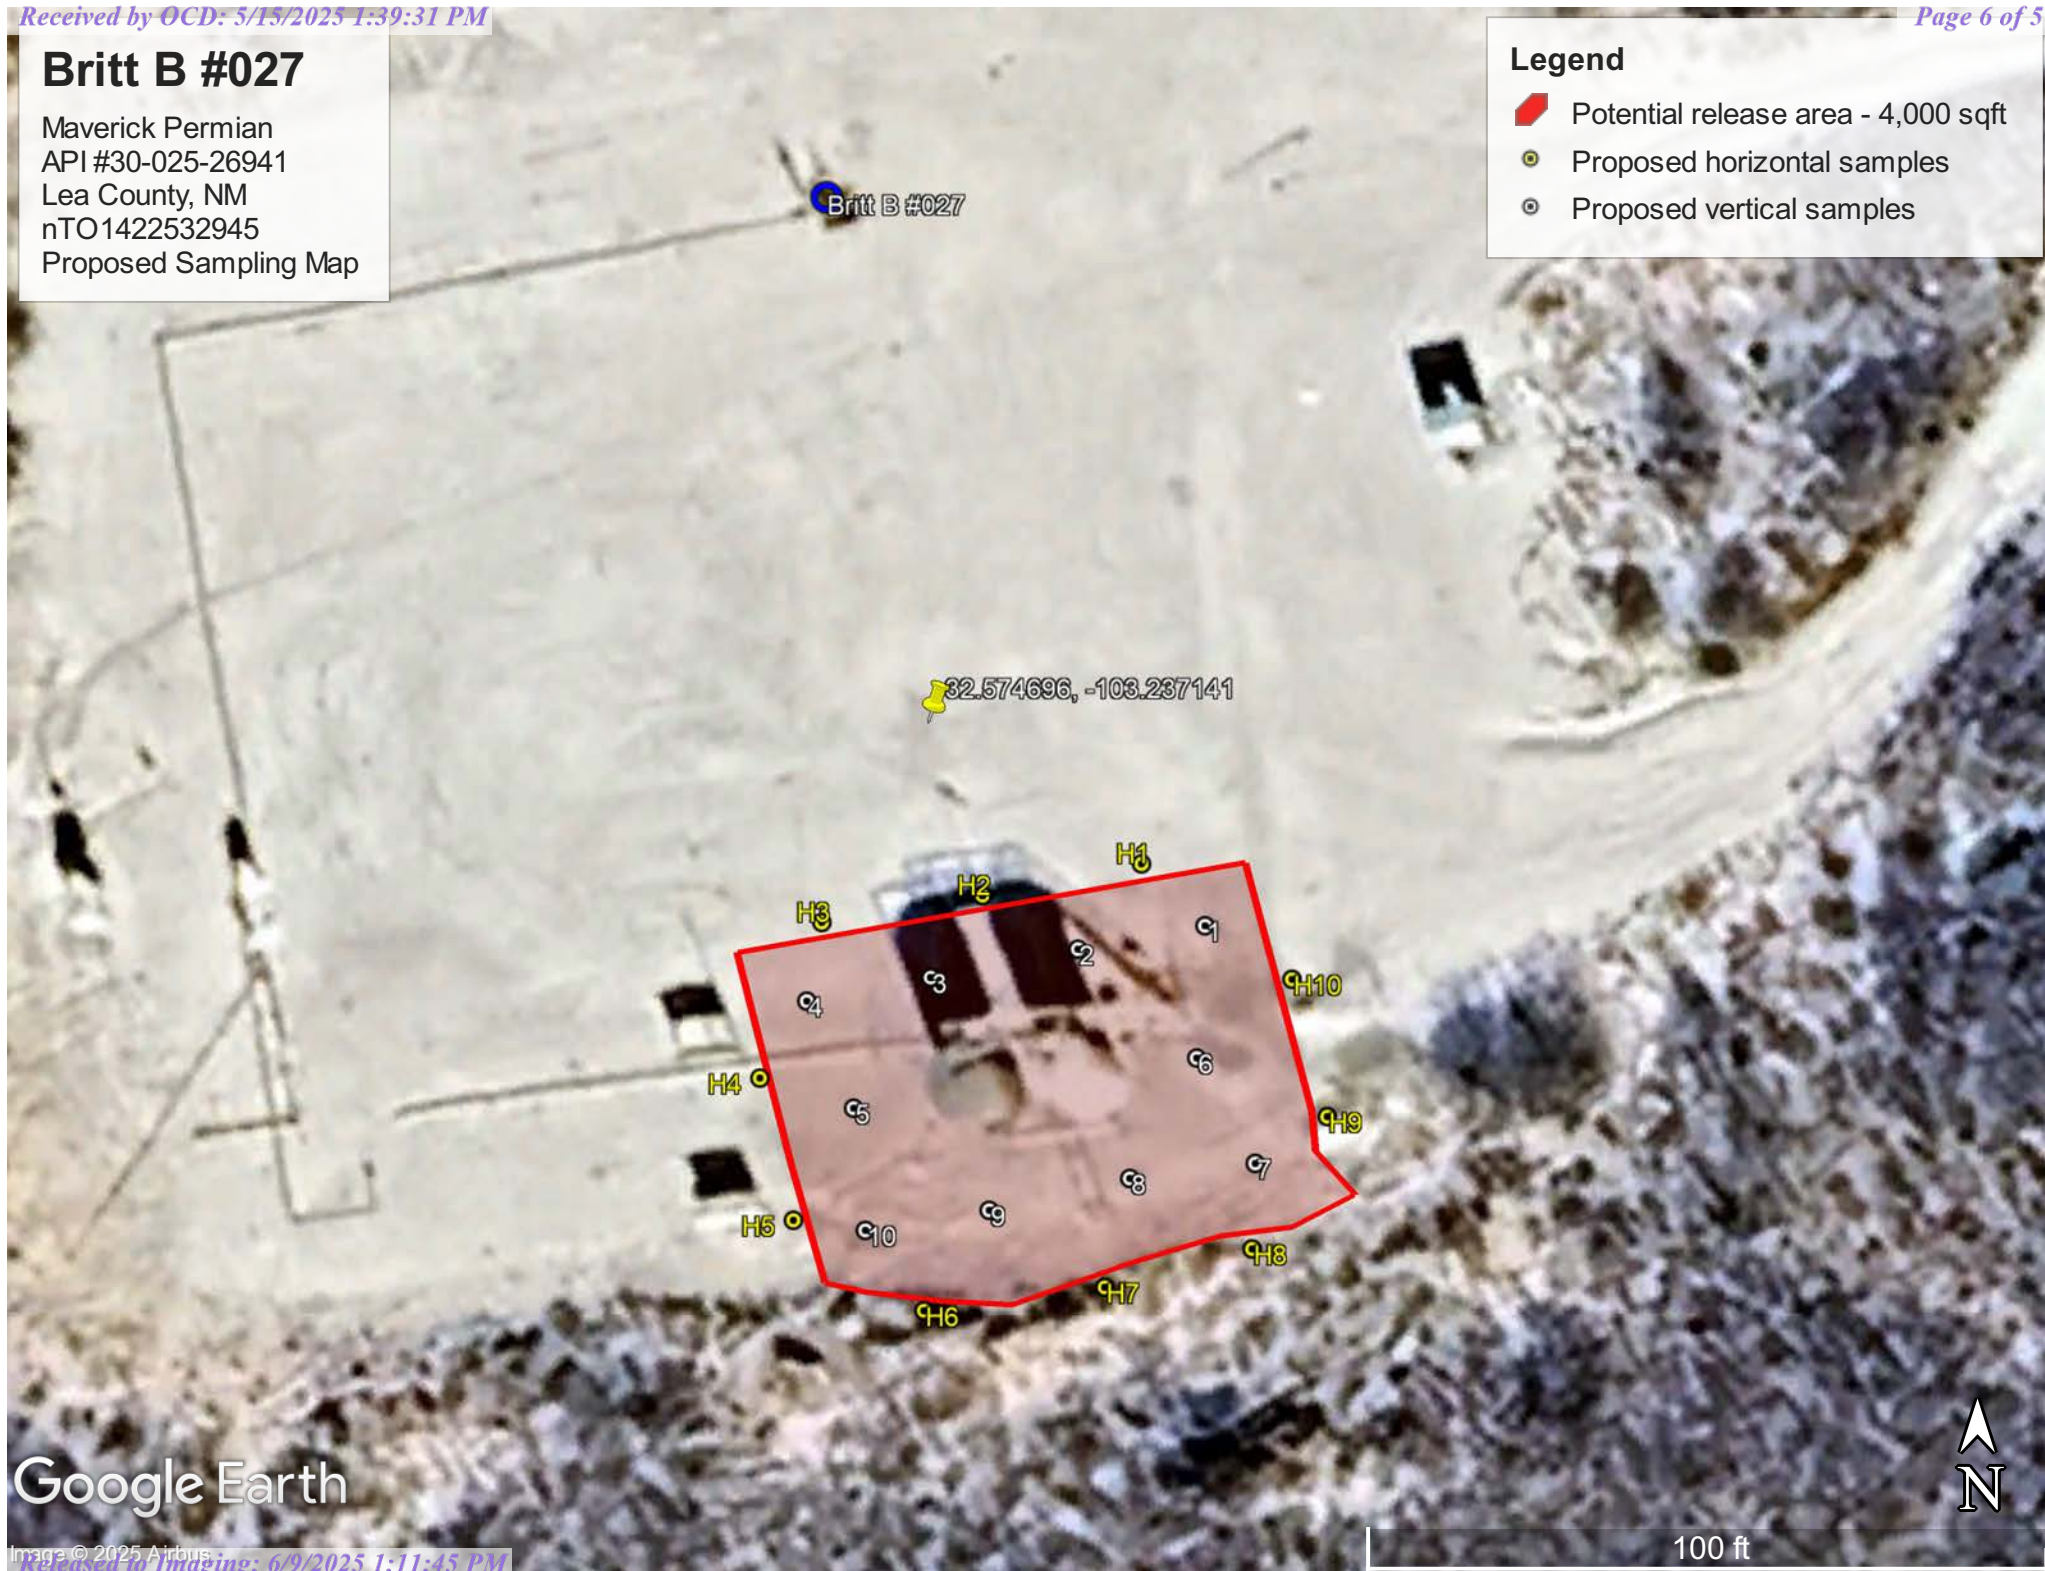
Maverick Permian
API #30-025-26941
Lea County, NM
nTO1422532945
Proposed Sampling Map

Potential release area - 4,000 sqft
-

Proposed horizontal samples
-

Proposed vertical samples

- The area of concern measures approximately 4,000 square feet and is entirely on the pad surface immediately adjacent to the pasture.
- Collect discrete samples from within and around the edges of the release area to evaluate the presence of contaminants. Fifty (50) samples will be collected from 10 different sample points within the release area from depths of surface, 1', 2', 3', and 4' bgs. Fifty (50) samples will be collected from 10 different sample points around the edges of the release area from depths of surface, 1', 2', 3', and 4' bgs.

- A 48-hour sampling notification will be issued to the NMOCD for these sampling events. A variance request is included below for permission to use the delineation samples as confirmation samples depending on the sample results of the soil. A Proposed Sample Map referencing the release area and the previously remediated area can be found in Figure 1.

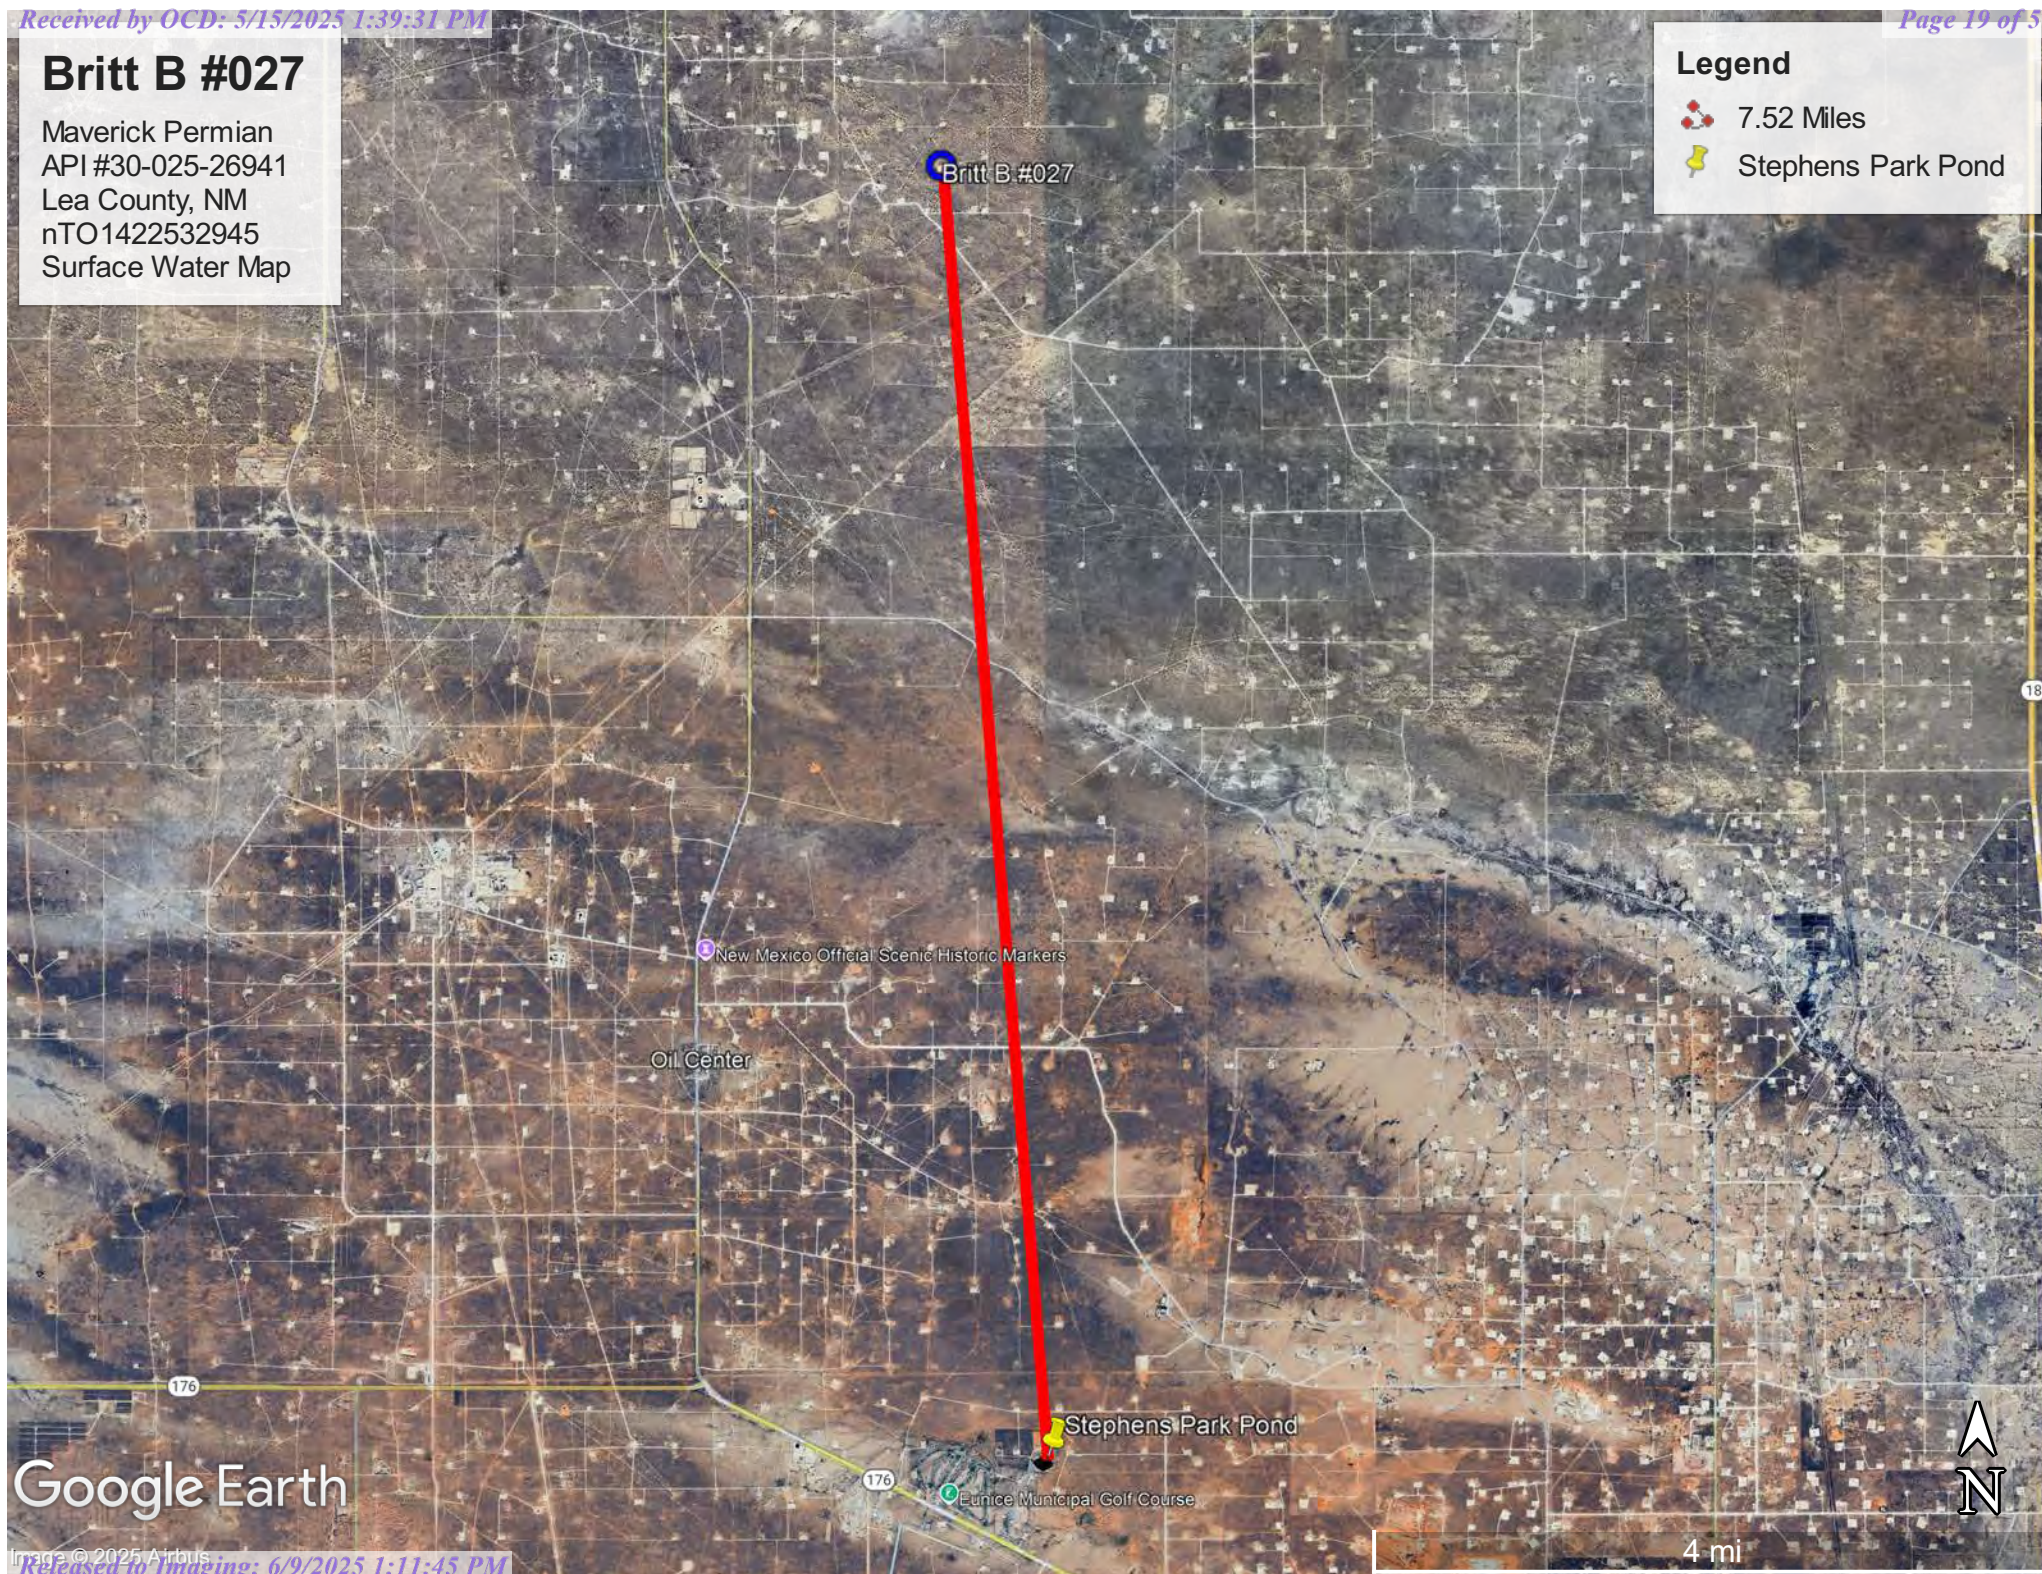
Maverick Permian
API #30-025-26941
Lea County, NM
nTO1422532945
Surface Water Map

7.52 Miles
-

Stephens Park Pond

The nearest surface water feature is Stephens Park Pond, and it is located approximately 7.52 miles to the south. The U.S. Fish and Wildlife Service National Wetlands Inventory shows the nearest wetland to be a Freshwater Emergent Wetland approximately 1.5 miles north. According to Fema's National Flood Hazard Layer search, the Site is situated in Zone D – Area of Undetermined Flood Hazard and is greater than 5 miles away from the nearest flood hazard zone. See Appendix B for referenced Water Surveys and Water-Related Maps.
