SITE CHARACTERIZATION AND REMEDIATION REPORT

**SOUTH JUSTIS UNIT #19 FLOWLINE
32.119208, -103.116675
UNIT F/G, SECTION 24, T25S-R37E
LEA COUNTY, NEW MEXICO
NMOCD INCIDENT ID #nAPP2504260553**

**TEAM OPERATING LLC
PO BOX 835
PINEHURST, TX 77362**

**RANGER ENVIRONMENTAL SERVICES, LLC
P.O. BOX 201179
AUSTIN, TEXAS 78720**

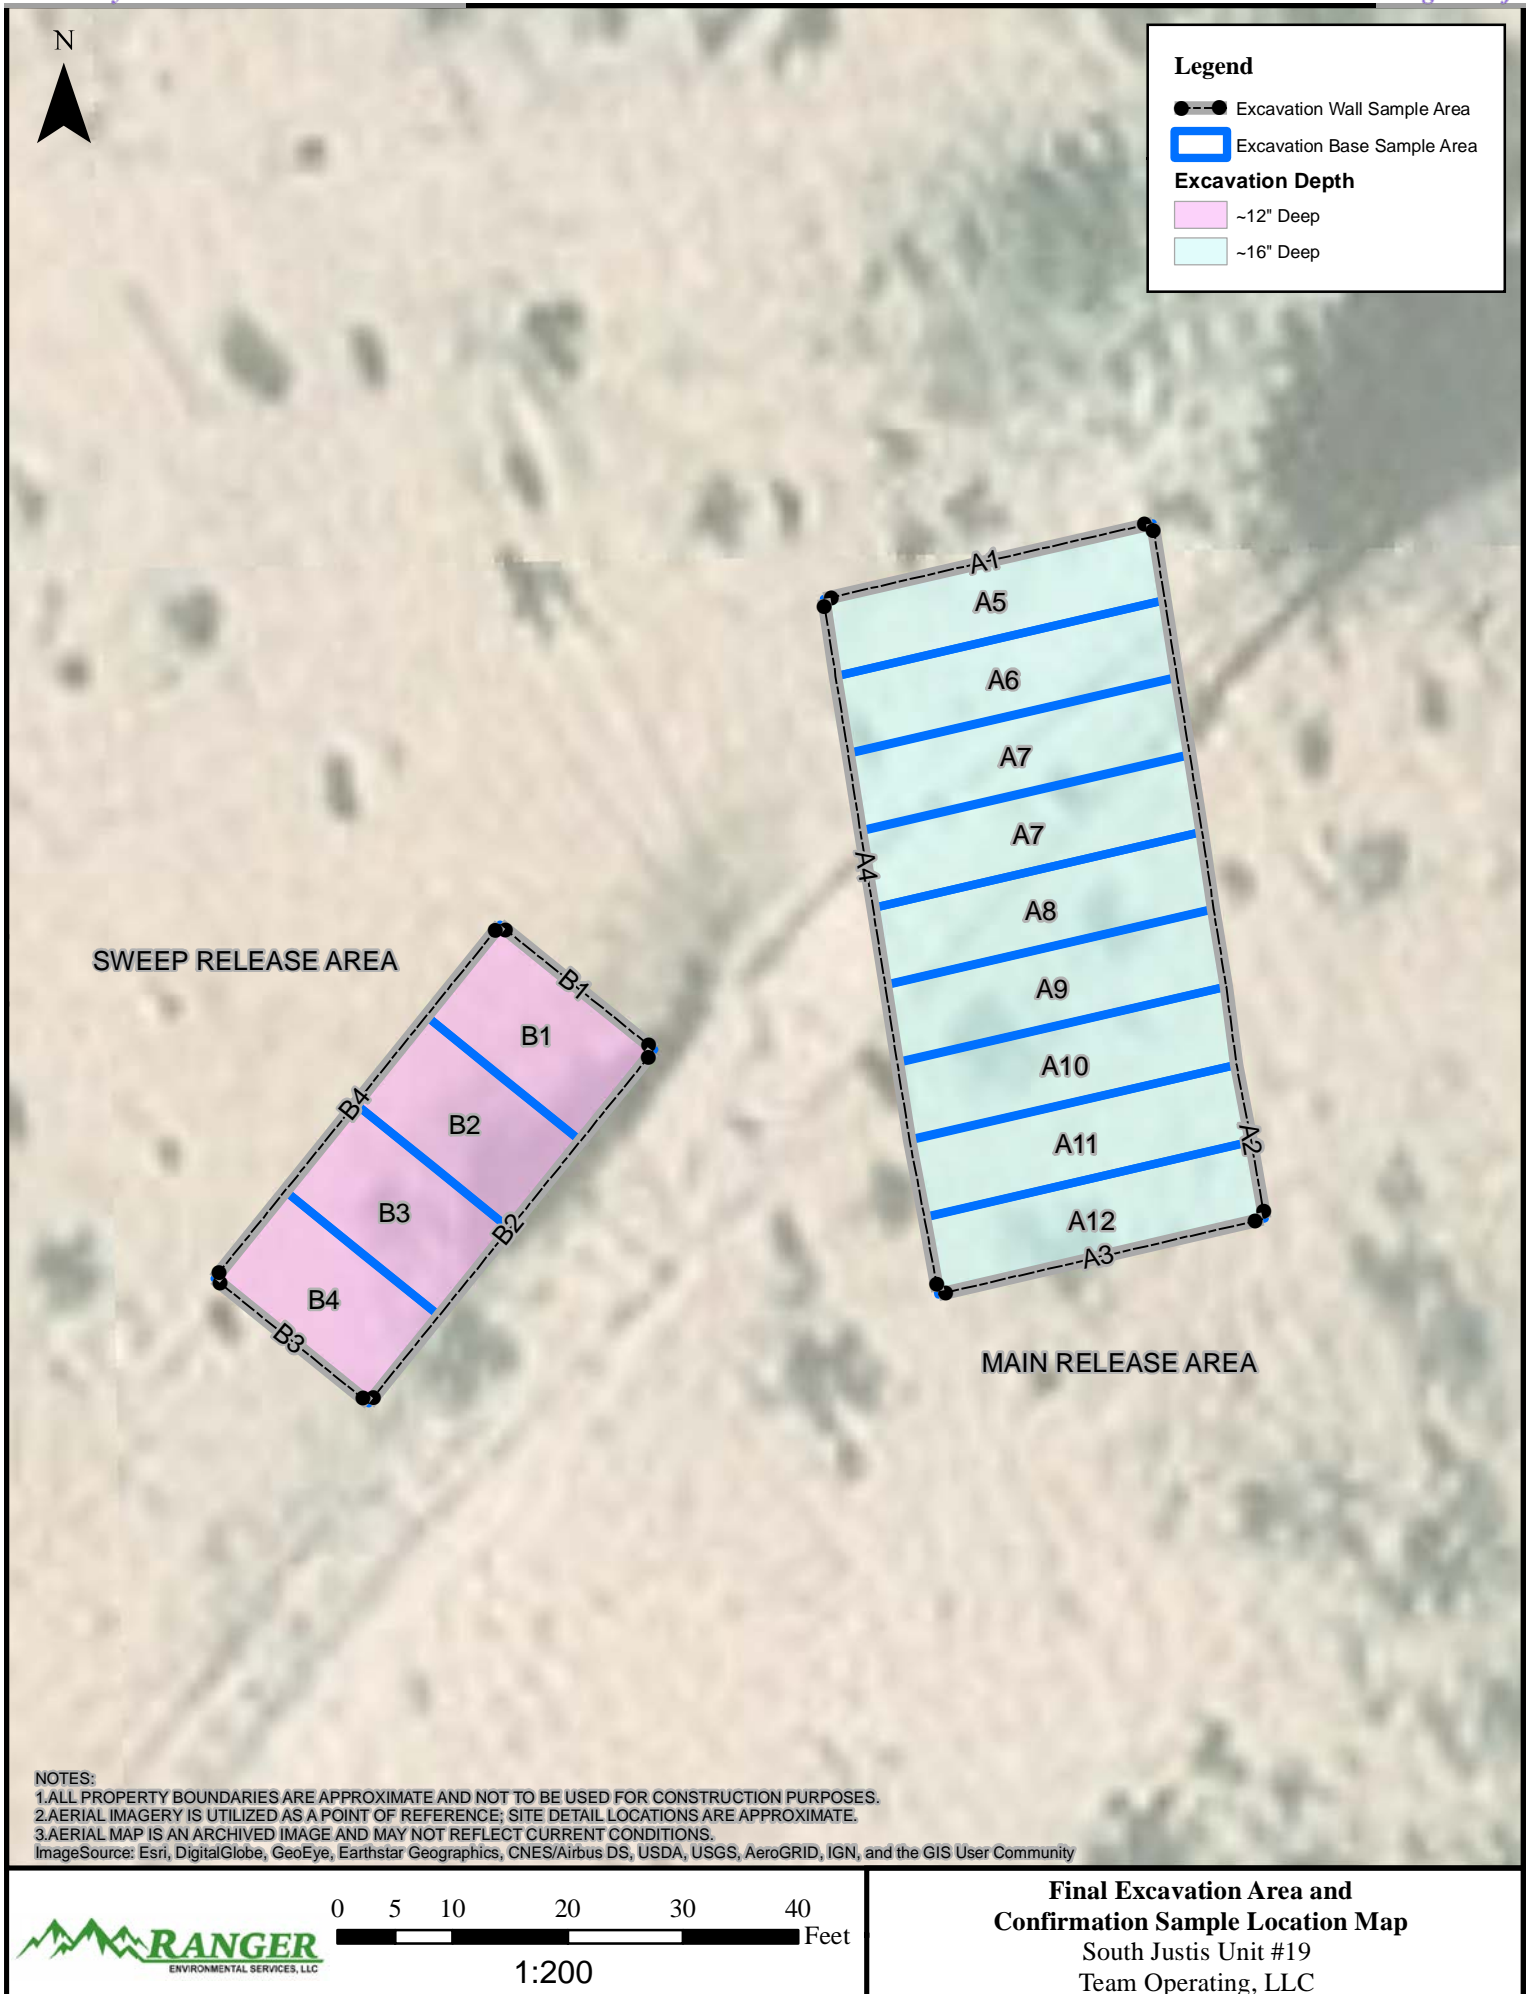
Final Excavation Area and Confirmation Sample Location Map

A *Final Excavation and Confirmation Sample Location Map* depicting the excavated area and confirmation sampling locations is attached.

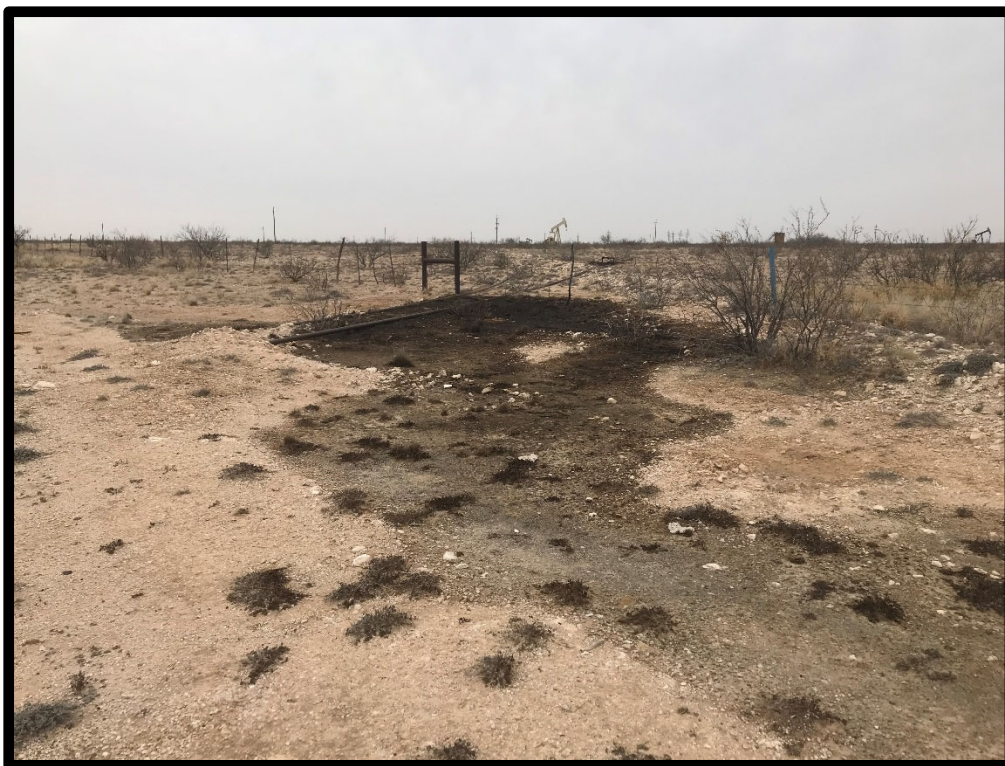
PHOTOGRAPH NO. 1 – A view of the flowline failure impact area upon discovery. The view is towards the southwest.

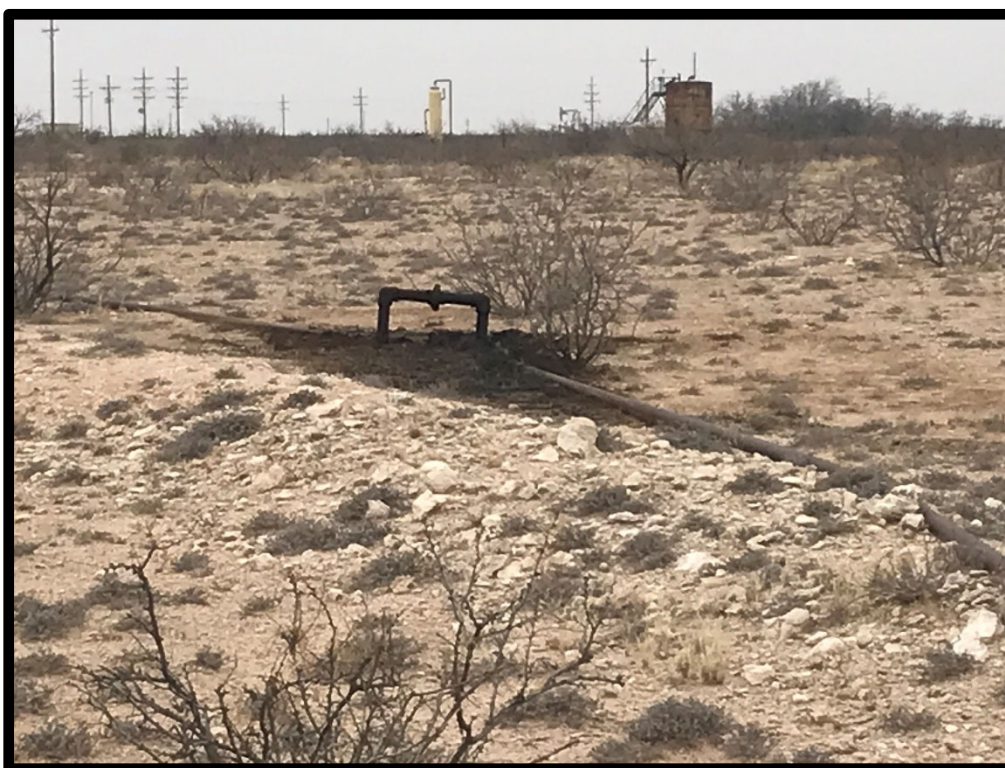
PHOTOGRAPH NO. 2 – A view of the flowline sweep release area upon discovery. The view is towards the southwest.

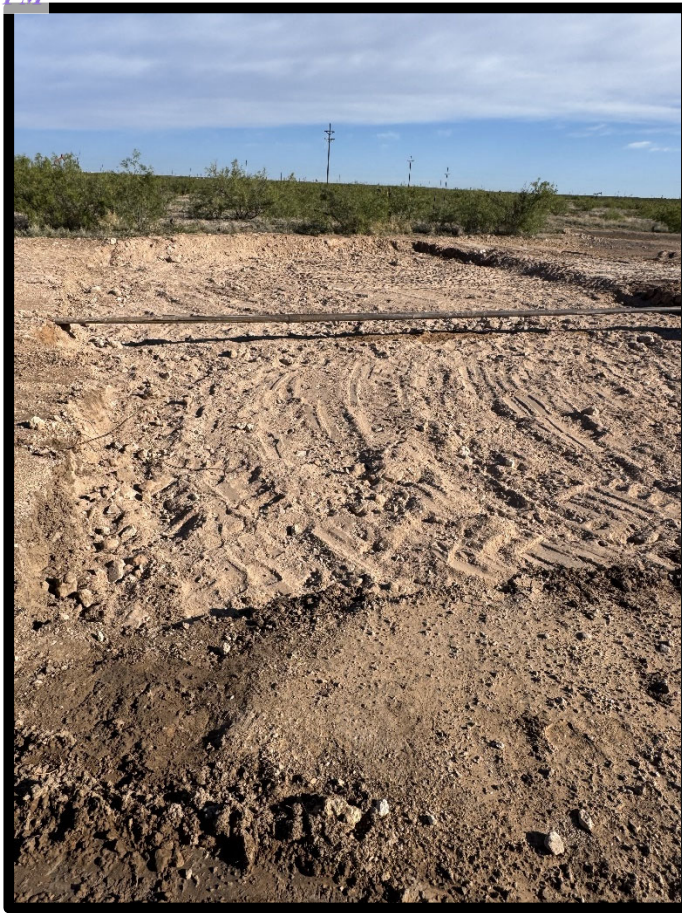
PHOTOGRAPH NO. 3 – A view of the flowline failure area upon completion of the removal process. The view is towards the north.

Upon completion of the initial soil removal operations, excavation in the Main Release area was reported to be completed to dimensions of approximately 46.5 feet by 34 feet and was completed to a depth of approximately 16 inches bgs. Initial excavation operations in the Sweep Release Area were completed to maximum dimensions of approximately 39 feet by 18 feet and to a depth of approximately one foot bgs.

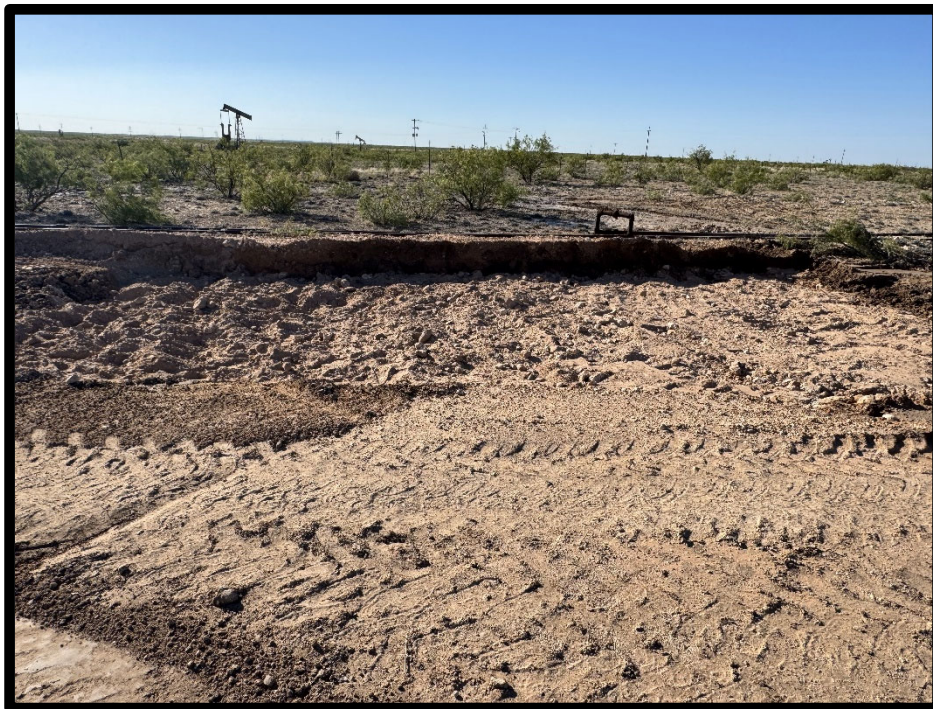
PHOTOGRAPH NO. 4 – A view of the flowline failure area upon completion of the removal process. The view is towards the southeast.
