RE: **North Brushy Draw Federal Com 35 #004H - Closure Request Report**

Incident Number: nAPP2503429238

ESRR Project No. 2836/ VP-19447

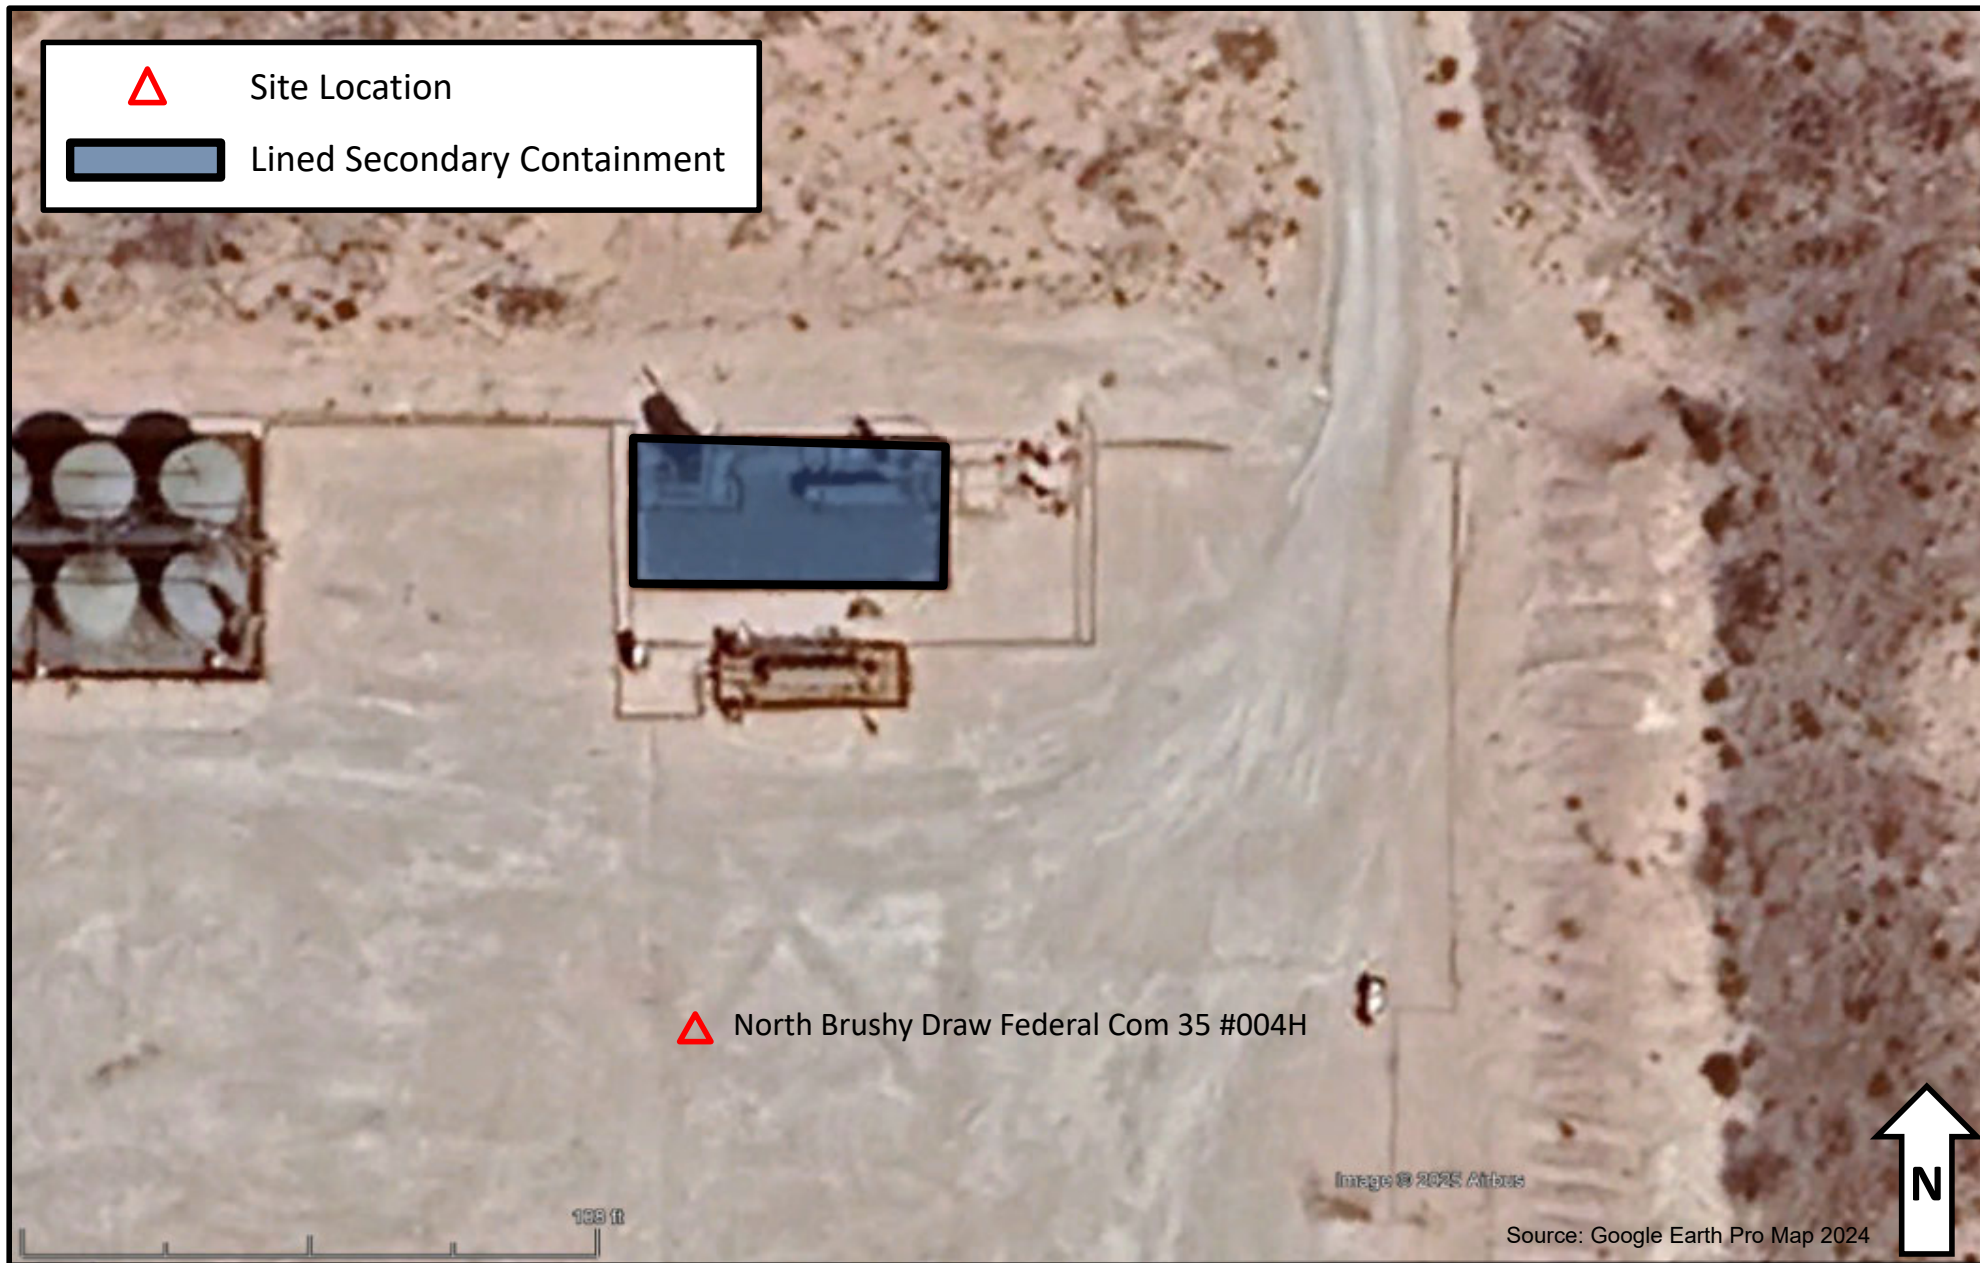
**Figure 2 – Release Extent**

On February 1, 2025, a thread on a water dump line failed, releasing approximately 10 barrels (bbls) of produced water within a LSC (**Figure 2**). The release was fully contained within the LSC with no fluids escaping to the production pad or adjacent native soils. A vacuum truck was immediately dispatched to the Site recovering the 10 bbls of produced water.

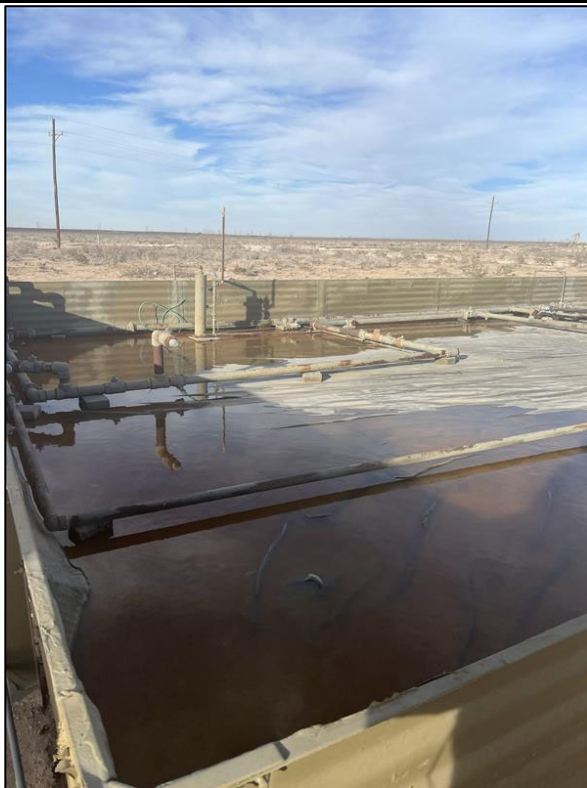
**PHOTO 1:** Northwestern view during initial site assessment by WPX. 2/01/2025

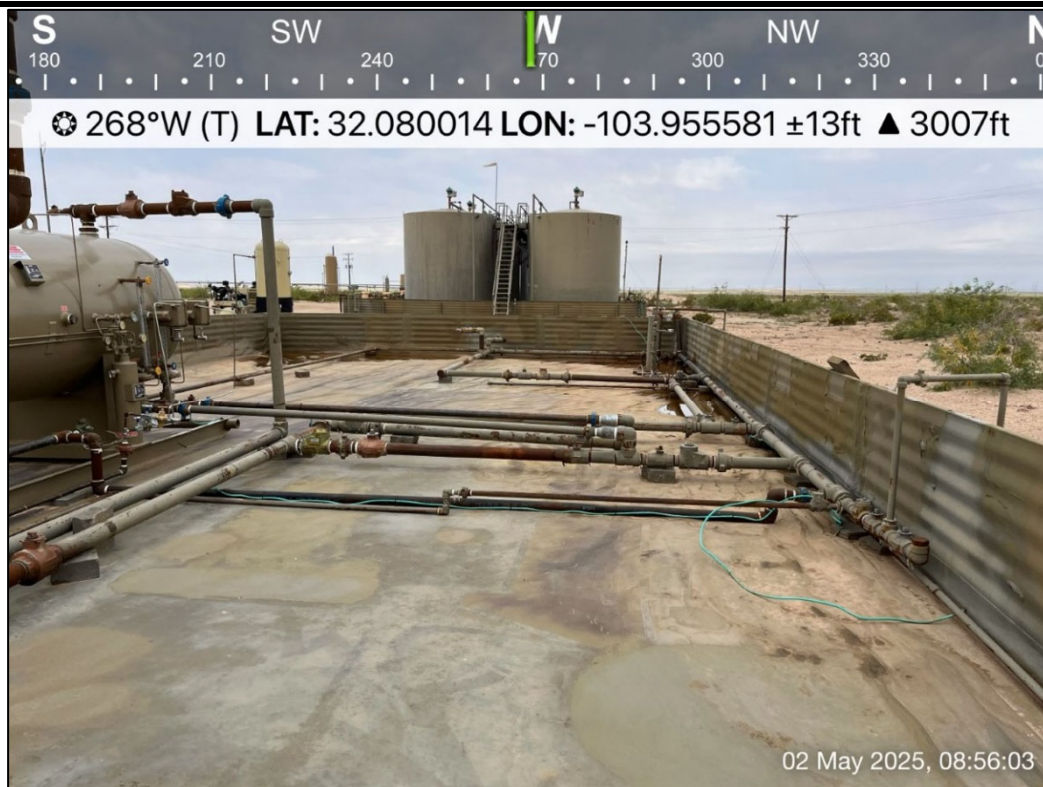
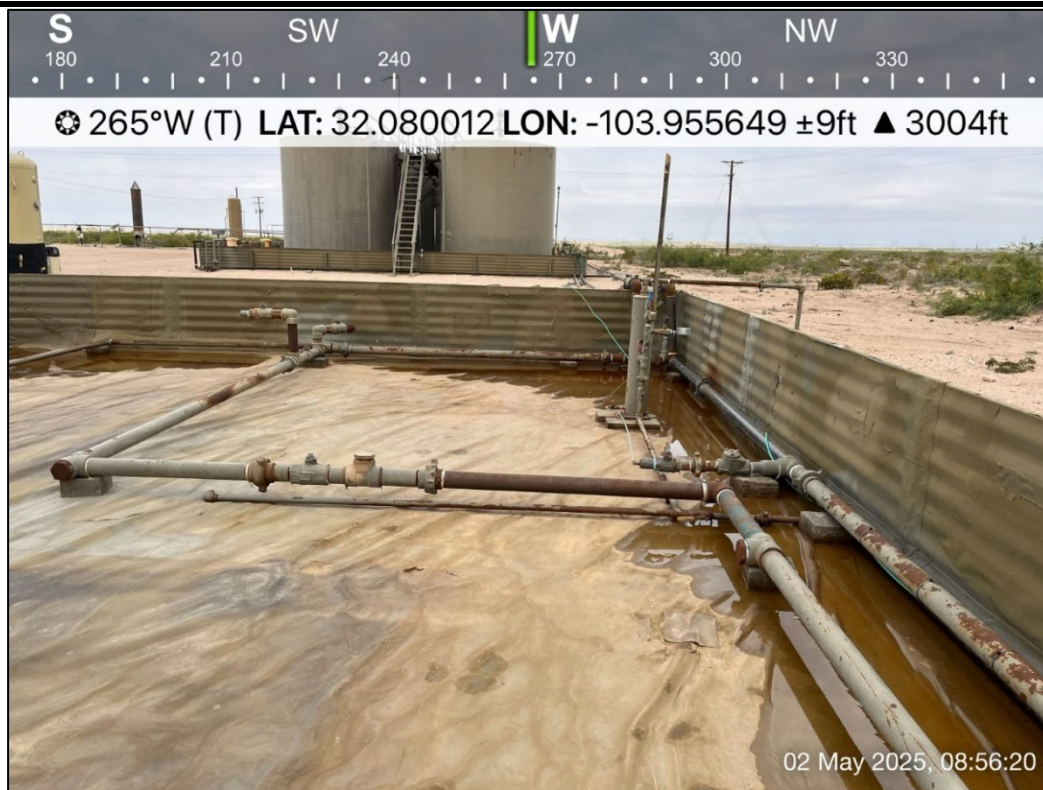
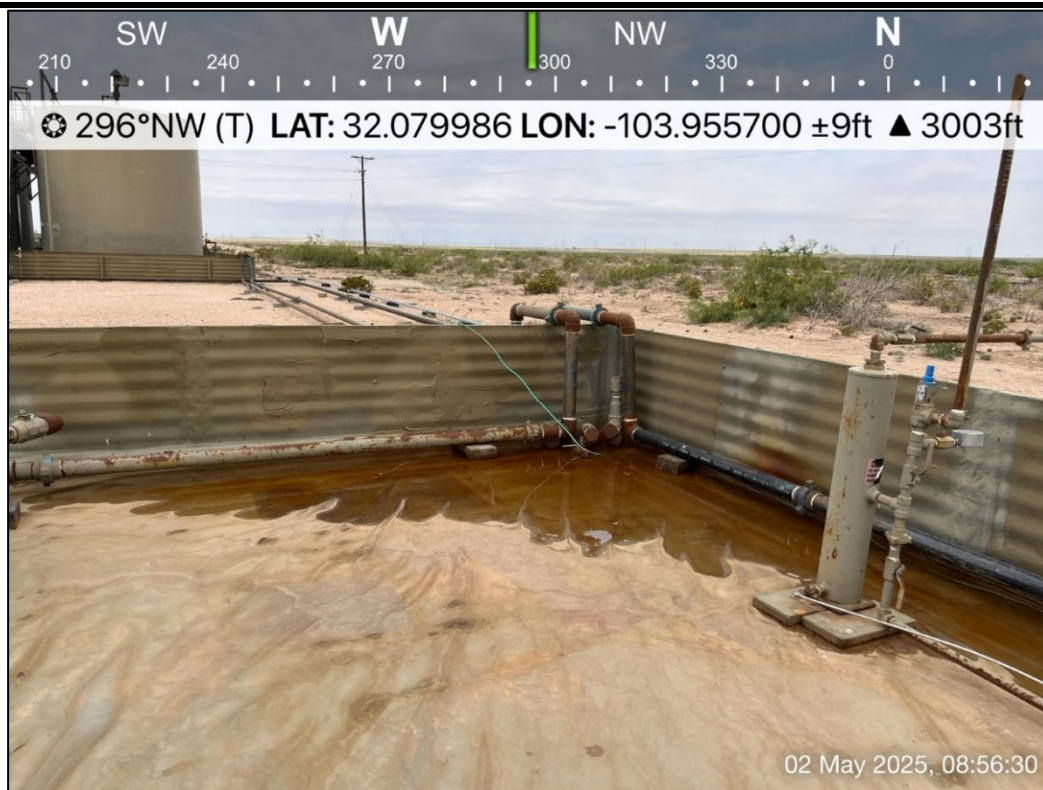
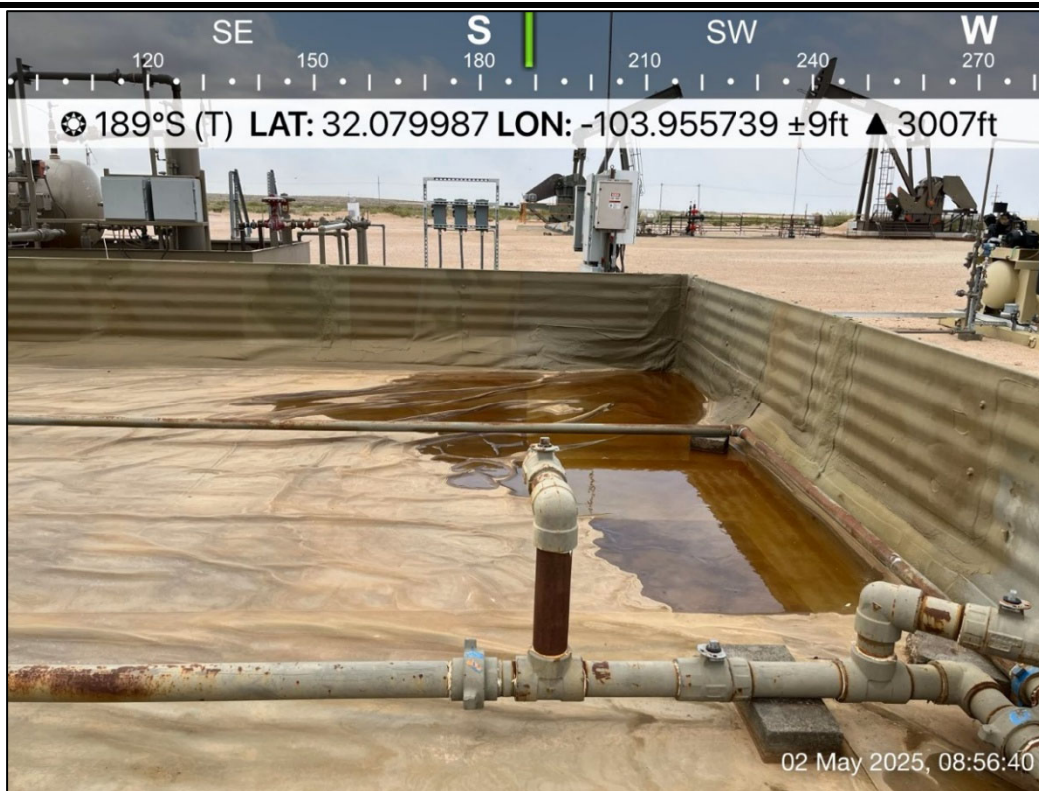
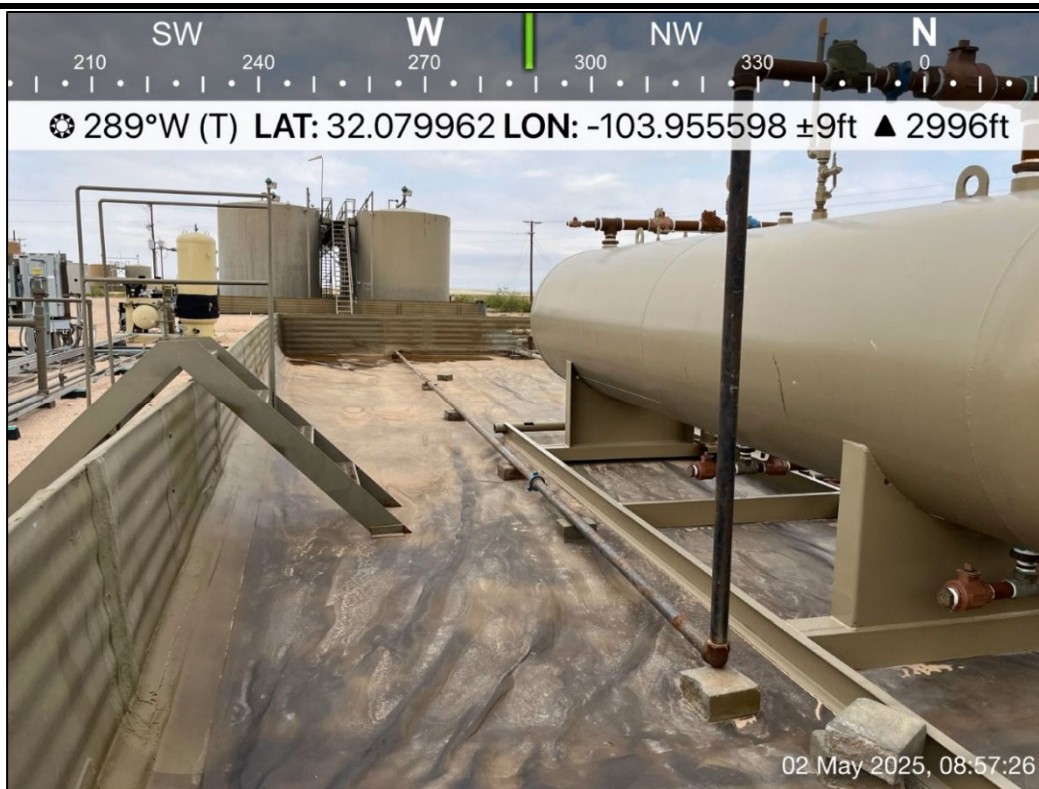
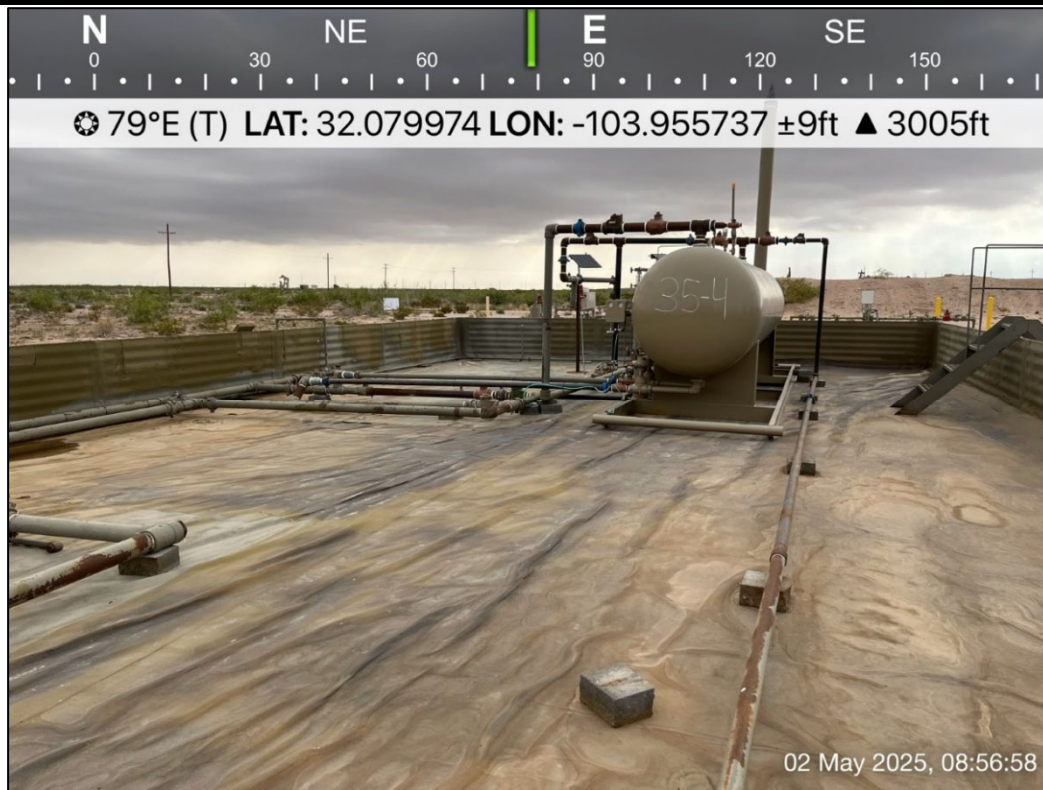
On May 2, 2025, ESRR conducted a thorough visual inspection of the LSC and found no tears, cracks, cuts, breaks, or other signs of damage, confirming no evidence of a breach to the LSC. The liner appeared to be in good condition and is performing as designed. **Photographic Documentation** of liner inspection activities is attached.

**PHOTO 6:** Southwestern view during liner inspection activities following pressure washing. 5/02/2025

**PHOTO 7:** Southwestern view during liner inspection activities following pressure washing. 5/02/2025

**PHOTO 8:** Northwestern view during liner inspection activities following pressure washing. 5/02/2025

**PHOTO 9:** Southwestern view during liner inspection activities following pressure washing. 5/02/2025

**PHOTO 10:** Northwestern view during liner inspection activities following pressure washing. 5/02/2025

PHOTO 11: Northeastern view during liner inspection activities following pressure washing. 5/02/2025

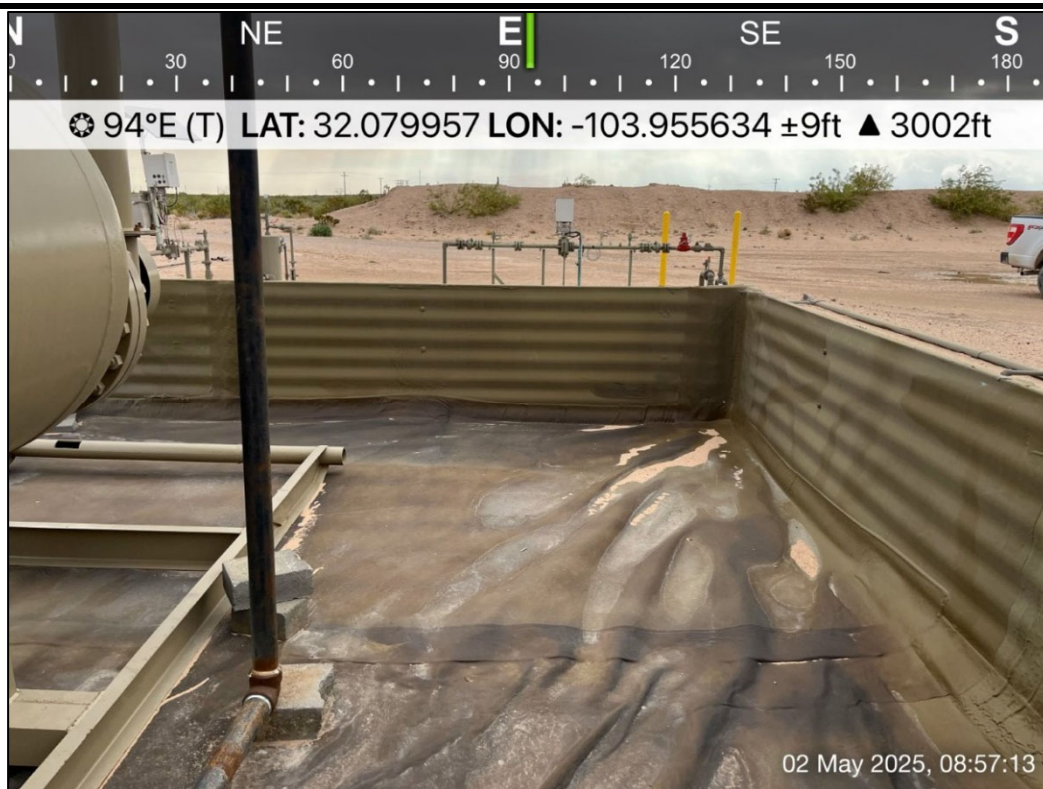
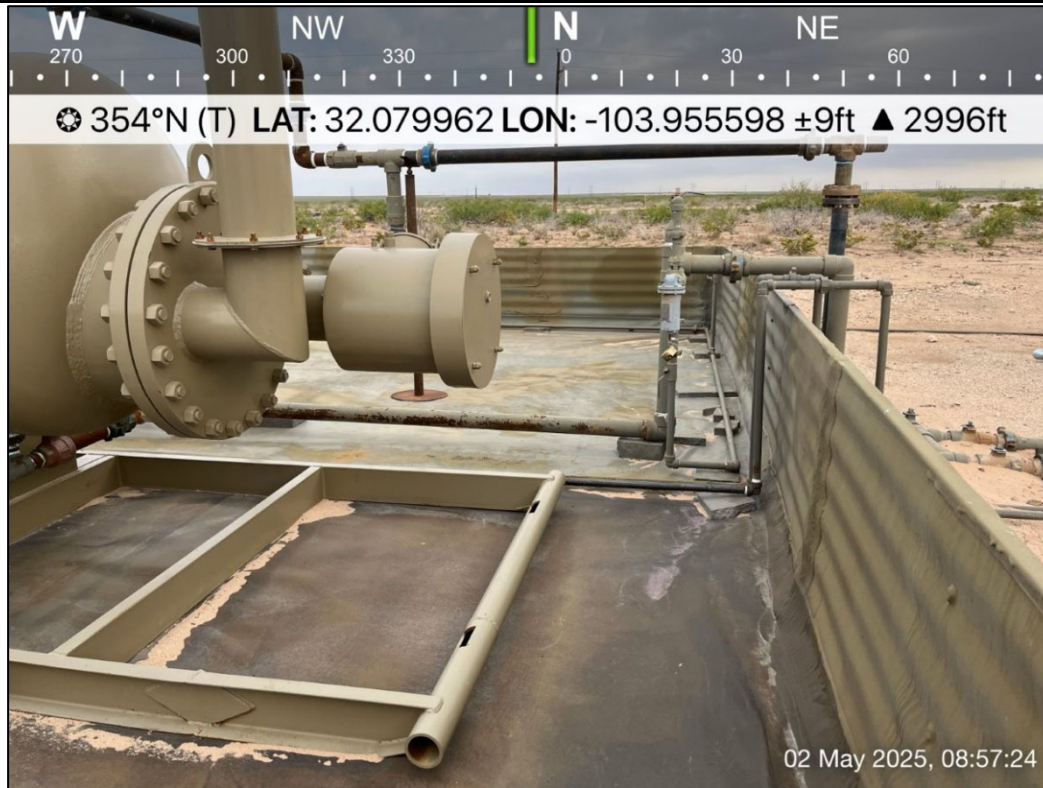
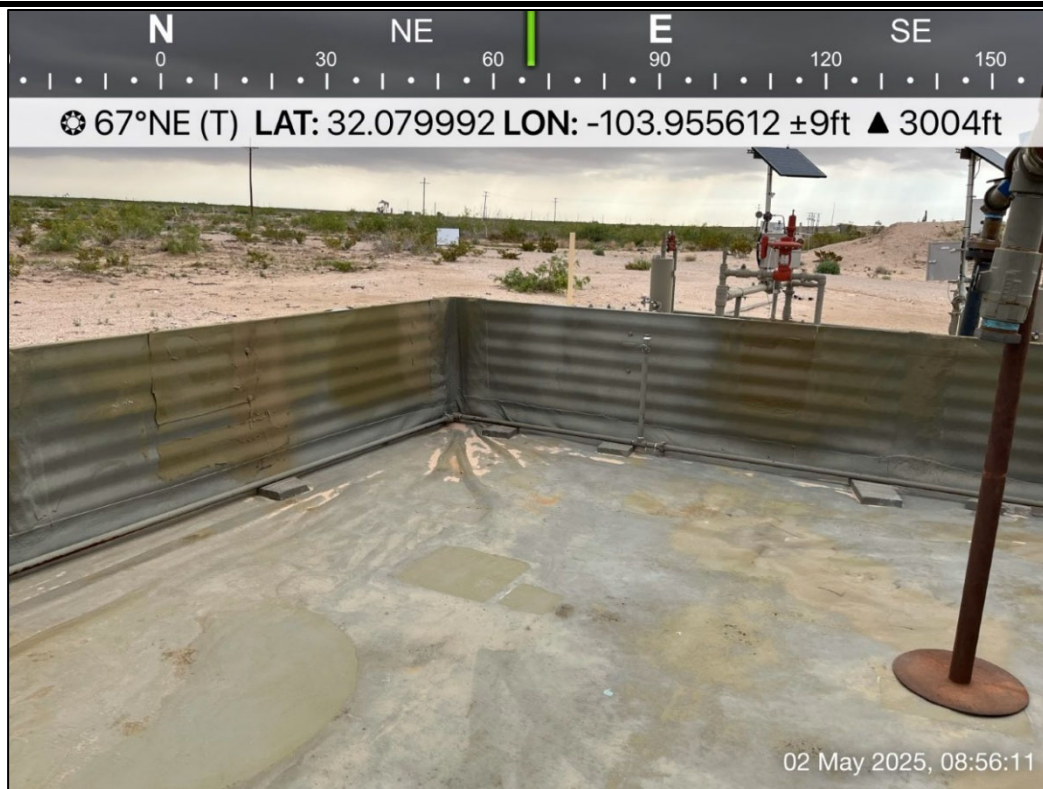
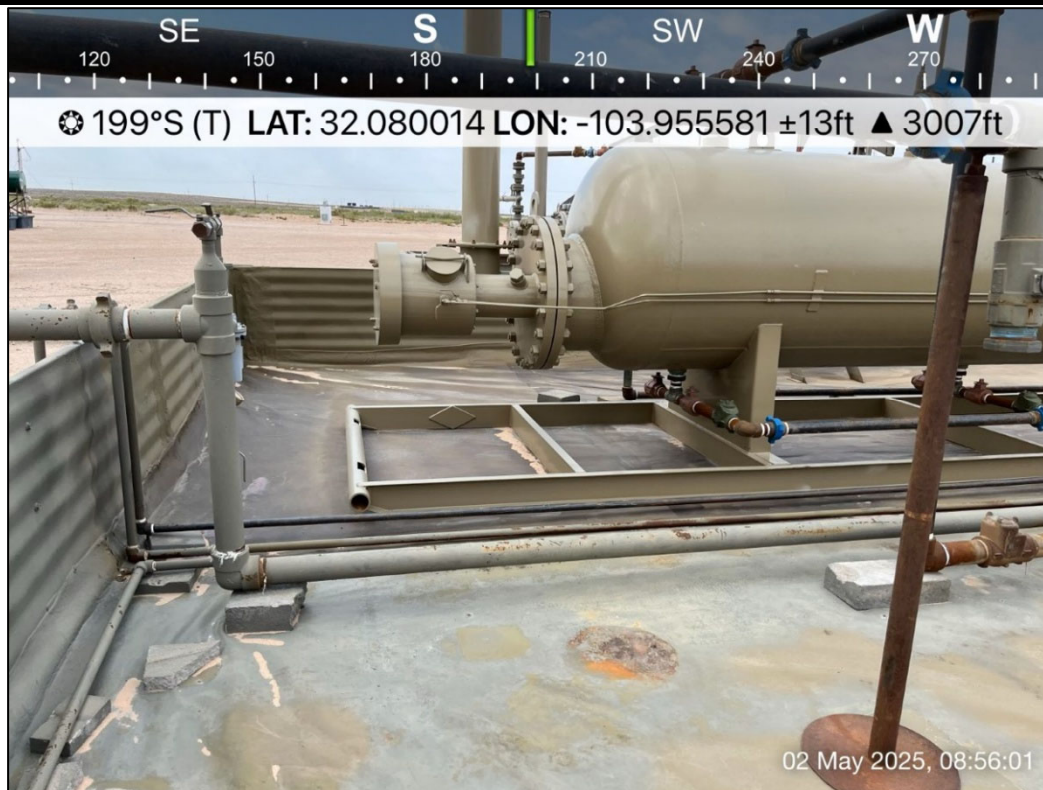
PHOTO 12: Southeastern view during liner inspection activities following pressure washing. 5/02/2025

PHOTO 13: Northwestern view during liner inspection activities following pressure washing. 5/02/2025

PHOTO 14: Northwestern view during liner inspection activities following pressure washing. 5/02/2025

PHOTO 15: Southwestern view during liner inspection activities following pressure washing. 5/02/2025
