**Re: Closure Request  
J R Oil, Ltd. Co.  
Fred Turner Jr B #001 Valve Release  
Unit Letter F, Section 17, Township 20 South, Range 38 East  
Lea County, New Mexico  
Incident ID# nGRL1013259660  
1RP-2524**

Closure Request  
April 25, 2025

J R Oil, Ltd. Co.

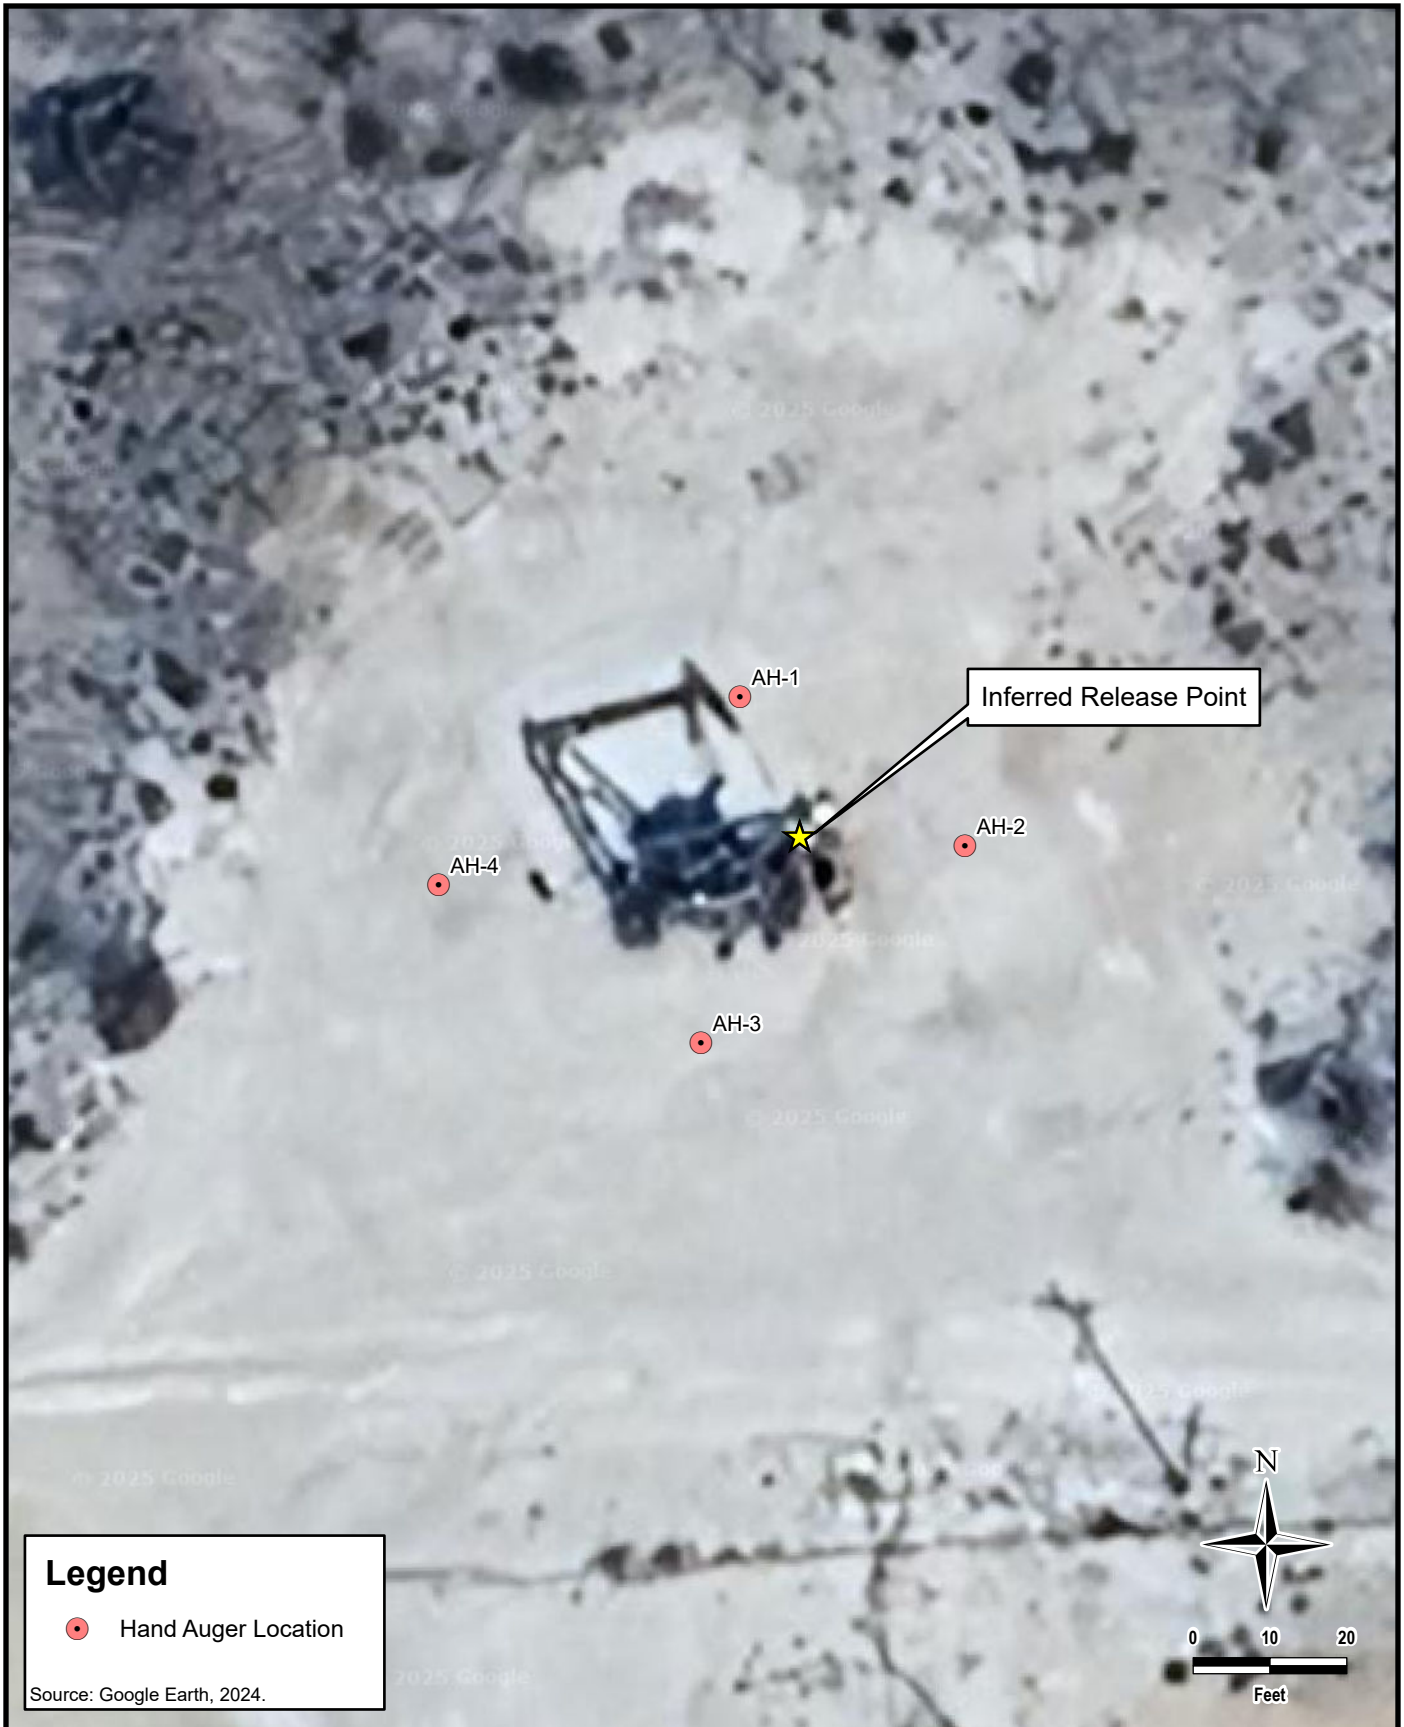
According to the State of New Mexico Oil Conservation Division (NMOCD) C-141 Initial Report, the release was discovered on April 25, 2010. The release occurred as a result of the back pressure valve plugging and failing. Approximately 14 barrels (bbls) of produced water and 8 bbls crude oil were released, of which 14 bbls of produced water were and 6 bbls of crude oil were recovered, a total loss of 2 bbls of crude oil. A vacuum truck was utilized to collect all remaining standing fluid. The inferred release point was located on a section of the pumping unit located on pad. The inferred release point is shown in Figure 3.

Based on the available information from the C-141 and information online from the NMOCD permitting website, no release footprint for this incident was found. As such, Tetra Tech elected to perform an assessment in the direct vicinity of the wellhead (back pressure valve), the source of the release. Tetra Tech was on site March 13, 2025, to install four (4) hand auger borings around the wellhead at the Fred Turner Jr B #001 pad to a depth of 1-foot below ground surface (bgs).

- Hand Auger Location

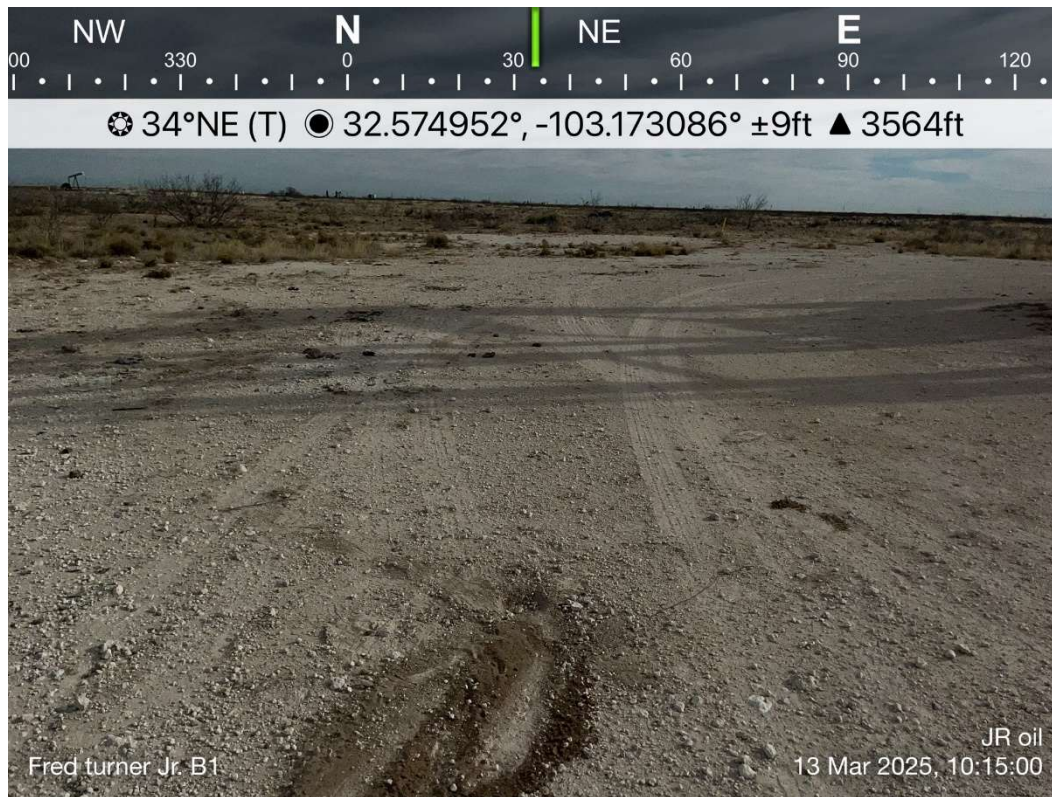
TETRA TECH, INC. PROJECT NO. 212C-MD-03536	DESCRIPTION	View northeast, north-side of pad and pumping unit.	2
	SITE NAME	JR Oil LTD Fred Turner JR B 001	03/13/2025

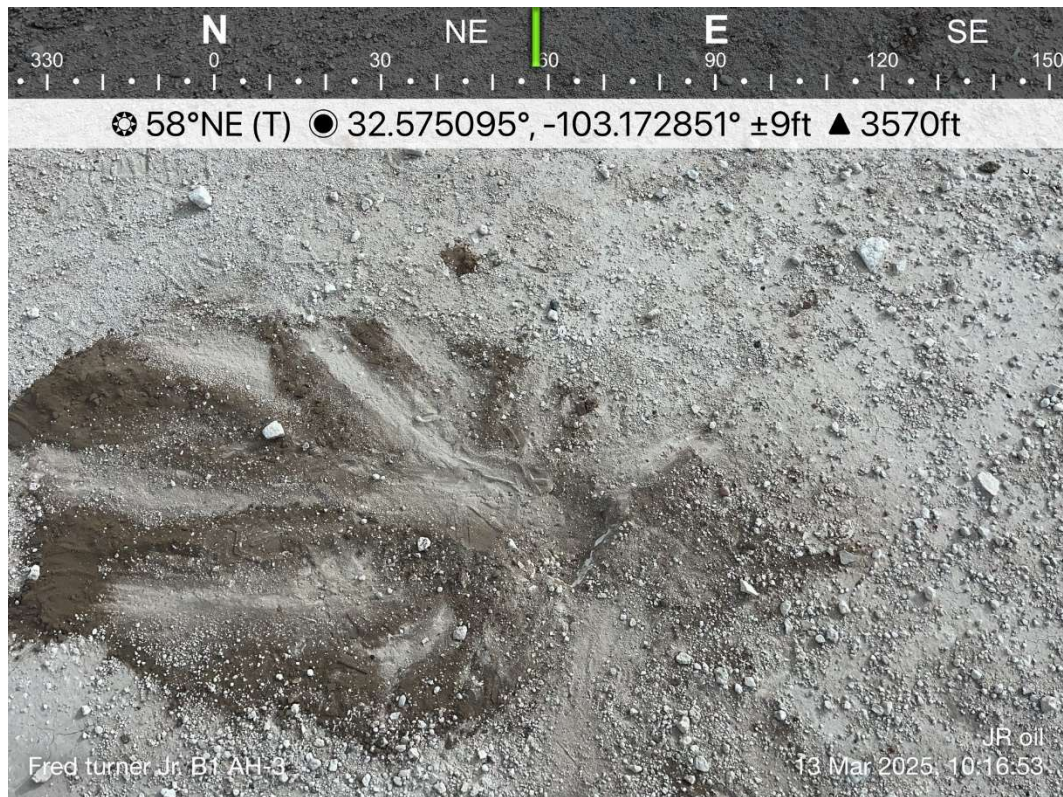
TETRA TECH, INC. PROJECT NO. 212C-MD-03536	DESCRIPTION	Photographic documentation of sample location AH-3.	4
	SITE NAME	JR Oil LTD Fred Turner JR B 001	03/13/2025

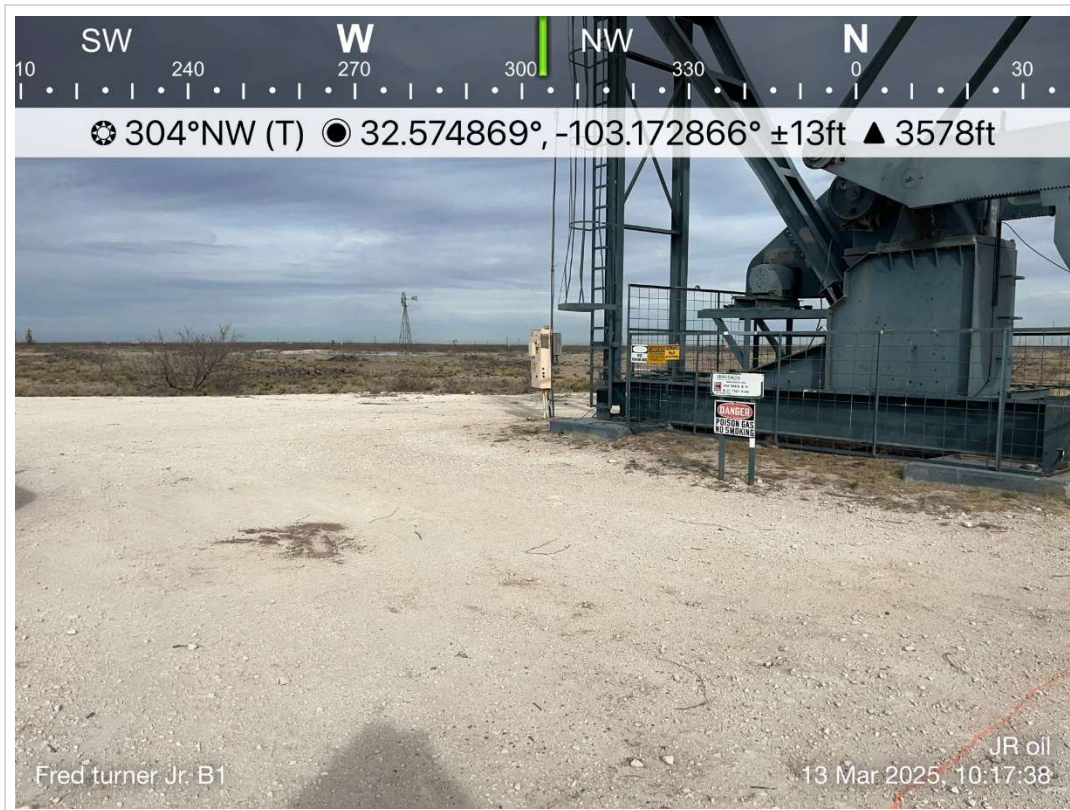
TETRA TECH, INC. PROJECT NO. 212C-MD-03536	DESCRIPTION	View northwest, area of pad directly south of pumping unit.	5
	SITE NAME	JR Oil LTD Fred Turner JR B 001	03/13/2025

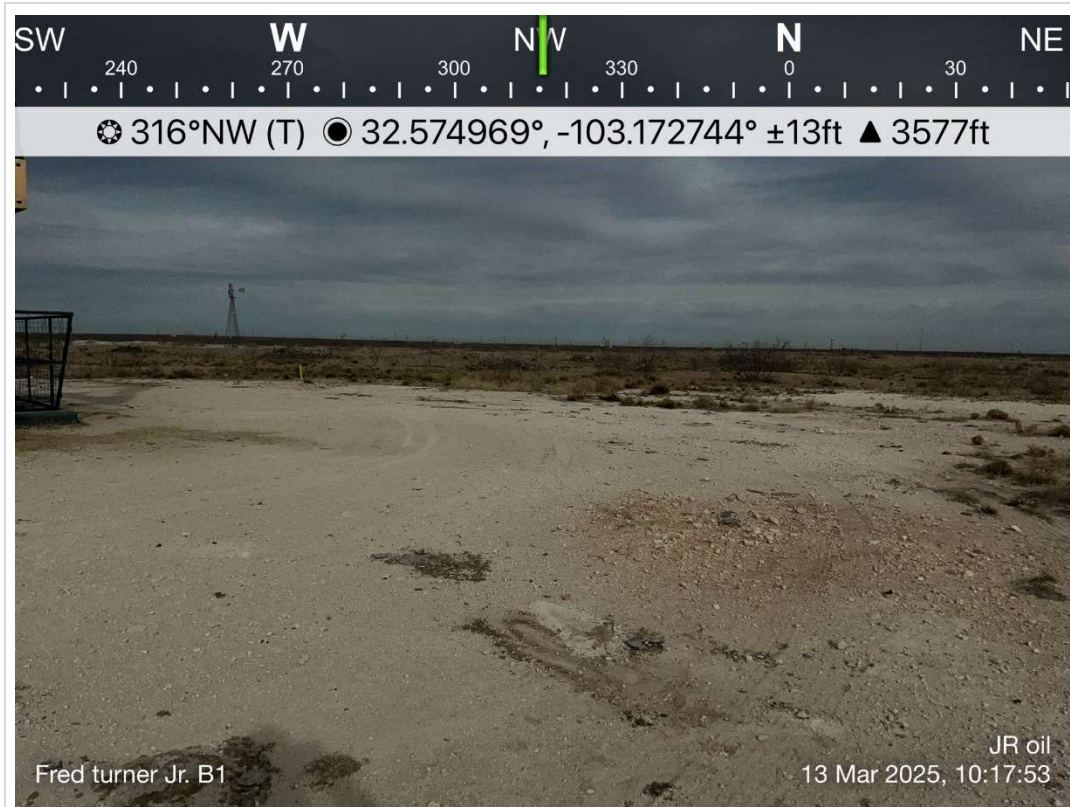
TETRA TECH, INC. PROJECT NO. 212C-MD-03536	DESCRIPTION	View northwest, east-northeast side of pumping unit.	6
	SITE NAME	JR Oil LTD Fred Turner JR B 001	03/13/2025

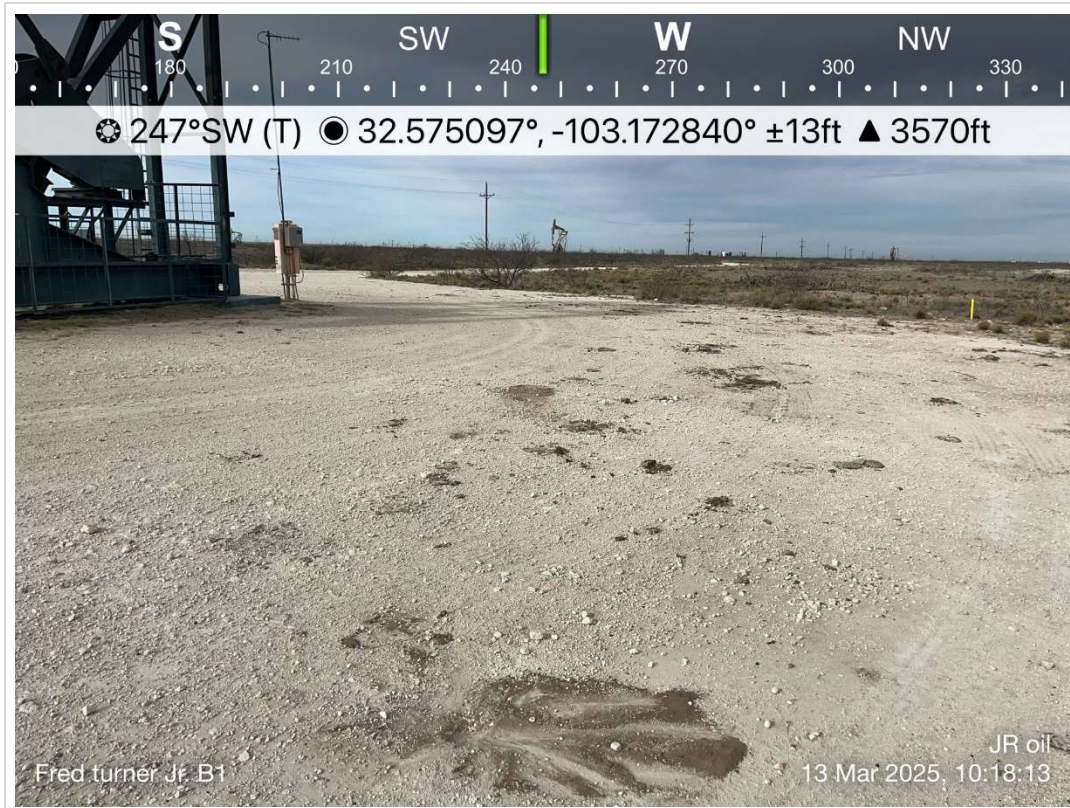
TETRA TECH, INC. PROJECT NO. 212C-MD-03536	DESCRIPTION	View west-southwest, north- and west-sides of pad adjacent to pumping unit visible.	7
	SITE NAME	JR Oil LTD Fred Turner JR B 001	03/13/2025
