SANTA FE #133  
nTO1425857071

PREPARED BY SAPEC-ECO, LLC.  
PREPARED FOR MAVERICK PERMIAN, LLC.

## **Proposed Sampling and Remediation Work Plan**

Re: Proposed Sampling and Remediation Work Plan  
NMOCD Incident Number: **nT01425857071**  
Santa Fe #133 API No. 30-025-32333  
Unit O, Section 31, Township 17S, Range 35E 435 FSL 1930 FEL Lea County, NM  
GPS Coordinates: Latitude 32.7854347 Longitude -103.4947052 NAD83

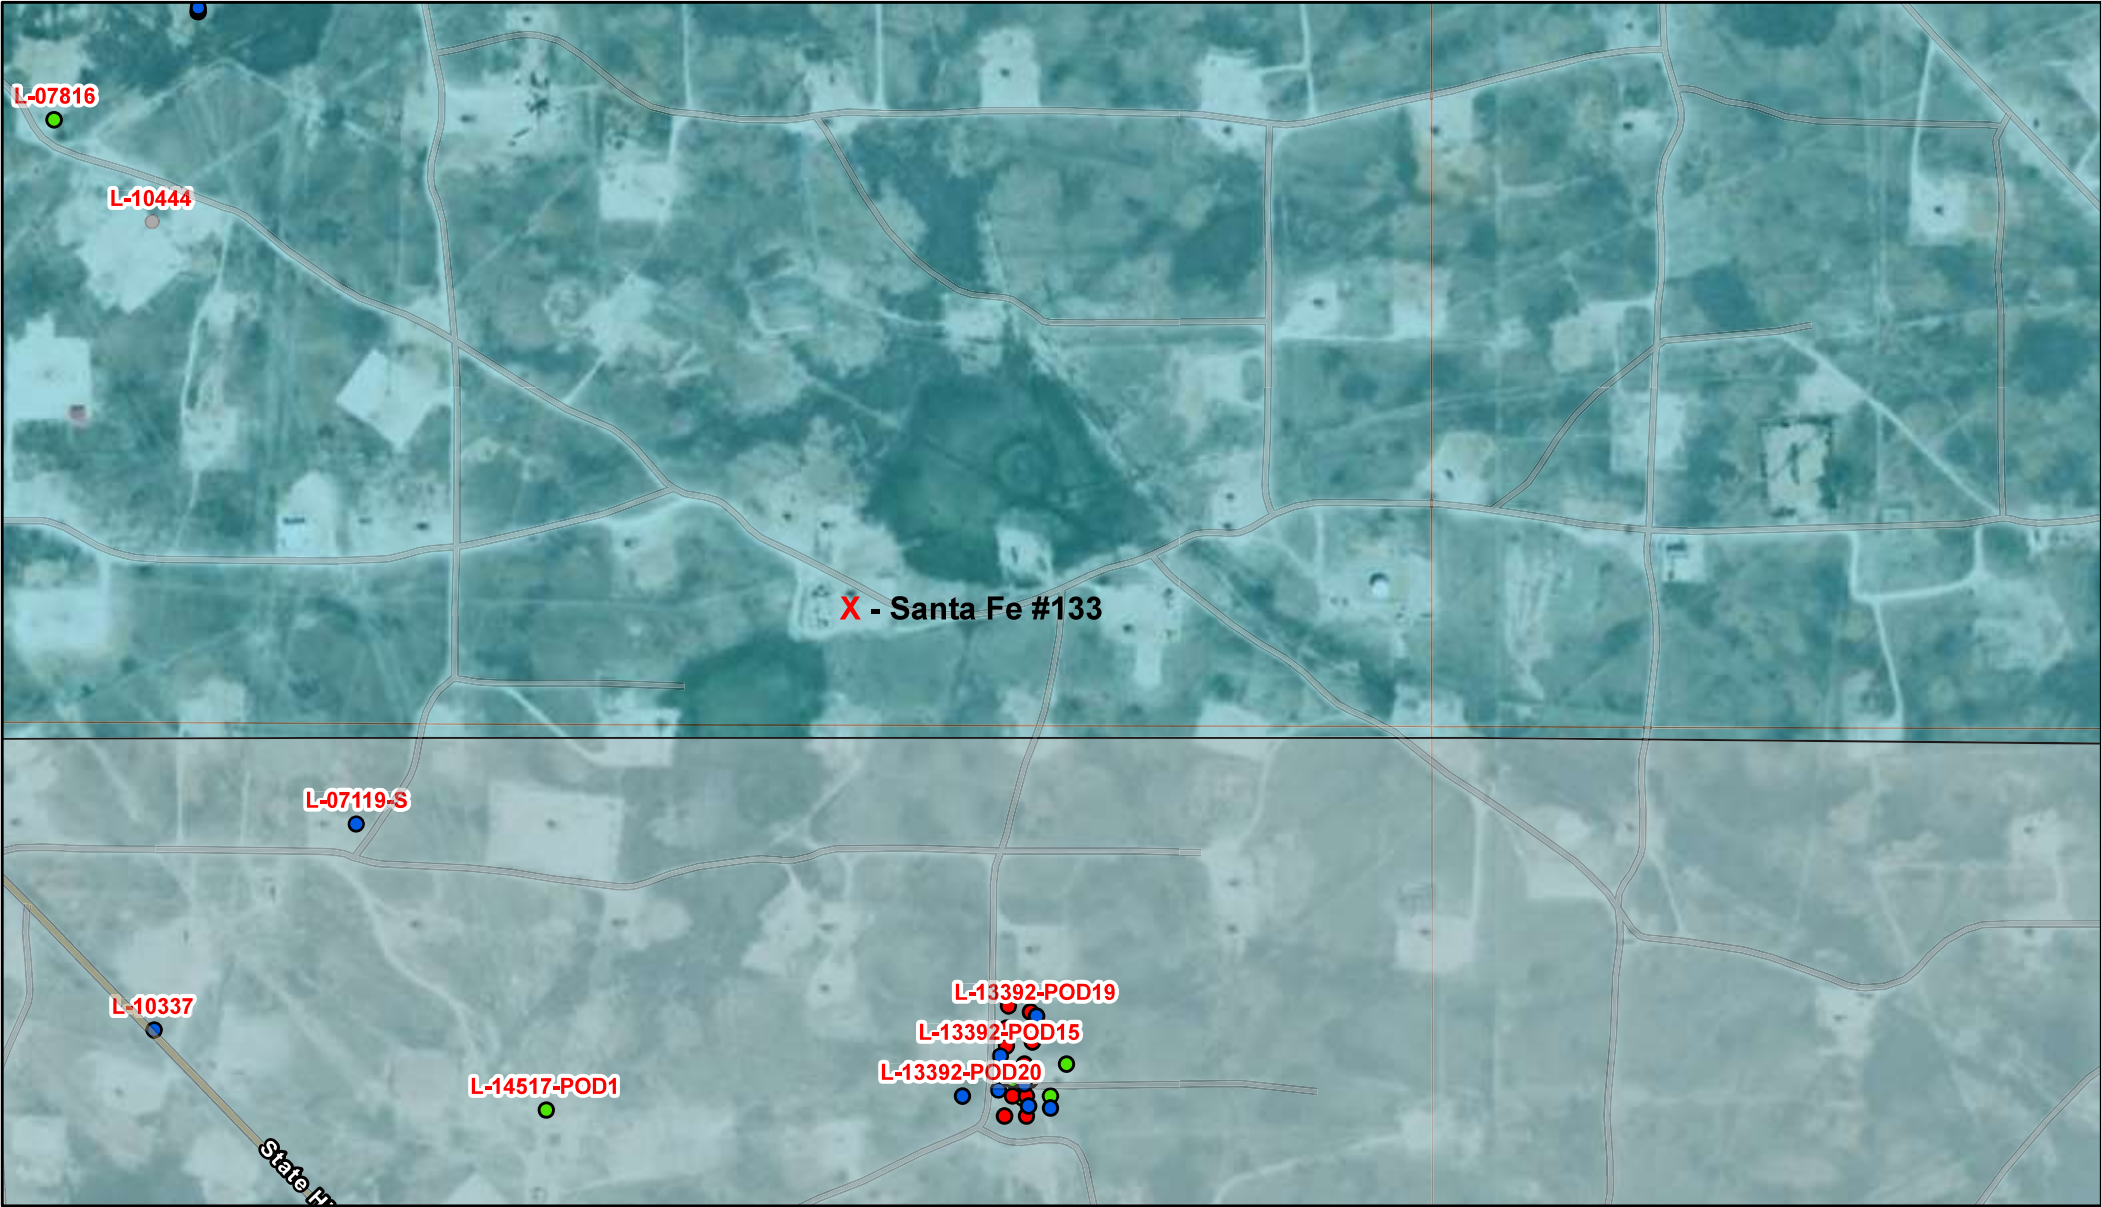
# OSE POD Location Map

GIS WATERS PODs

The nearest surface water feature is an Unnamed Pond, and it is located approximately 1.42 miles to the north. The U.S. Fish and Wildlife Service National Wetlands Inventory shows the nearest wetland to be a Freshwater Pond approximately 280 feet southeast. According to Fema's National Flood Hazard Layer search, the Site is situated in Zone D - Area of Undetermined Flood Hazard and is greater than 5 miles away from the nearest flood hazard zone. See Appendix B for referenced Water Surveys and Water-Related Maps.

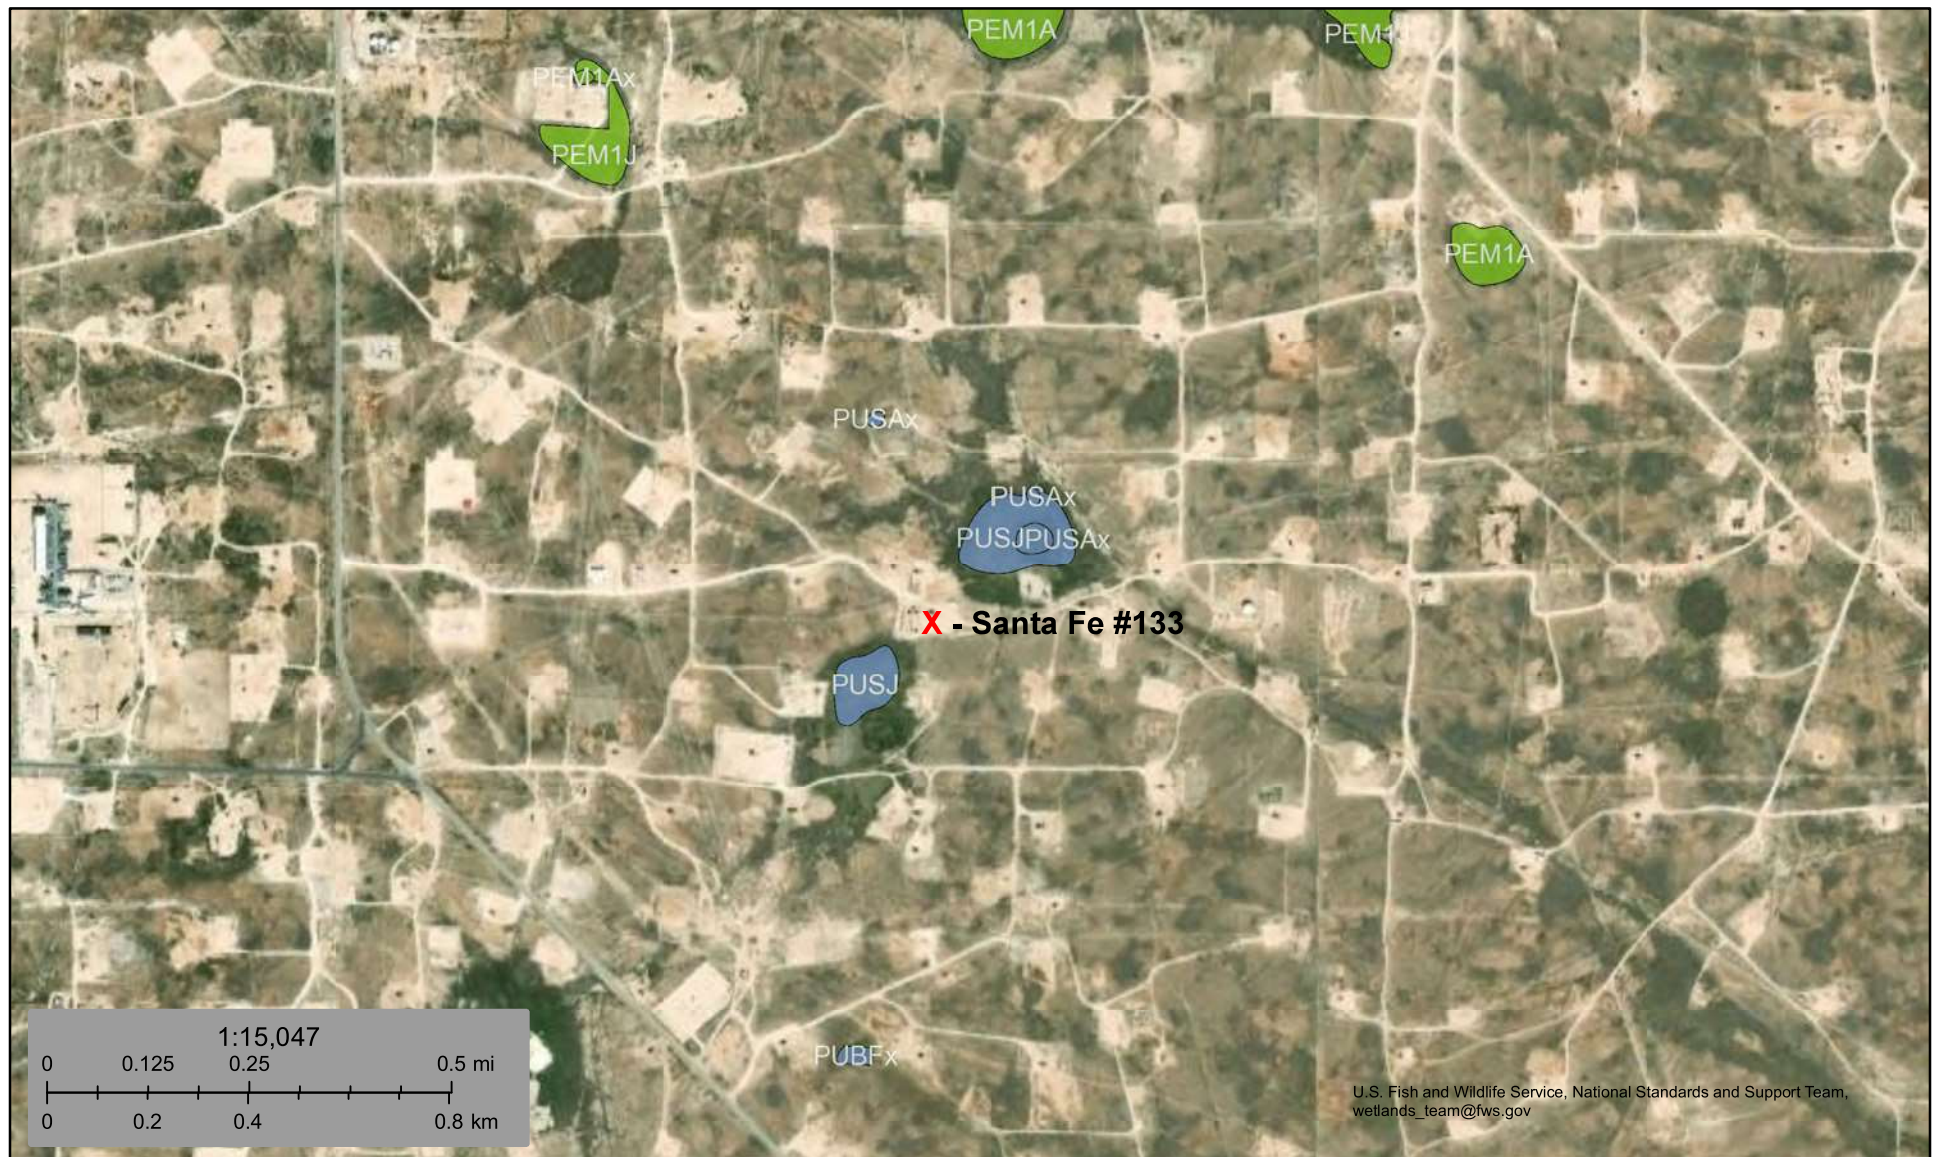
## Wetlands Map

## Wetlands

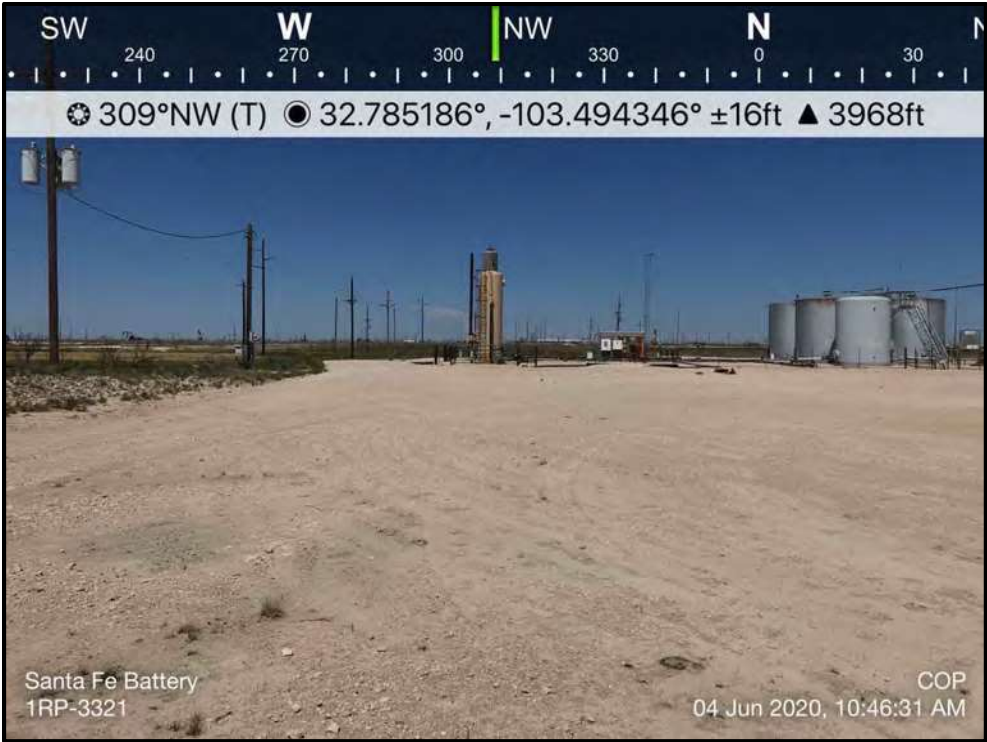
TETRA TECH, INC. PROJECT NO. 212C-MD-02152	DESCRIPTION	View facing northwest of well pad. Heater treater and battery tanks in background.	1
	SITE NAME	Santa Fe Battery Heater Treater Release	6/4/2020

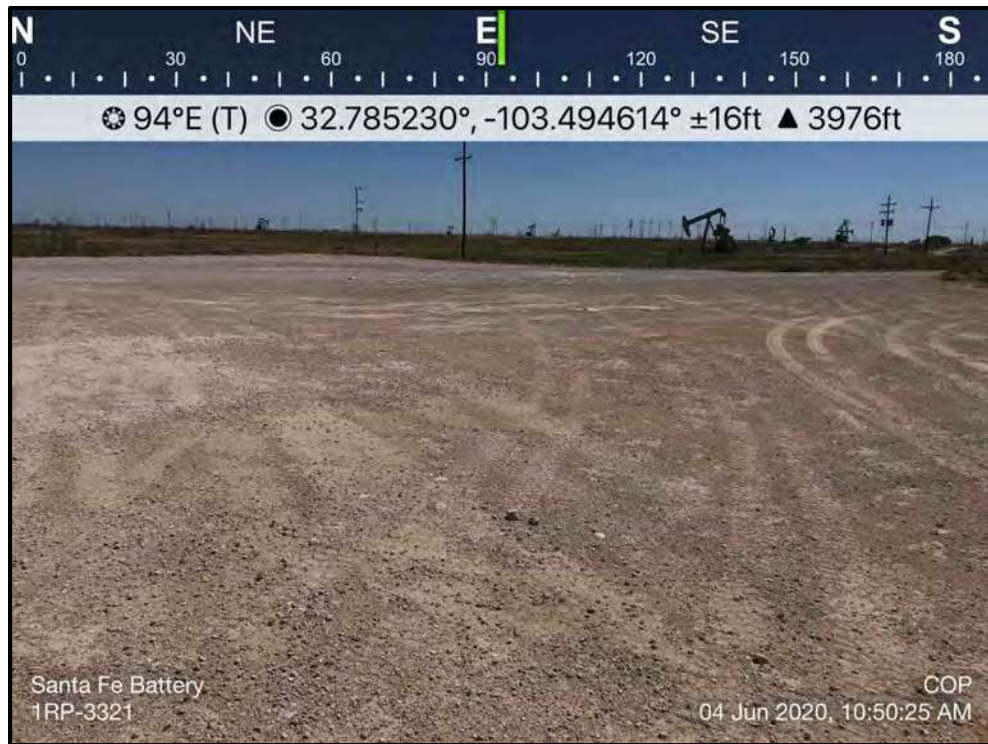
TETRA TECH, INC. PROJECT NO. 212C-MD-02152	DESCRIPTION	View facing east of well pad. Lease road in background.	3
	SITE NAME	Santa Fe Battery Heater Treater Release	6/4/2020

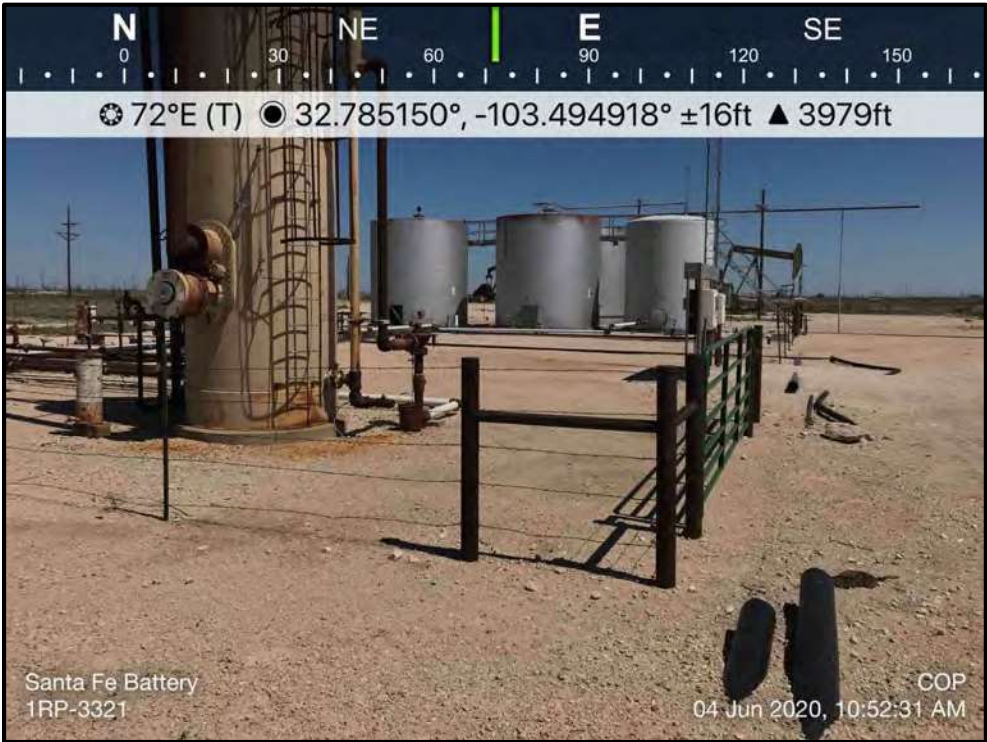
TETRA TECH, INC. PROJECT NO. 212C-MD-02152	DESCRIPTION	View facing east of heater treater and battery tanks.	7
	SITE NAME	Santa Fe Battery Heater Treater Release	6/4/2020

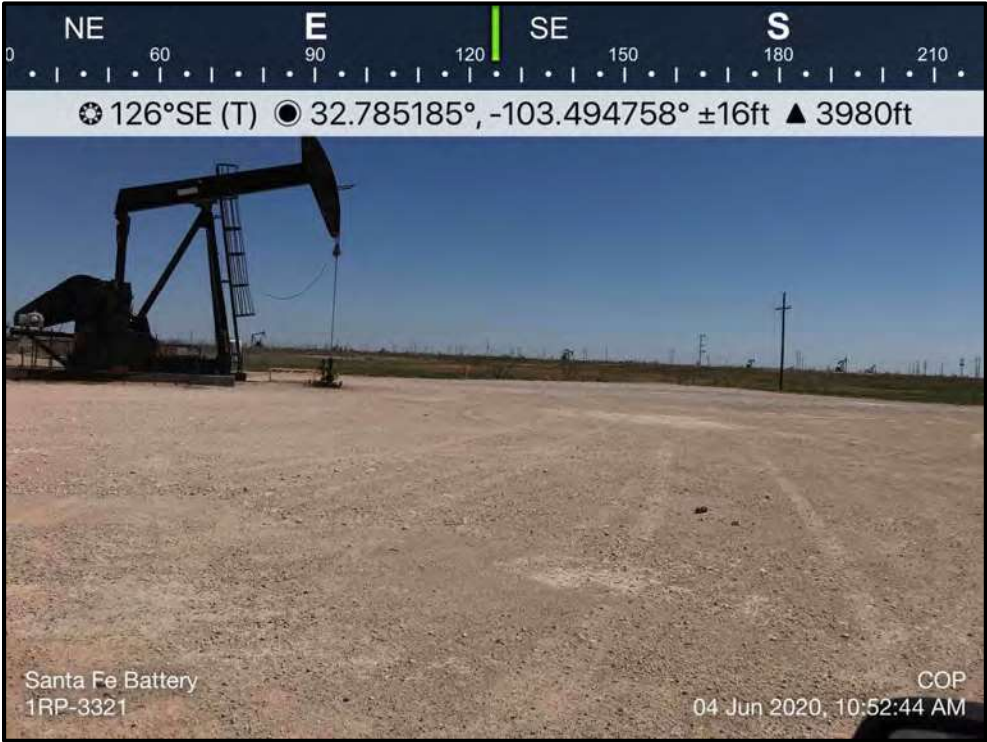
TETRA TECH, INC. PROJECT NO. 212C-MD-02152	DESCRIPTION	View facing southeast of well head.	8
	SITE NAME	Santa Fe Battery Heater Treater Release	6/4/2020
