RE: 2024 Annual Groundwater Report

Rice Operating Company – BD SWD System

BD L-36 EOL (1R426-278): UL/L, Sec. 36, T21S, R37E

NMOCD Incident ID: nAPP2110356466

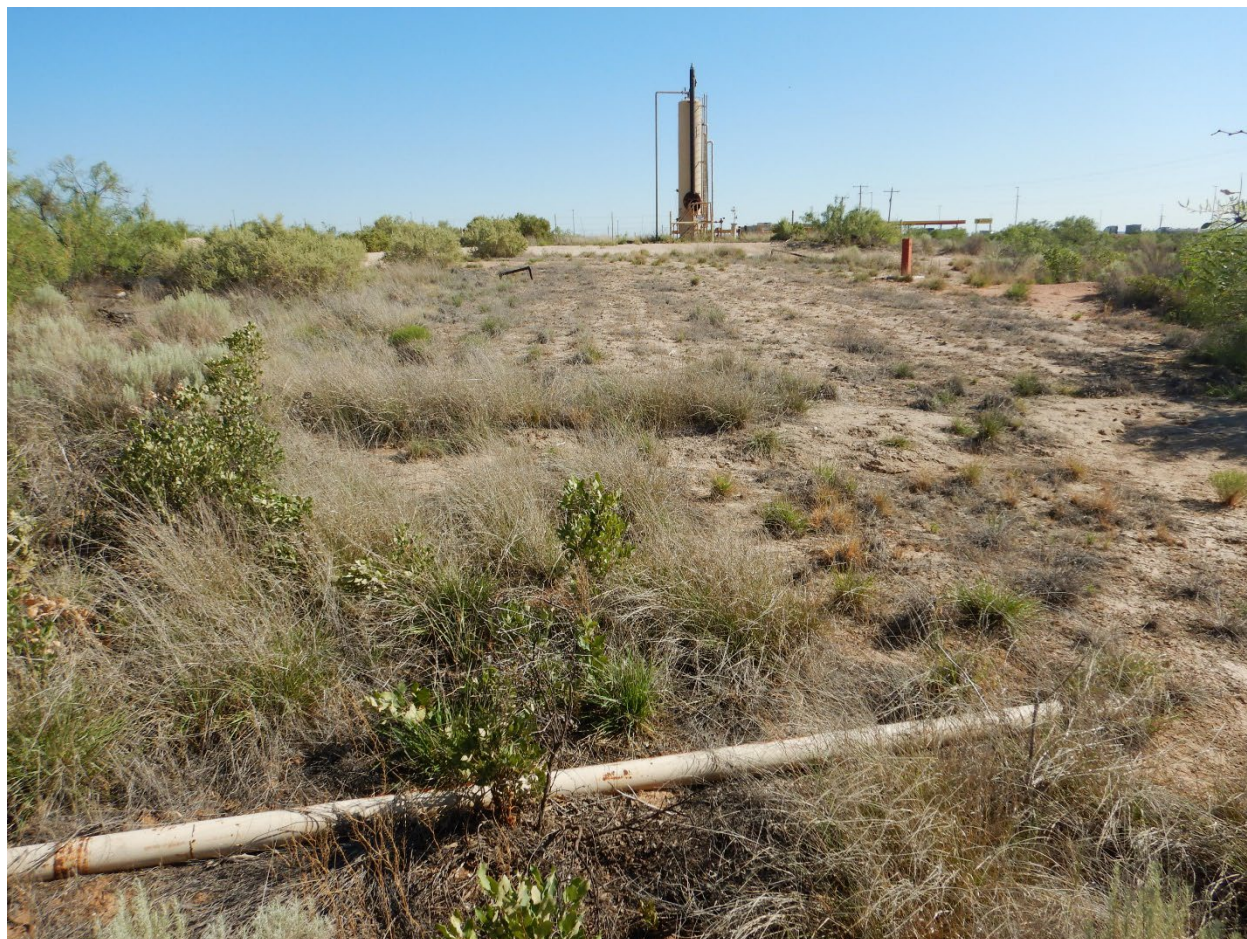
BD L-36 EOL (nAPP2110356466, 1R426-278)
Unit L, Section 36, T21S, R37E

Facing North

7/9/2024

The most recent sampling event resulted in a chloride concentration of 980 mg/L in MW-1, 510 mg/L in MW-2, and 500 mg/L in MW-3. BTEX concentrations have remained below detectable limit in each well since installation. The samples collected from the up-gradient well (MW-2) suggests a non-ROC, up-gradient source has contributed to the degradation of groundwater quality. The highest chloride observed in the up-gradient well (MW-2) resulted in a concentration of 600 mg/L on May 3rd, 2022. Based on the non-ROC up-gradient source contributing to the degradation of groundwater quality, ROC submitted a Termination Request to NMOCD on August 22nd, 2022. NMOCD granted approval on March 1st, 2024, citing that all revegetation activities will need to be documented and included in the revegetation report. ROC suspended groundwater monitoring from MW-1, MW-2, and MW-3. On July 9th, 2024, ROC submitted via email the soil closure documentation previously submitted to NMOCD. The submission included the CAP Report and Soil Closure Request previously submitted on May 17th, 2018, NMOCD's June 20th, 2018, approval granting soil closure, and a recent photo showing from July 9th, 2024, showing the revegetation.

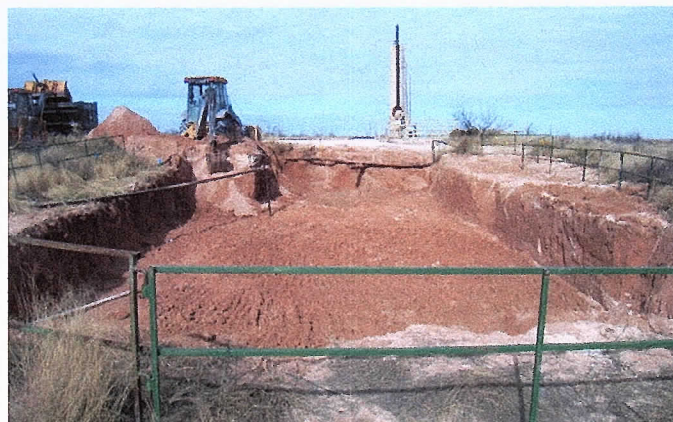
Excavating the site to 5 ft bgs,
facing north

12/18/2017

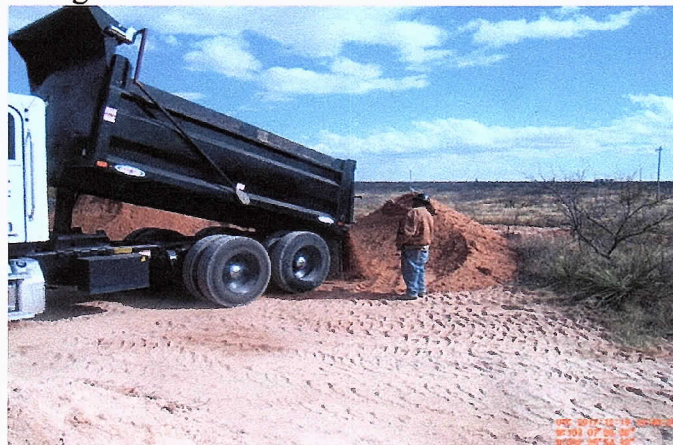
Importing blow sand,
facing south

12/19/2017

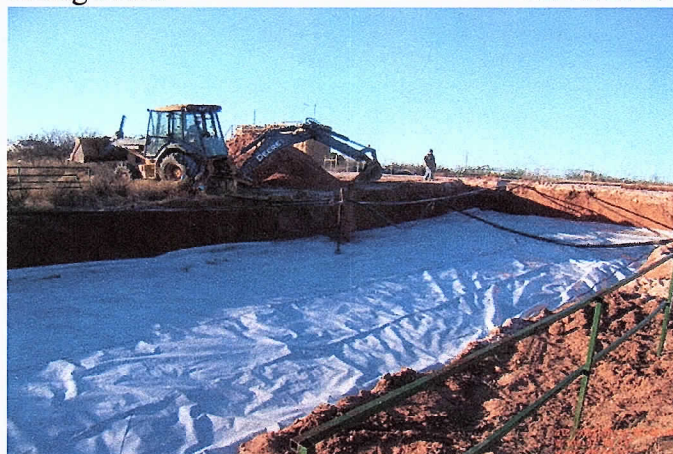
Padding the 20-mil, reinforced liner with imported
soil, facing northeast

12/19/2017

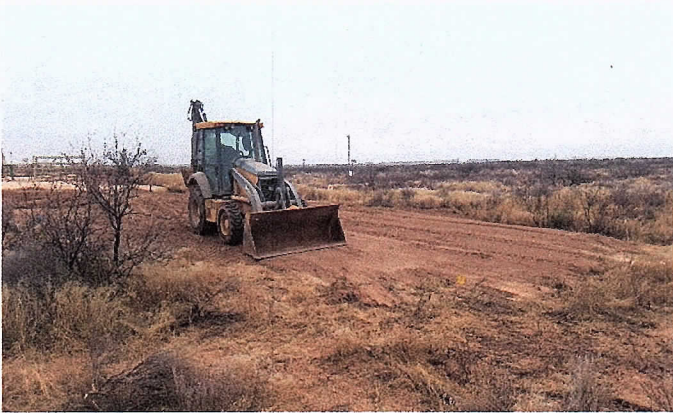
Backfilling and contouring the site with imported soil, facing west 12/27/2017

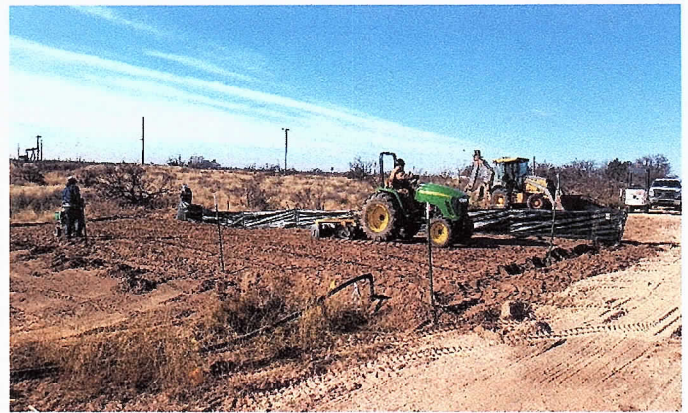
Tilling and seeding backfilled site, facing southwest 12/28/2017

The soils over and surrounding the site was prepared with soil amendments as necessary and seeded with a native vegetative mix. Vegetation above the liner will also provide a natural infiltration barrier for the site since plants capture water through their roots thereby reducing the volume of water moving through the vadose zone.

Custom Seed Mix	X	Prescribed Mix	<input type="checkbox"/>	Seed Mix Name: 5 lbs Lea County Mix & 50 lbs Winter Wheat Seed Mix	Date: 12/28/2017
Method: broadcast with seeder					
Soil conditions during seed:		Dry	X	Damp	<input type="checkbox"/>
Wet		<input type="checkbox"/>	<input type="checkbox"/>		
Observations: Seed was tilled into the soil

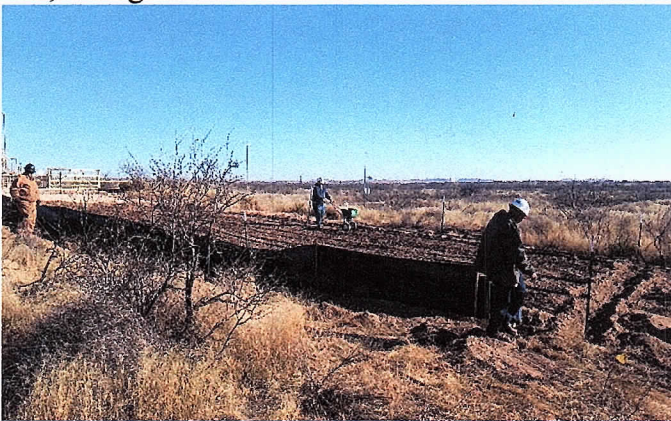
Seeding site, completing silt net fencing, facing northeast 12/28/2017

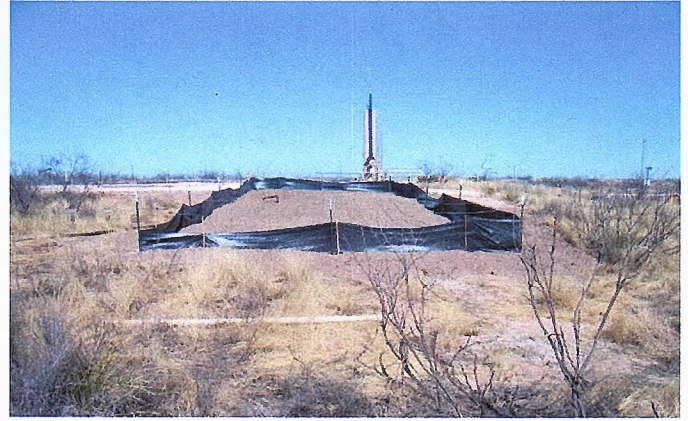
Site complete, facing north
