**Re: Release Characterization and Remediation Work Plan
Mesa 11 CTB
BTA Oil Producers, LLC
Lea County, New Mexico
NMOCD Incident ID: nAPP2508742989
Project Location: 32.065820°, -103.628840°
Facility ID: fAPP2129922652**

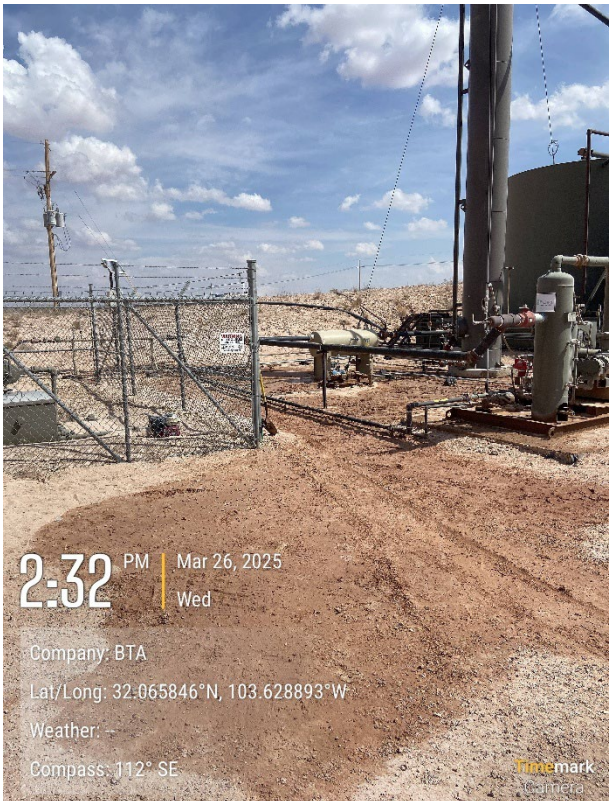
TETRA TECH, INC. PROJECT NO. 212C-MD-03837	DESCRIPTION	View southeast of approximate release extent and production equipment.	1
	SITE NAME	Mesa 11 CTB Release	3/26/2025

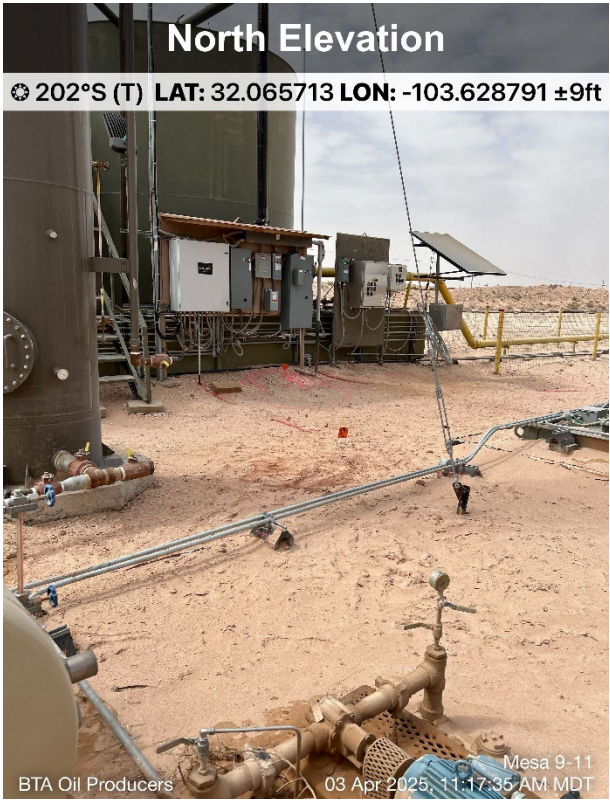
TETRA TECH, INC. PROJECT NO. 212C-MD-03837	DESCRIPTION	View north of approximate release extent and production equipment. Surface/Subsurface electrical lines.	4
	SITE NAME	Mesa 11 CTB Release	4/3/2025

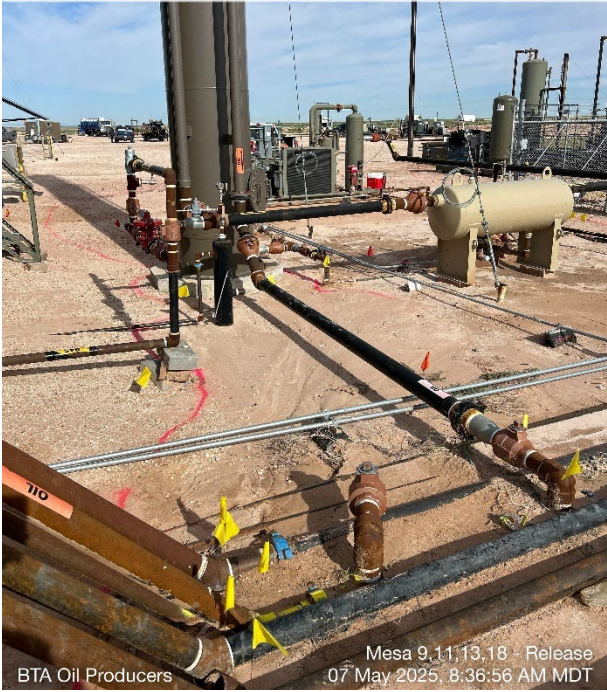
TETRA TECH, INC. PROJECT NO. 212C-MD-03837	DESCRIPTION	View southeast of marked release extent and subsurface utilities.	6
	SITE NAME	Mesa 11 CTB Release	5/7/2025

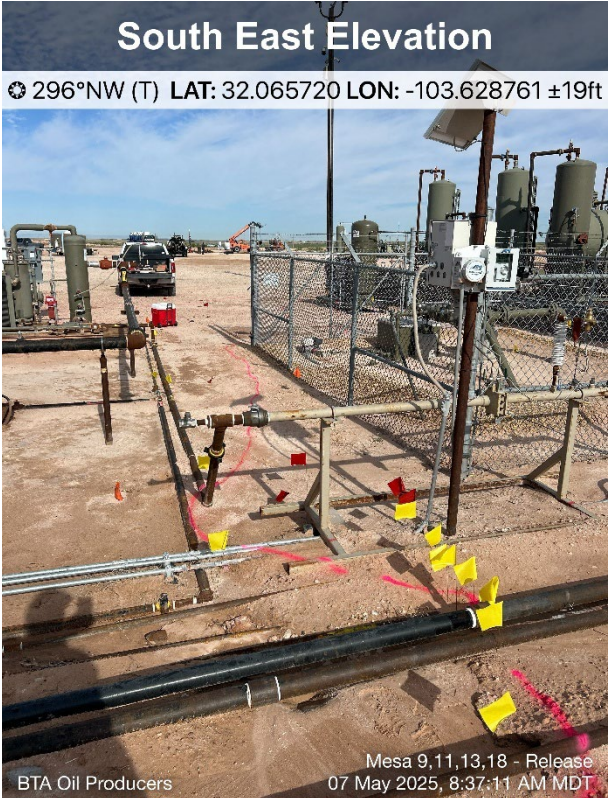
TETRA TECH, INC. PROJECT NO. 212C-MD-03837	DESCRIPTION	View southeast of marked release extent and subsurface utilities. Surface steel and electrical lines.	7
	SITE NAME	Mesa 11 CTB Release	5/7/2025

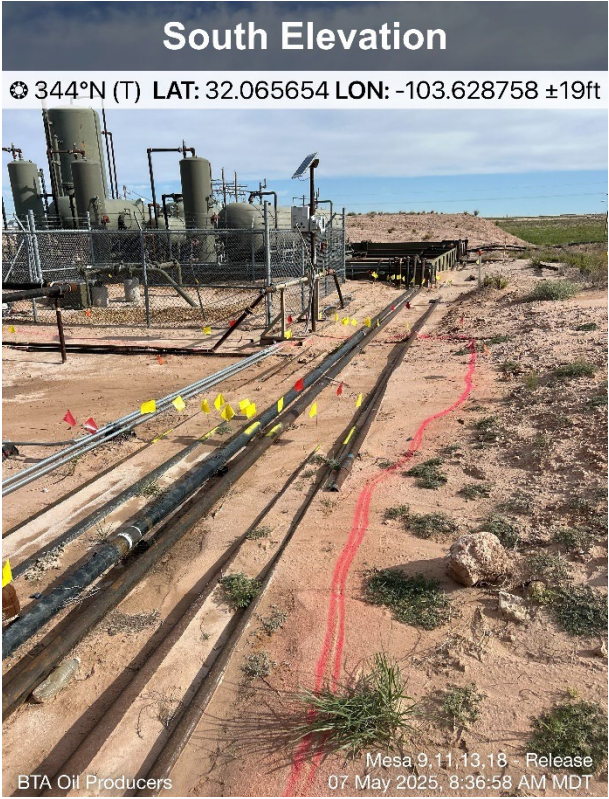
TETRA TECH, INC. PROJECT NO. 212C-MD-03837	DESCRIPTION	View south of marked release extent and subsurface utilities. Surface steel and electrical lines.	8
	SITE NAME	Mesa 11 CTB Release	5/7/2025
