RE: Site Assessment – Liner Inspection Summary  
Contest Fed Com CTB (6-05-2025)  
Incident No. nAPP2515635628  
Tasman Project No. 8875  
UL “K”, Sec. 09, Township 24 South, Range 34 East, Lea County, New Mexico

Tasman, Inc. is submitting this Liner Inspection Summary to outline response actions conducted by and on behalf of Civitas Permian Operating, LLC (Civitas) at the above-referenced site. Activities were conducted in accordance with NMOCD regulations for reportable releases of produced water to the environment. The activities conducted are described below – supporting information is provided in the attached figure(s), table(s), and appendices.

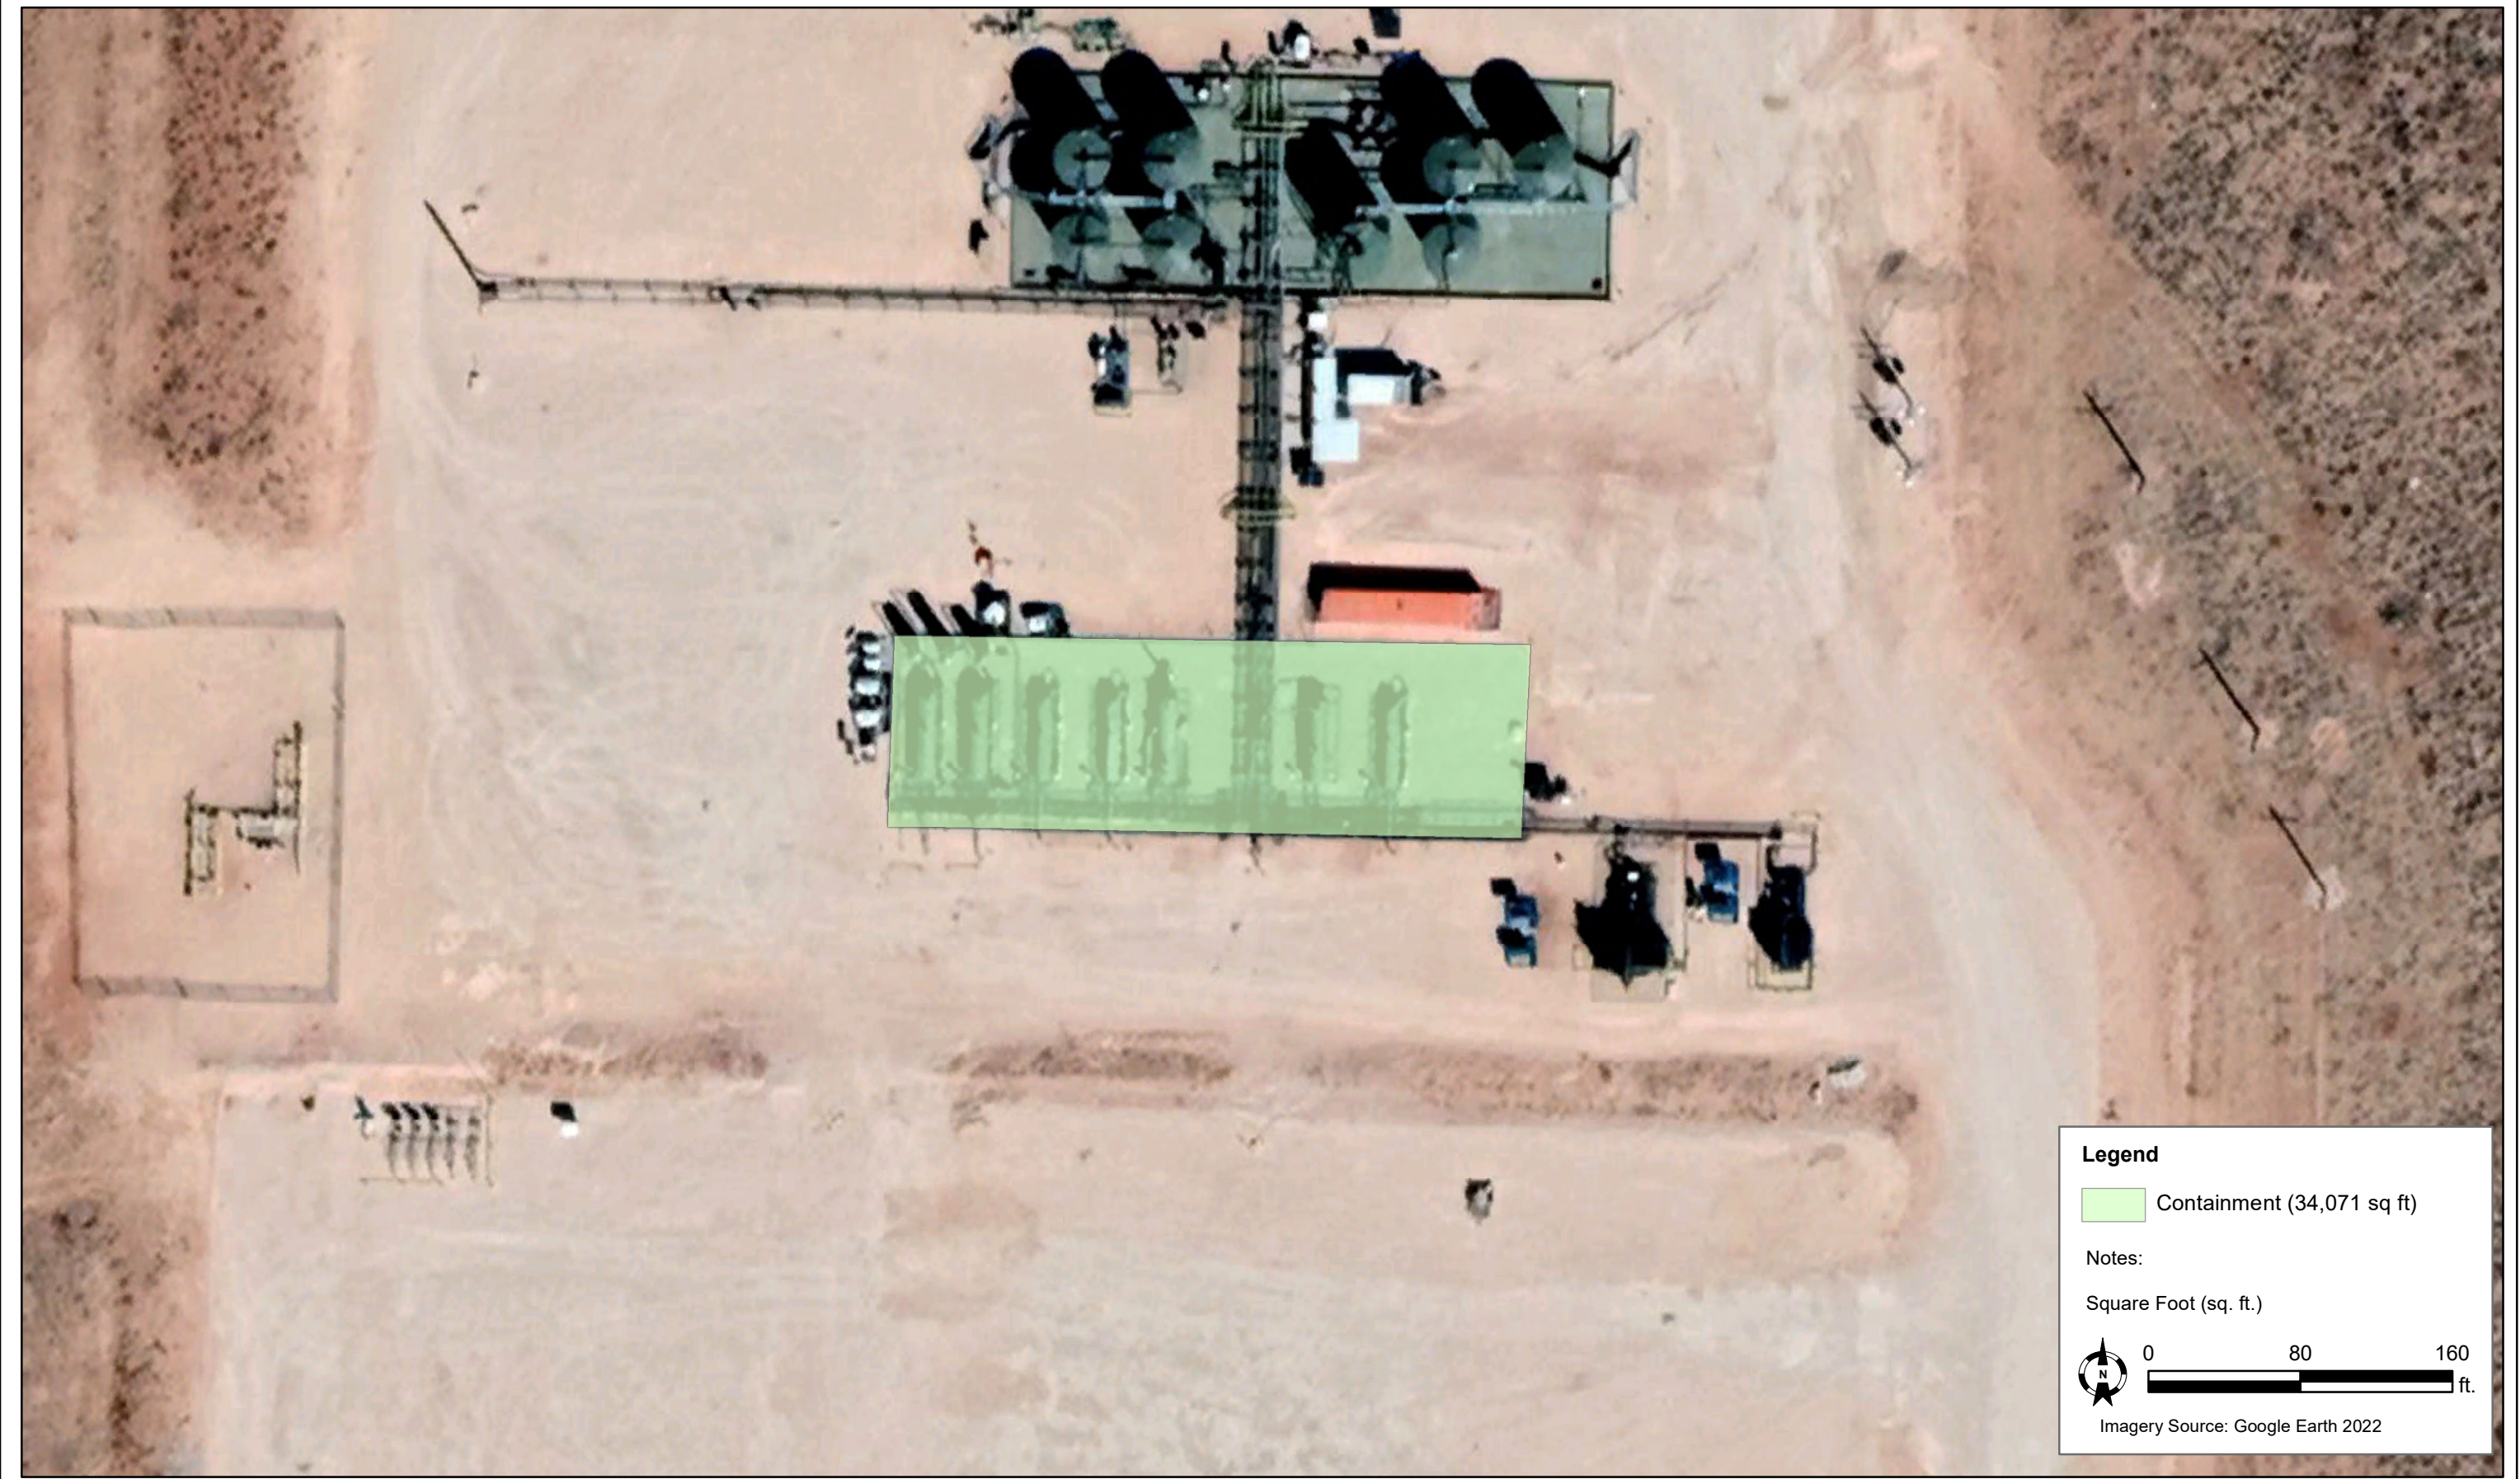
Figure  
5

On August 4, 2025, Tasman personnel conducted site evaluation of the release extent based on the information provided on Form C-141. A site assessment and liner inspection were conducted of the lined containment. Assessment and observation of the site confirmed no visible staining or releases outside of the lined containment. During inspection of the liner, no visible tears or other damage were observed. Photographic documentation from the liner inspection is provided in Appendix B, and overview of the containment in figure 5.

Based on the information provided herein, the release of produced water was entirely contained within the lined containment, and the liner integrity is sound. Tasman recommends that no further action be taken regarding the release of produced water at the site.

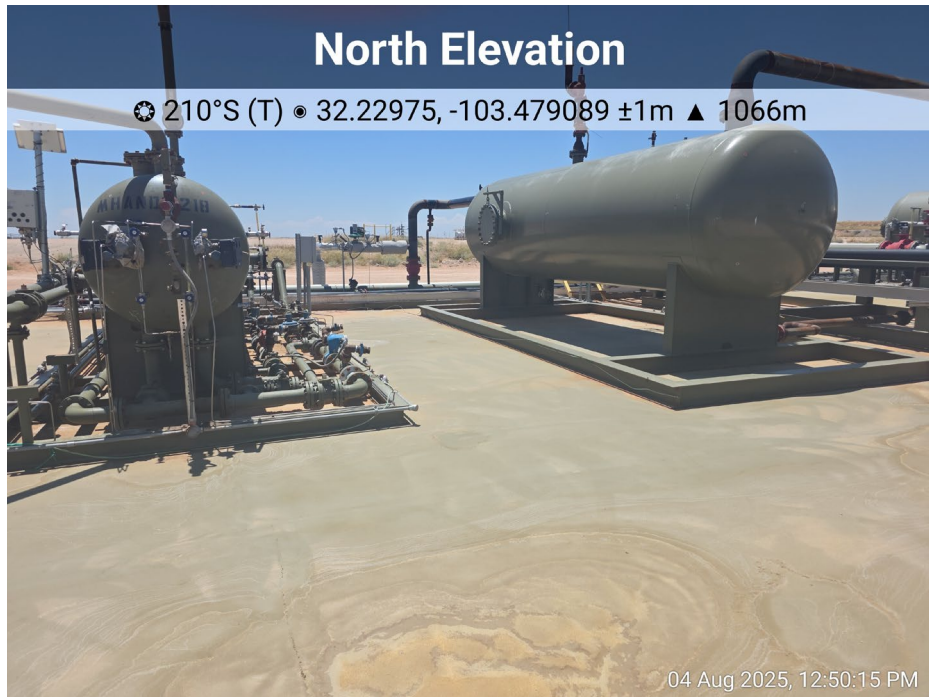
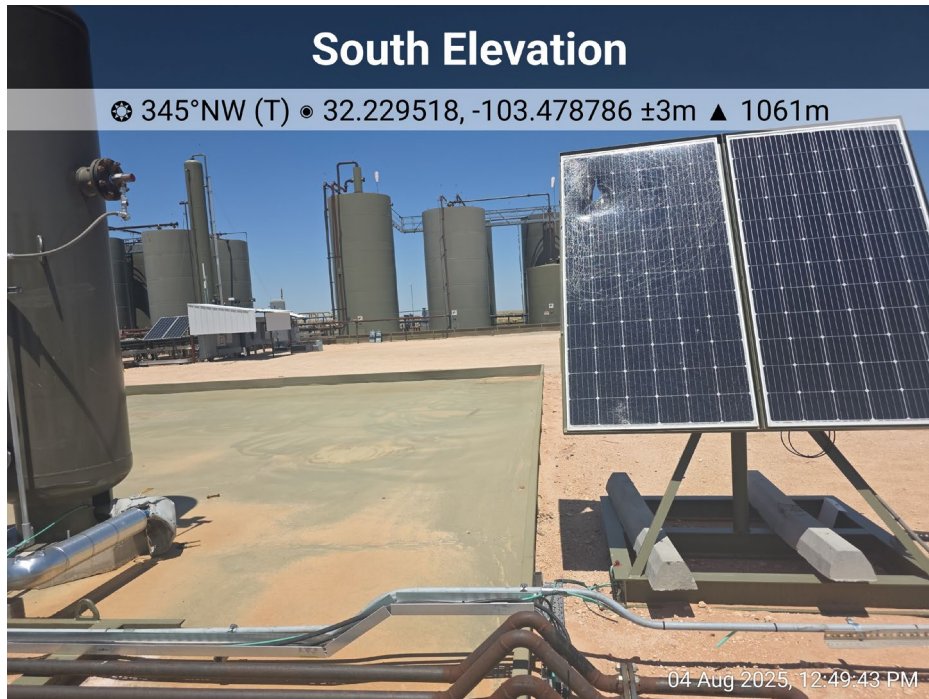
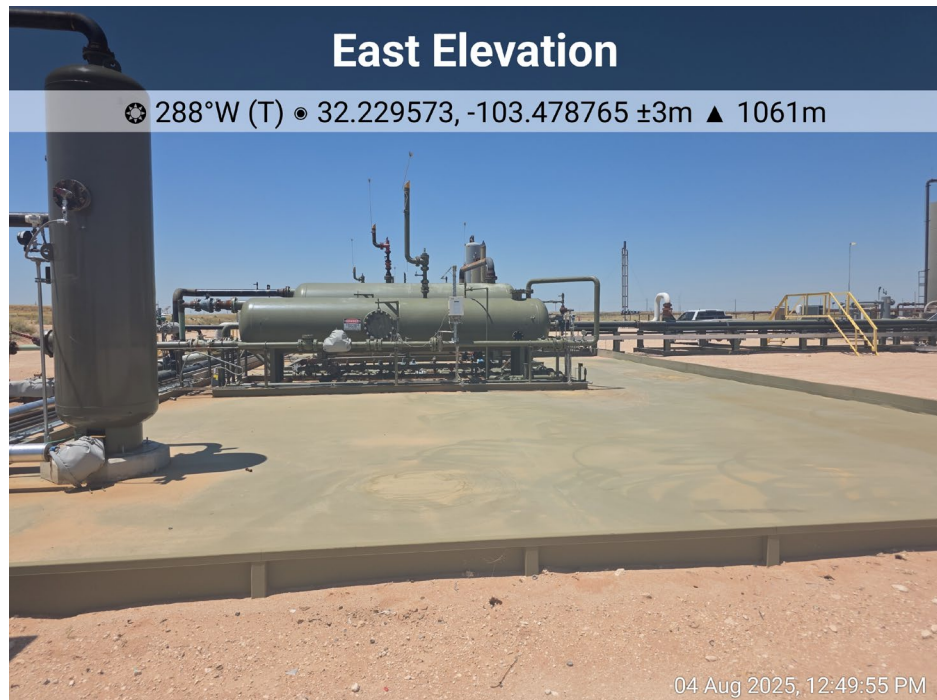
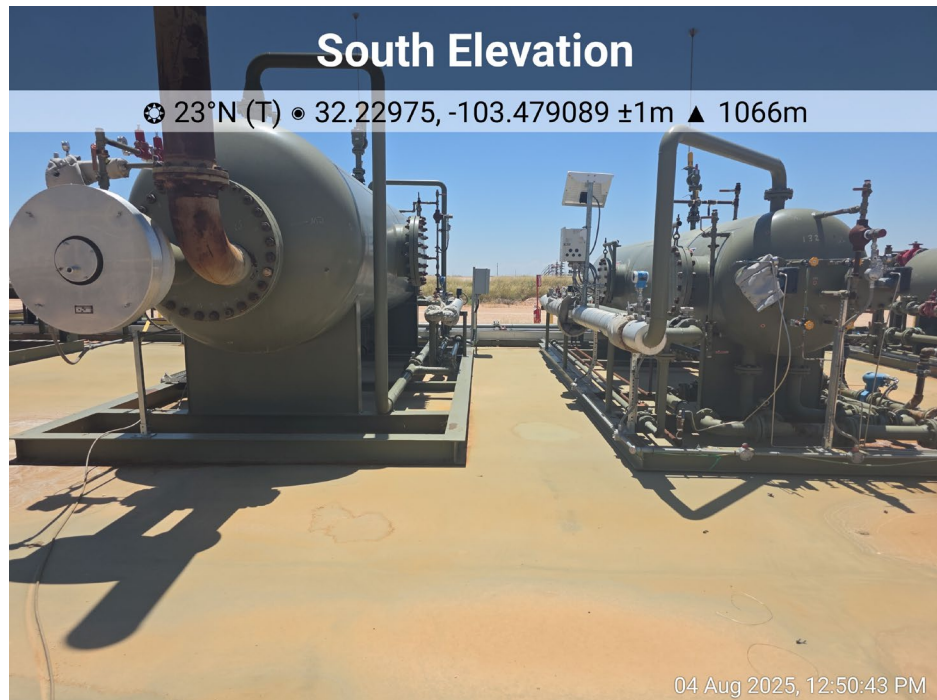
Requesting a remediation closure approval with this submission	Yes
Have the lateral and vertical extents of contamination been fully delineated	Yes
Was this release entirely contained within a lined containment area	Yes
What was the total surface area (in square feet) remediated	6870
What was the total volume (cubic yards) remediated	0
Summarize any additional remediation activities not included by answers (above)	The liner inspection was observed to have no rips or tears to allow release to escape containment.
