**Re: Closure Request
Woolhead CTB
Incident Number nAPP2500853952
Lea County, New Mexico**

Ensolum, LLC (Ensolum), on behalf of Matador Production Company (Matador), has prepared this *Closure Request* to document assessment, excavation, and soil sampling activities at the Woolhead CTB (Site). The purpose of the Site assessment and soil sampling activities was to assess for the presence or absence of impacts to soil following an equipment failure. Based on field observations, field screening activities, and soil sample laboratory analytical results, Matador is submitting this *Closure Request*, describing Site assessment, delineation, and excavation activities that have occurred and requesting no further action for Incident Number nAPP2500853952.

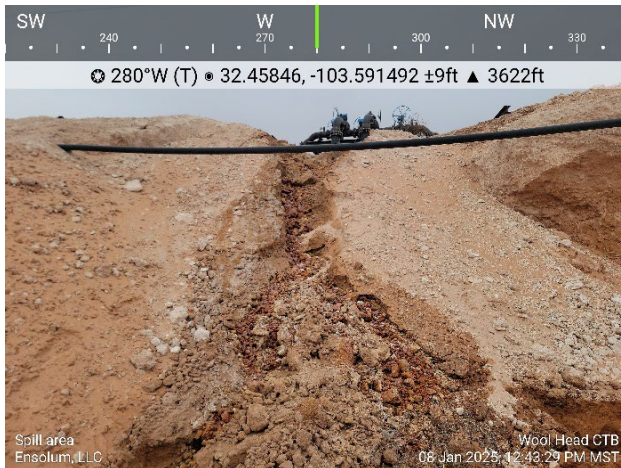
Photograph 1
Description: Spill area
View: West

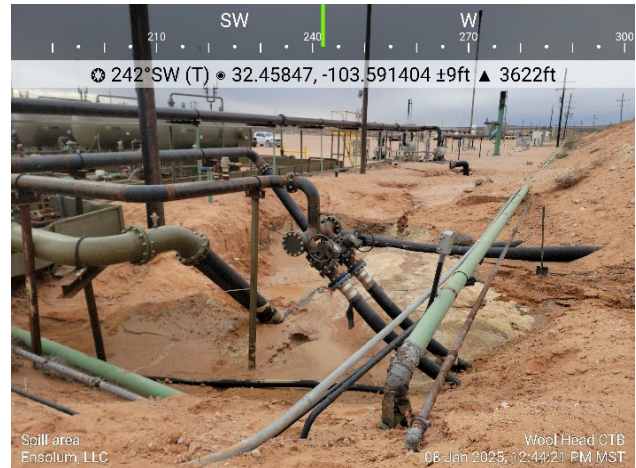
Photograph 2
Description: Spill area
View: Southwest

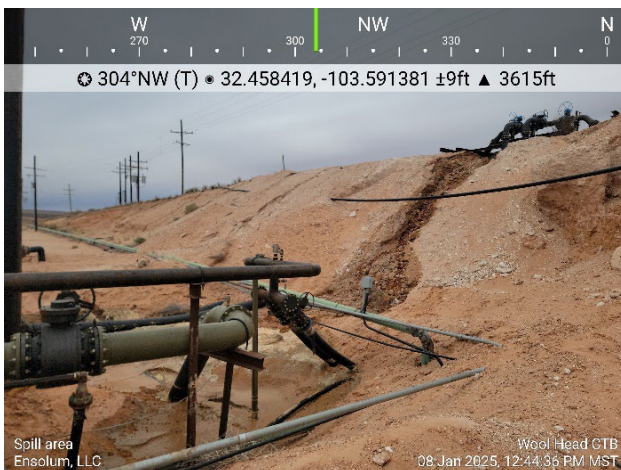
Photograph 3
Description: Spill area
View: Northwest

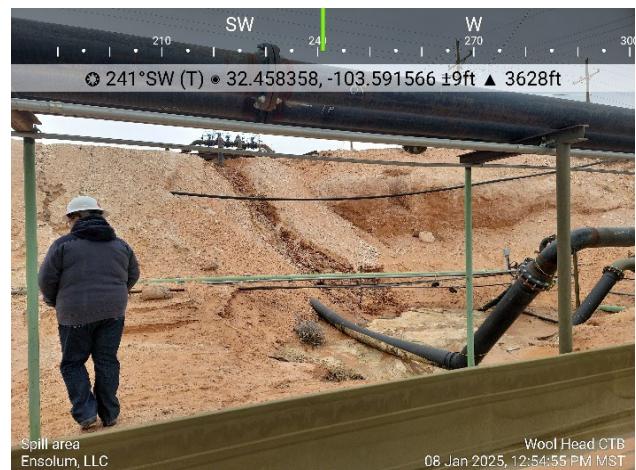
Photograph 4
Description: Spill area
View: Southwest

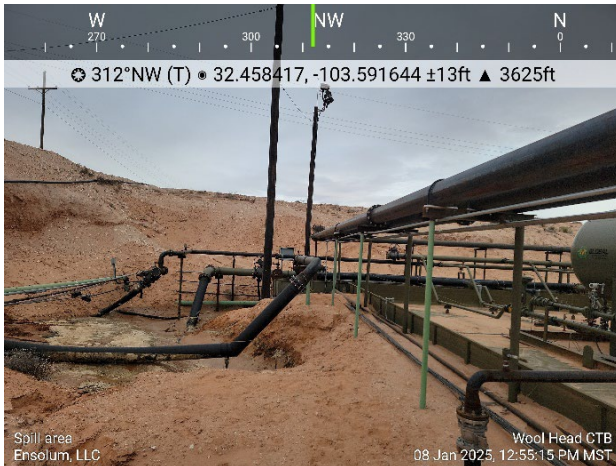
Photograph 5

Description: Spill area

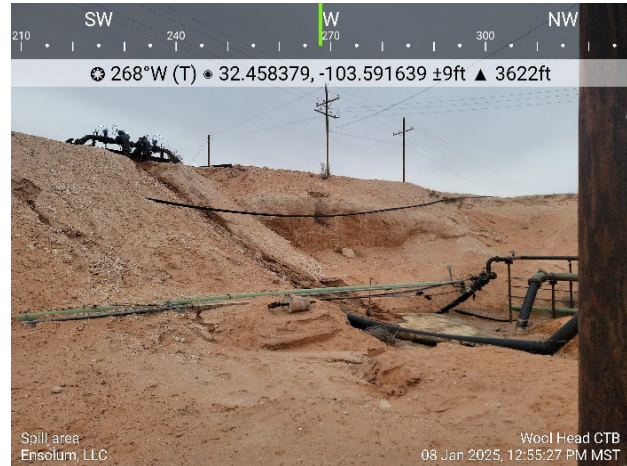
Photograph 6

Description: Spill area

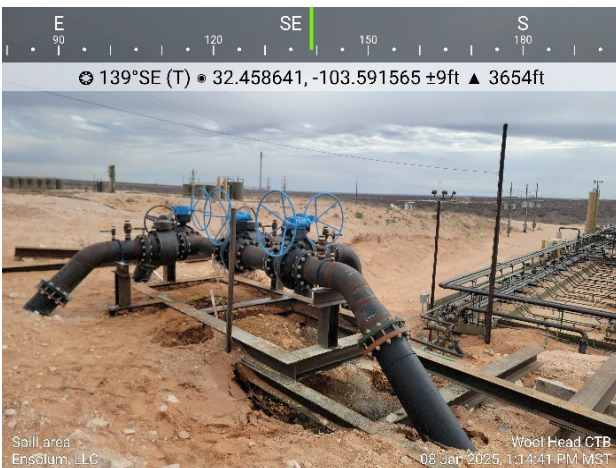
Photograph 7

Description: Spill area

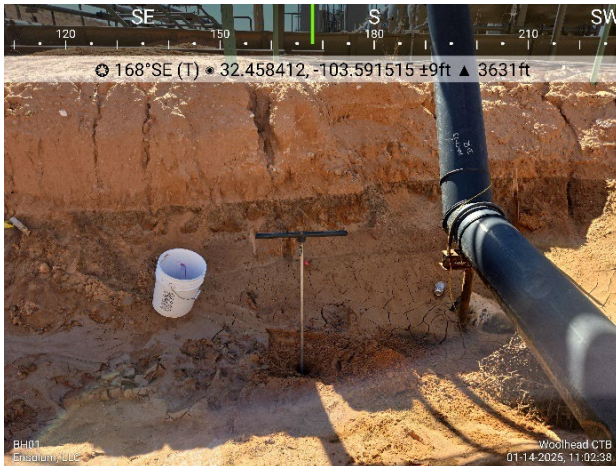
Photograph 9

Description: BH01

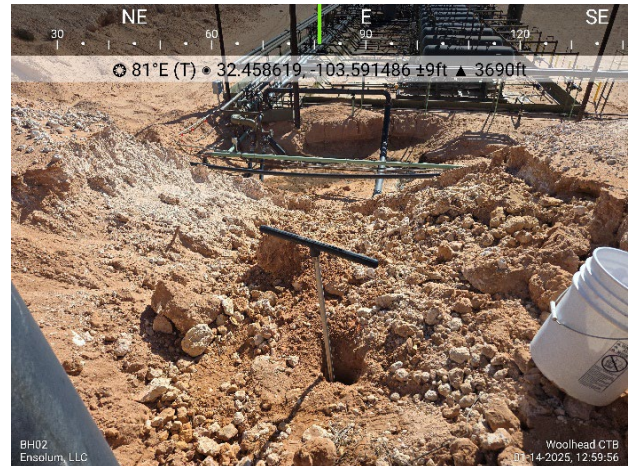
Photograph 10

Description: BH02

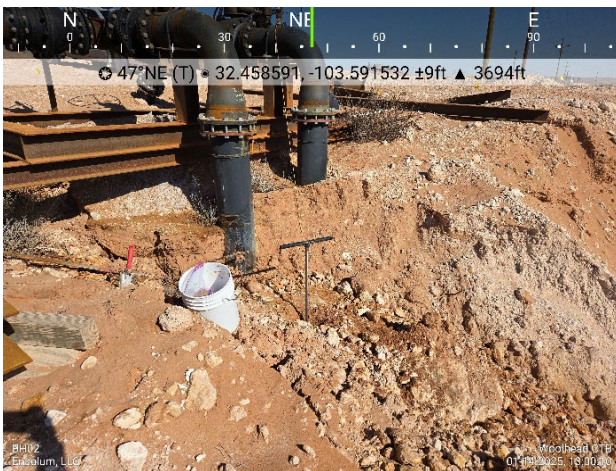
Photograph 11

Description: BH02

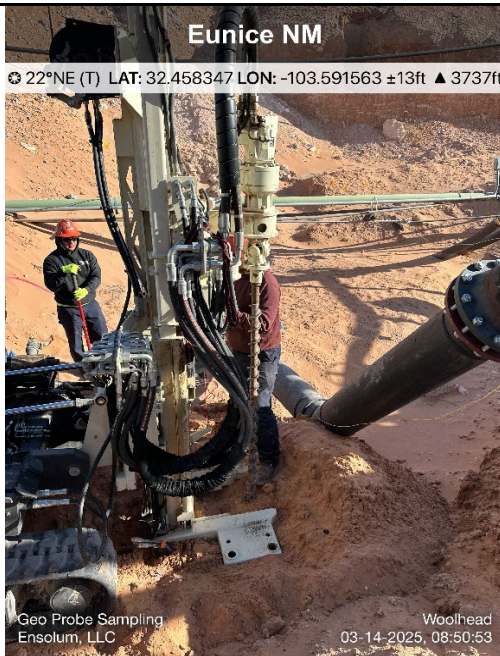
Photograph 13

Description: Delineation (BH01)

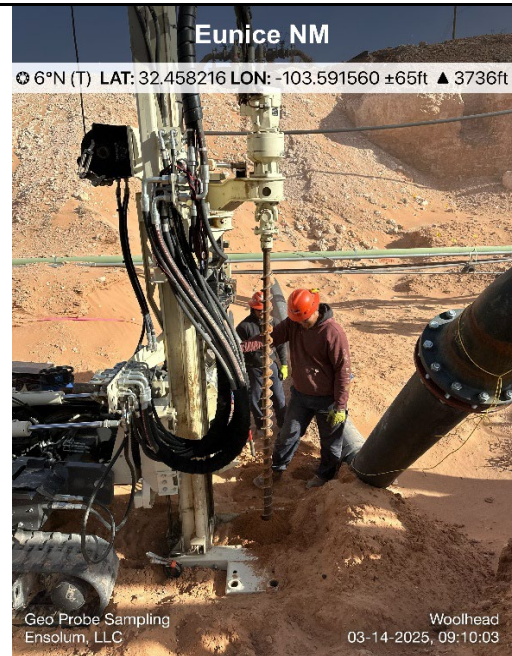
Photograph 14

Description: Delineation (BH01)

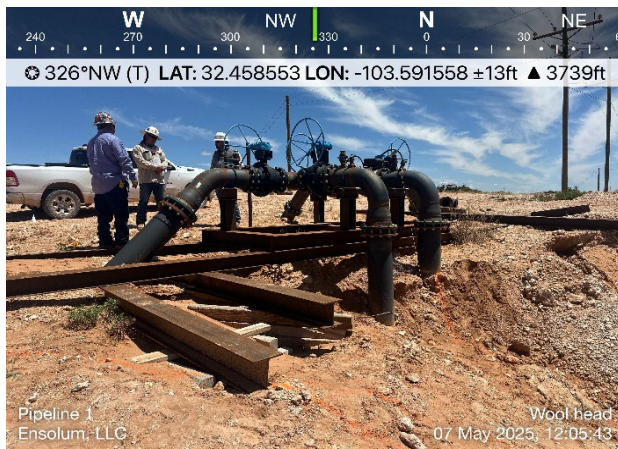
Photograph 15

Description: Excavation Activities

Beginning on May 7, 2025, impacted and waste containing soil was excavated from the release area as indicated by visible staining and delineation soil sampling results. Excavation activities were performed using a hydrovac, skid steer, and hand digging crew. To direct excavation activities, Ensolum personnel screened soil for chloride and TPH utilizing the processes described above.

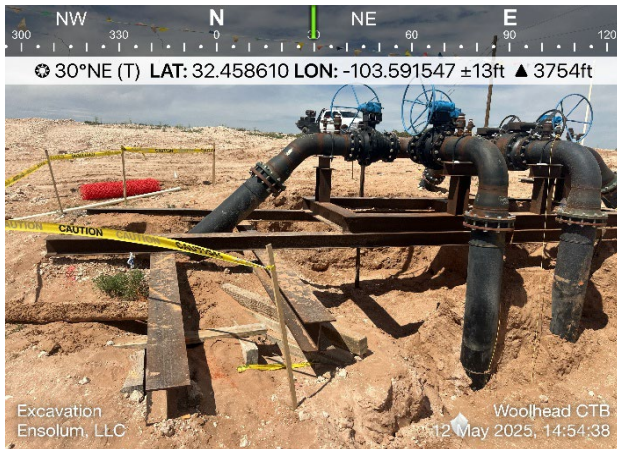
Photograph 17

Description: Excavation Activities

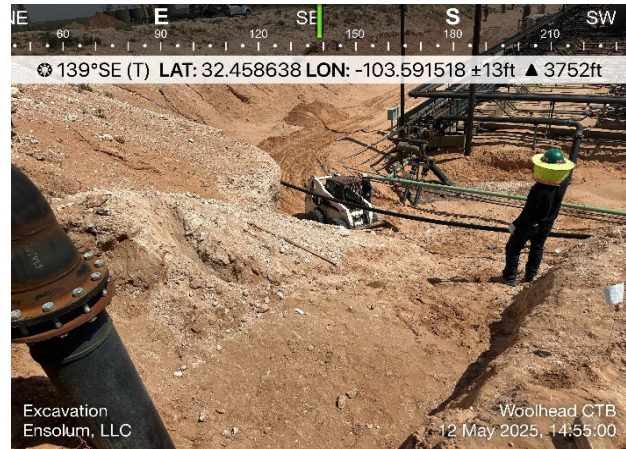
Photograph 18

Description: Excavation Activities

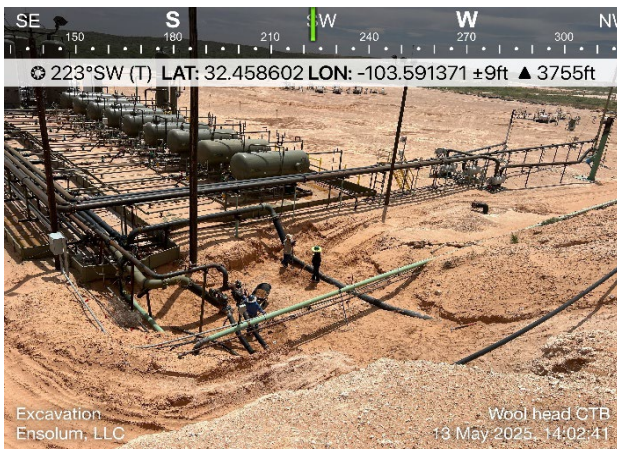
Photograph 19

Description: Excavation Activities

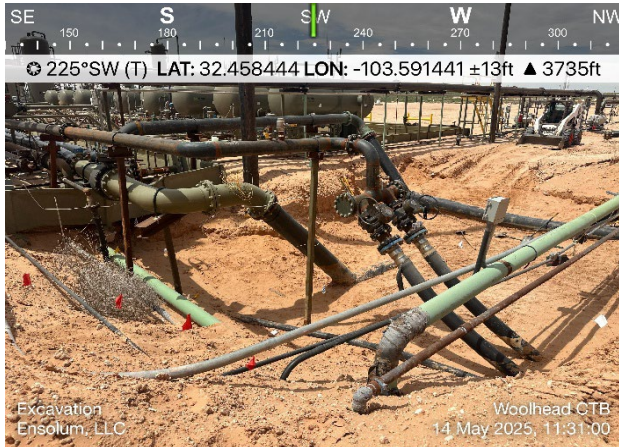
Photograph 21
Description: Excavation Area
View: Southwest

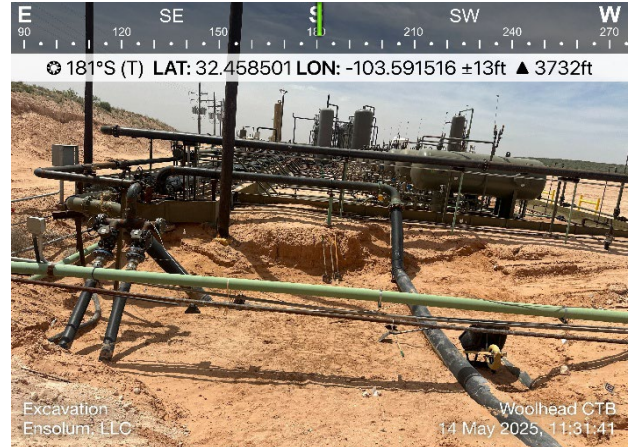
Photograph 22
Description: Excavation Area
View: South

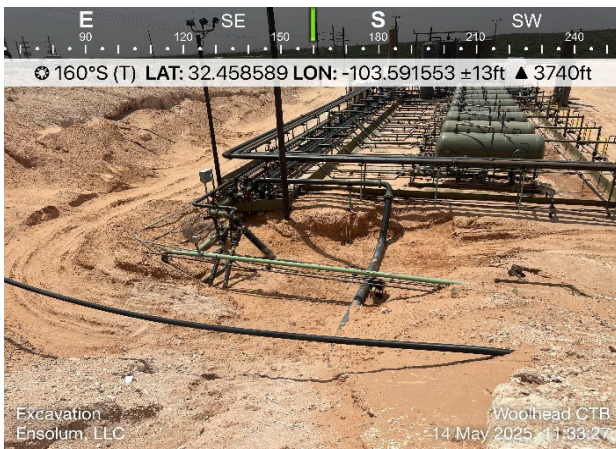
Photograph 23
Description: Excavation Area
View: South

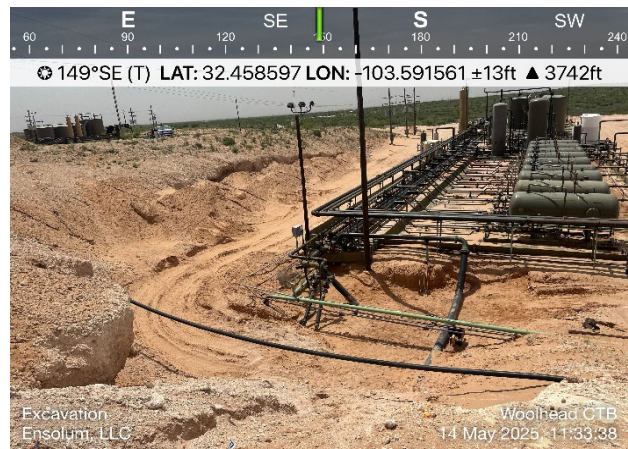
Photograph 24
Description: Excavation Area
View: Southeast
