**Closure Report**  
**Hamon Federal Com ROW (01.31.2025) / Lea Unit Frac (02.01.2025)**  
**Lea County, New Mexico**  
**Unit E, Sec 08, T20S, R34E**  
**32.587845°, -103.59017°**

**Prepared for:**  
**Coterra Energy Operating Co.**  
**6001 Deauville Blvd.**  
**Suite 300N**  
**Midland, Texas 79706**

**Prepared by:**  
**Carmona Resources, LLC**  
**310 West Wall Street**  
**Suite 500**  
**Midland, Texas 79701**

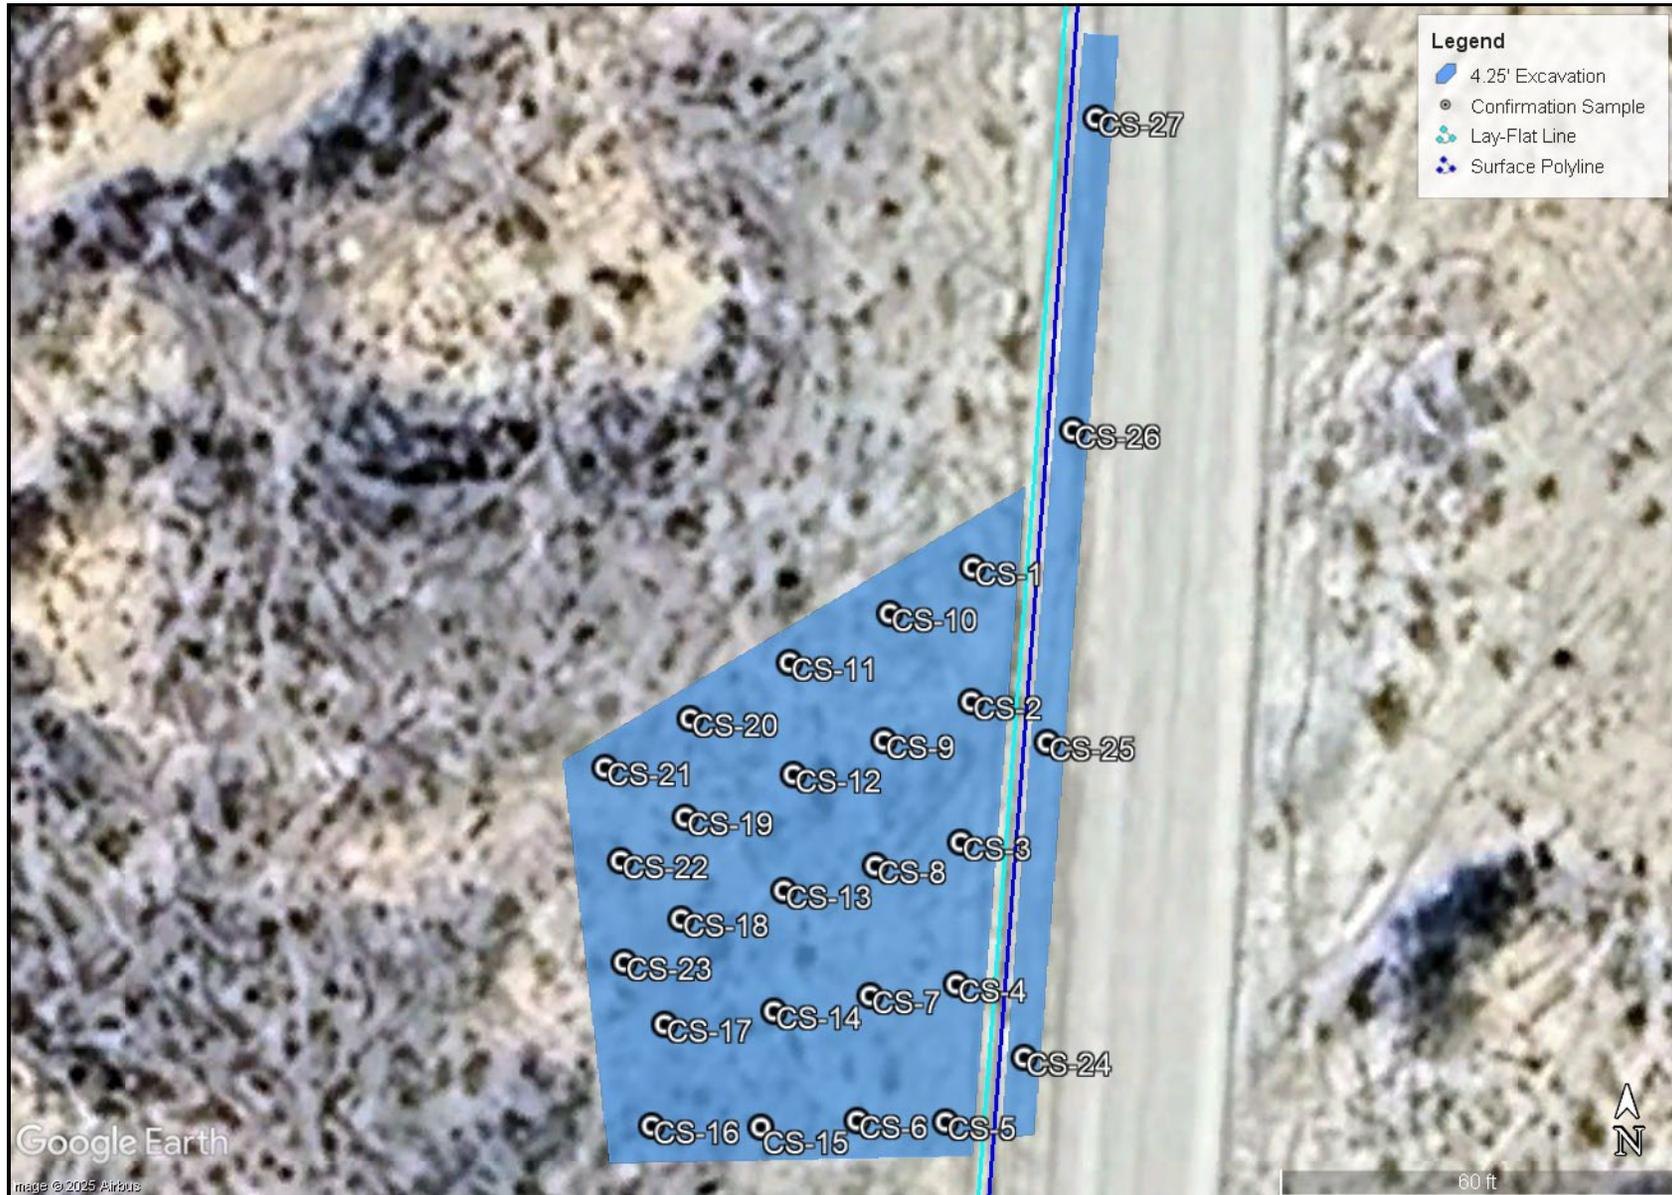
</p>	<p>FIGURE 3A</p>
--	--	------------------

<p>EXCAVATION DEPTH MAP COTERRA ENERGY OPERATING CO. HAMON FEDERAL COM ROW/ LEA UNIT FRAC LEA COUNTY, NEW MEXICO 32.587845°, -103.59017°</p>	<p>CARMONA RESOURCES

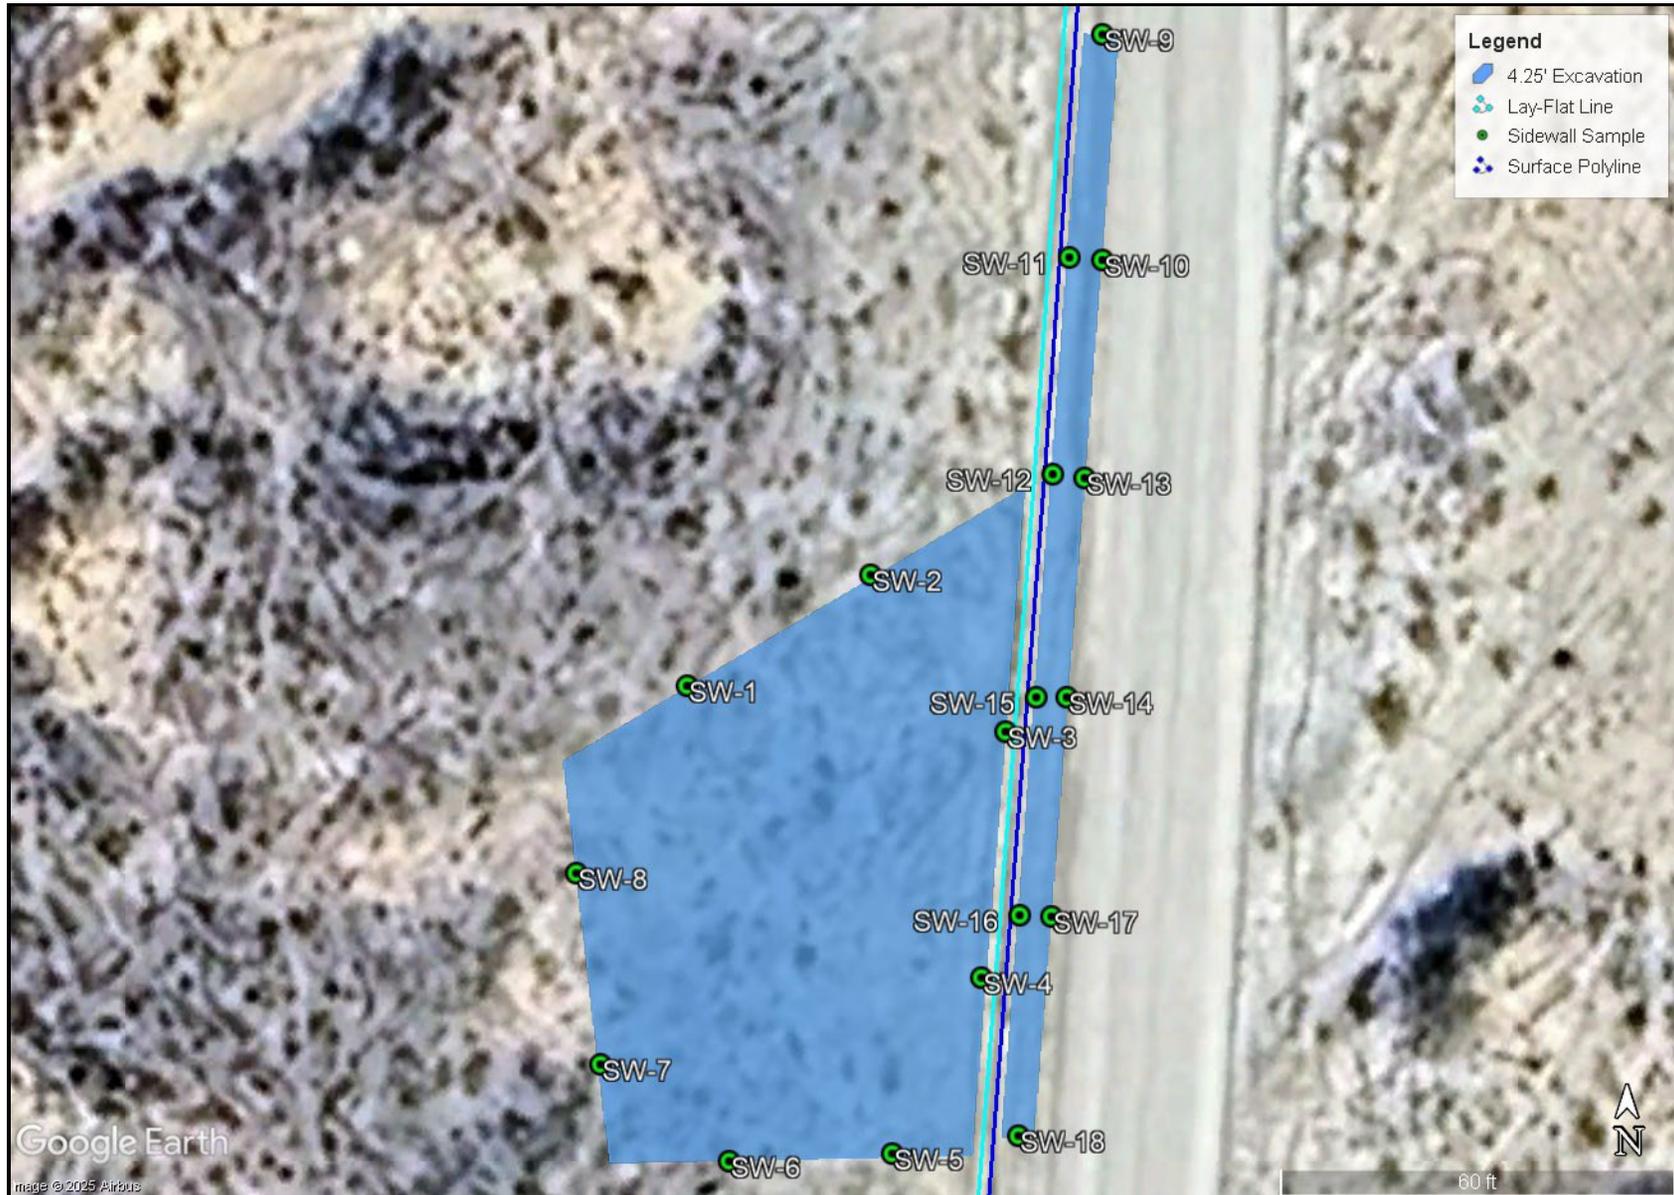
</p>	<p>FIGURE 3B</p>
--	--	------------------

<p>EXCAVATION DEPTH MAP COTERRA ENERGY OPERATING CO. HAMON FEDERAL COM ROW/ LEA UNIT FRAC LEA COUNTY, NEW MEXICO 32.587845°, -103.59017°</p>	<p>CARMONA RESOURCES

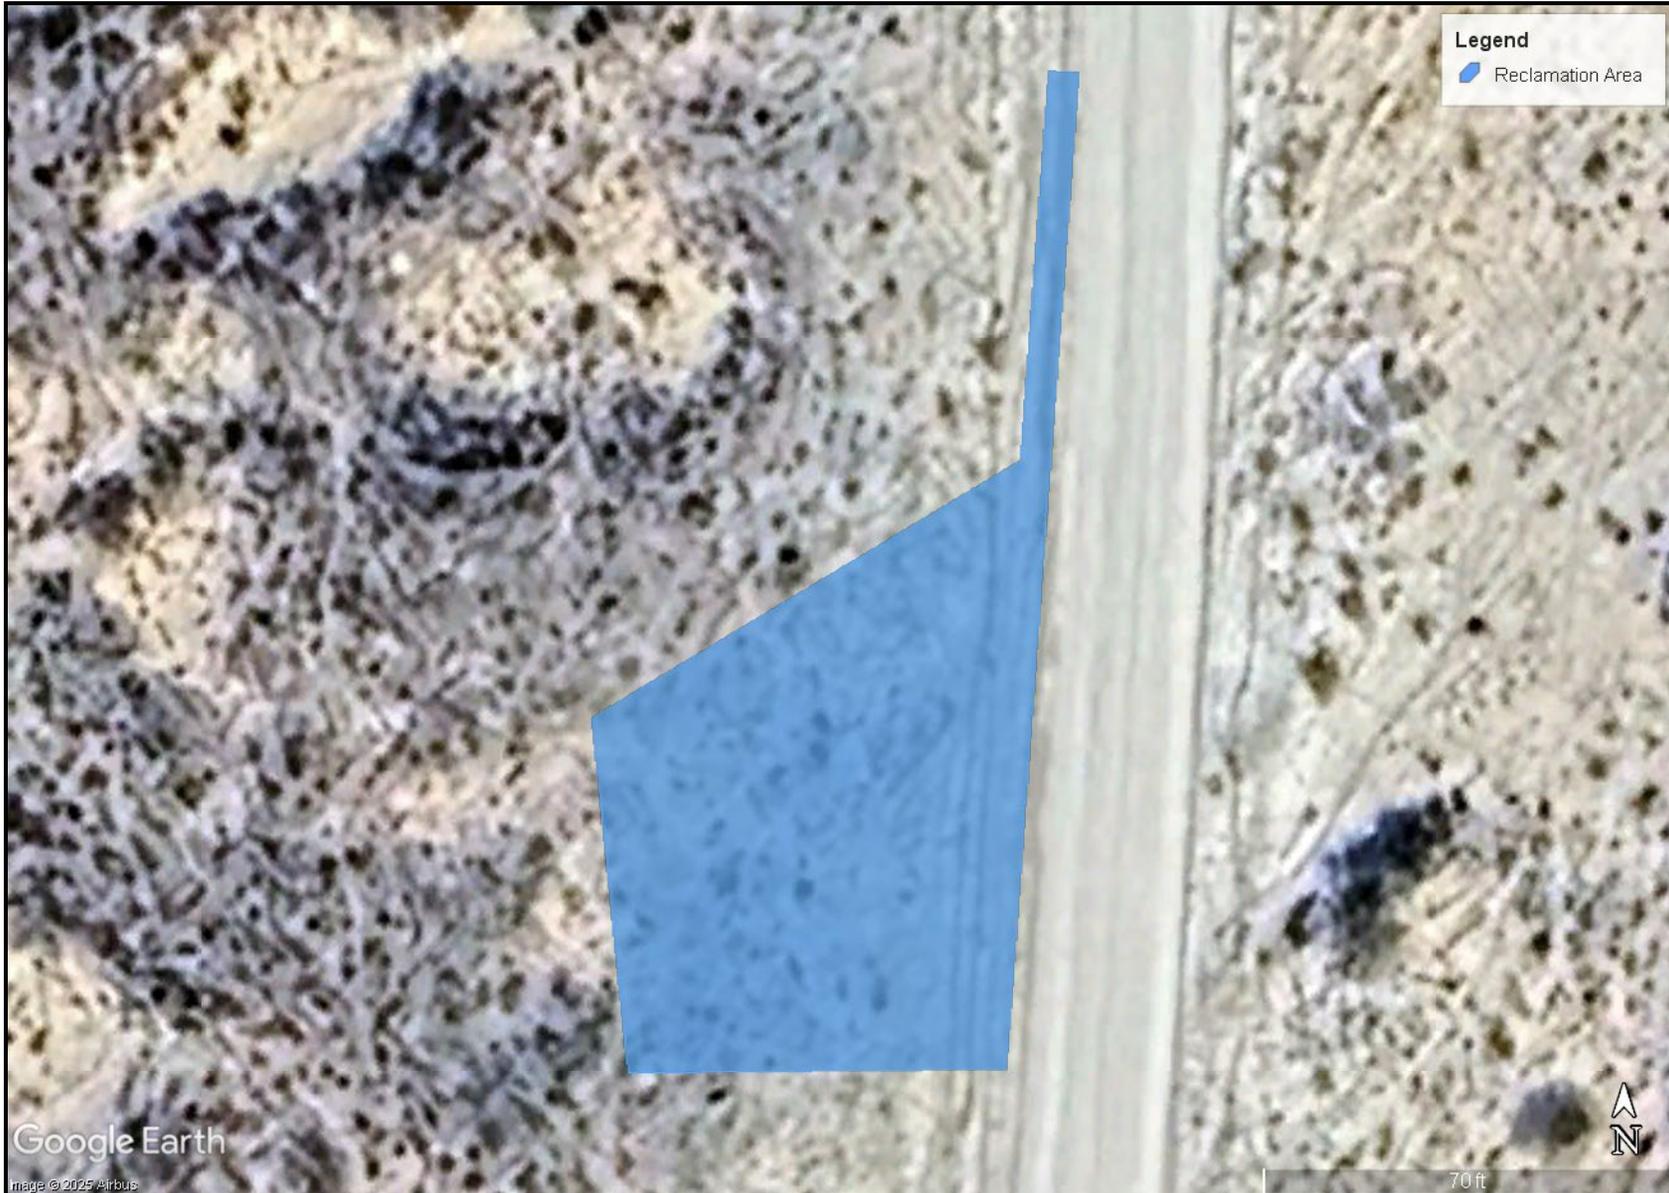
<p>RECLAMATION AREA MAP COTERRA ENERGY OPERATING CO. HAMON FEDERAL COM ROW/ LEA UNIT FRAC LEA COUNTY, NEW MEXICO 32.587845°, -103.59017°</p>	<p>CARMONA RESOURCES

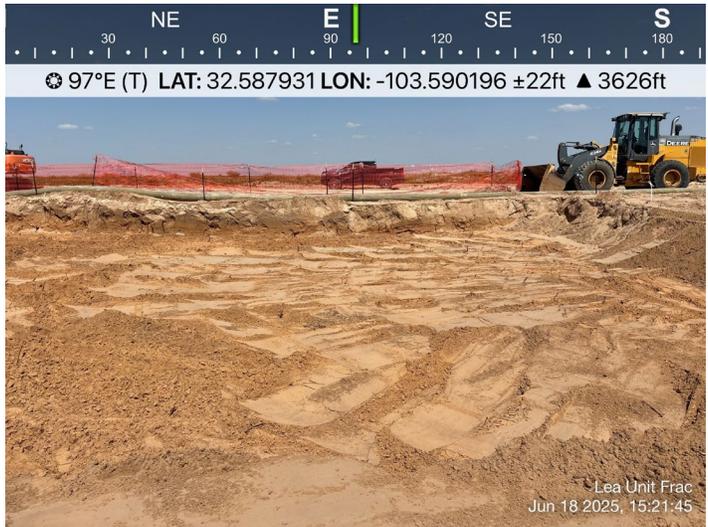
**Description:**  
View East, area of CS-1 through CS-23.

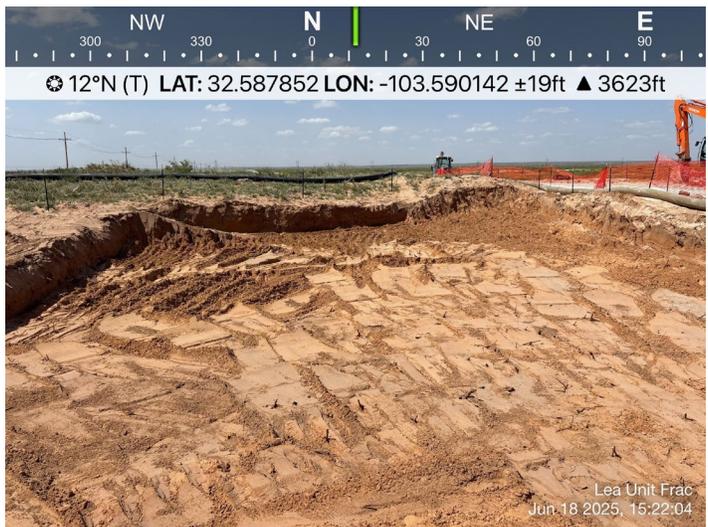
### Photograph No. 2

**Description:**  
View North, area of CS-1 through CS-23.

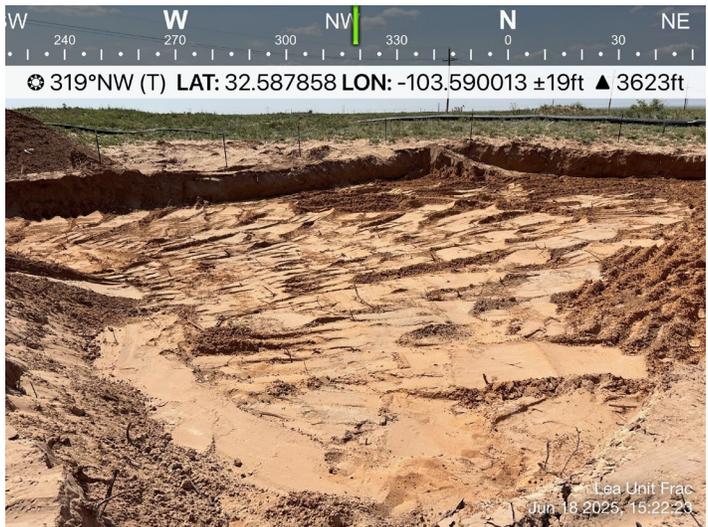
### Photograph No. 3

**Description:**  
View North, area of CS-1 through CS-15.

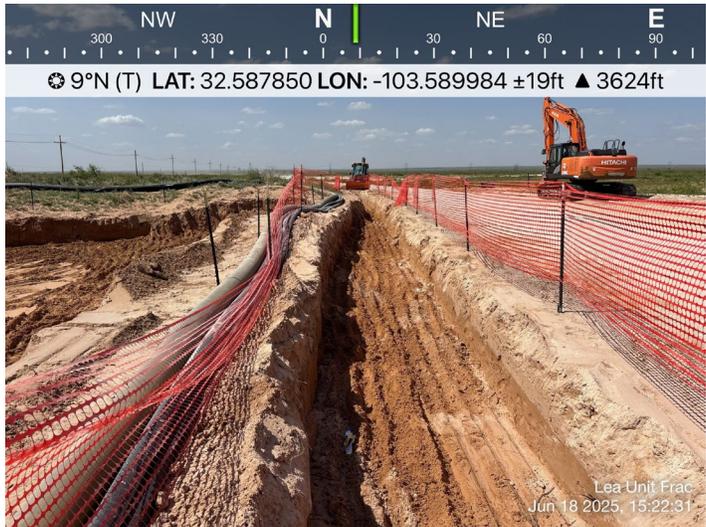
**Description:**  
View North, area of CS-24 through CS-27.

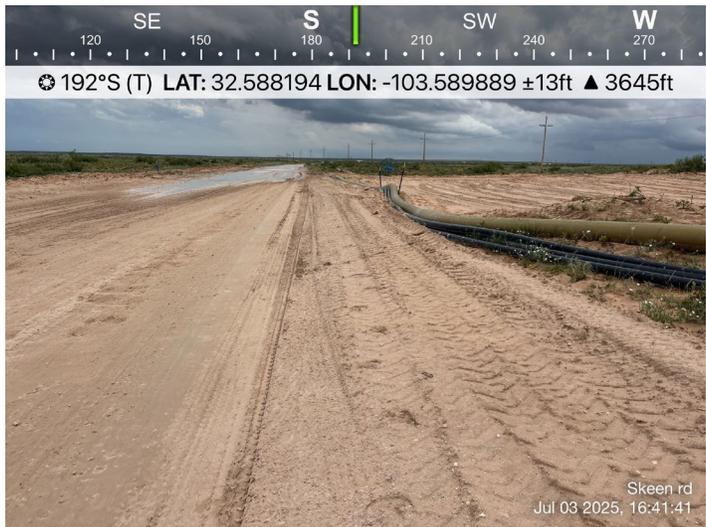
### Photograph No. 6

**Description:**  
View South of backfilled area.

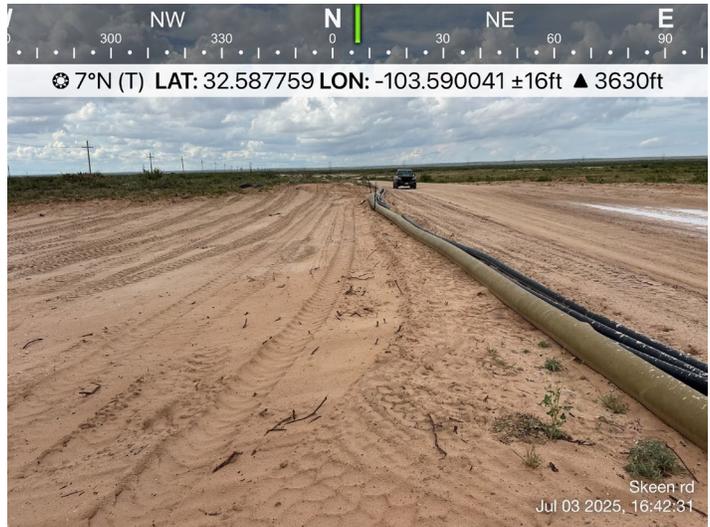
**Description:**  
View North of backfilled area.

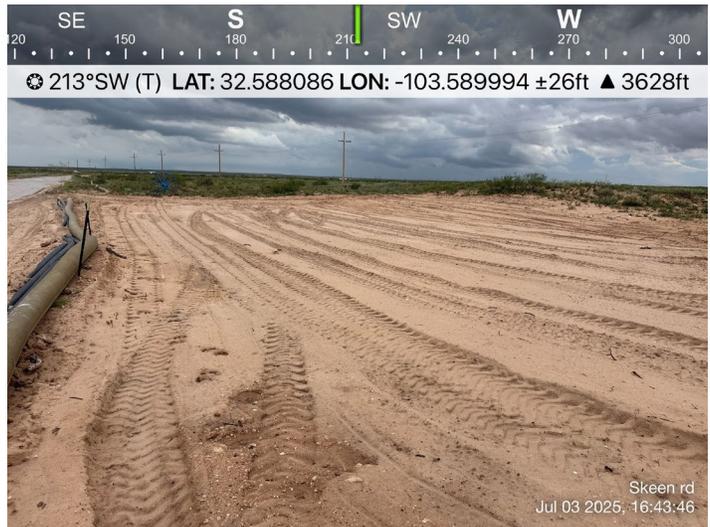
### Photograph No. 8

**Description:**  
View Southwest of backfilled area.

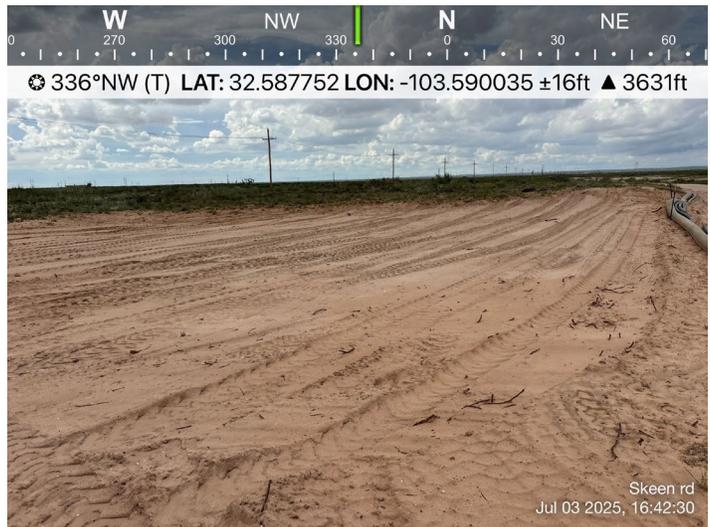
### Photograph No. 9

**Description:**  
View Northwest of backfilled area.

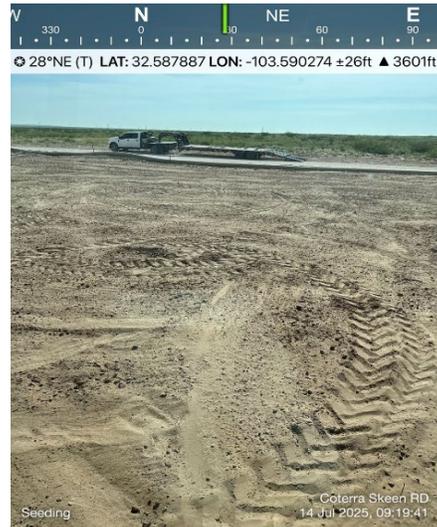
**Description:**  
View Northeast of reclamation area.

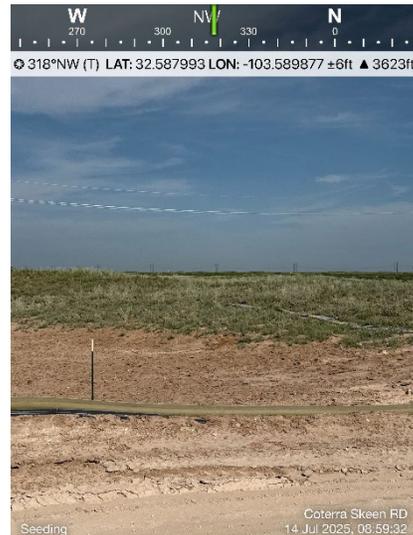
### Photograph No. 12

**Description:**  
View Northwest of reclamation area.

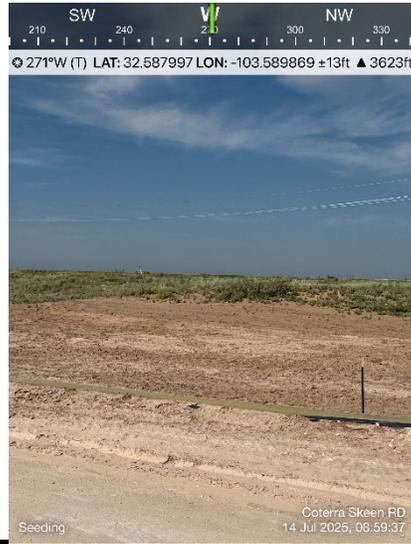
**Description:**  
View Northwest of reclamation area.
