# Revised Remediation Summary and Closure Request

September 14, 2025

**Bagley SWD #004, Area 3  
API 30-025-01015  
Historical Produced Water Release  
Incident No. nAPP2509978375  
Lea County, New Mexico**

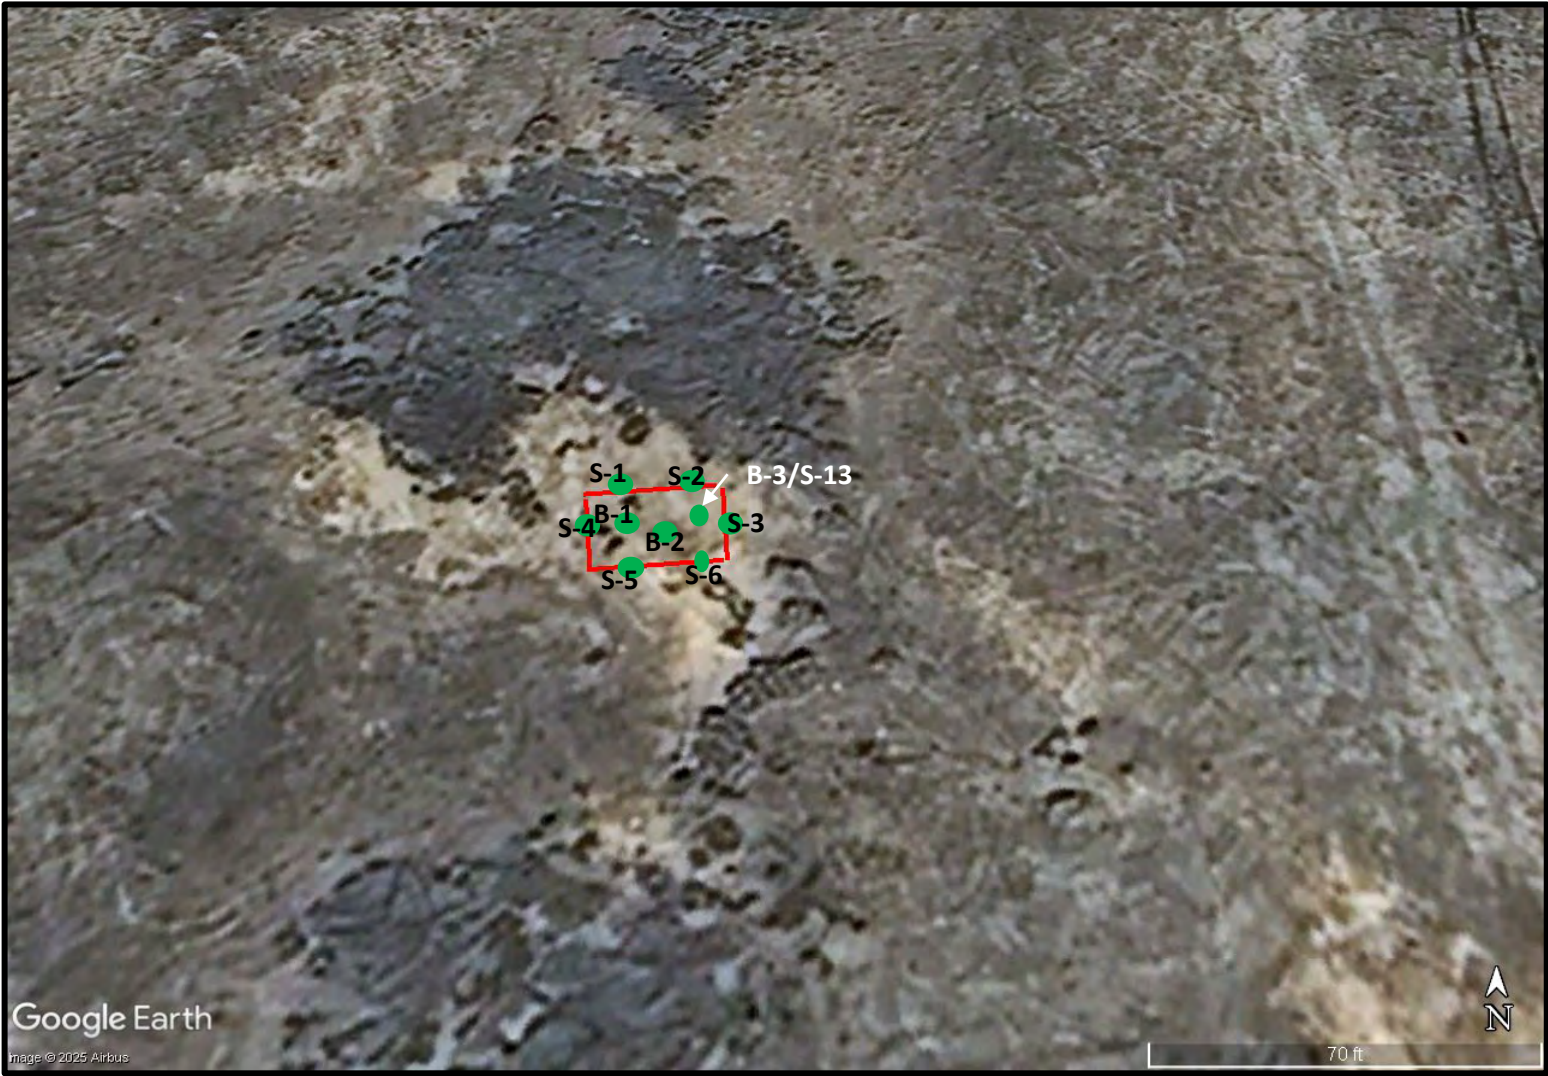
| LEGEND: | | <div>Figure 7</div> <div>Sample Location Map</div> <div></div> <div>BXP Operating, LLC</div> <div>Bagley SWD #004 - Area 3</div> <div>Lea County, New Mexico</div> | | <div></div> |

As required by 19.15.29.11 NMAC, a scaled diagram showing significant Site infrastructure, sample point locations, and known subsurface features such as utilities are provided on Figures 2 and 7.

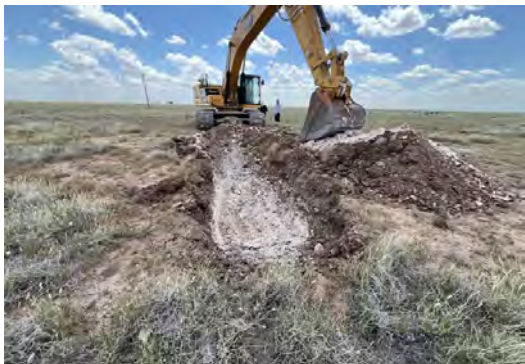
View to S of N-S trench at Area 3 (6/19/25).

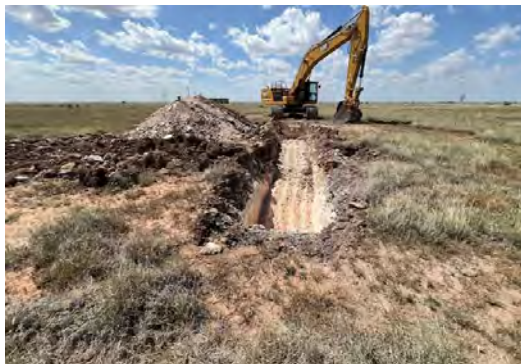
View to W of E-W trench at Area 3 (6/19/25).

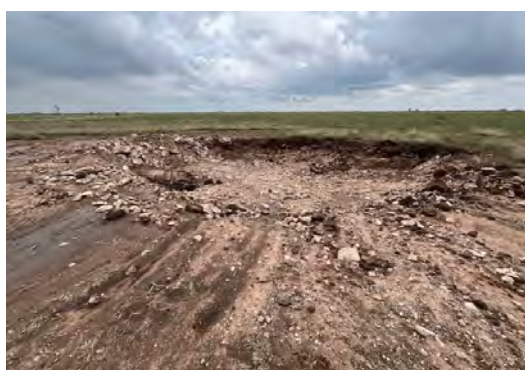
View to SW of excavation (6/24/25).

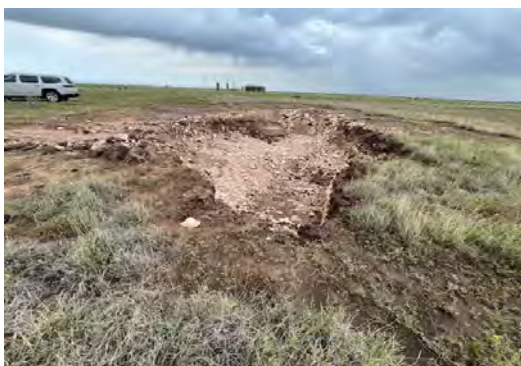
View to N of excavation (6/24/25).

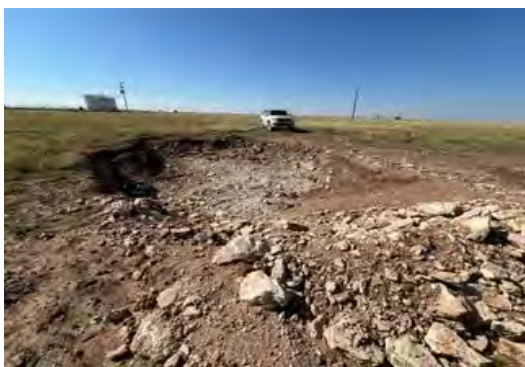
View to SE of excavation (8/22/25).

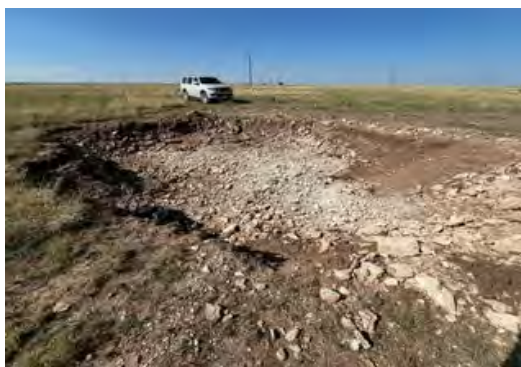
View to S of excavation (8/22/25).
