Remediation Report and Closure Request
Lateral B 1 Pipeline Release
Lat: 36.8737876/36.8805775 Long: -108.1457160/-108.1456979
San Juan County, New Mexico

Photo Page
Lateral B 1 Pipeline Release
Lat: 36.8737876 Long: -108.1456979

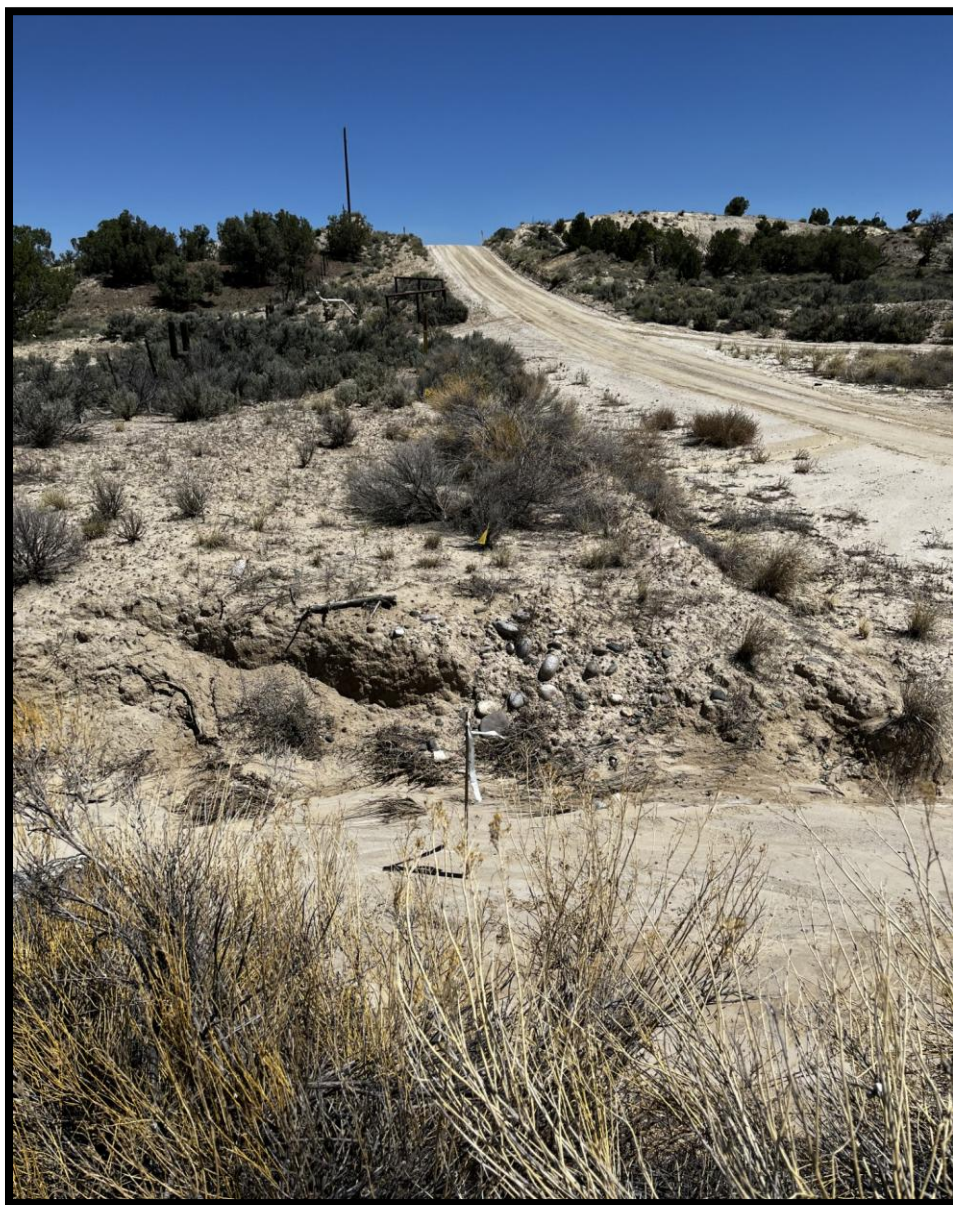
Photo: Leak 1

A crew was onsite to excavate leak points and make repairs to pipeline. Failed piping in both locations was cut out and replaced with new four-inch piping. It was determined that the holes formed in both spots were caused by internal corrosion. 24 yards of contaminated soil were removed from each excavation and hauled to Envirotech's land farm.

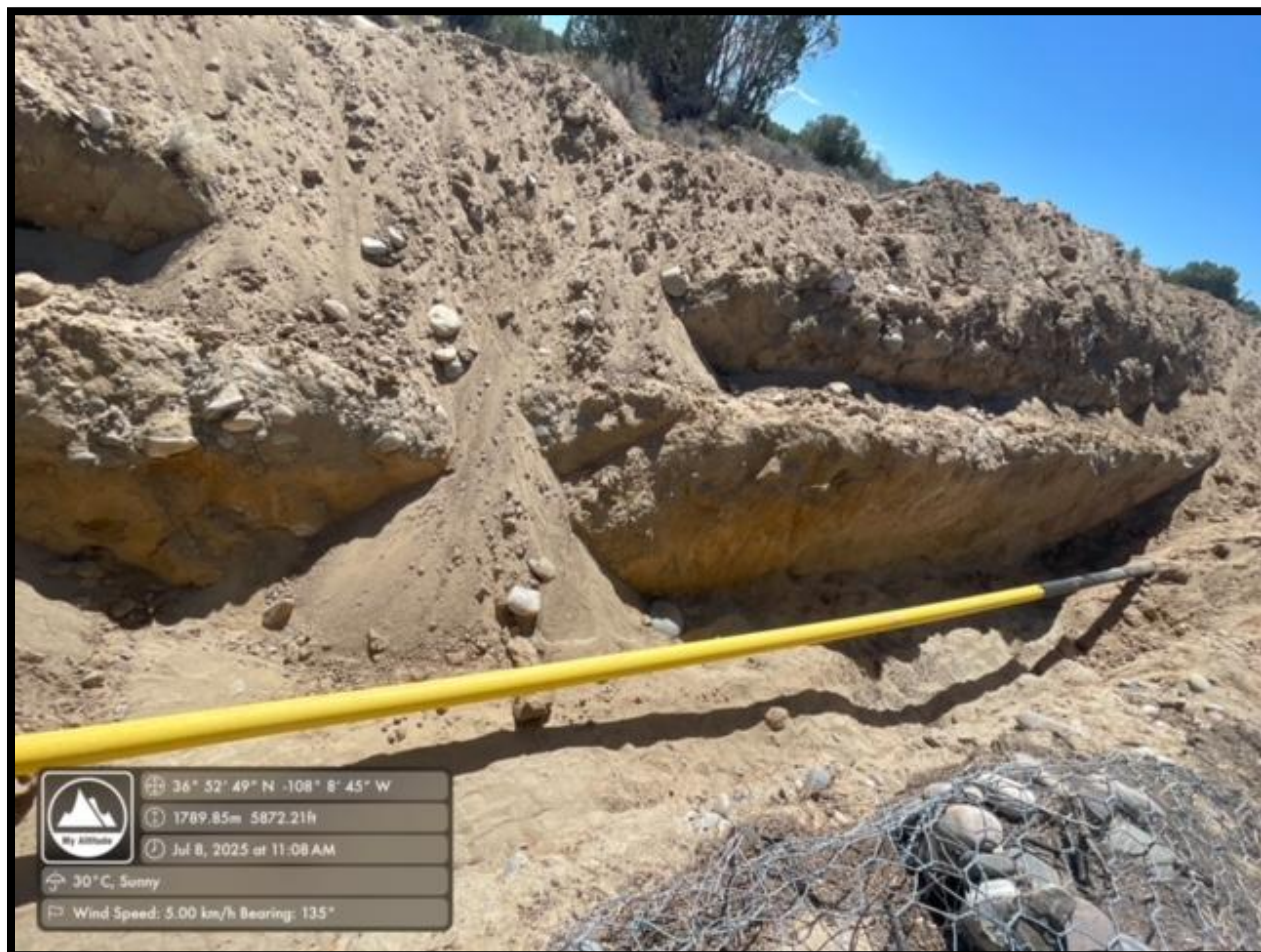
Photo: Leak 1 Facing East Wall

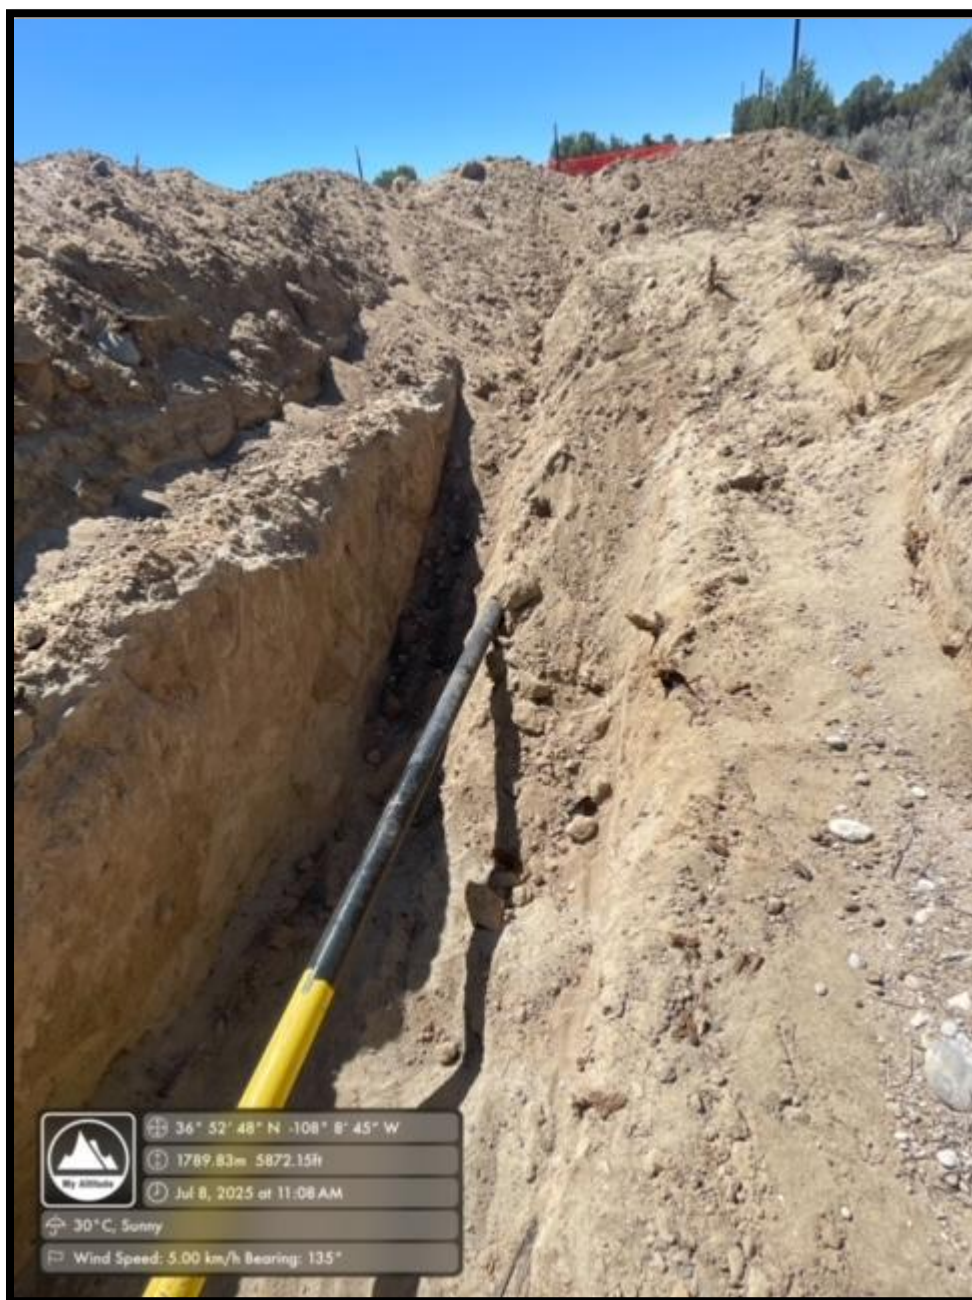
Photo: Leak 1 Facing South Wall

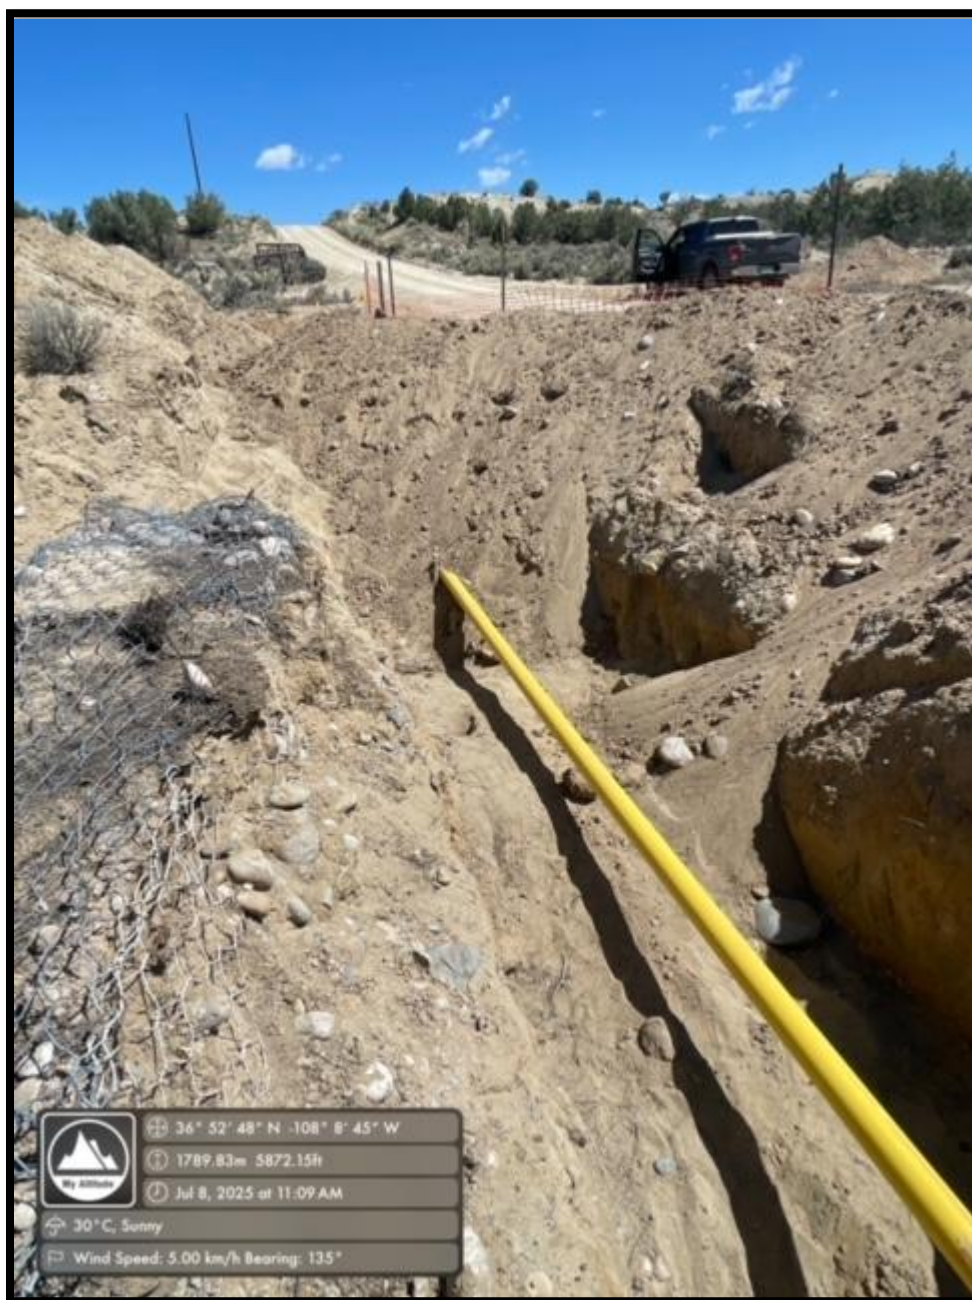
Photo: Leak 1 Facing North Wall

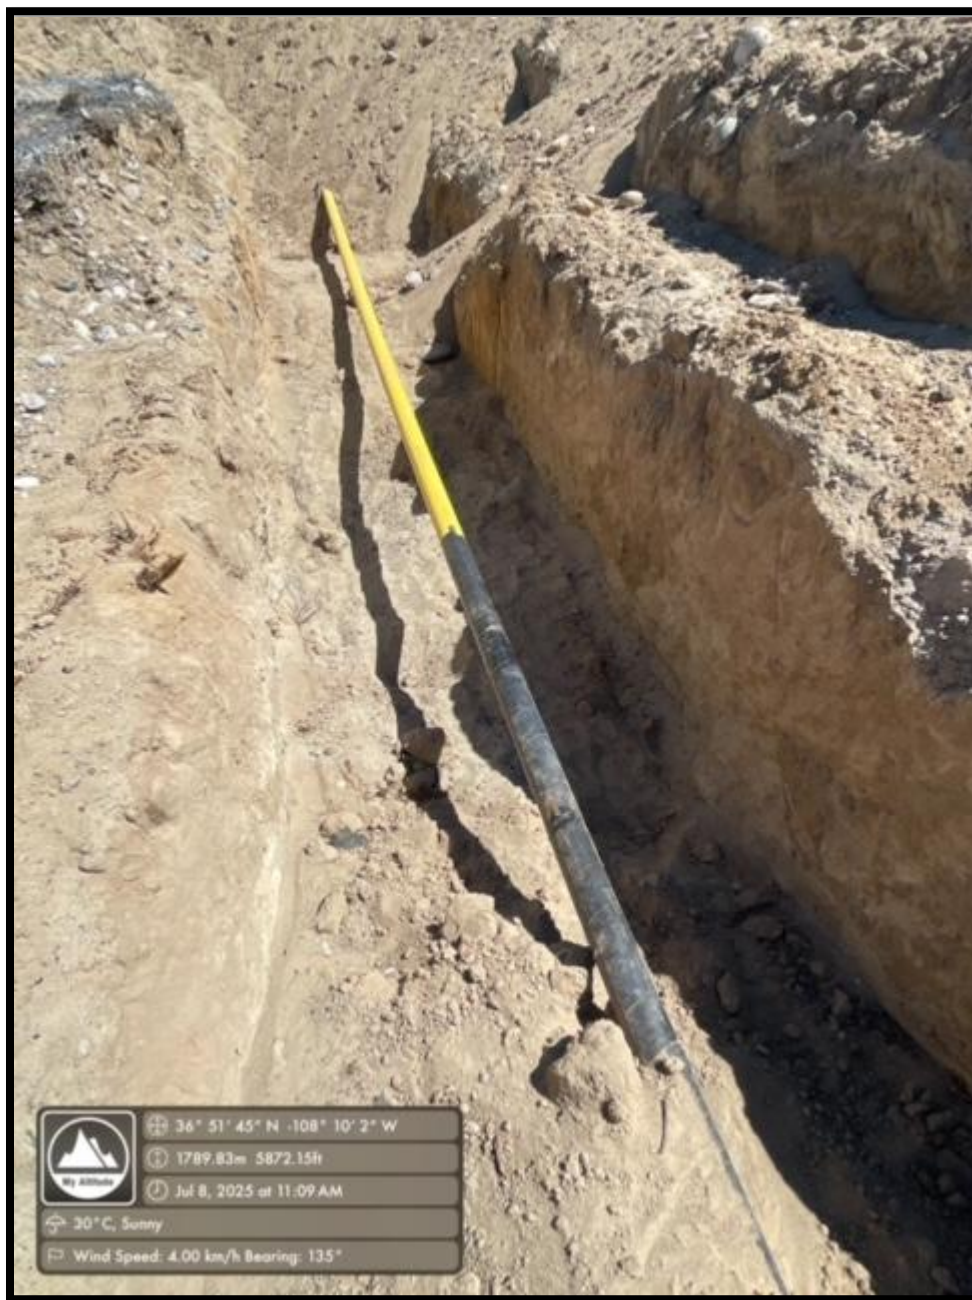
Photo: Leak 1 Bottom Facing North

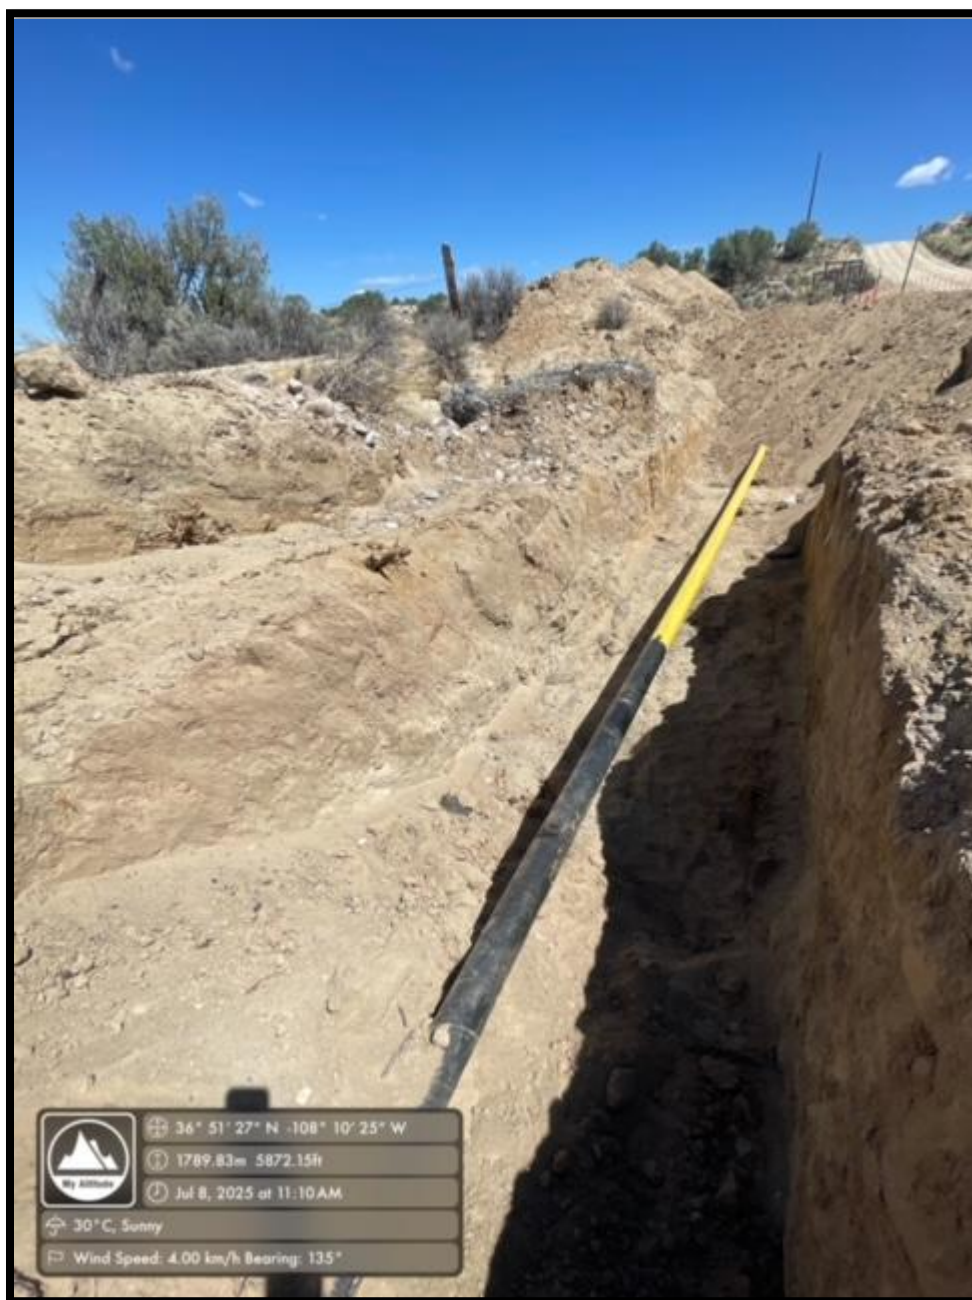
Photo: Leak 1 Facing North West.

A crew was onsite to remove contaminated soil from the west walls on Leak Point 1 and Leak Point 2. Six inches of soil was removed from each wall. Twelve yards of contaminated soil were removed and hauled to Envirotech for disposal.

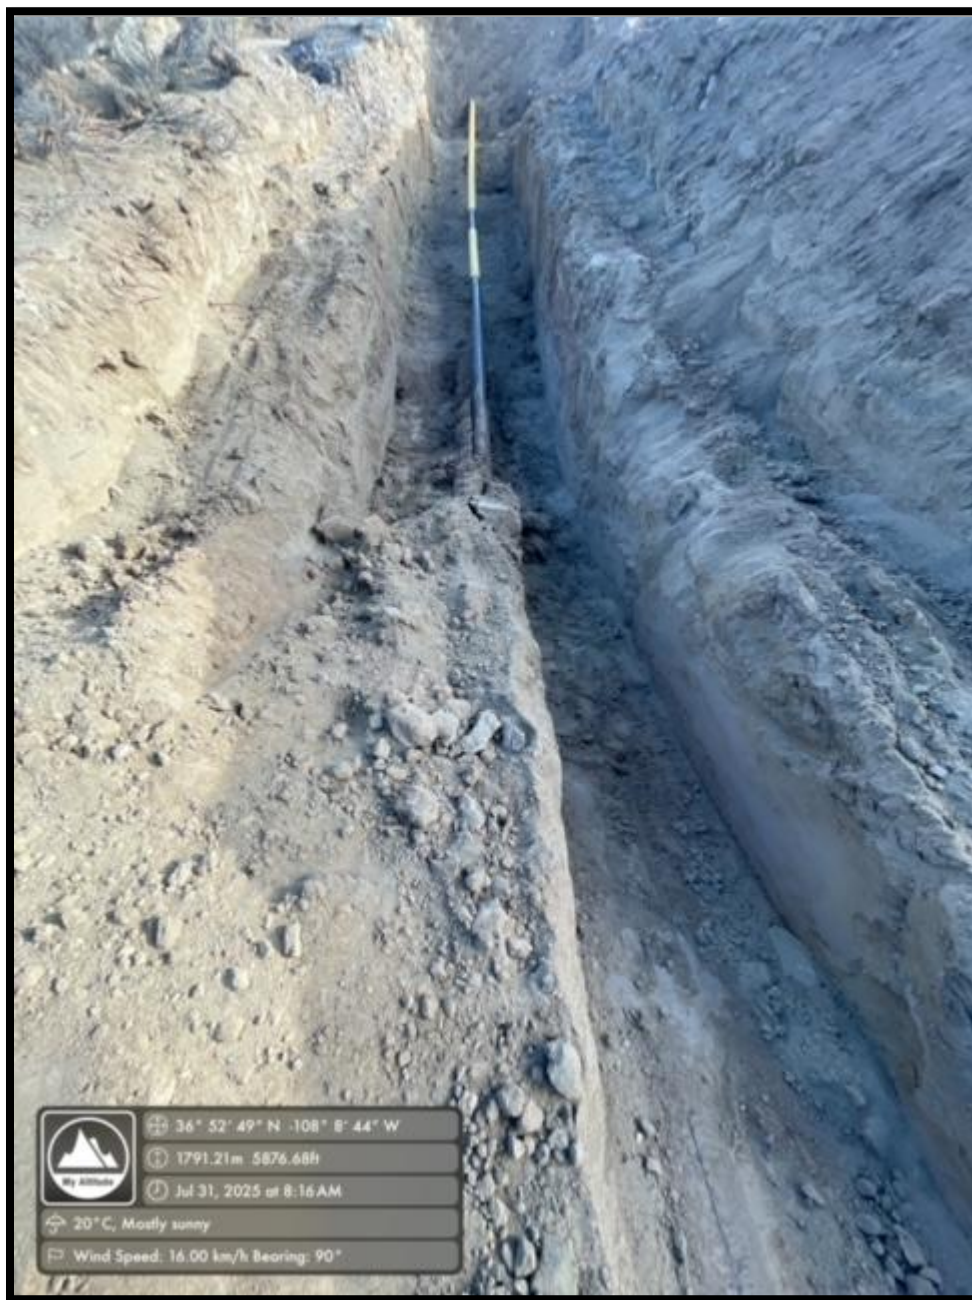
Photo: Leak 1 and 3 Facing North

Harvest personnel were onsite to take PID readings before scheduling sampling activities. While the Harvest employee was collecting PID readings in Leak Point 1 excavation, a third leak in the pipeline was discovered. The leak was identified using a gas detector and pressure test. There were no liquids or gas blowing from the pipeline. The pipeline was isolated and blown down to stop the leak. GPS points for this leak are Lat: 36.8805381 Long: -108.1456838.

A crew was onsite and cut out failed piping and replace with new x-true pipe. All welds were primed and taped. The hole formed in the pipeline was due to internal corrosion.

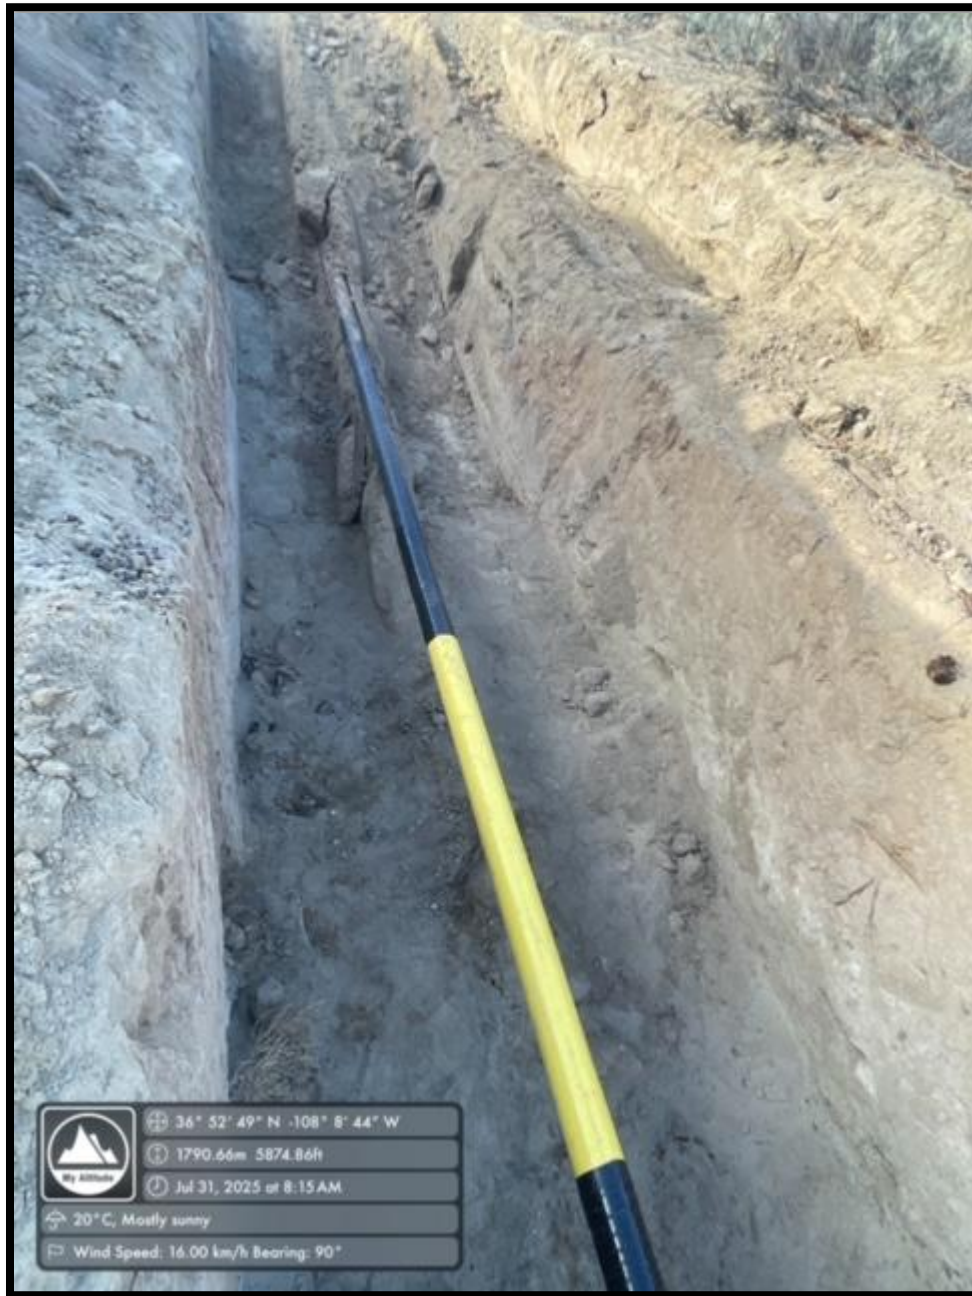
Photo: Leak 1 and 3 Facing South

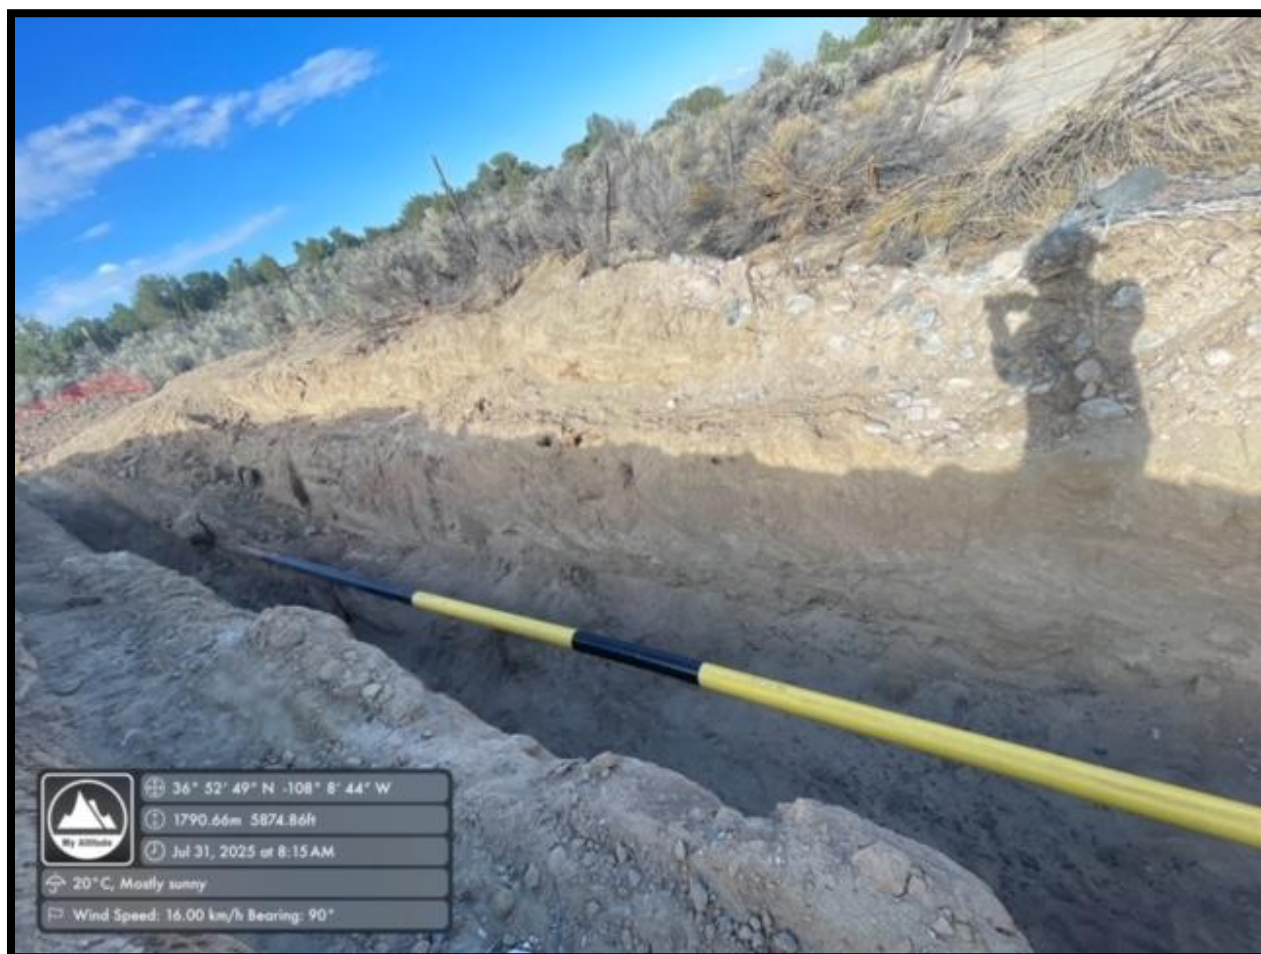
Photo: Leak 1 and 3 Facing West

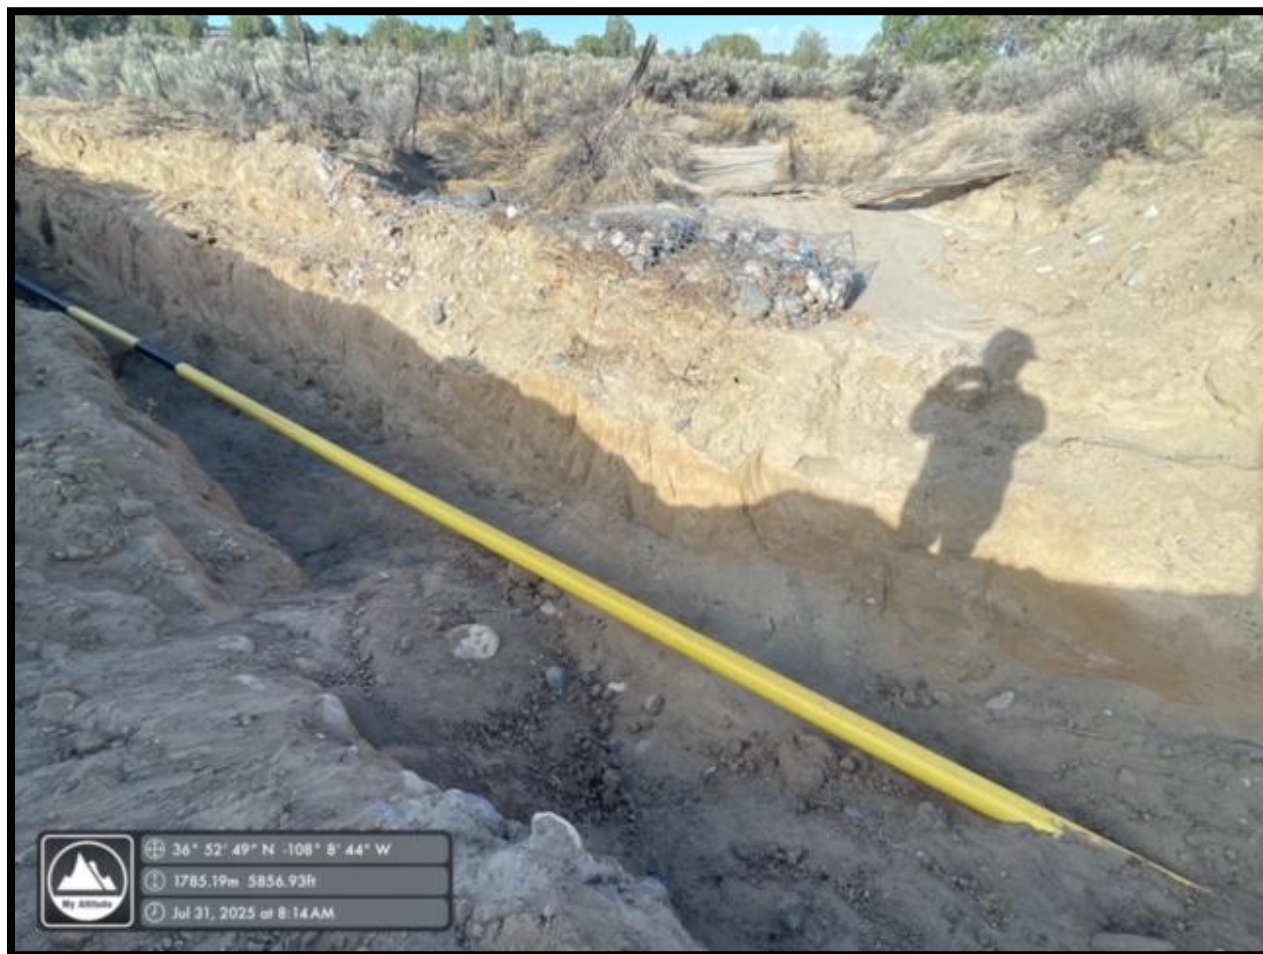
Photo: Leak 1 Facing West.

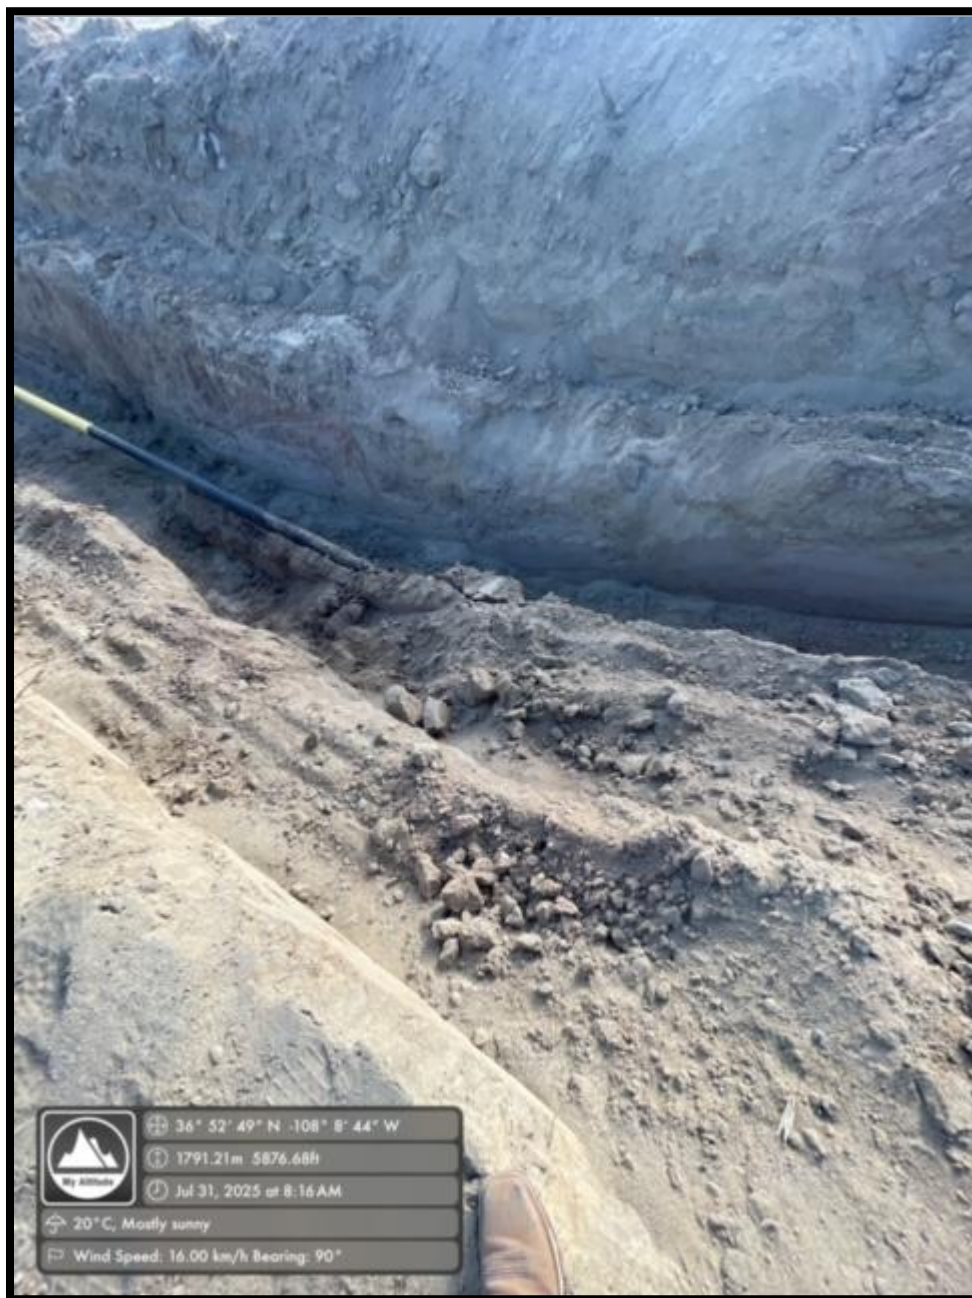
Photo: Facing toward East Wall 2

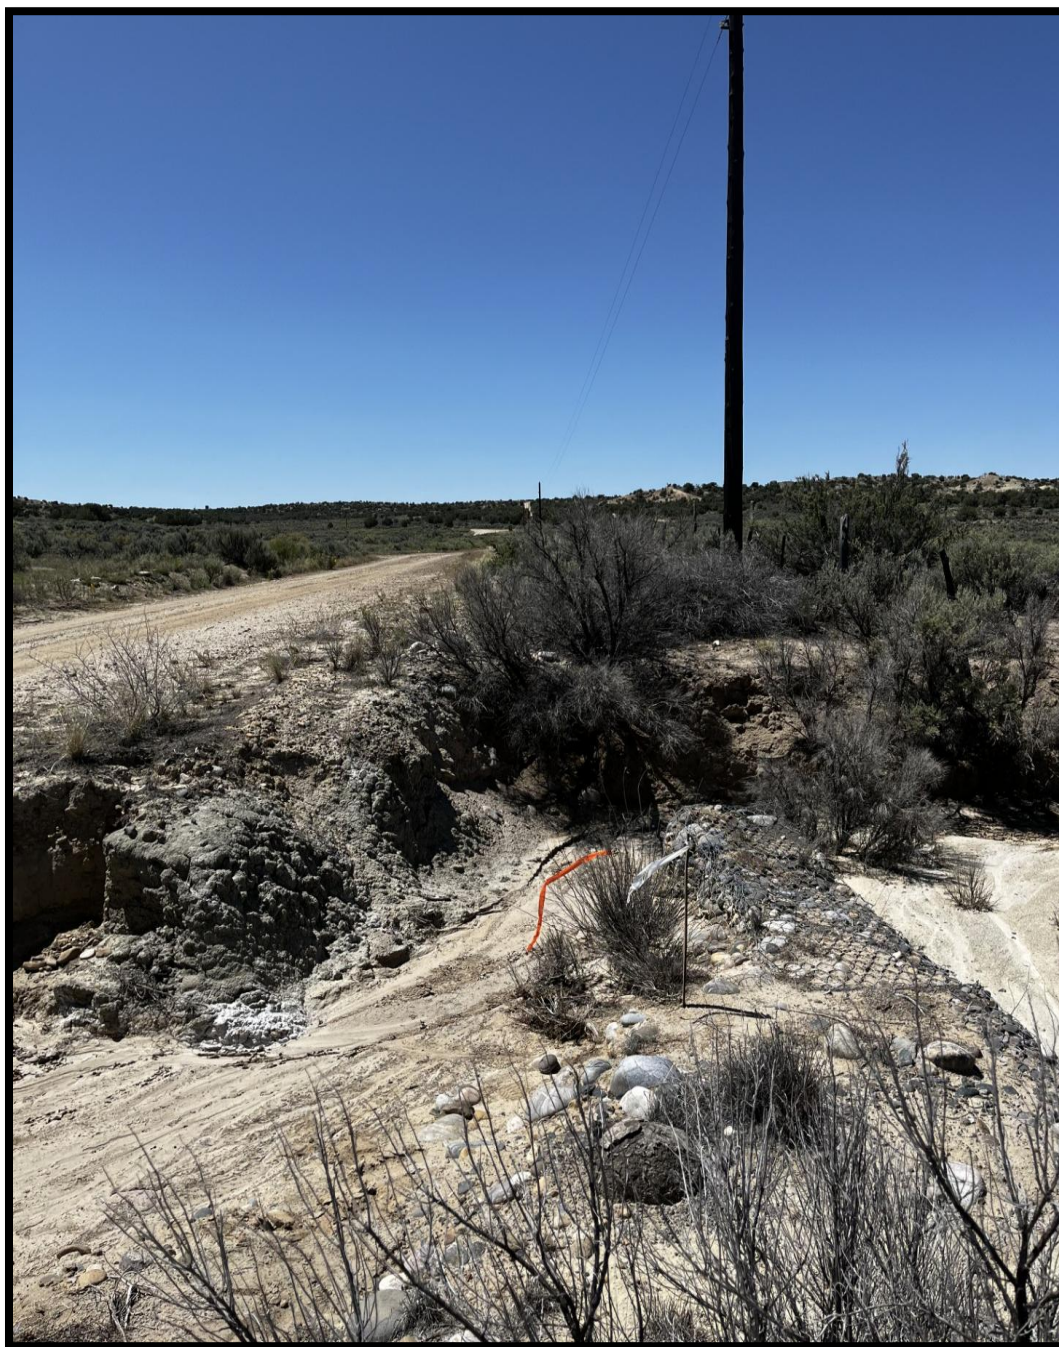
Photo: Leak 2 Facing South

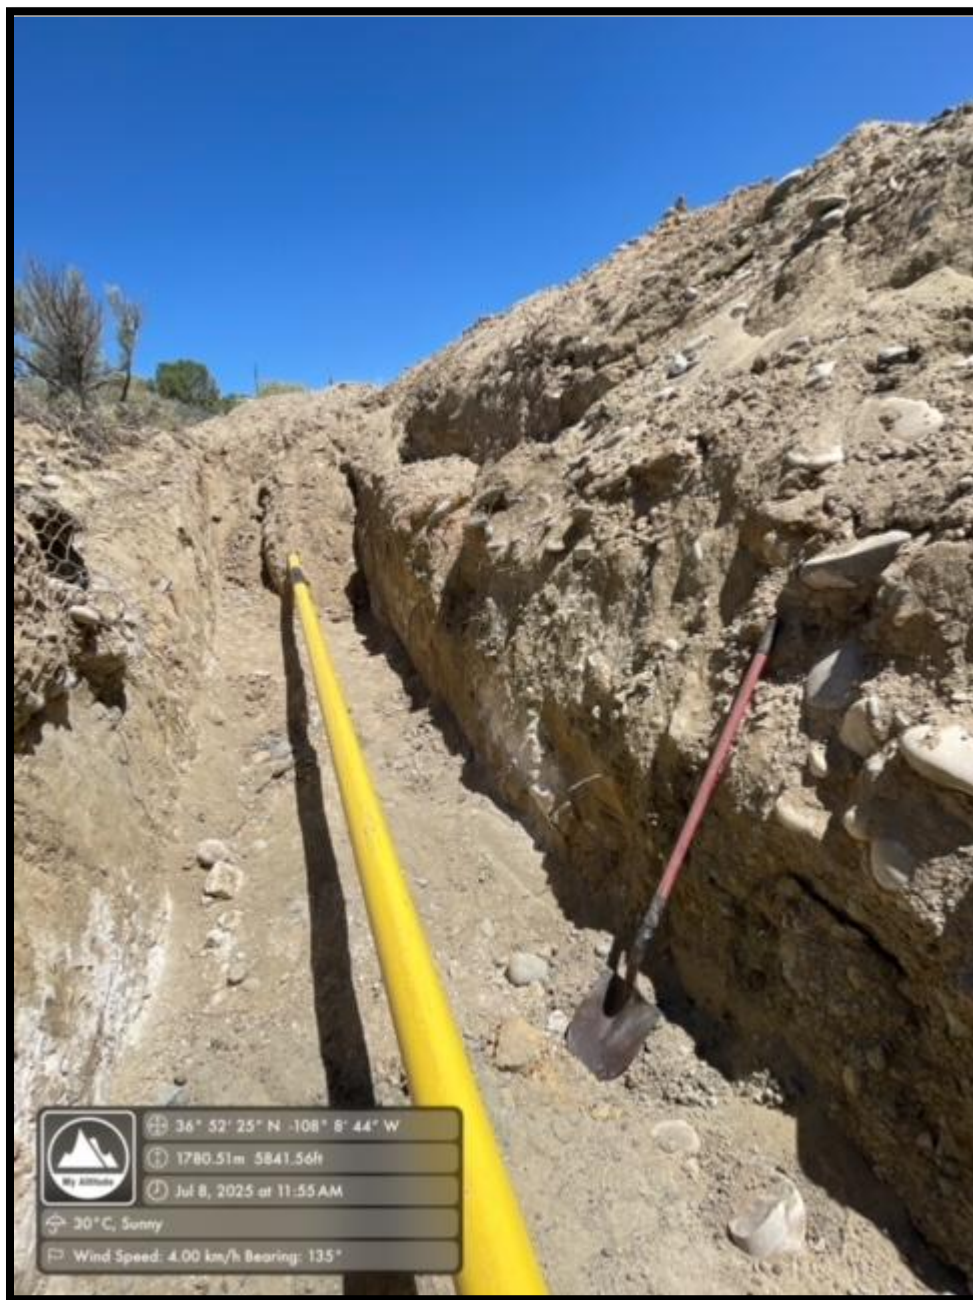
Photo: Leak 2 Facing North

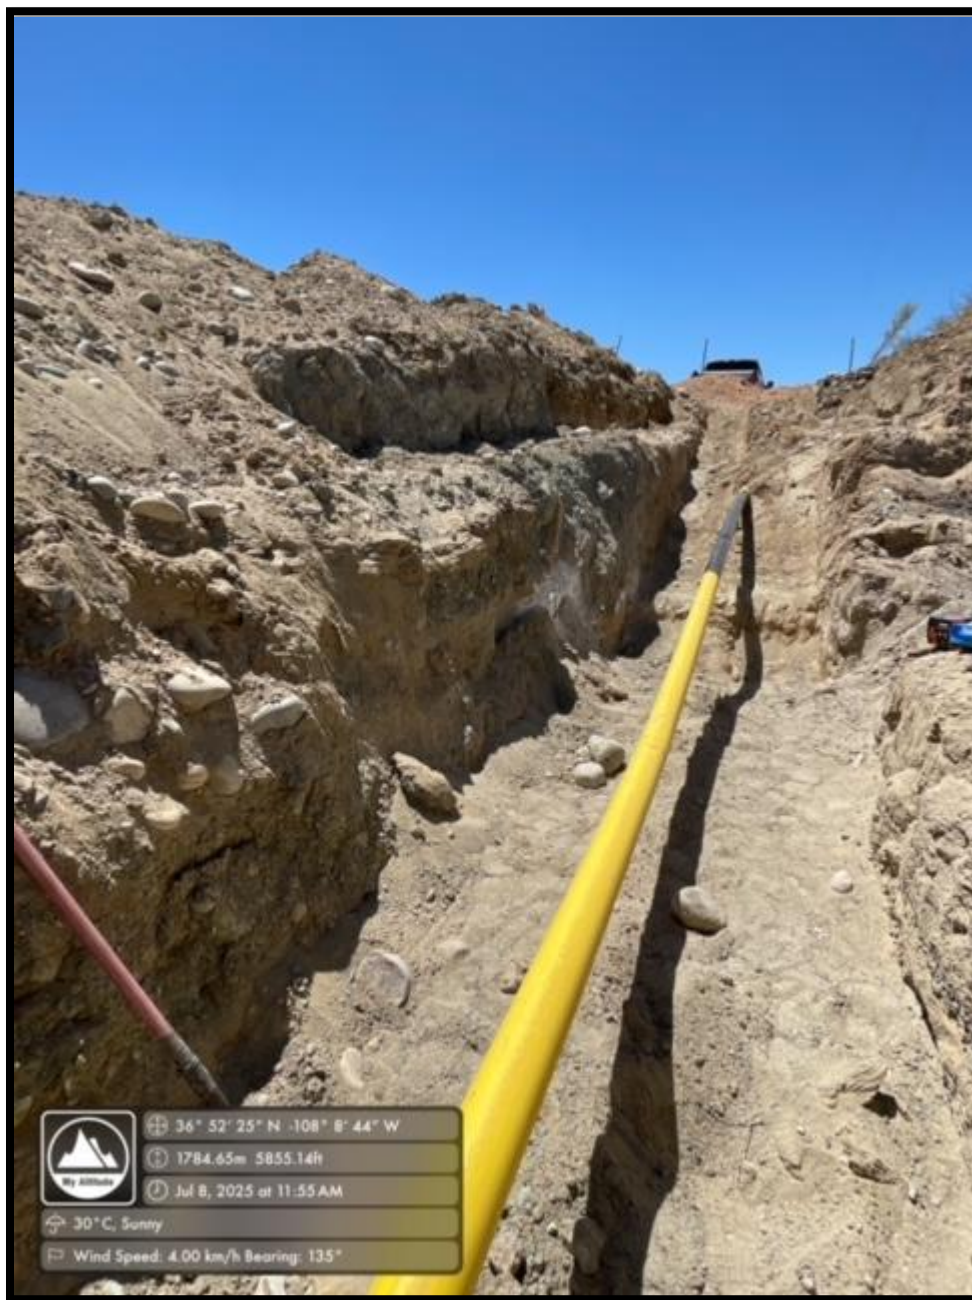
Photo: Leak 2 Facing South

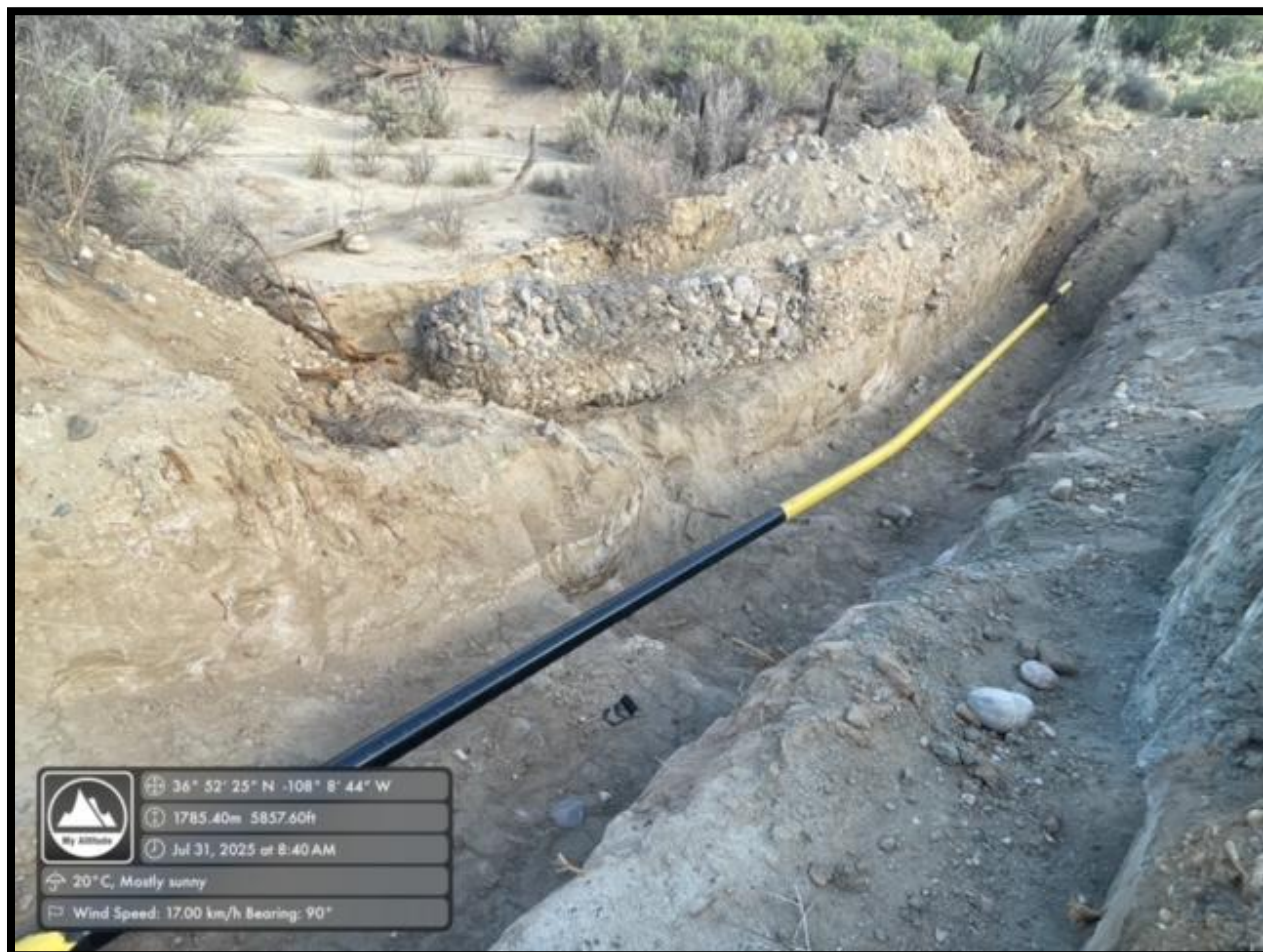
Photo: Leak 2 Facing West.

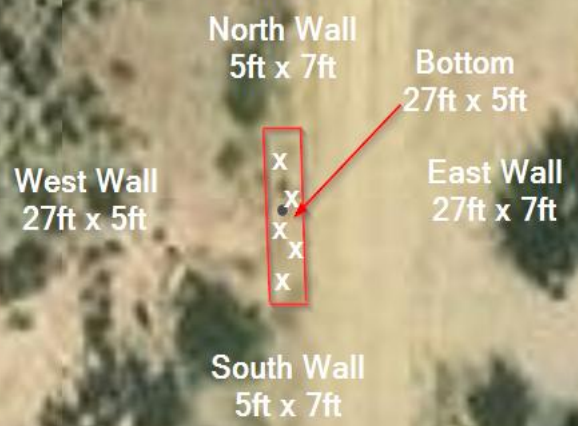
Leak Point 1 Sample Map
7/8/2025

Harvest personnel were onsite to perform sampling activities with no witnesses from the NMOCD nor the BLM. Excavation located at Lat: 36.8737876 Long: -108.1457160 was identified as Leak Point 1 and excavation located at lat:36.8805775 long: -108.1456979 was identified as Leak Point 2. Five composite samples were collected from Leak Point 1, all within a two hundred square foot area and sent in for lab analysis of BTEX, TPH and Chlorides. Four composite samples were collected at Leak Point 2, all

within a two hundred square foot area and sent in for lab analysis of BTEX, TPH and Chlorides. See attached "Leak Point 1 Sample Map 7/8/2025" and "Leak Point 2 Sample Map 7/8/2025" for reference.
