Report Type: Closure Report nAPP2307052908

Site:	Honey Buzzard 102 Lay Flat Line					
Company:	EOG Resources					
Section, Township and Range	Unit A	Sec. 32	T 24S	R 34E		
Lease Number:						
County:	Lea County					
GPS:	32.180930°			-103.487017°		
Surface Owner:	State					
Mineral Owner:						
Directions:	From intersection 128 and Vaca Ln, travel south on Vaca Ln for 2.26 miles. Turn Left and travel East on Resource Ln for 1.89 miles. Release location south of the lease road.

**RE: Remediation Work Plan
EOG Resources
Honey Buzzard 102 Lay Flat Line
Lea County, New Mexico
nAPP2307052908**

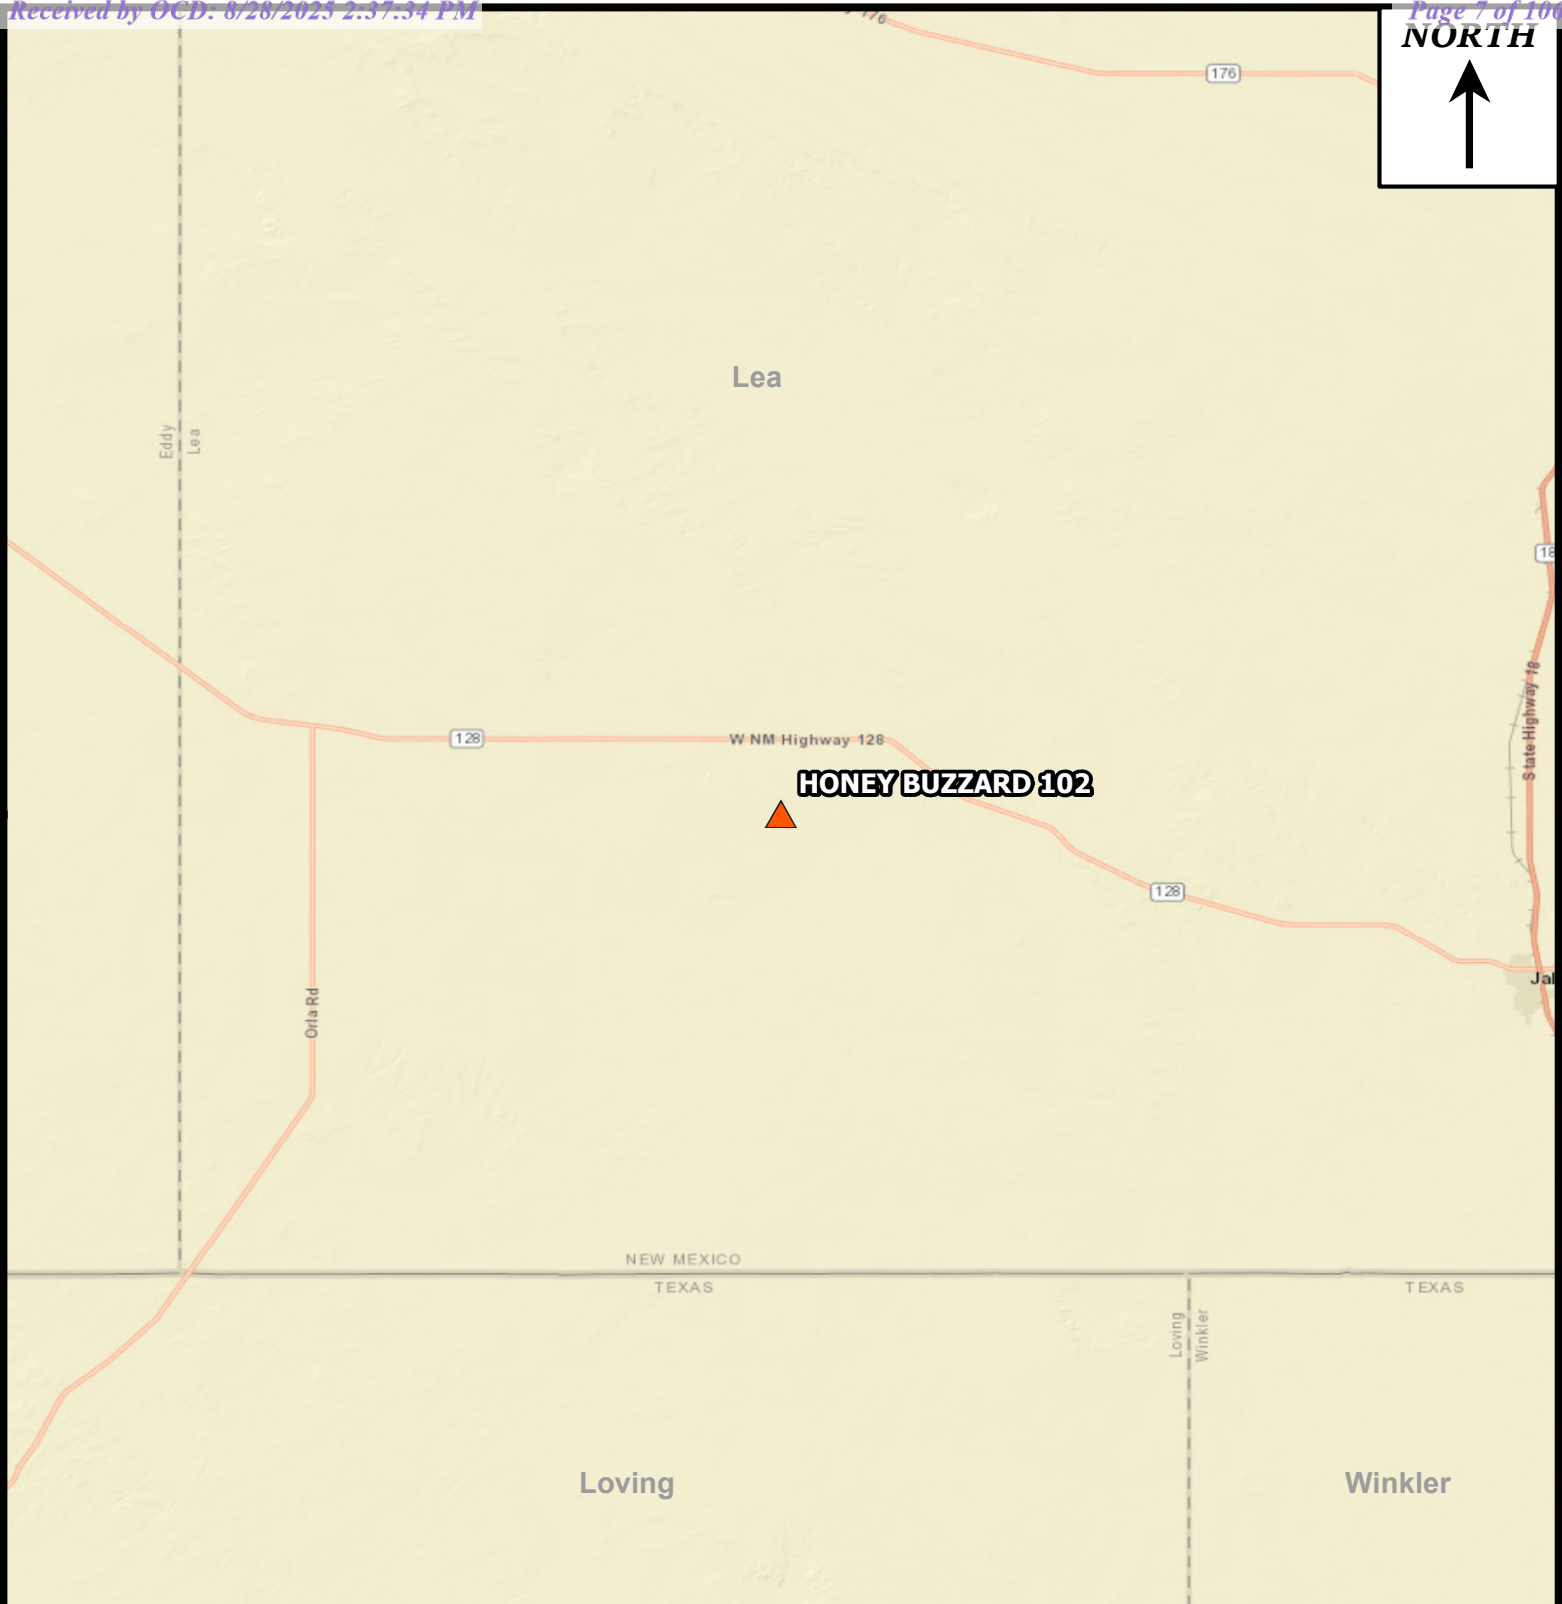
FIGURE 1
OVERVIEW MAP
HONEY BUZZARD 102
LEA COUNTY, NEW MEXICO
32.180812°, -103.486974°

Tetra Tech, Inc. (Tetra Tech) was contacted by EOG Resources (EOG) to assess a release that occurred at the Honey Buzzard 102 Lay Flat Line Release, Unit A, Section 32, Township 24 South, Range 34 East, Lea County, New Mexico (Site). The spill site coordinates are 32.180930°, -103.487017°. The site location is shown on **Figures 1 and 2**.

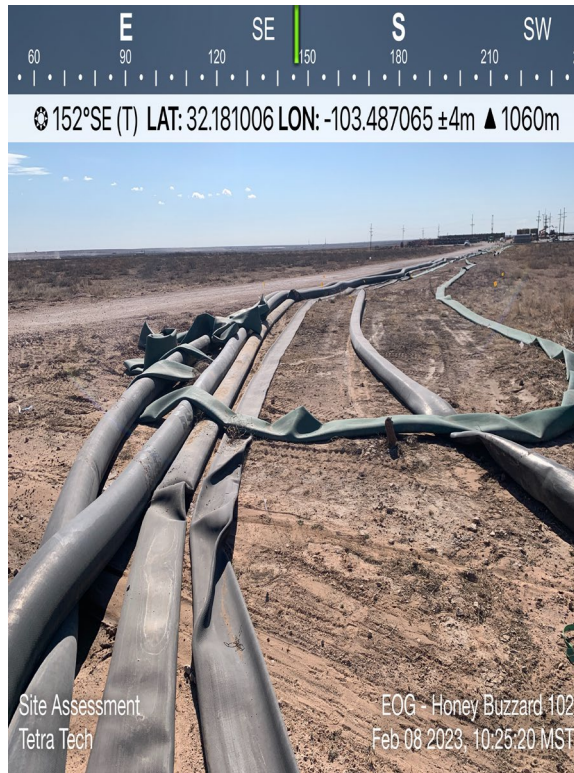
View of Release Area – View Southeast

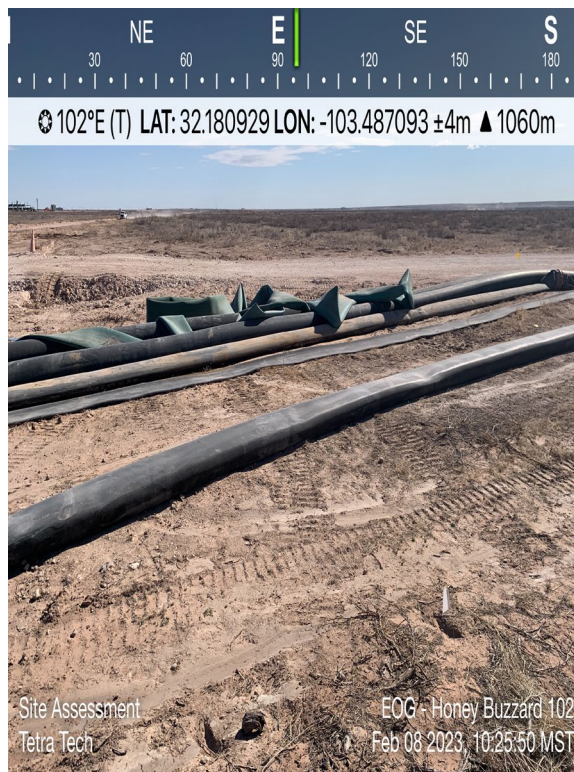
View of Release Area – View East

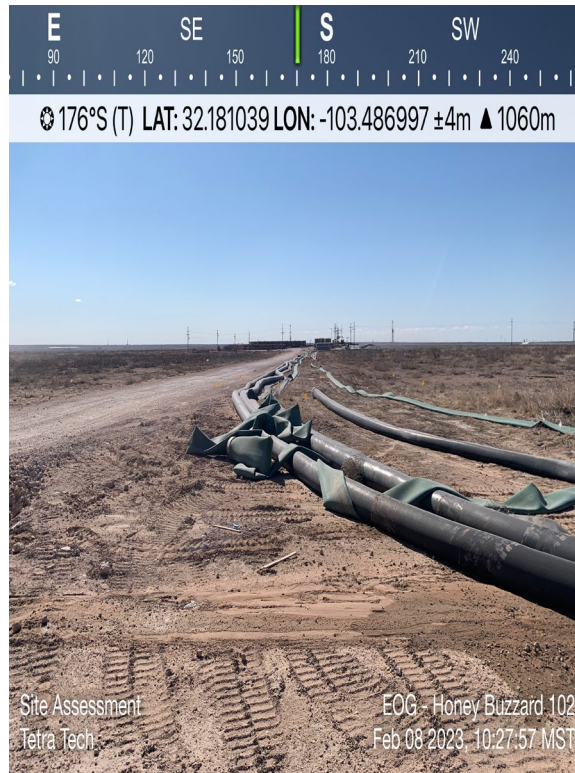
View of Release Area – View South

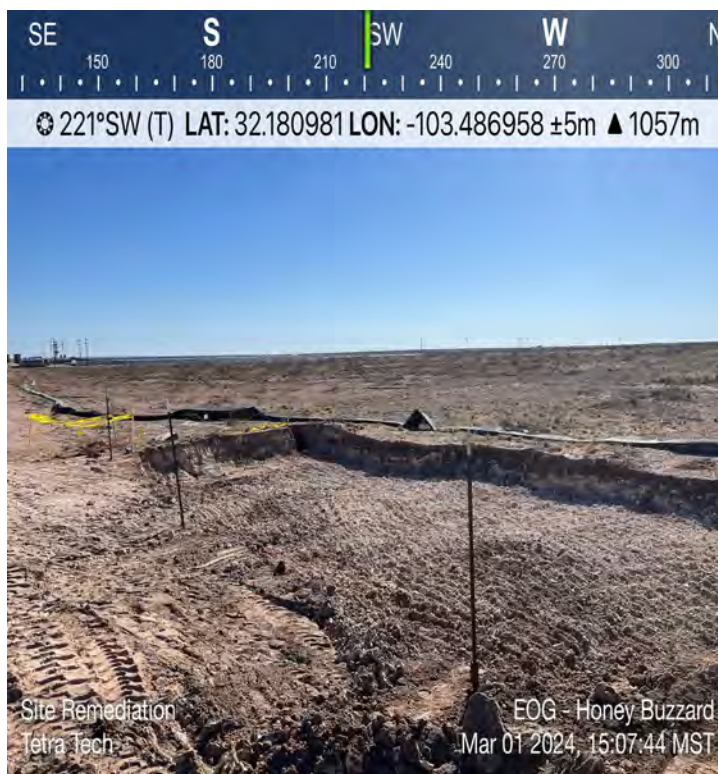
View of Remediation Activities – View Southwest

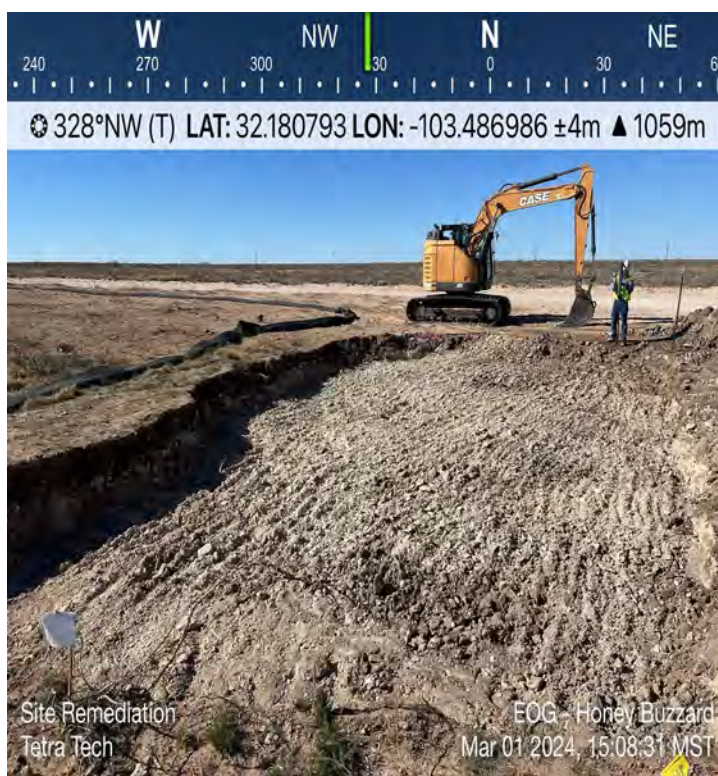
View of Remediation Activities – View Northeast
