Remediation Summary & Soil Closure Request

XTO Energy, Inc. Poker Lake Unit 22 DTD

Eddy County, New Mexico
Unit Letter "B", Section 22, Township 24 South, Range 30 East
Latitude 32.208363 North, Longitude 103.867791 West
NMOCD Reference No. nAPP2405961992

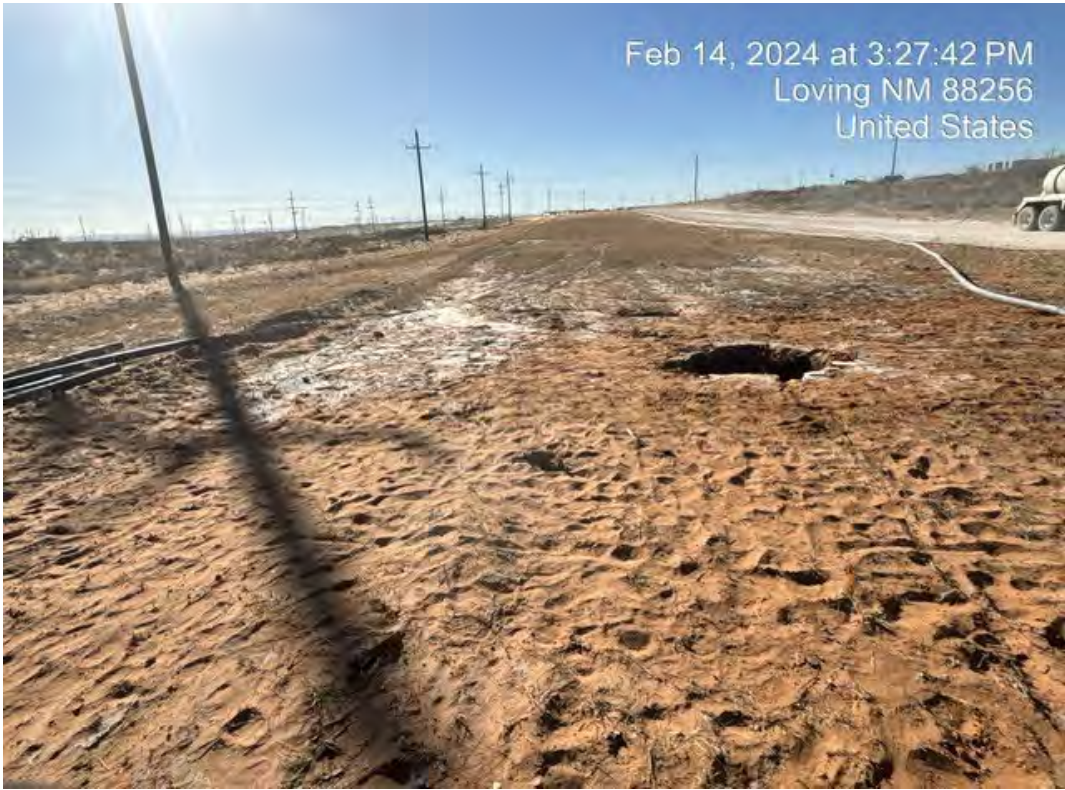
Photo Number: 1

<p>Feb 14, 2024 at 3:27:42 PM Loving NM 88256 United States</p>
Photo Direction: West	
Photo Description: View of the affected area.

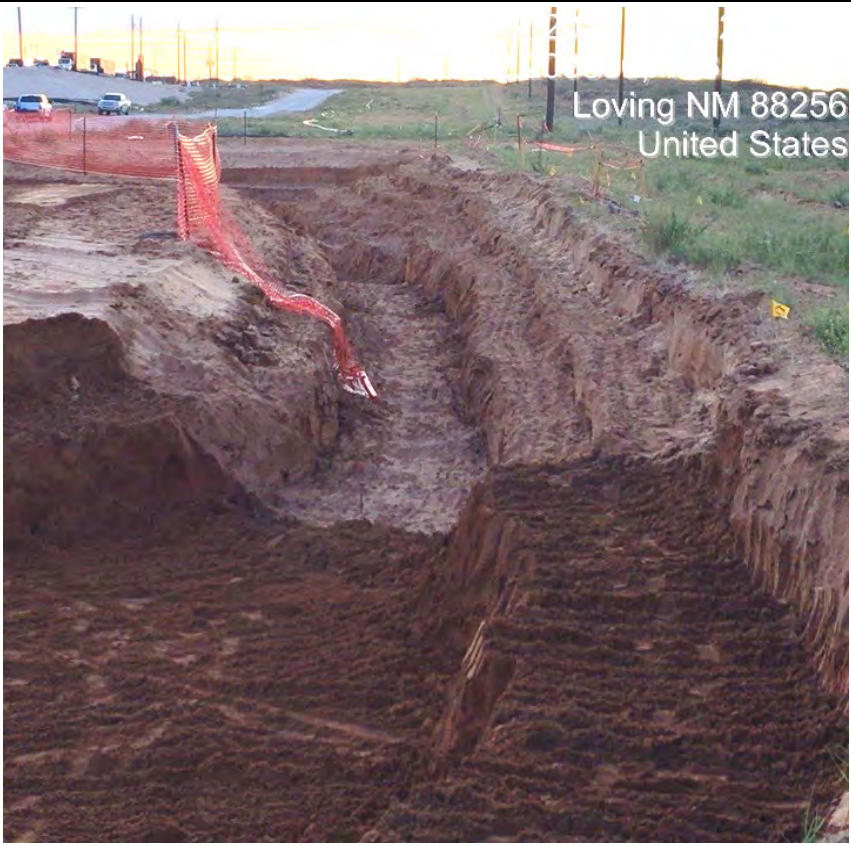
Photo Number: 7

<p>Loving NM 88256 United States</p>
Photo Direction: East	
Photo Description: View of the excavated area.

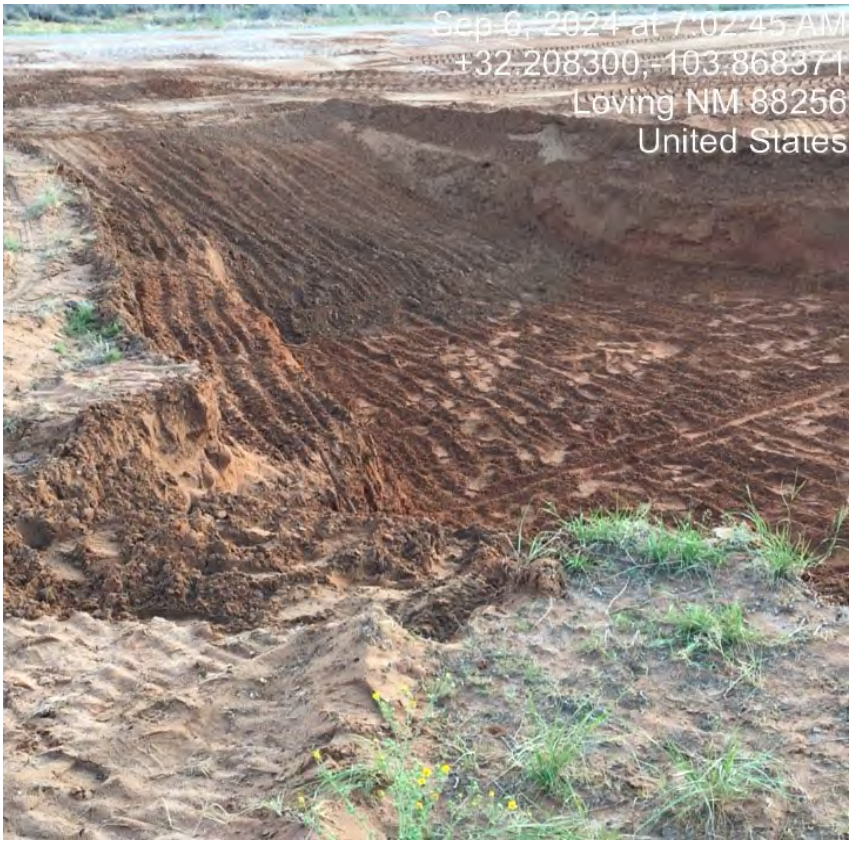
Photo Number: 8

<p>Sep 6, 2024 at 7:02:45 AM +32.208300, -103.868371 Loving NM 88256 United States</p>
Photo Direction: Southeast	
Photo Description: View of the excavated area.

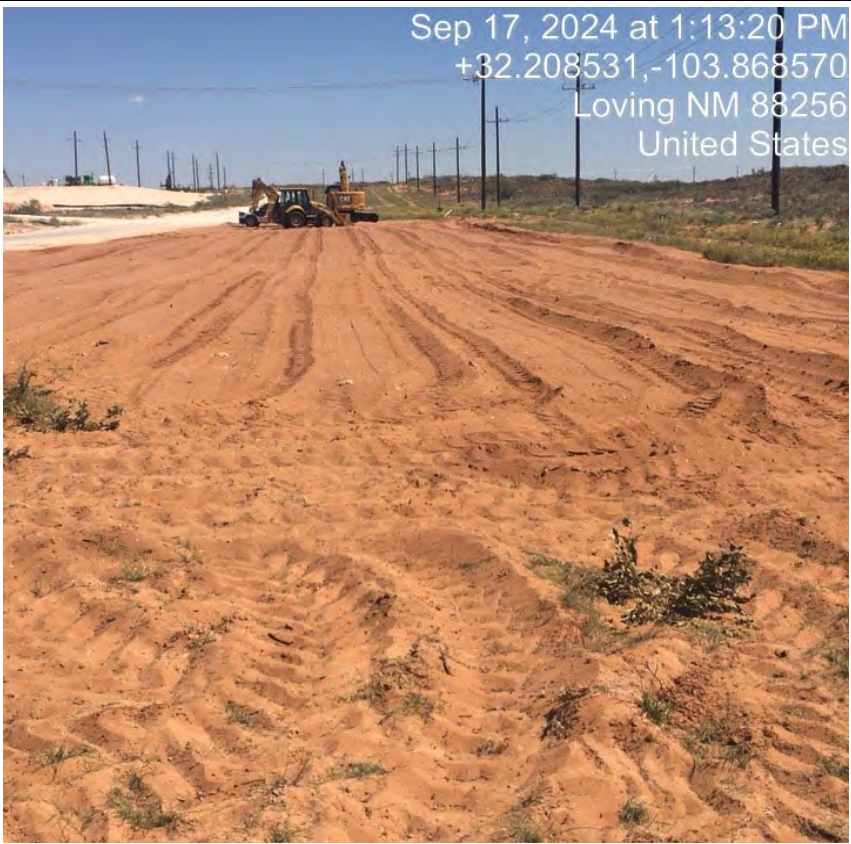
Photo Number: 9

<p>Sep 17, 2024 at 1:13:20 PM +32.208531,-103.868570 Loving NM 88256 United States</p>
Photo Direction: East	
Photo Description: View of the remediated area after backfill and regrading.

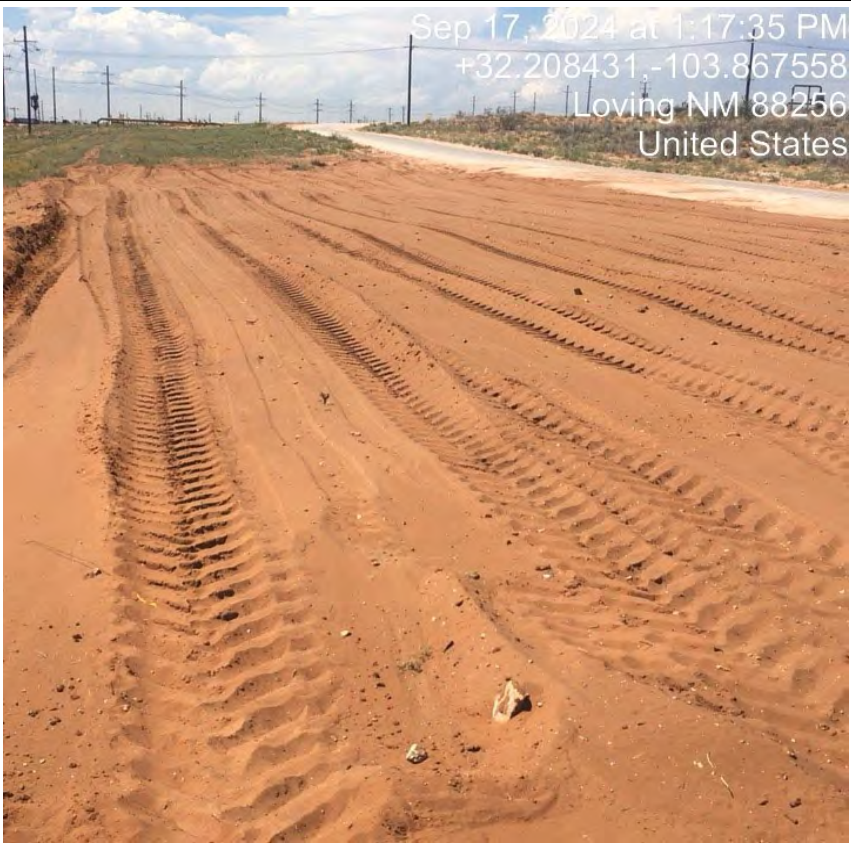
Photo Number: 11

Photo Direction: West-Northwest	
Photo Description: View of the remediated area after backfill and regrading.

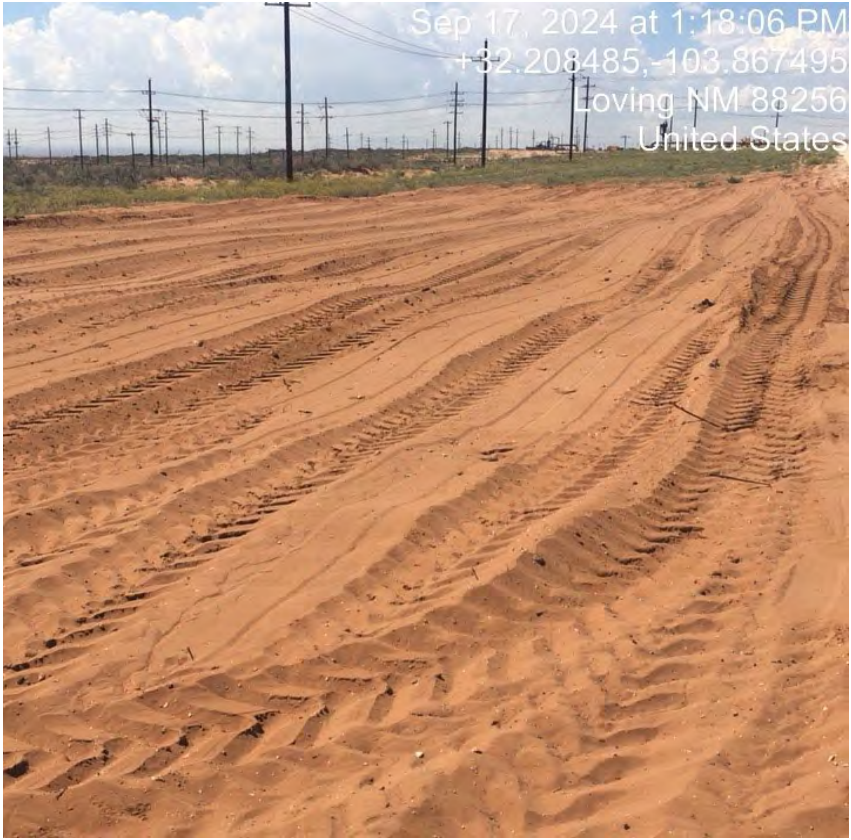
Photo Number: 12

Photo Direction: West-Southwest	
Photo Description: View of the remediated area after backfill and regrading.

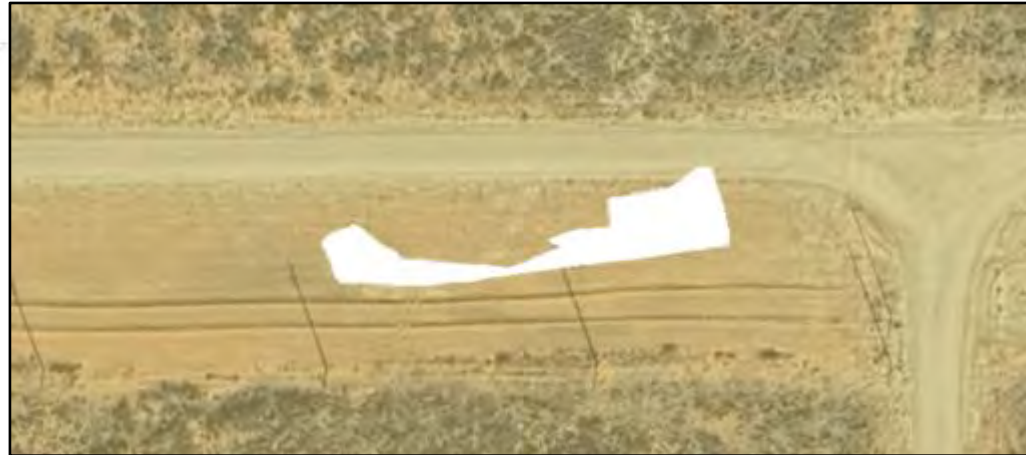
Figure 2. Aerial image of spill area. White polygon represents the spill area, overlapping primarily with a pipeline ROW and slightly with an adjacent graded road. Remediation activities are planned to be confined to these disturbed areas.
