Incident Closure

North Indian Flats 24 Fed 010

ExxonMobil Upstream Company
North Indian Flats 24 Fed 010

Incident Closure
September 2025

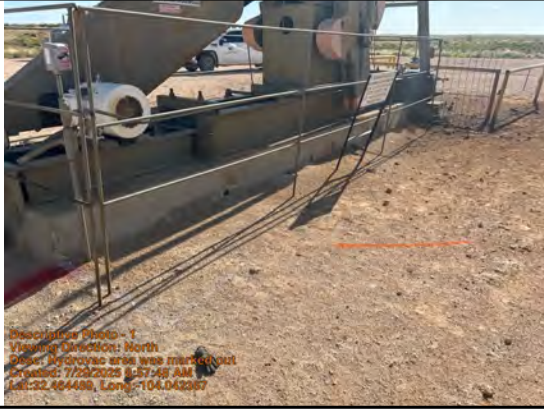
Diagnostic Photo - 1
Viewing Direction: North
Desc: Hydrovac area was marked out
Created: 7/29/2025 8:57:49 AM
Lat:32.484488, Long:-104.043267

Hydrovac area was marked out

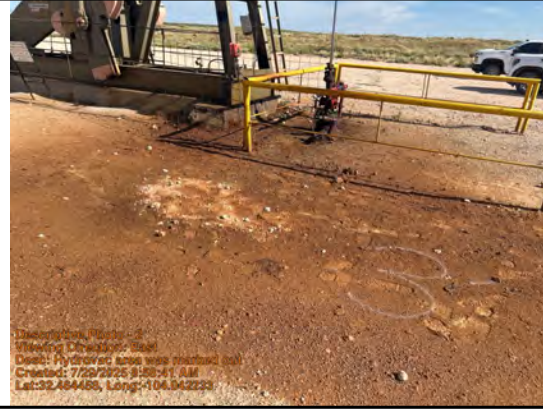
Diagnostic Photo - 2
Viewing Direction: East
Desc: Hydrovac area was marked out
Created: 7/29/2025 9:08:41 AM
Lat:32.484488, Long:-104.042233

Hydrovac area was marked out

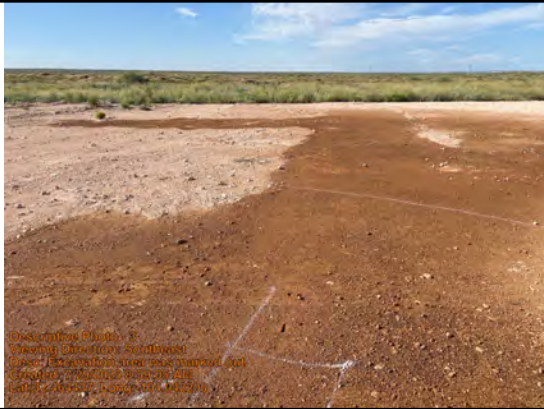
Diagnostic Photo - 3
Viewing Direction: Southeast
Desc: Excavation area was marked out
Created: 7/29/2025 9:08:41 AM
Lat:32.484488, Long:-104.042233

Excavation area was marked out

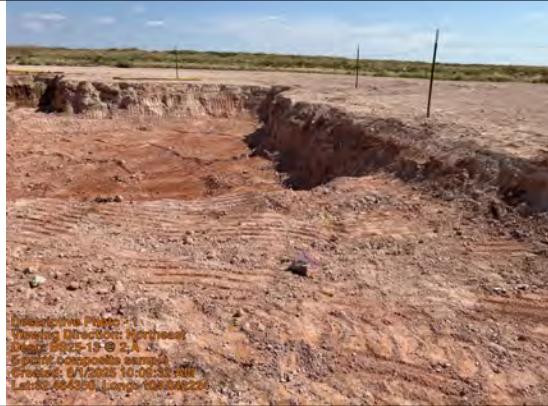
Descriptive Photo - 2
Viewing Direction: Northeast
Desc: BS25-13 @ 2'A
5 point composite sample
Created: 9/1/2025 10:00:35 AM
Lat:32.484358, Long:-104.62294

BS25-13 @ 2'
5 point composite sample

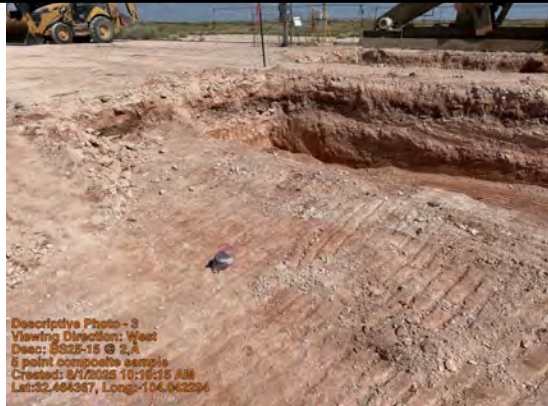
Descriptive Photo - 3
Viewing Direction: West
Desc: BS25-15 @ 2'A
5 point composite sample
Created: 9/1/2025 10:10:15 AM
Lat:32.484367, Long:-104.62294

BS25-15 @ 2'
5 point composite sample

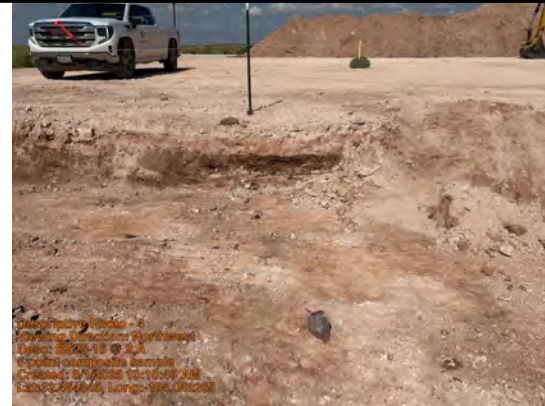
Descriptive Photo - 4
Viewing Direction: Northwest
Desc: BS25-16 @ 2'A
5 point composite sample
Created: 9/1/2025 10:10:49 AM
Lat:32.484348, Long:-104.62297

BS25-16 @ 2'
5 point composite sample

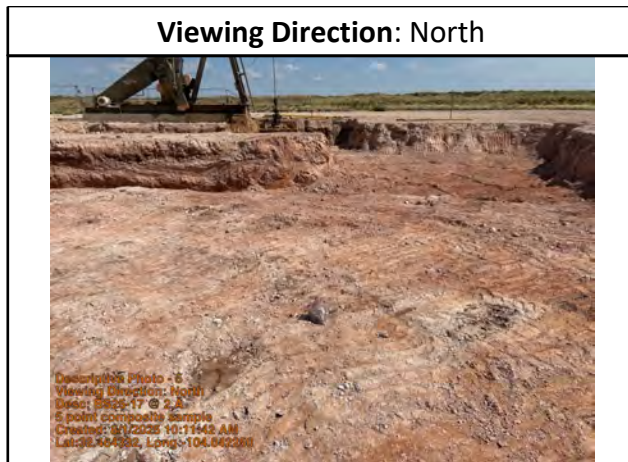
BS25-17 @ 2'
5 point composite sample

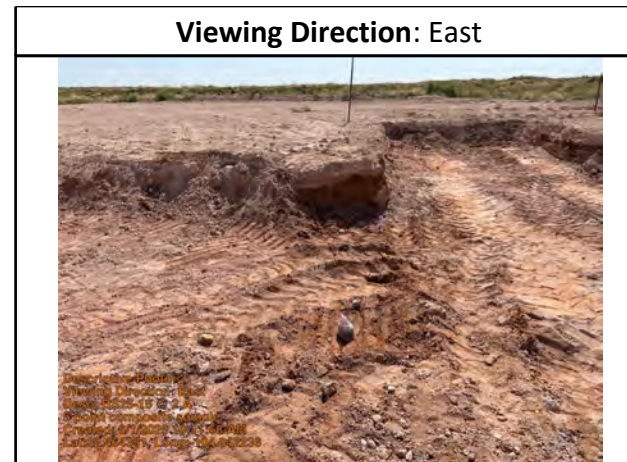
BS25-18 @ 2'
5 point composite sample

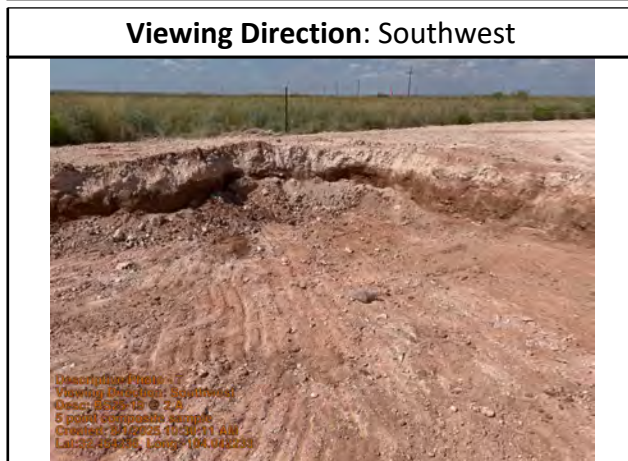
BS25-19 @ 2'
5 point composite sample

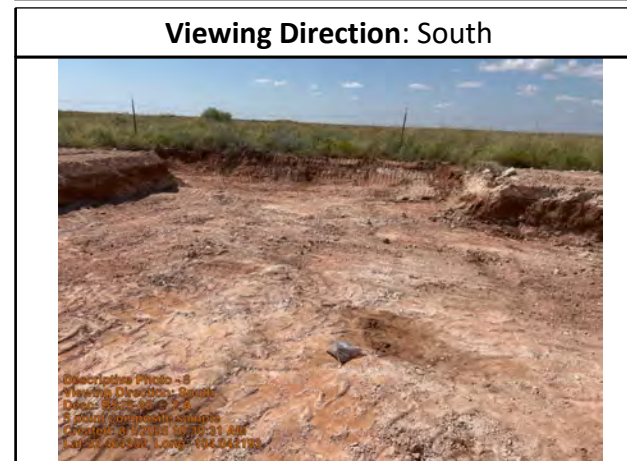
BS25-20 @ 2'
5 point composite sample

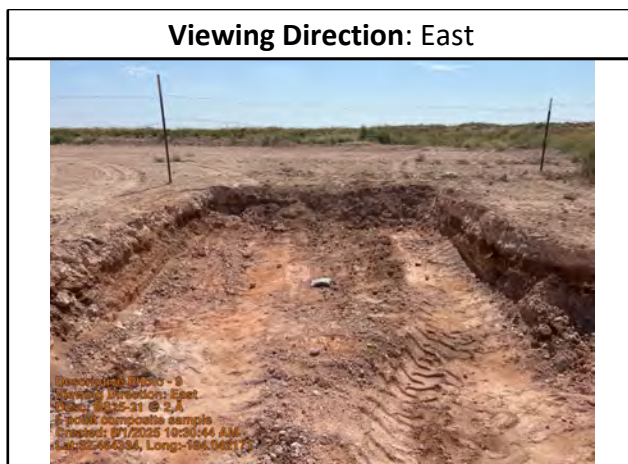
BS25-21 @ 2'
5 point composite sample

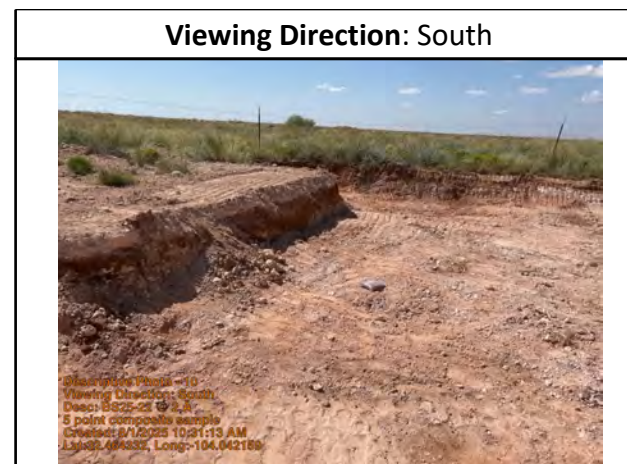
BS25-22 @ 2'
5 point composite sample

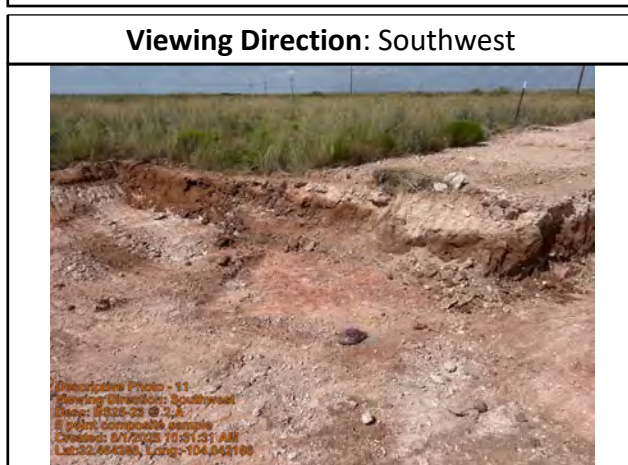
BS25-23 @ 2'
5 point composite sample

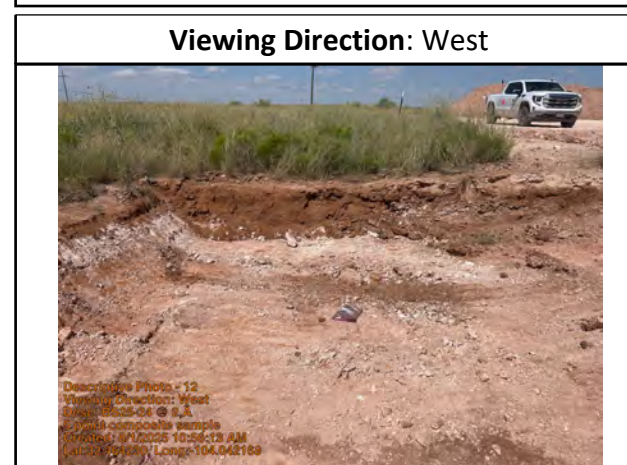
BS25-24 @ 2'
5 point composite sample

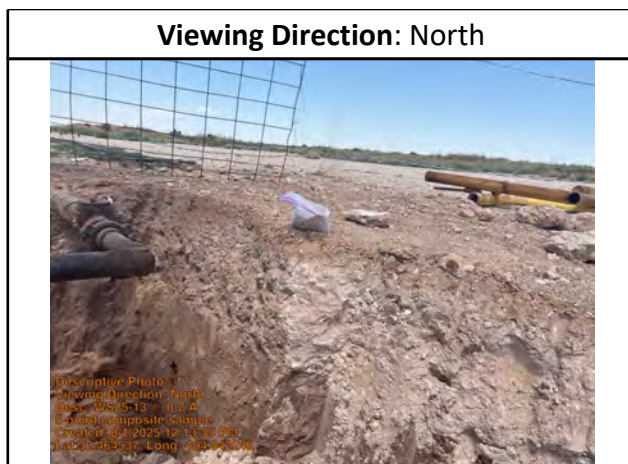
WS25-13 @ 0-2'
5 point composite sample

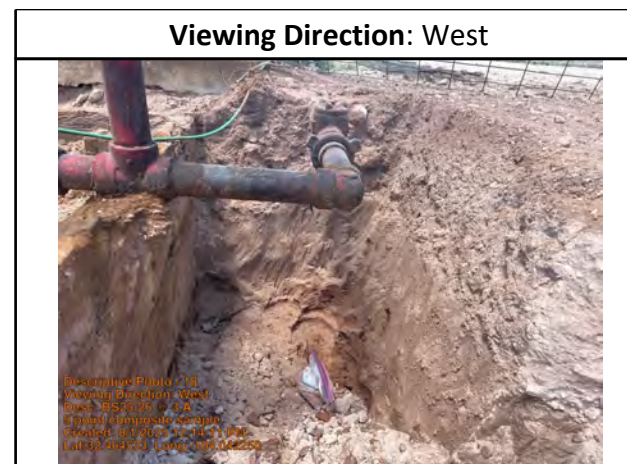
BS25-26 @ 3'
5 point composite sample

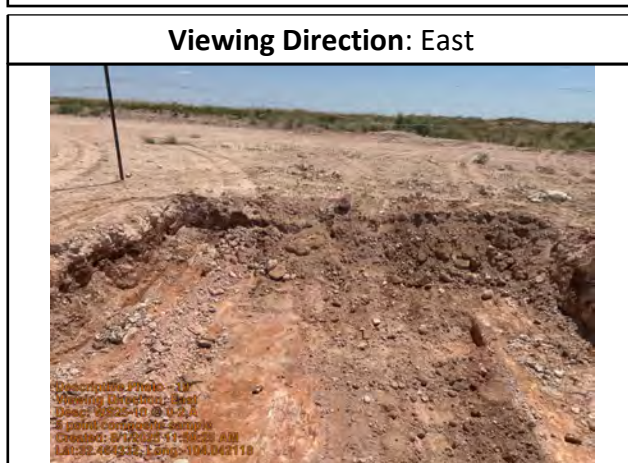
WS25-10 @ 0-2'
5 point composite sample

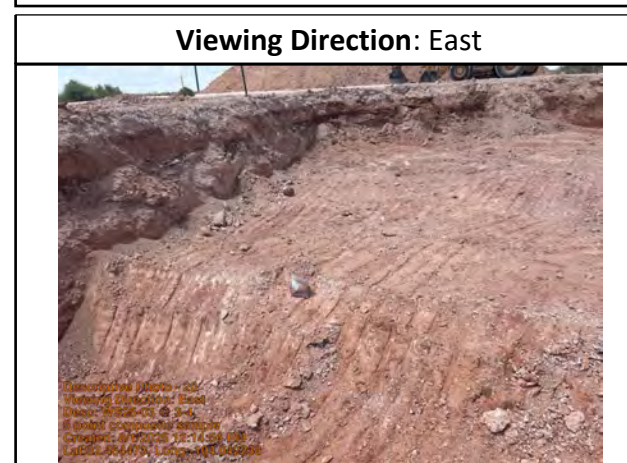
WS25-03 @ 3-4'
5 point composite sample

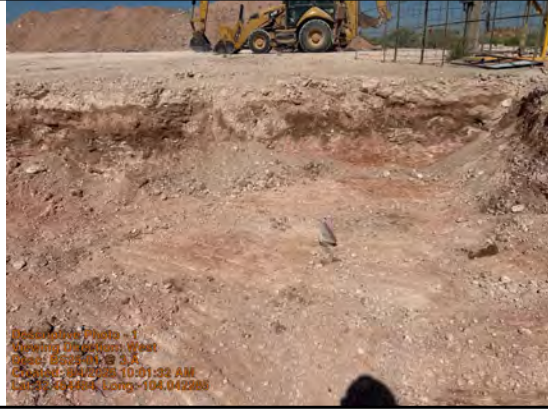
Descriptive Photo - 1
Viewing Direction: West
Date: 8/4/2025 @ 3:4
Created: 8/4/2025 10:01:33 AM
Lat: 32.464486, Long: 104.042284

BS25-01 @ 3'

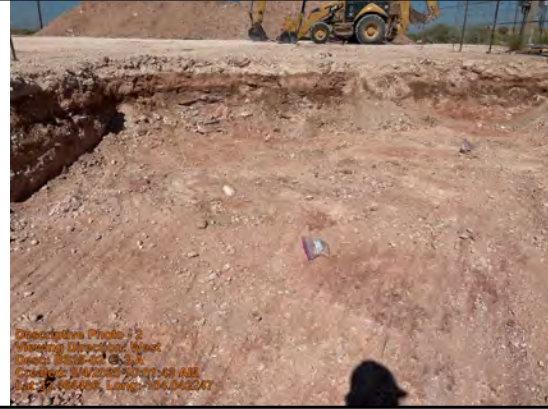
Descriptive Photo - 2
Viewing Direction: West
Date: 8/4/2025 @ 3:4
Created: 8/4/2025 10:01:43 AM
Lat: 32.464486, Long: 104.042284

BS25-02 @ 3'

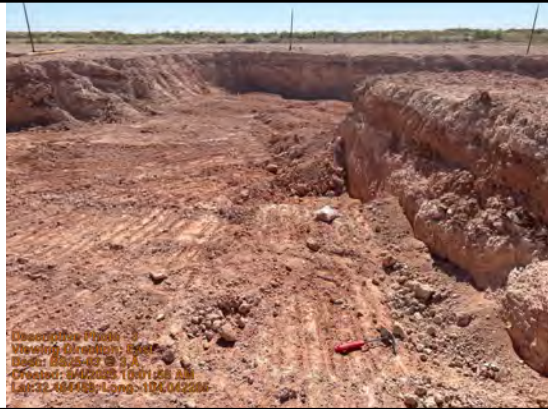
Descriptive Photo - 3
Viewing Direction: East
Date: 8/4/2025 @ 3:4
Created: 8/4/2025 10:01:58 AM
Lat: 32.464486, Long: 104.042284

BS25-03 @ 3'

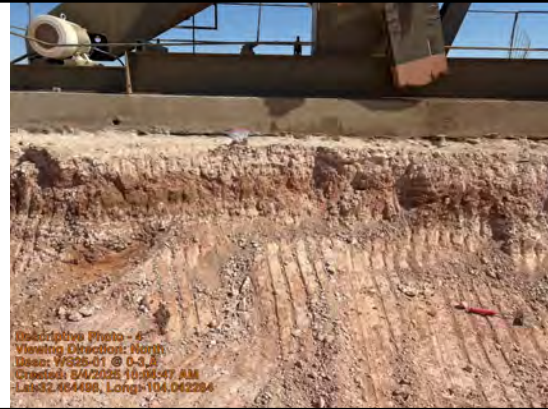
Descriptive Photo - 4
Viewing Direction: North
Date: 8/4/2025 @ 3:4
Created: 8/4/2025 10:04:47 AM
Lat: 32.464486, Long: 104.042284

WS25-01 @ 0-3'

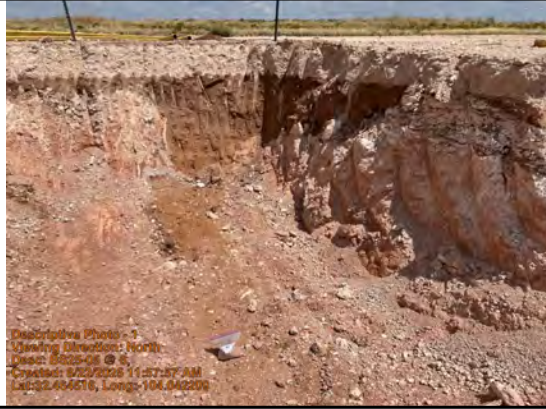
Descriptive Photo: 3
Viewing Direction: North
Date: 8/22/2025 @ 8
Created: 8/22/2025 11:27:57 AM
Lat:32.484616, Long:-104.042209

BS25-05 @ 6'

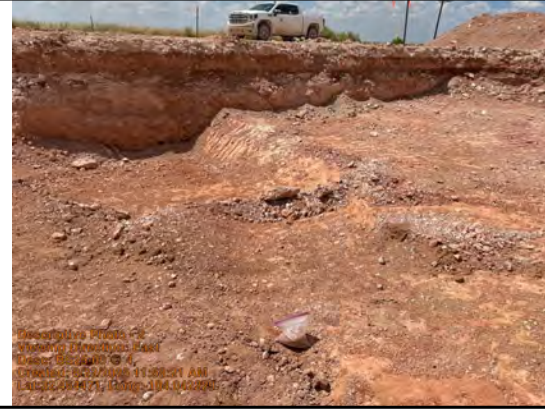
Descriptive Photo: 3
Viewing Direction: SW
Date: 8/22/2025 @ 8
Created: 8/22/2025 11:28:51 AM
Lat:32.484616, Long:-104.042209

BS25-06 @ 4'
