Release Assessment and Incident Closure

Big Eddy Unit DI 29 Battery
Section 21, Township 20 South, Range 32 East
Facility: FAPP2123046227
County: Lea
Coordinates: 32.56479, -103.77798
Vertex File Number: 25A-03635

Prepared for:
ExxonMobil Production Company

Prepared by:
Vertex Resource Services Inc.

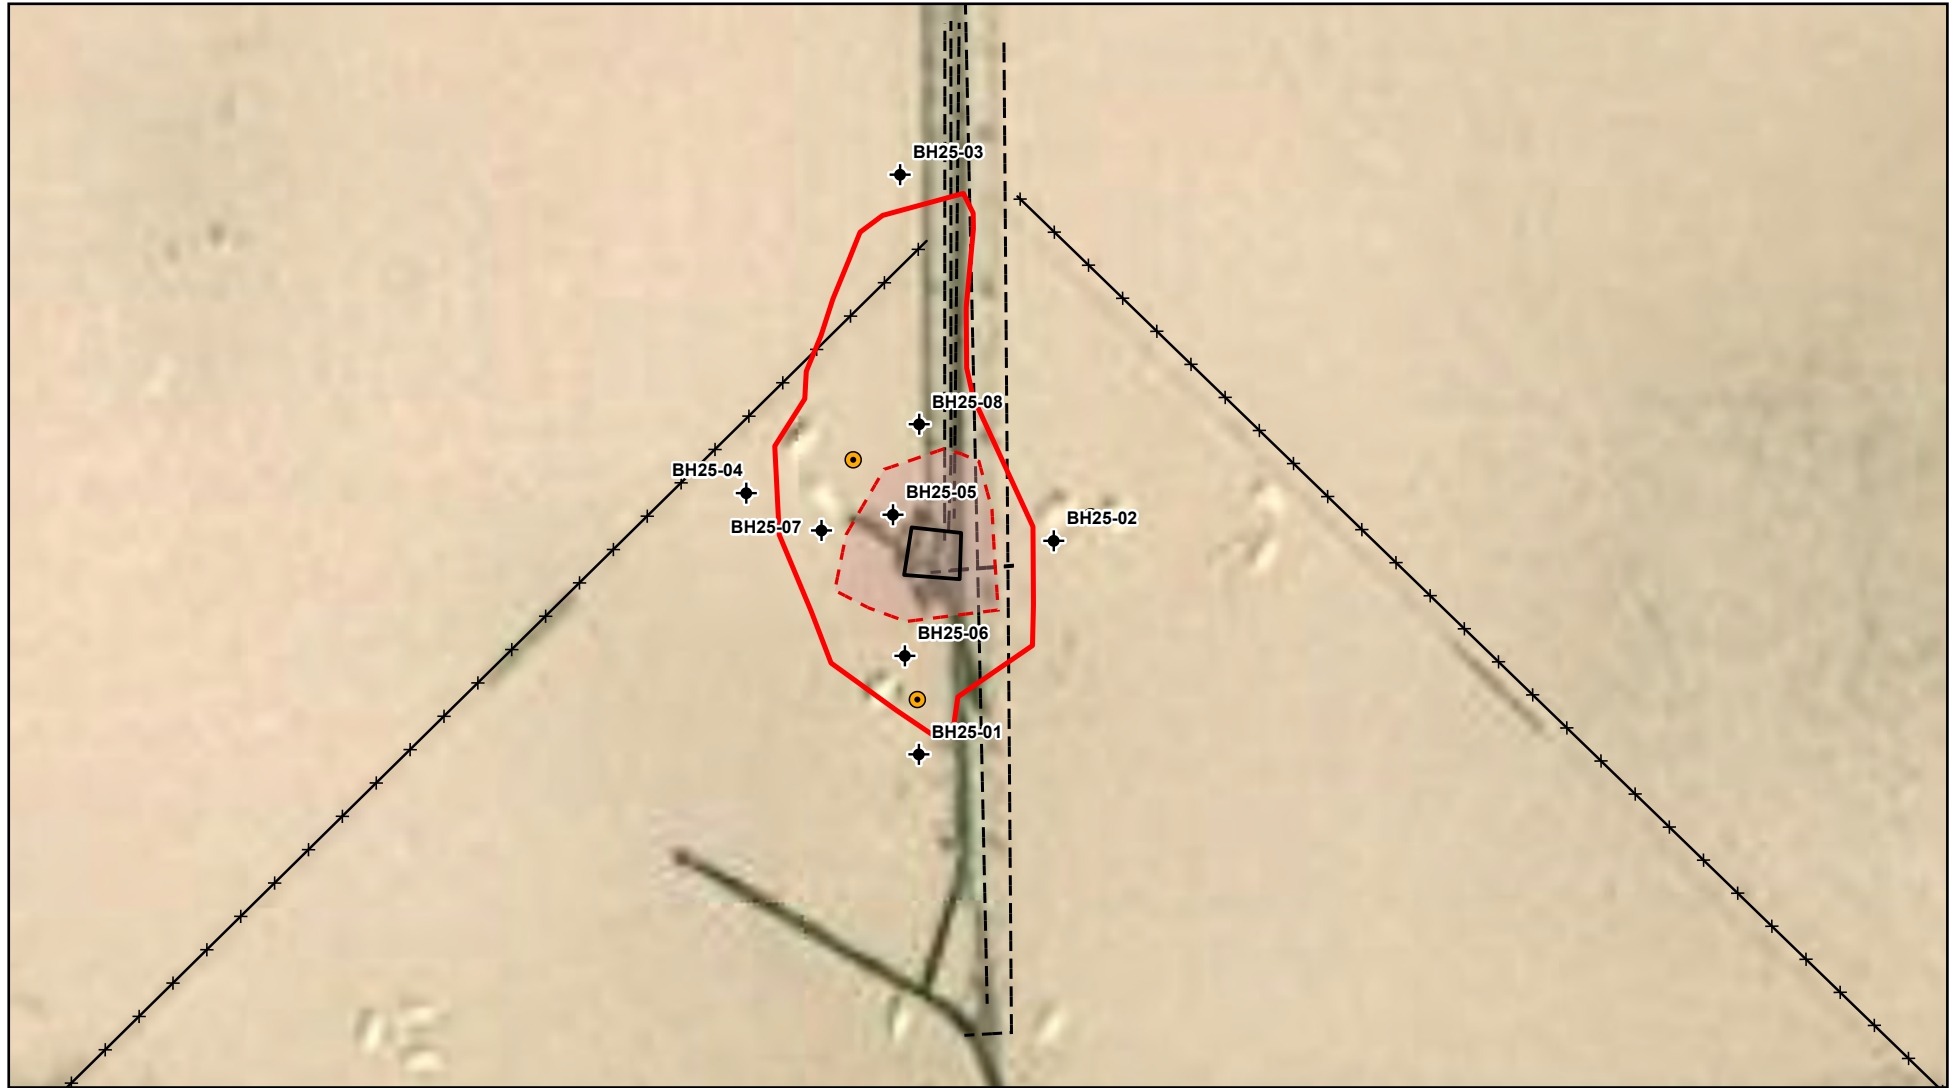
Figure 1. Characterization Sampling Site Schematic

An initial site assessment of the release area was concluded on July 16, 2025, which identified an area of interest containing staining as specified in the initial C-141 Report. Due to safety concerns about prolonged work near an active flare, delineation sampling was limited, and a stop work was issued to shut in the well for a safer work environment. Returning on September 22, 2025, after the well was shut in, a further detailed delineation was conducted. Delineation of the release area was completed during excavation and confirmation sampling. In total, eight sample points were established, one borehole with at least two discrete samples, for each cardinal direction. Eighteen delineation samples were collected and submitted for laboratory analysis. Daily Field Reports including site photographs are included in Appendix B. Laboratory results are presented in Table 3 and the laboratory data reports are included in Appendix C. Sample locations and release area are presented on Figure 1.

- ◆ Borehole
- ✕ Fence
- Guide Wire
- - Pipeline (Aboveground)
- ▭ Production Equipment
- ▭ (Red) Area of Interest
- ▭ (Dashed Red) Approximate Release Area (~362 sq.ft. | 72 ft.)

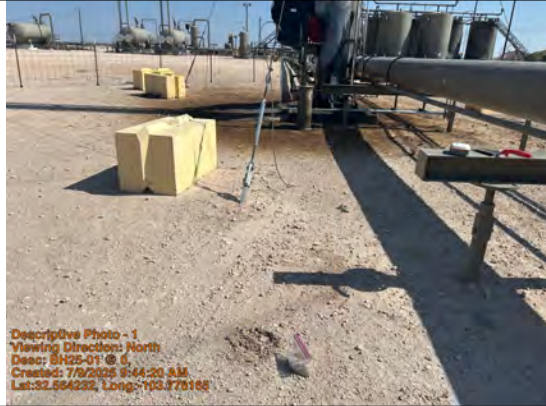
Descriptive Photo - 1
Viewing Direction: North
Desc: BH25-01 @ 0'
Created: 7/9/2025 9:44:20 AM
Lat:32.564232, Long:-103.778165

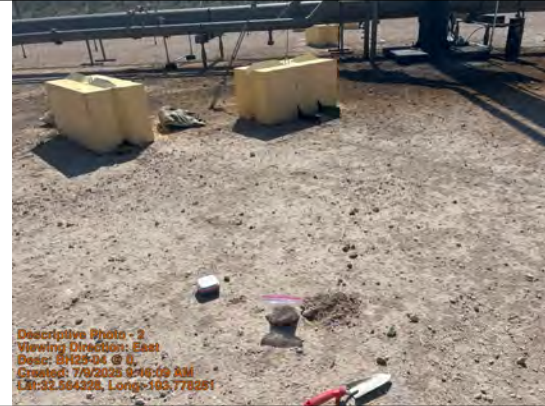
Descriptive Photo - 2
Viewing Direction: East
Desc: BH25-04 @ 0'
Created: 7/9/2025 9:46:59 AM
Lat:32.564228, Long:-103.778251

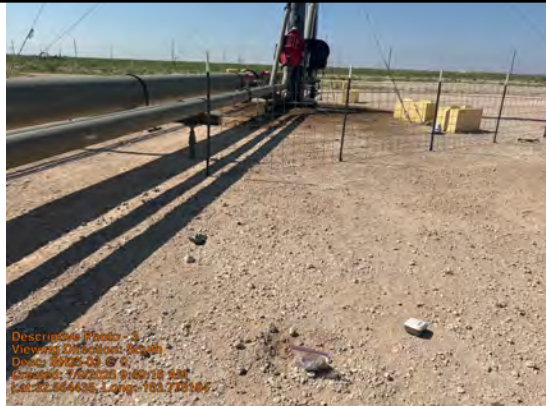
Descriptive Photo - 3
Viewing Direction: South
Desc: BH25-03 @ 0'
Created: 7/9/2025 9:49:18 AM
Lat:32.564435, Long:-103.778165

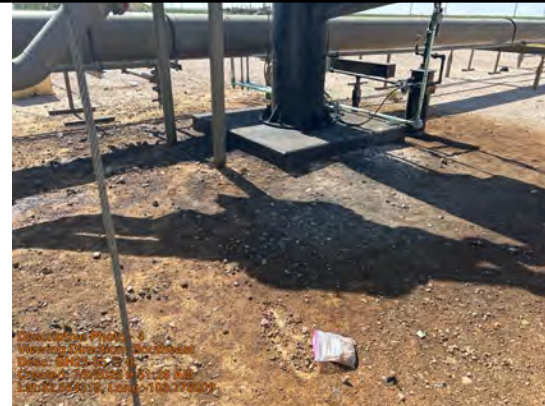
Descriptive Photo - 4
Viewing Direction: Southeast
Desc: BH25-05 @ 0'
Created: 7/9/2025 9:51:59 AM
Lat:32.564319, Long:-103.778307

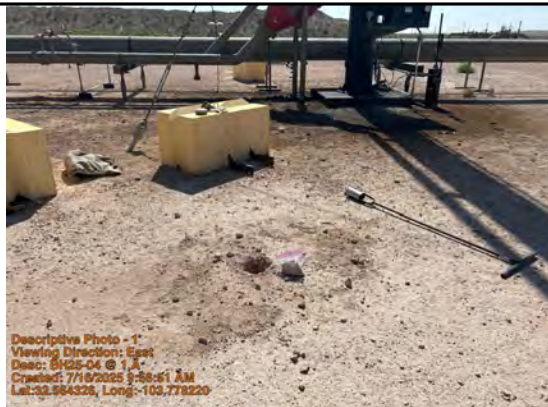
Descriptive Photo - 1
Viewing Direction: East
Desc: BH25-04 @ 1'R
Created: 7/16/2025 9:58:51 AM
Lat:32.584326, Long:-103.778220

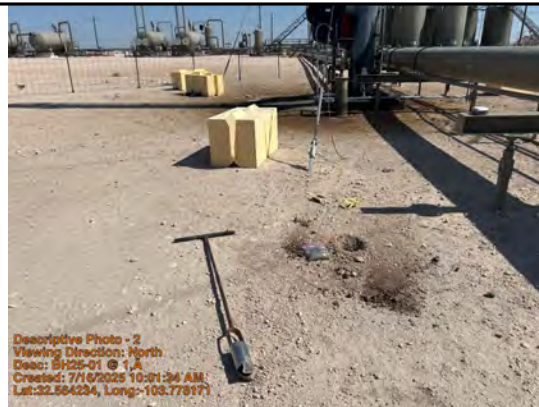
Descriptive Photo - 2
Viewing Direction: North
Desc: BH25-01 @ 1'R
Created: 7/16/2025 10:01:34 AM
Lat:32.584234, Long:-103.778171

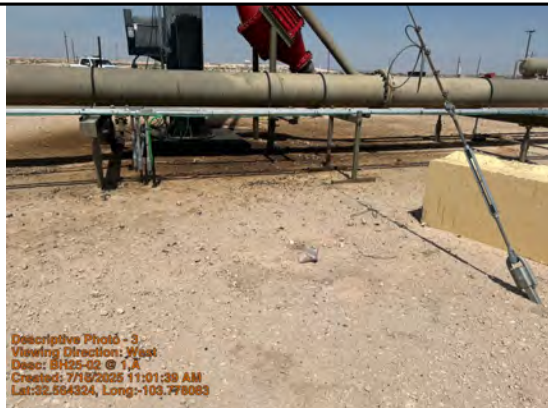
Descriptive Photo - 3
Viewing Direction: West
Desc: BH25-02 @ 1'R
Created: 7/16/2025 11:01:39 AM
Lat:32.584324, Long:-103.778063

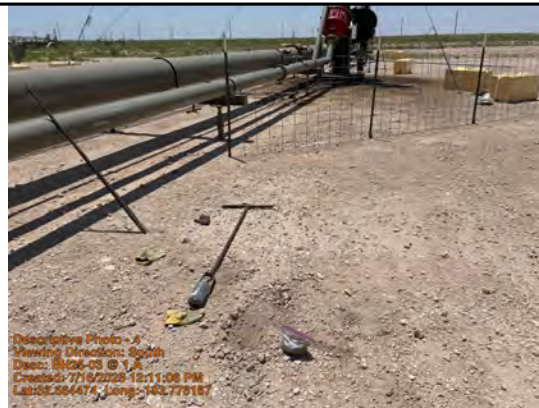
Descriptive Photo - 4
Viewing Direction: South
Desc: BH25-03 @ 1'R
Created: 7/16/2025 12:11:08 PM
Lat:32.584474, Long:-103.778157

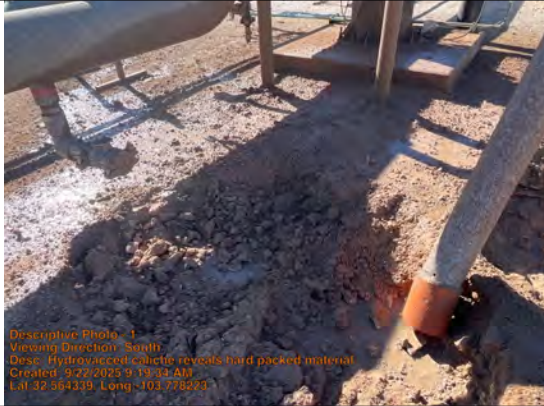
Descriptive Photo - 1
Viewing Direction: South
Desc: Hydrovaccated caliche reveals hard packed material
Created: 9/22/2025 9:13:33 AM
Lat:32.564339, Long:-103.778222

Hydrovaccated caliche reveals hard packed material

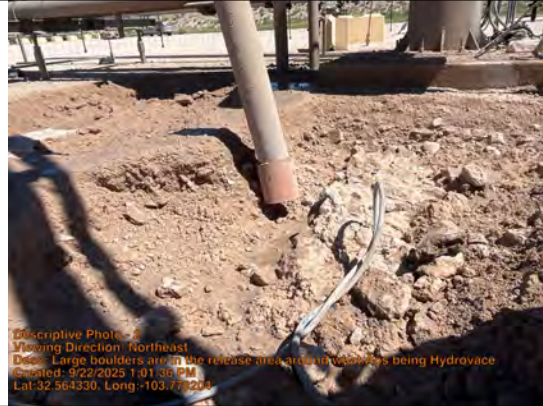
Descriptive Photo - 2
Viewing Direction: Northeast
Desc: Large boulders are in the release area around what's being Hydrovaccated
Created: 9/22/2025 1:01:30 PM
Lat:32.564330, Long:-103.778201

Large boulders are in the release area around what's being Hydrovaccated

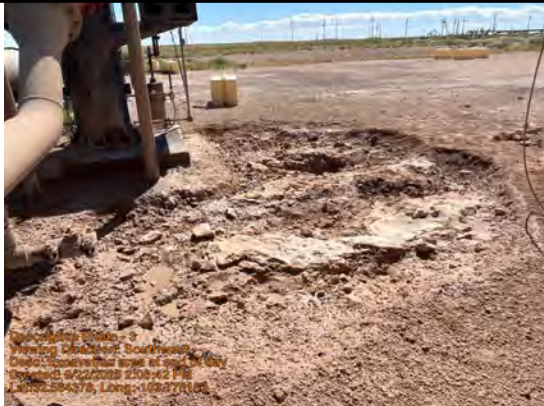
Descriptive Photo - 3
Viewing Direction: Southwest
Desc: Excavation area at end of day
Created: 9/22/2025 2:08:42 PM
Lat:32.564316, Long:-103.778185

Excavation area at end of day

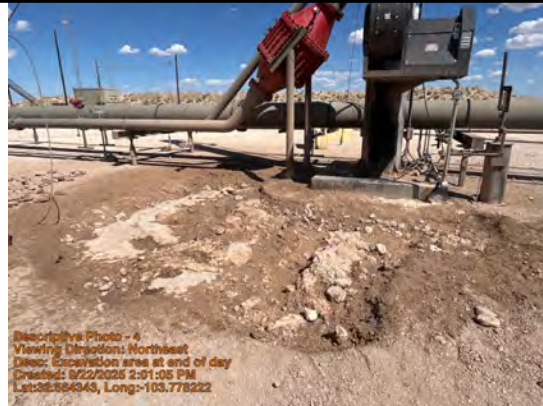
Descriptive Photo - 4
Viewing Direction: Northeast
Desc: Excavation area at end of day
Created: 9/22/2025 2:01:05 PM
Lat:32.564345, Long:-103.778222

Excavation area at end of day

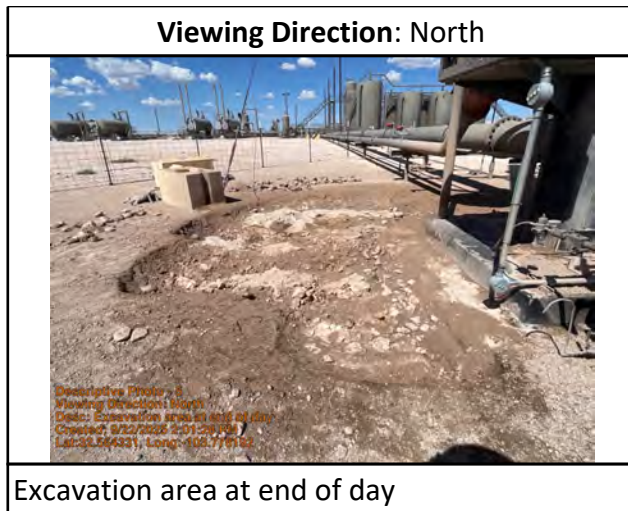
- 9:51** Completed safety paperwork, had a safety meeting, received work authorization, and confirmed the flare was shut off before starting work
- 9:51** Continued hydrovaccing to start then began breaking up some of the bolders with rock bars
- 17:27** Base is at refusal for hand excavation and hydrovaccing at end of day. Field screened indicated that the base was clean
- 17:27** BS25-01, BS25-02, WS25-01 and the remainder of delineation was collected
- 17:28** The extent of the excavation was to 1ft past the visible stain

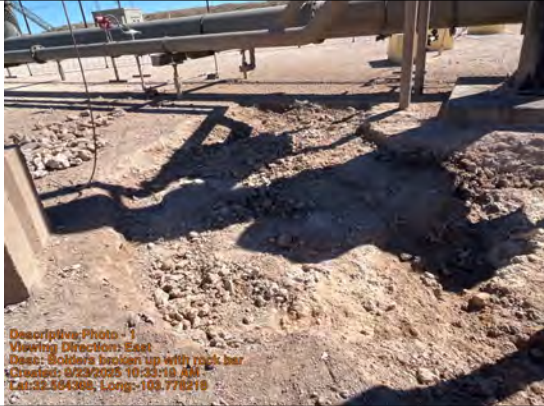
Descriptive Photo - 1
Viewing Direction: East
Desc: Boulders broken up with rock bar
Created: 9/23/2025 10:33:18 AM
Lat:32.564388, Long:-103.778216

Boulders broken up with rock bar

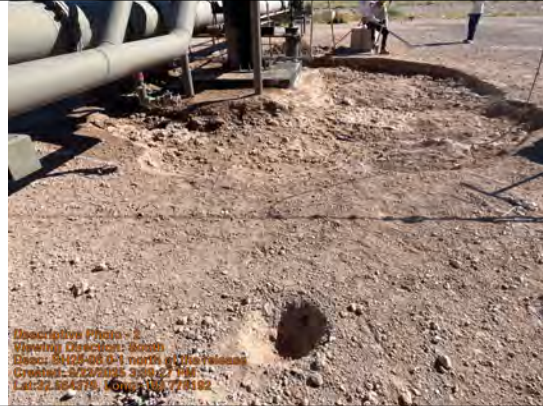
Descriptive Photo - 2
Viewing Direction: South
Desc: BH25-08 0-1 north of the excavation
Created: 9/23/2025 3:58:02 PM
Lat:32.564376, Long:-103.778192

BH25-08 0-1 north of the excavation

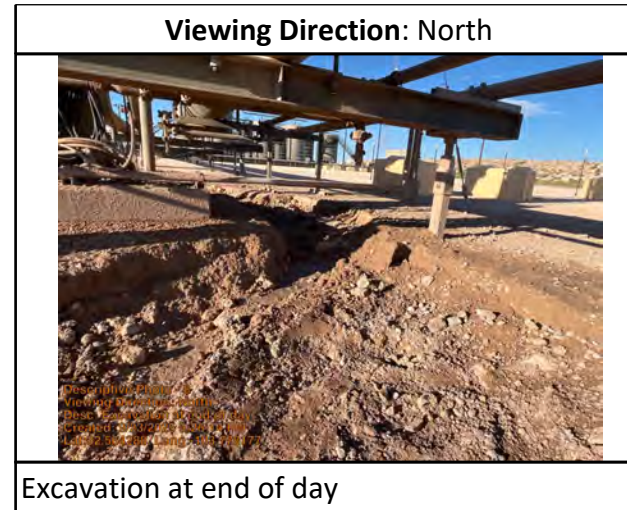
Excavation at end of day

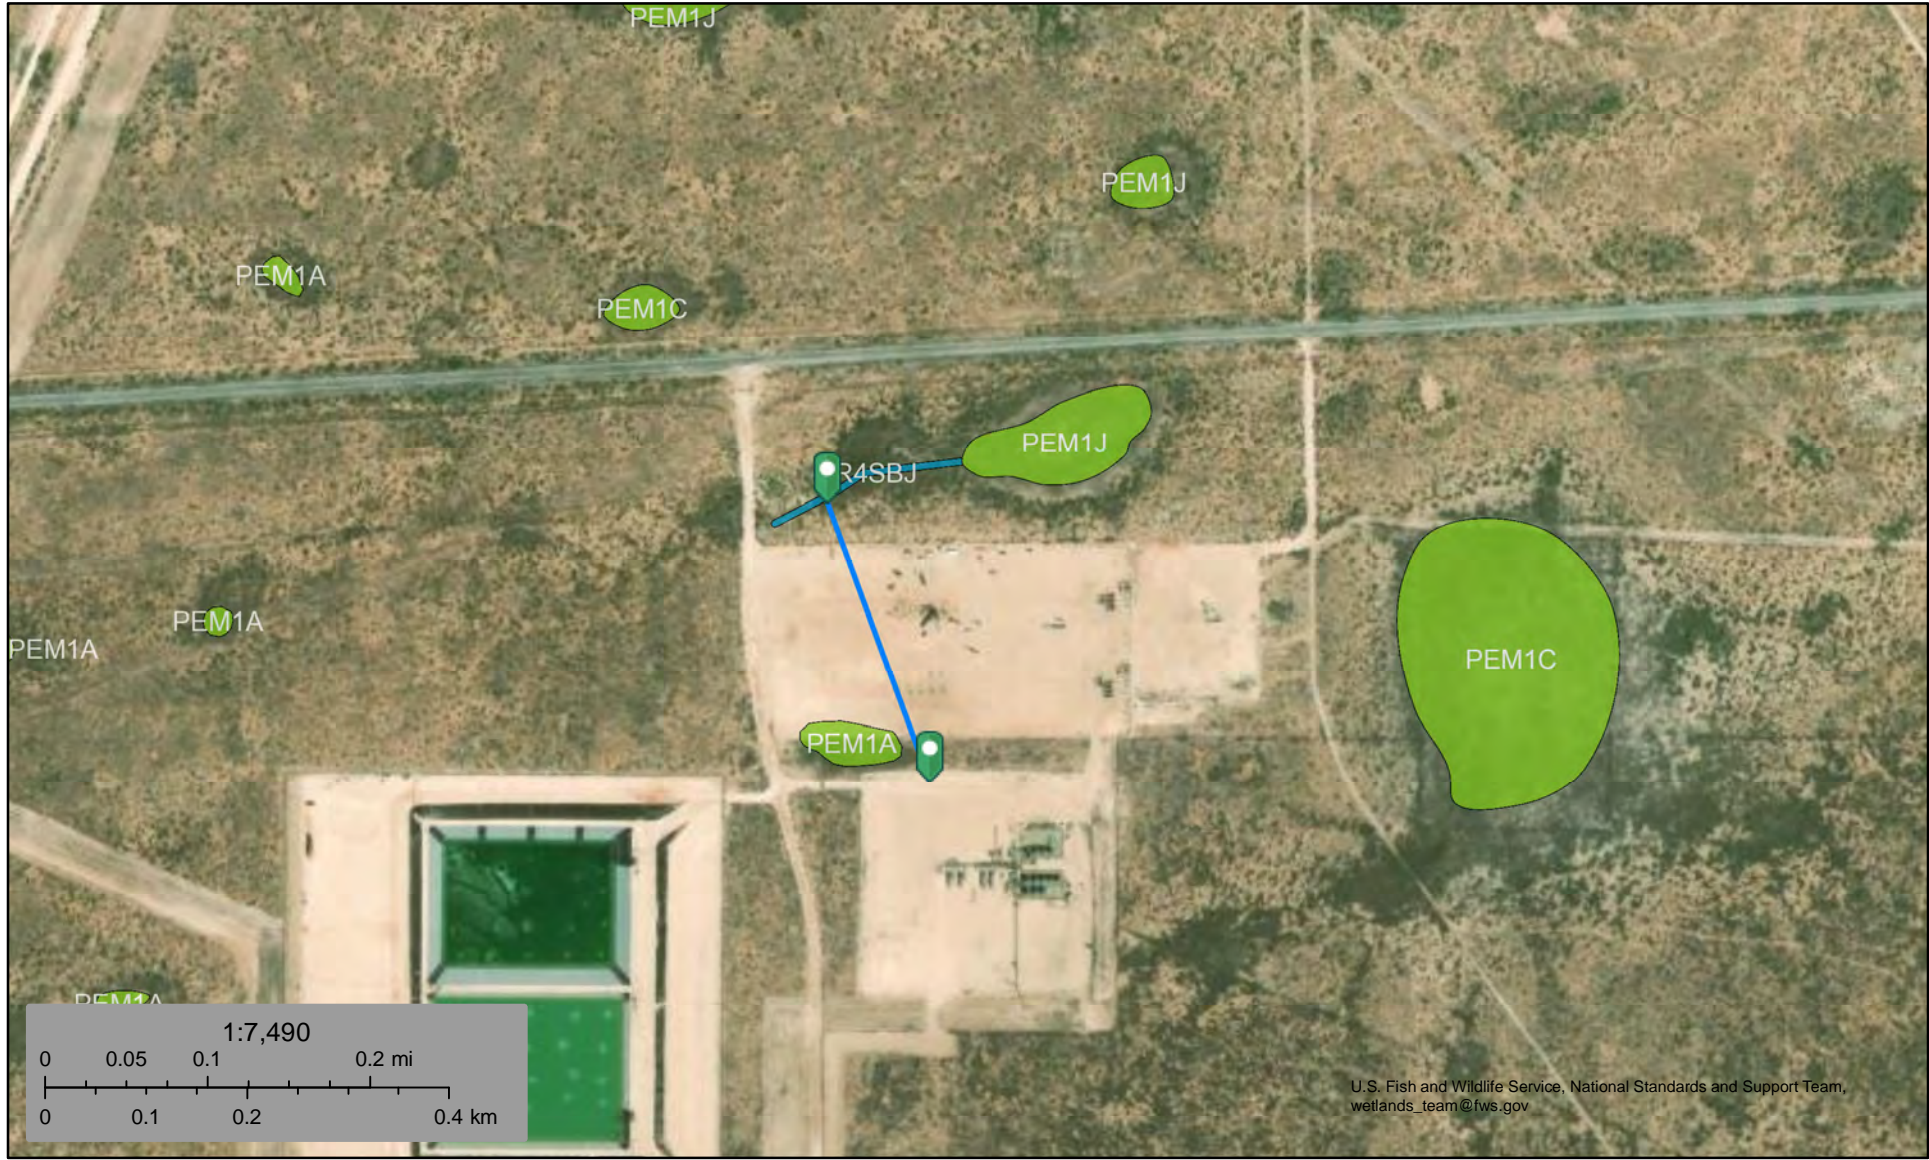
02 Big Eddy Unit DI 29 Intermittent Stream - 810ft

Wetlands

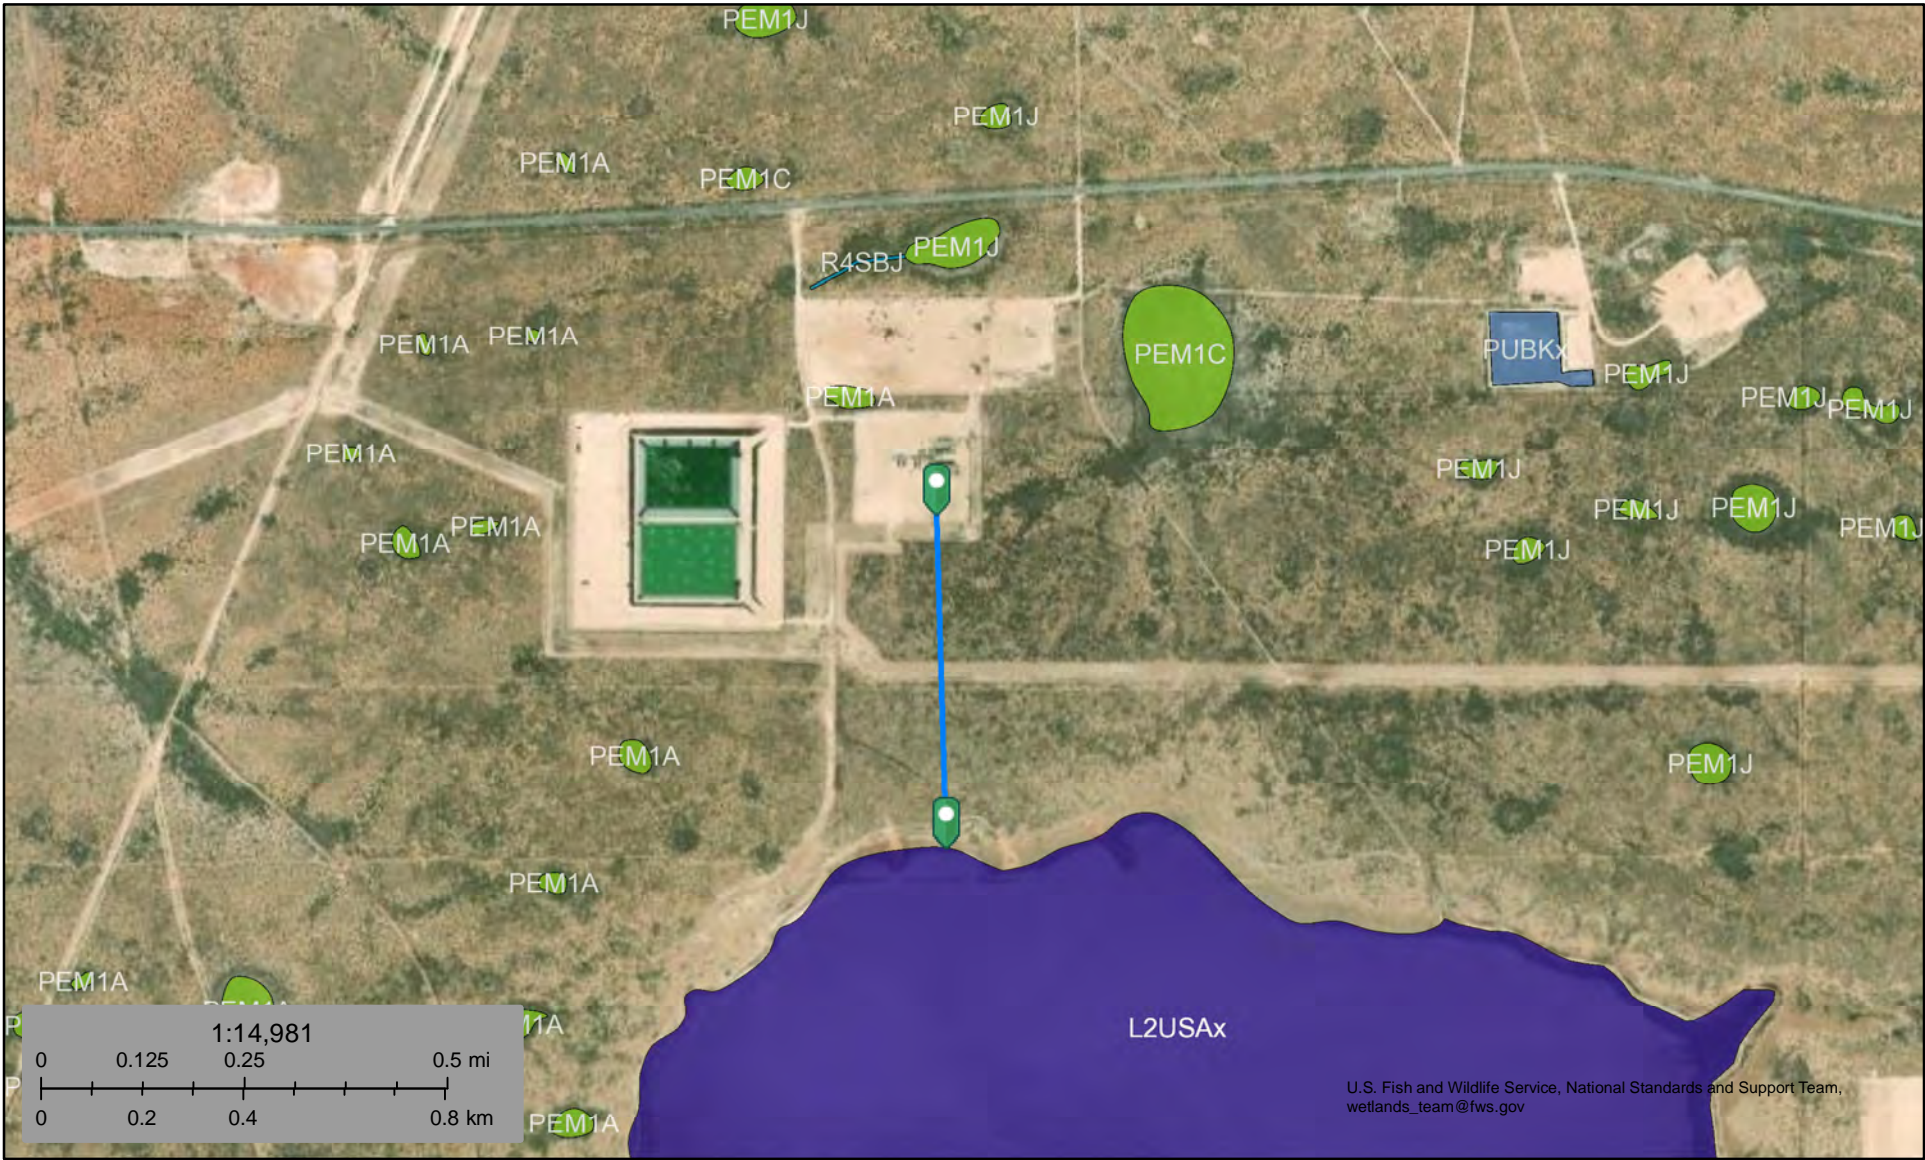
Big Eddy Unit DI 29_Lake_1,823 ft

Wetlands

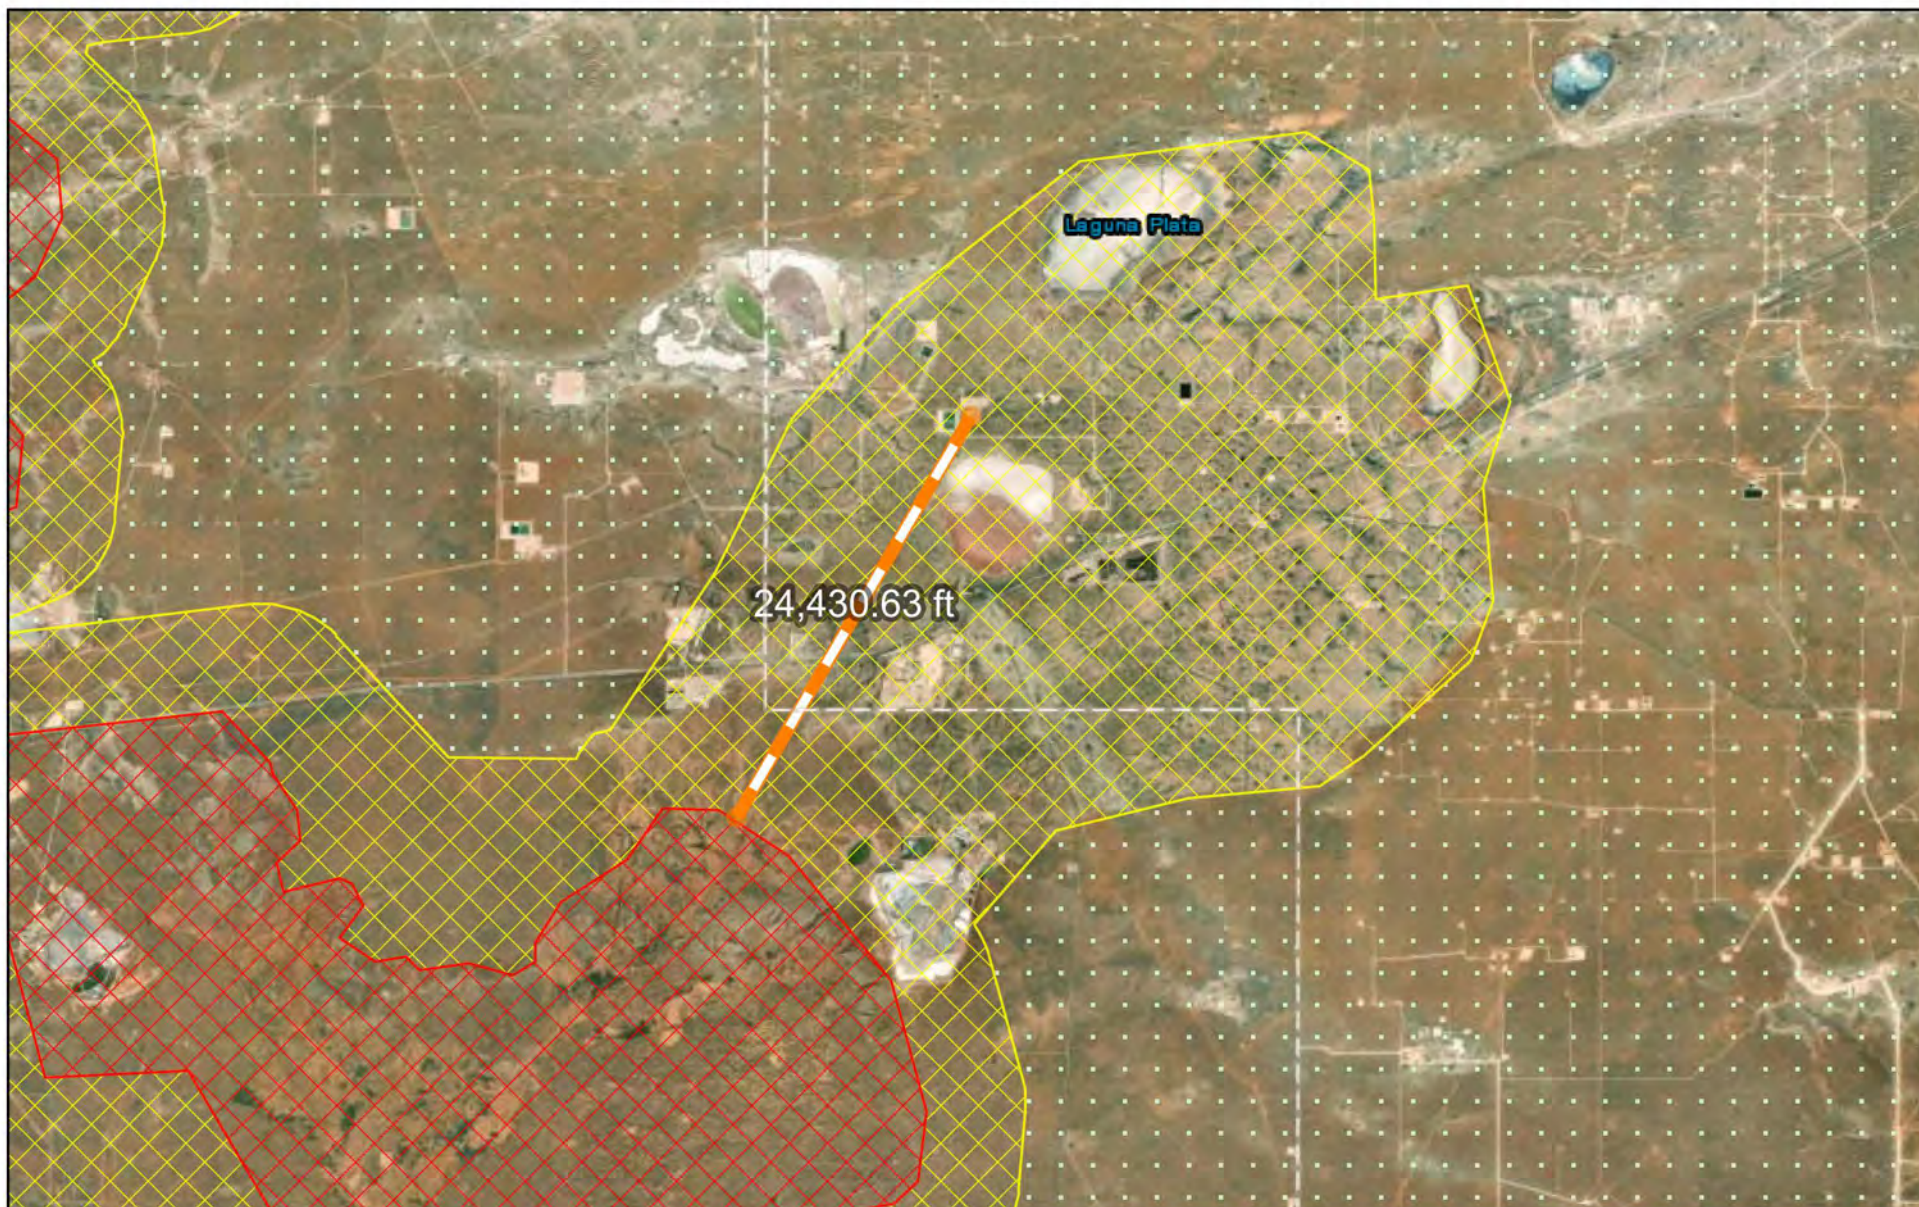
Big Eddy Unit DI 29 Karst Potential

- World_Boundaries_and_Places
- BLM NM Carlsbad Field Office Karst Potential Areas
-
