Re: Remediation Work Plan

Marbob State #001

Incident Number: nAB1821141249

Eddy County, New Mexico

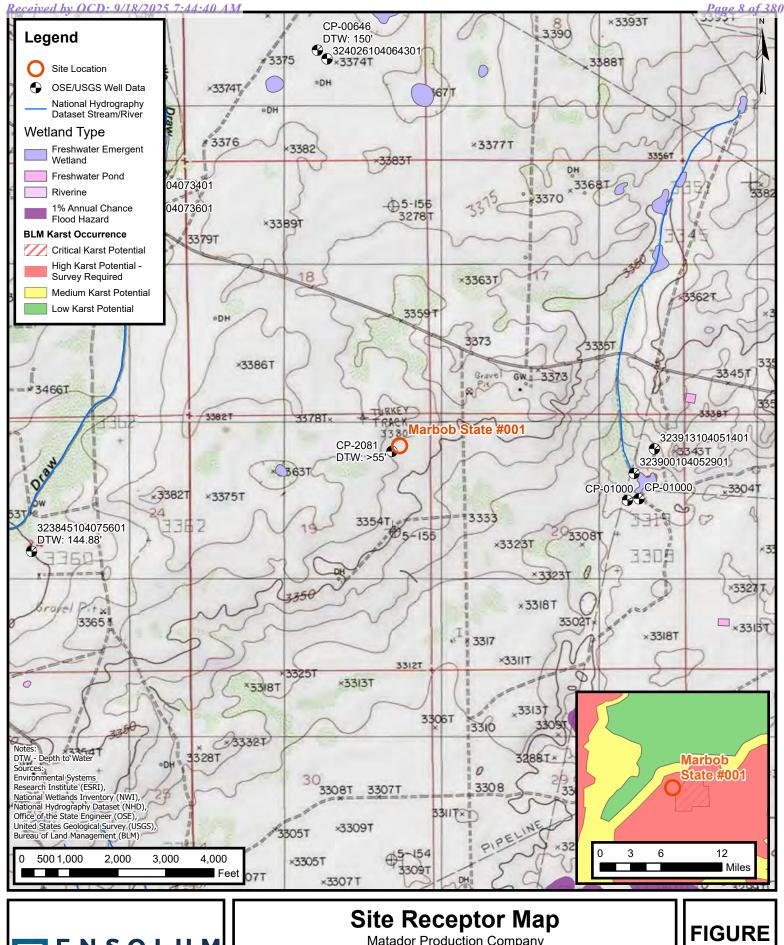
Matador Production Company Marbob State #001 Incident Number: nAB1821141249 Unit A, Section 19, T 19S, R 29E Eddy County, New Mexico FIGURE 1

The closest permitted groundwater well with depth to groundwater data is New Mexico Office of the State Engineer (NMOSE) well CP-2081 POD1, located on the southwest corner of the Site; this soil boring was advanced to determine depth to water at the Site. The soil boring had a reported depth to groundwater greater than 55 below ground surface (bgs) (measured on August 15, 2025) and a total depth of 55 feet bgs. There are no regional or Site-specific hydrogeological conditions, such as shallow surface water, known karst features, wetlands, or vegetation to suggest the Site is conducive to shallower groundwater. All wells used for depth to groundwater determination are presented on Figure 1; the referenced well record is included in Appendix A.

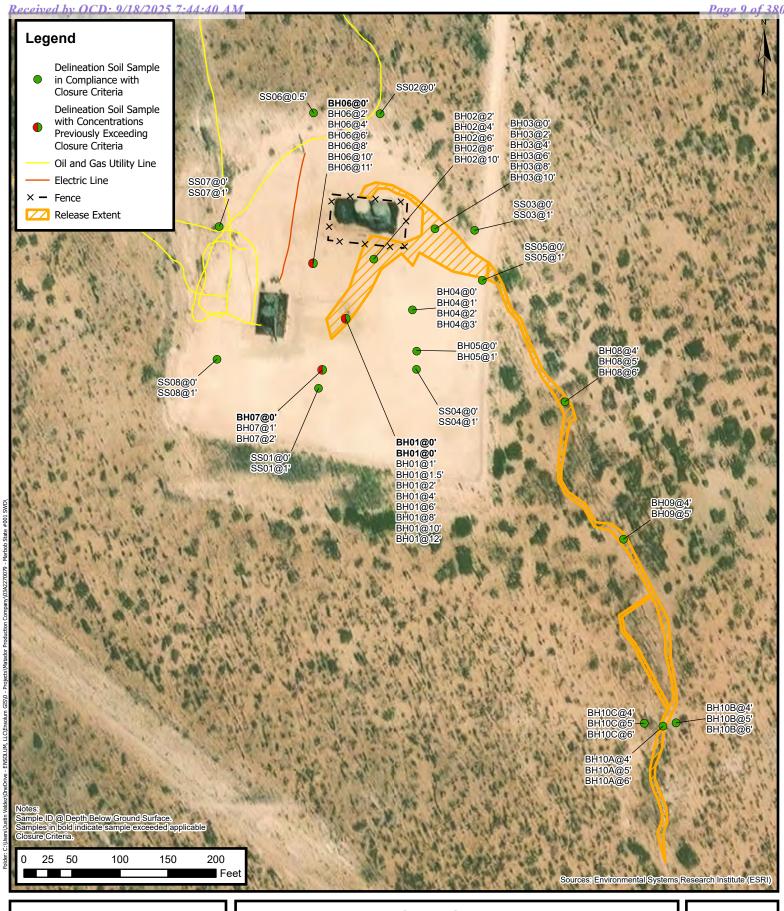
Matador Production Company Marbob State #001 Incident Number: 30-015-26040 Unit A, Section 19, T 19S, R 29E Eddy County, New Mexico FIGURE 2

Delineation Soil Sample Locations

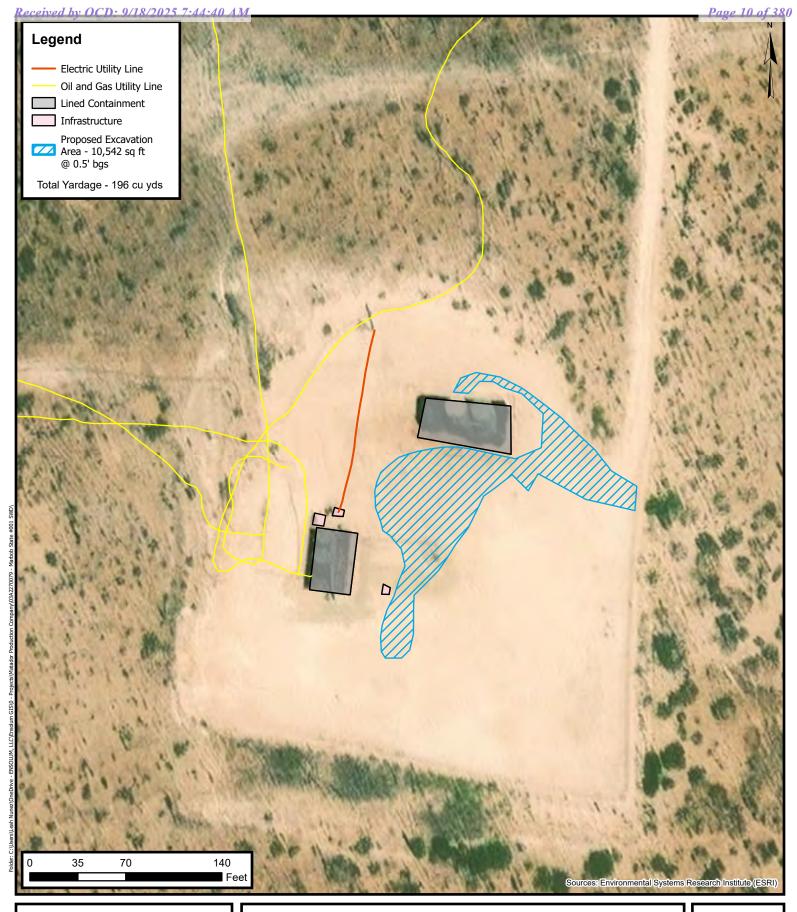
Matador Production Company Marbob State #001 SWD Incident Number: nAB1821141249 Unit A, Section 19, T 19S, R 29E Eddy County, New Mexico FIGURE 3a

Proposed Excavation Extent

- The excavation will be backfilled and recontoured to match pre-existing conditions and seeded
 utilizing a weed-free seed mix designed by the NMSLO to meet reclamation standards for this
 region. Seeding is anticipated to be completed in the spring or fall when temperatures and
 precipitation is most conducive for vegetative growth.

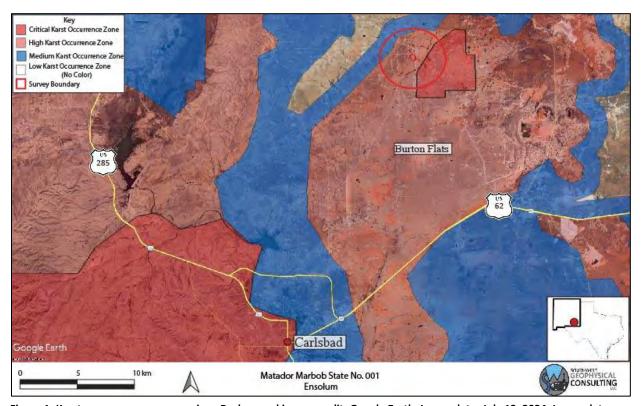
A high karst occurrence zone is defined as an area in known soluble rock types that contains a high frequency of significant caves and karst features such as sinkholes, bedrock fractures that provide rapid recharge of karst aquifers, and springs that provide riparian habitat [4].

Figure 1: Karst occurrence zone overview. Background image credit: Google Earth. Image date: July 13, 2024. Image datum: WGS-84.

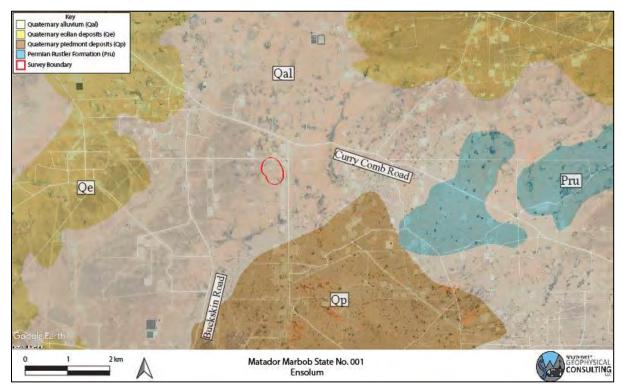
The site for the MS01 survey is located at an elevation of 1,024 meters (3,360 feet), \pm 6 meters (19.7 feet). This region is entirely underlain by the Permian Rustler Formation (Pru). The area is mantled by thin gypsiferous soils (gypsite), Quaternary alluvial piedmont gravels (Qp), eolian deposits (Qe), and alluvium (Qal)^[11] up to 5 meters in depth (**Figure 3**).

The Rustler Formation is an evaporite facies composed mainly of thin siltstones and sandstones interbedded with claystones, dolomite, and gypsum, and contains both karst-forming strata (the Forty-niner and Tamarisk members) and two shallow aquifers (the Magenta and Culebra Dolomite members)^[12].

The Pru overlies the Permian Salado Formation (PsI – not shown in the below image), a layer of extremely soluble halite which can readily dissolve to create caves, sinkholes, and other karst features; however, due to its extremely soluble nature, only non-soluble silt and sand remain from the dissolution of this layer at the surface^[12]. The Rustler Formation may be subject to collapse if a void has developed beneath it in the Salado Formation^[13].

Figure 3: Geology overview. Geology map credit: The Digital Geologic Map of New Mexico in ARC/INFO Format. Background image credit: Google Earth. Image date: July 13, 2024. Image datum: WGS-84.

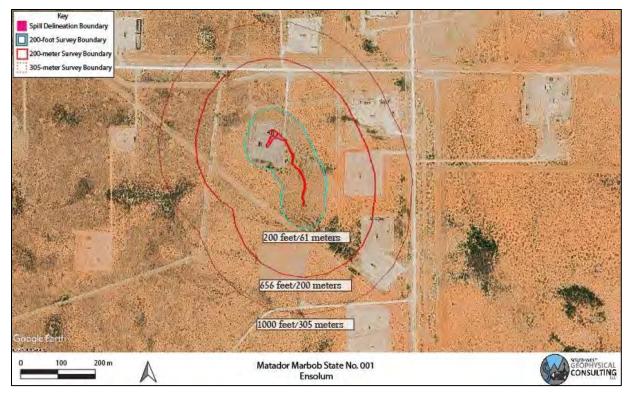
Surface karst surveys are conducted by sUAS at low elevation within 200 meters of the spill delineation boundary^[4] (**Figure 4**) following a preplanned raster pattern flightpath designed for the purpose of generating at least 75% imagery overlap. The collected high-resolution, georeferenced imagery is stitched together to develop orthomosaic imagery which is further developed into a digital elevation model (DEM); the DEM is then processed into a local relief model (LRM) (**Figure 6**). This LRM is color coded to enhance differences in elevation of as little as five centimeters. The orthoimagery, DEM, and LRM are uploaded to a server where they are analyzed by an experienced karst geologist. Finally, the data is reviewed by a senior karst geologist for quality assurance and downloaded into a table for inclusion in a written report^[16].

Figure 4: Surface survey overview. Background image credit: Google Earth. Image date: July 13, 2024. Datum: WGS-84.

The resolution of the orthoimagery is clear enough that features as small as 10 centimeters can be positively identified in most circumstances. Occasionally there are ambiguous features identified during an aerial survey that will need to be checked in the field if they are impacted by the proposed remediation efforts. Specifically, it is difficult to tell the difference between solution tubes, abandoned uncased well bores, and some burrows in drone imagery. If an ambiguous feature is located during imagery analysis, it is marked with a yellow dot in **Figure 6**. If a feature of any likelihood is subsequently verified in the field prior to publication of the report, the dot will be changed to a red triangle if confirmed as a karst feature or deleted if not.

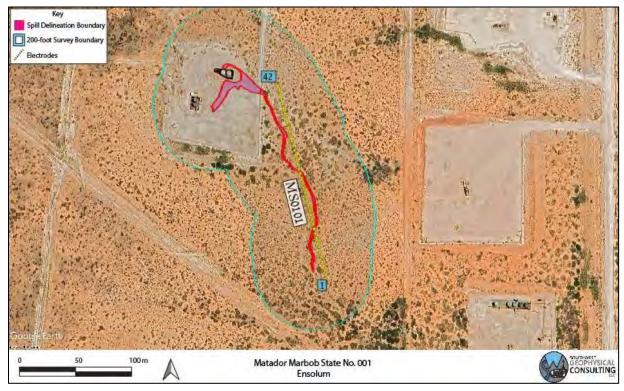
For this survey, a Guideline Geo Terrameter LS 2 and a 42-electrode array of 40-centimeter-long electrodes were used to image the subsurface. This survey consisted of one resistivity line in a dipole-dipole configuration laid out south to north. This line consisted of 42 electrodes at 5-meter spacing, resulting in a 205-meter-long array (**Figure 5**, **Table 1**). A preconfigured protocol file was used to run the data collection (DipoleDipole3x14). This electrode configuration provided a depth of investigation of 41 meters (135 feet) and a resolution of 2.5 to 3.0 meters (8.2 to 9.8 feet) within the first 5 to 8 meters (16 to 26 feet) from the surface. A Leica GS18 GPS was used to record electrode locations and elevations.

Figure 5: Geophysical survey overview. One survey line was conducted with 42 electrodes at 5-meter spacing (yellow dots denoted with blue numbers). Background image credit: Google Earth. Image date: July 13, 2024. Image datum: WGS-84.

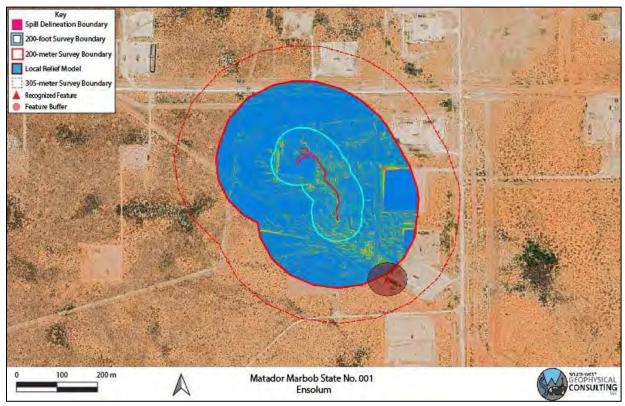
One recognized surface karst feature is located within the 305-meter survey boundary (**Figure 6**, **Table 3**). Recognized surface karst features are features that are positively identified in either satellite or aerial imagery as karst features and the features have been visited by a qualified karst professional in the field and fully identified. Images for the feature are available on request.

No springs exist within the 305-meter (1,000-foot)^[1] survey boundary (**Figure 6**).

Figure 6: Surface karst survey results. Background image credit: Google Earth. Image date: July 13, 2024. Image datum: WGS-84.

No surface karst features exist within 200 feet of the spill delineation boundary. One recognized surface karst feature exists outside the 200-meter survey boundary, but within the 305-meter survey boundary. This feature is associated with the nearby pipeline and may be either trench collapse caused by soil settling or karst related, with soil raveling into a solution-enlarged fracture or small void beneath the pipeline.

Caution should be exercised while operating in or around all karst-related features due to the possibility of near-surface voids. Employing a BLM-CFO approved karst monitor on site during these activities should be considered.

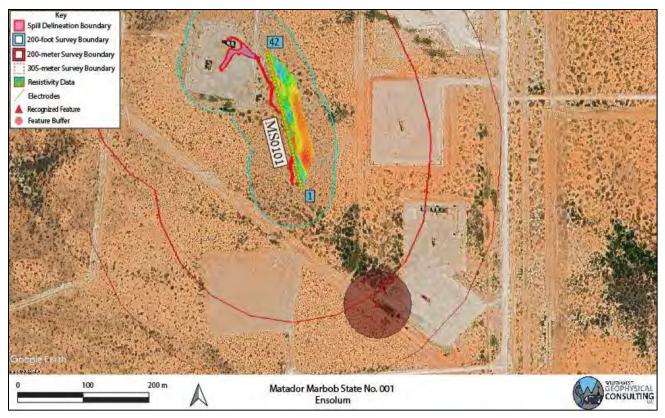
No anomalies consistent with air-filled subsurface voids are found within the MS01 survey area. Small solutionally enlarged voids or fractures at or near the resolution limit of the survey (2.5 - 3.0 meters) may be present. Areas of moderate resistivity (yellows, and greens) near the surface are interpreted as dry gypsite soils and gypsum or dolomite bedrock of the Rustler Formation^[17] (**Figure 7** and **Figure 8**). Very low-resistivity areas between 19.2 - 25 Ohm-m may either represent fluid from the brine release, surface-to-subsurface hydrologic pathways, or a layer of either clays and halite lenses or moist or saturated layers within the Rustler Formation (**Figure 7**).

Figure 8: Data overlay. Colored trapezoid is the 2D inverted resistivity line. Background image credit: Google Earth. Image date: July 13, 2024.

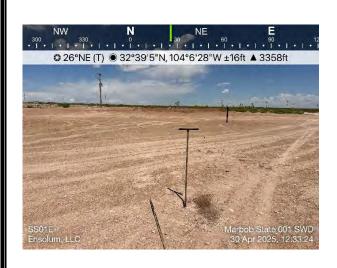
Photograph 6 Date: 04/30/2025 Description: Delineation Soil Sampling Activites

View: Wesr
